Baseline Assessment – Stream Attributes

Reach S-RR5 (Pipeline ROW)

Giles County, Virginia

Crossing S-RR5 - UNT to Sinking Creek (MP 208.4)

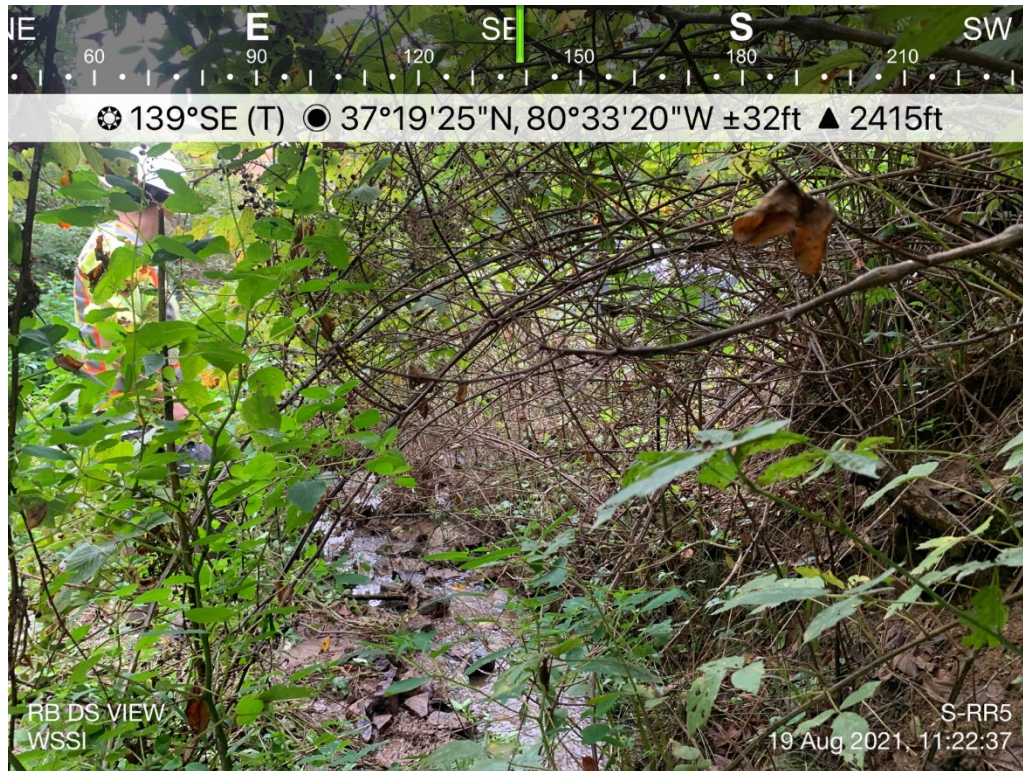
Photo Type: RB DS VIEW

Location, Orientation, Photographer Initials: Standing on RB looking downstream along the ROW looking SE, AW

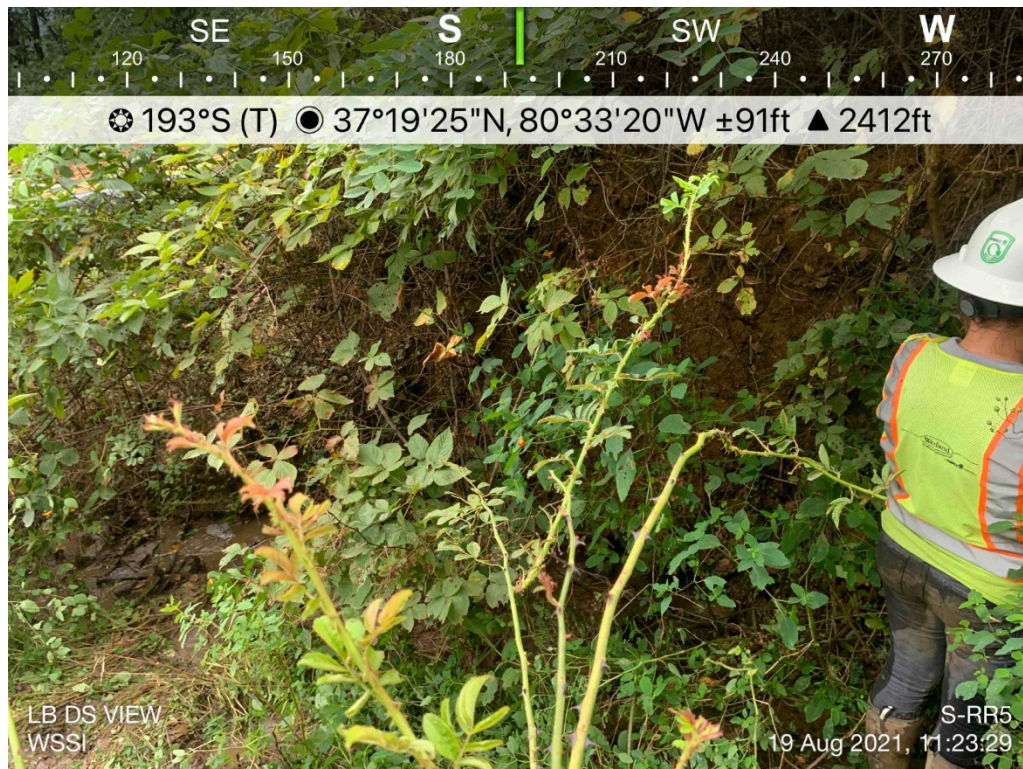
Photo Type: LB DS VIEW

Location, Orientation, Photographer Initials: Standing on LB looking downstream along the ROW looking S, AW

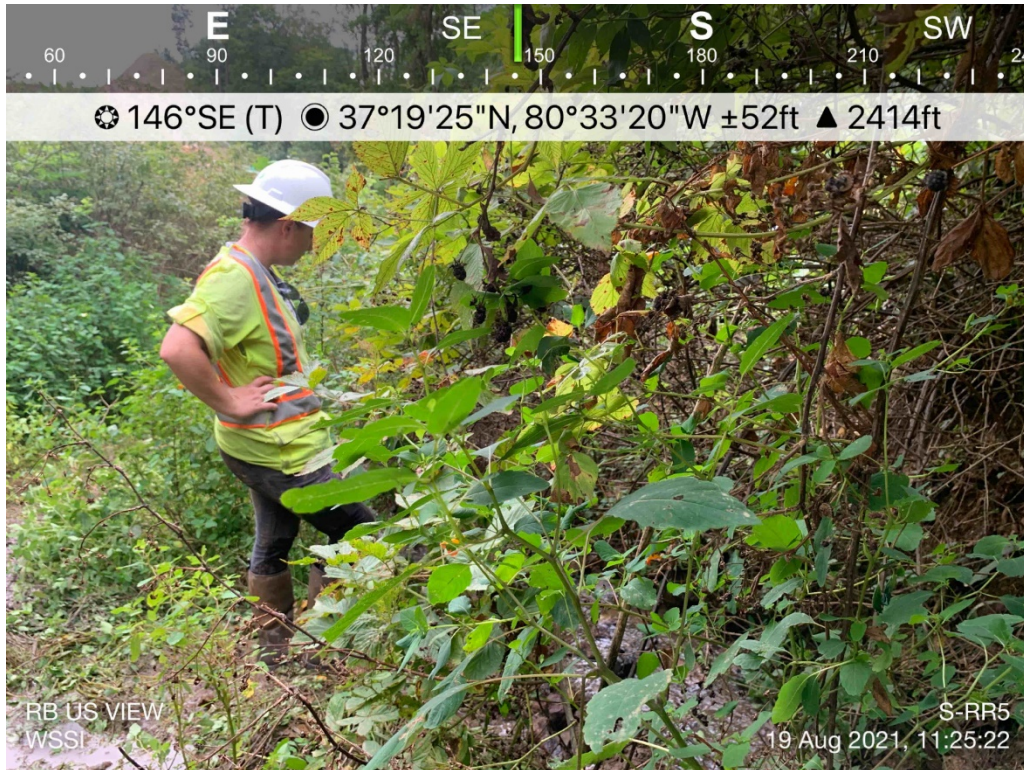
Photo Type: RB US VIEW

Location, Orientation, Photographer Initials: Standing on RB looking upstream along the ROW looking NW, AW

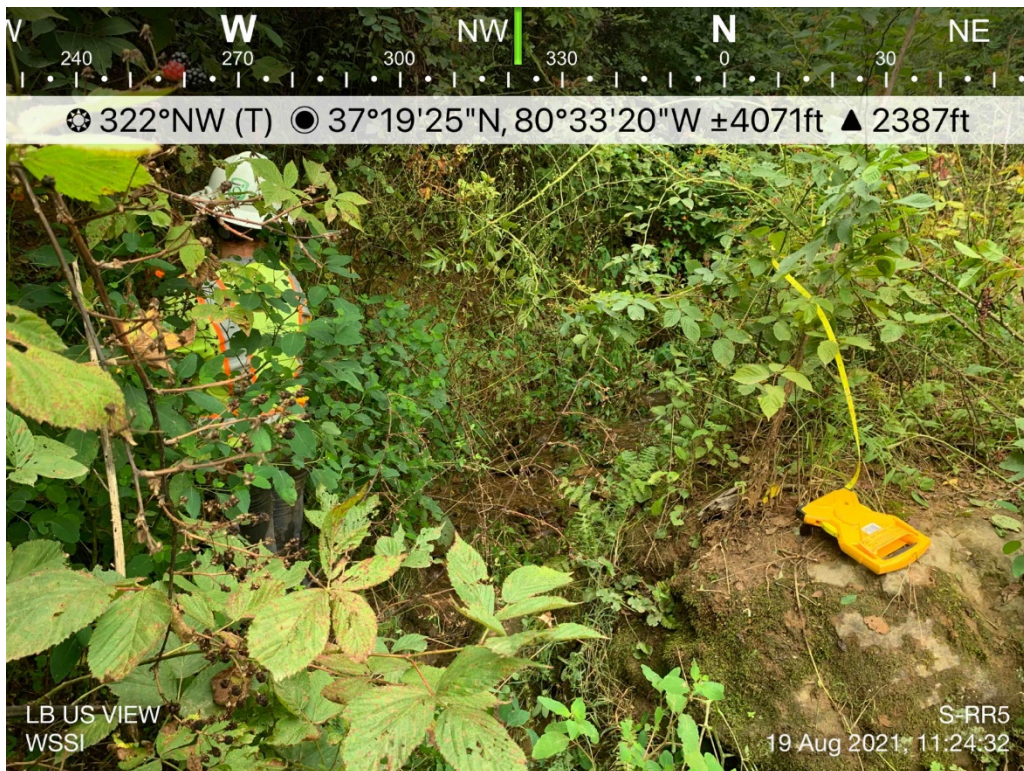
Photo Type: LB US VIEW

Location, Orientation, Photographer Initials: Standing on LB looking upstream along the ROW looking NW, AW

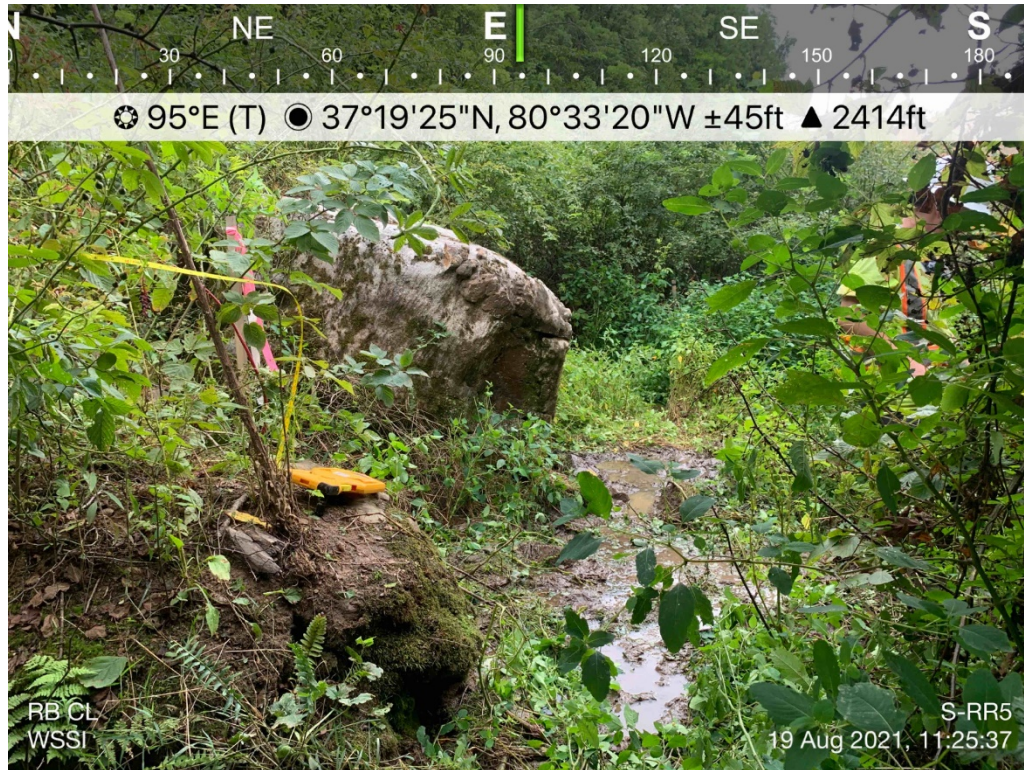
Photo Type: RB CL

Location, Orientation, Photographer Initials: Standing on RB looking at LB along pipe centerline looking E, AW

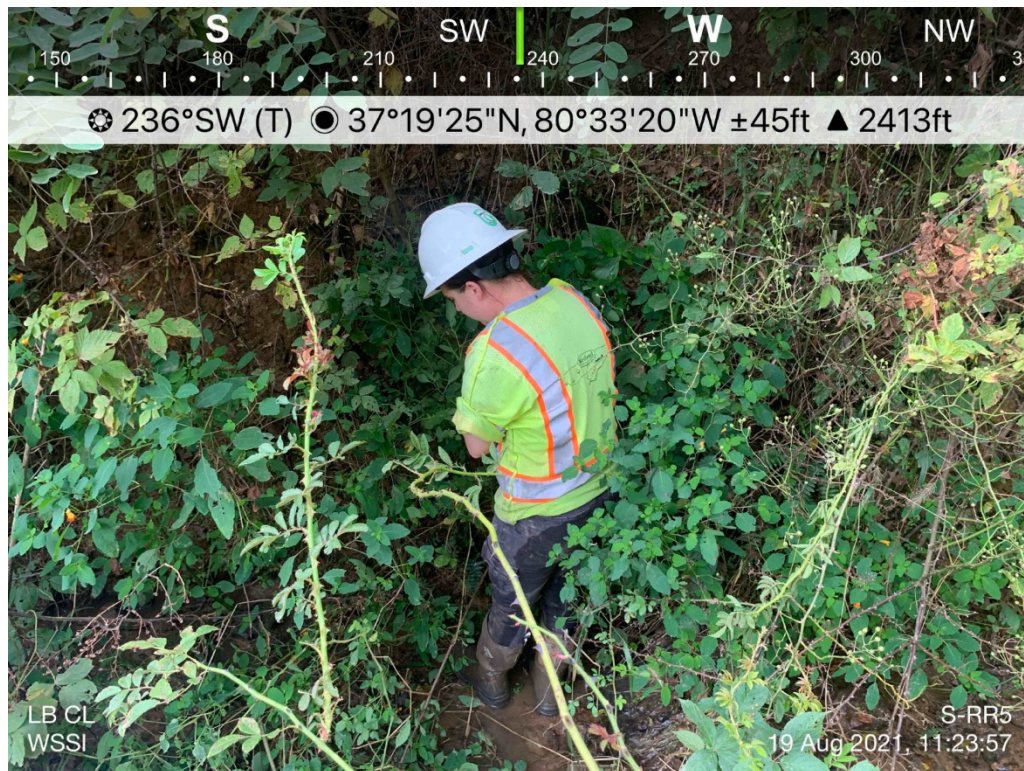
Photo Type: LB CL

Location, Orientation, Photographer Initials: Standing on LB looking at RB along pipe centerline looking SW, AW

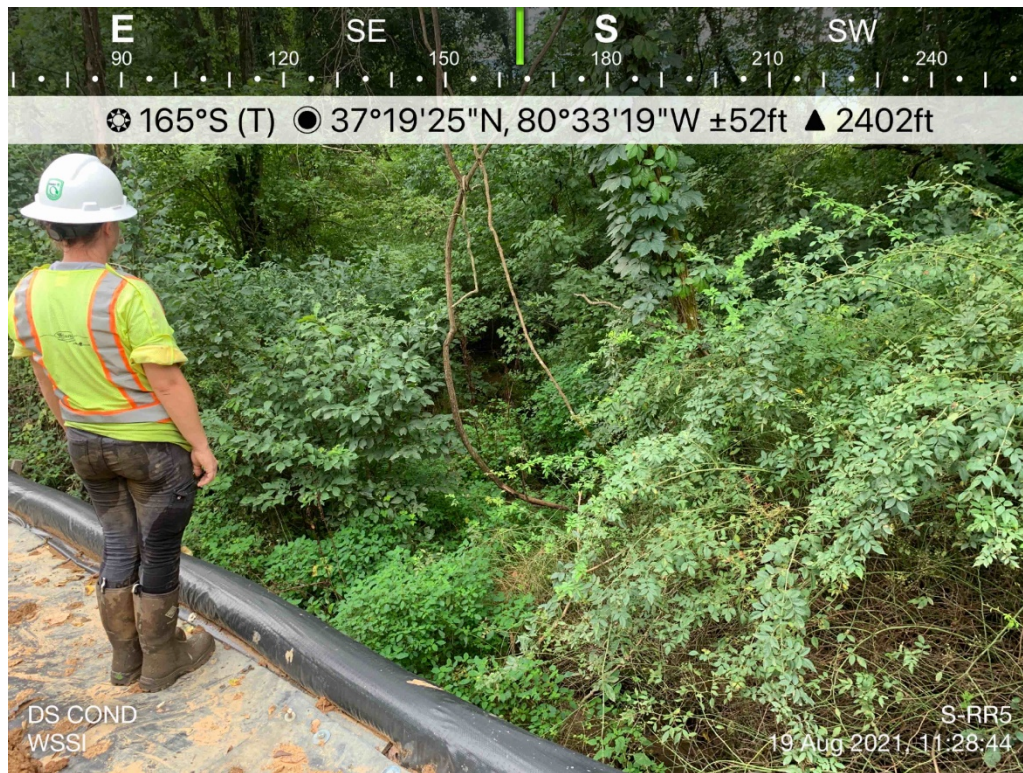
Photo Type: DS COND

Location, Orientation, Photographer Initials: Downstream conditions outside of ROW looking SE, AW

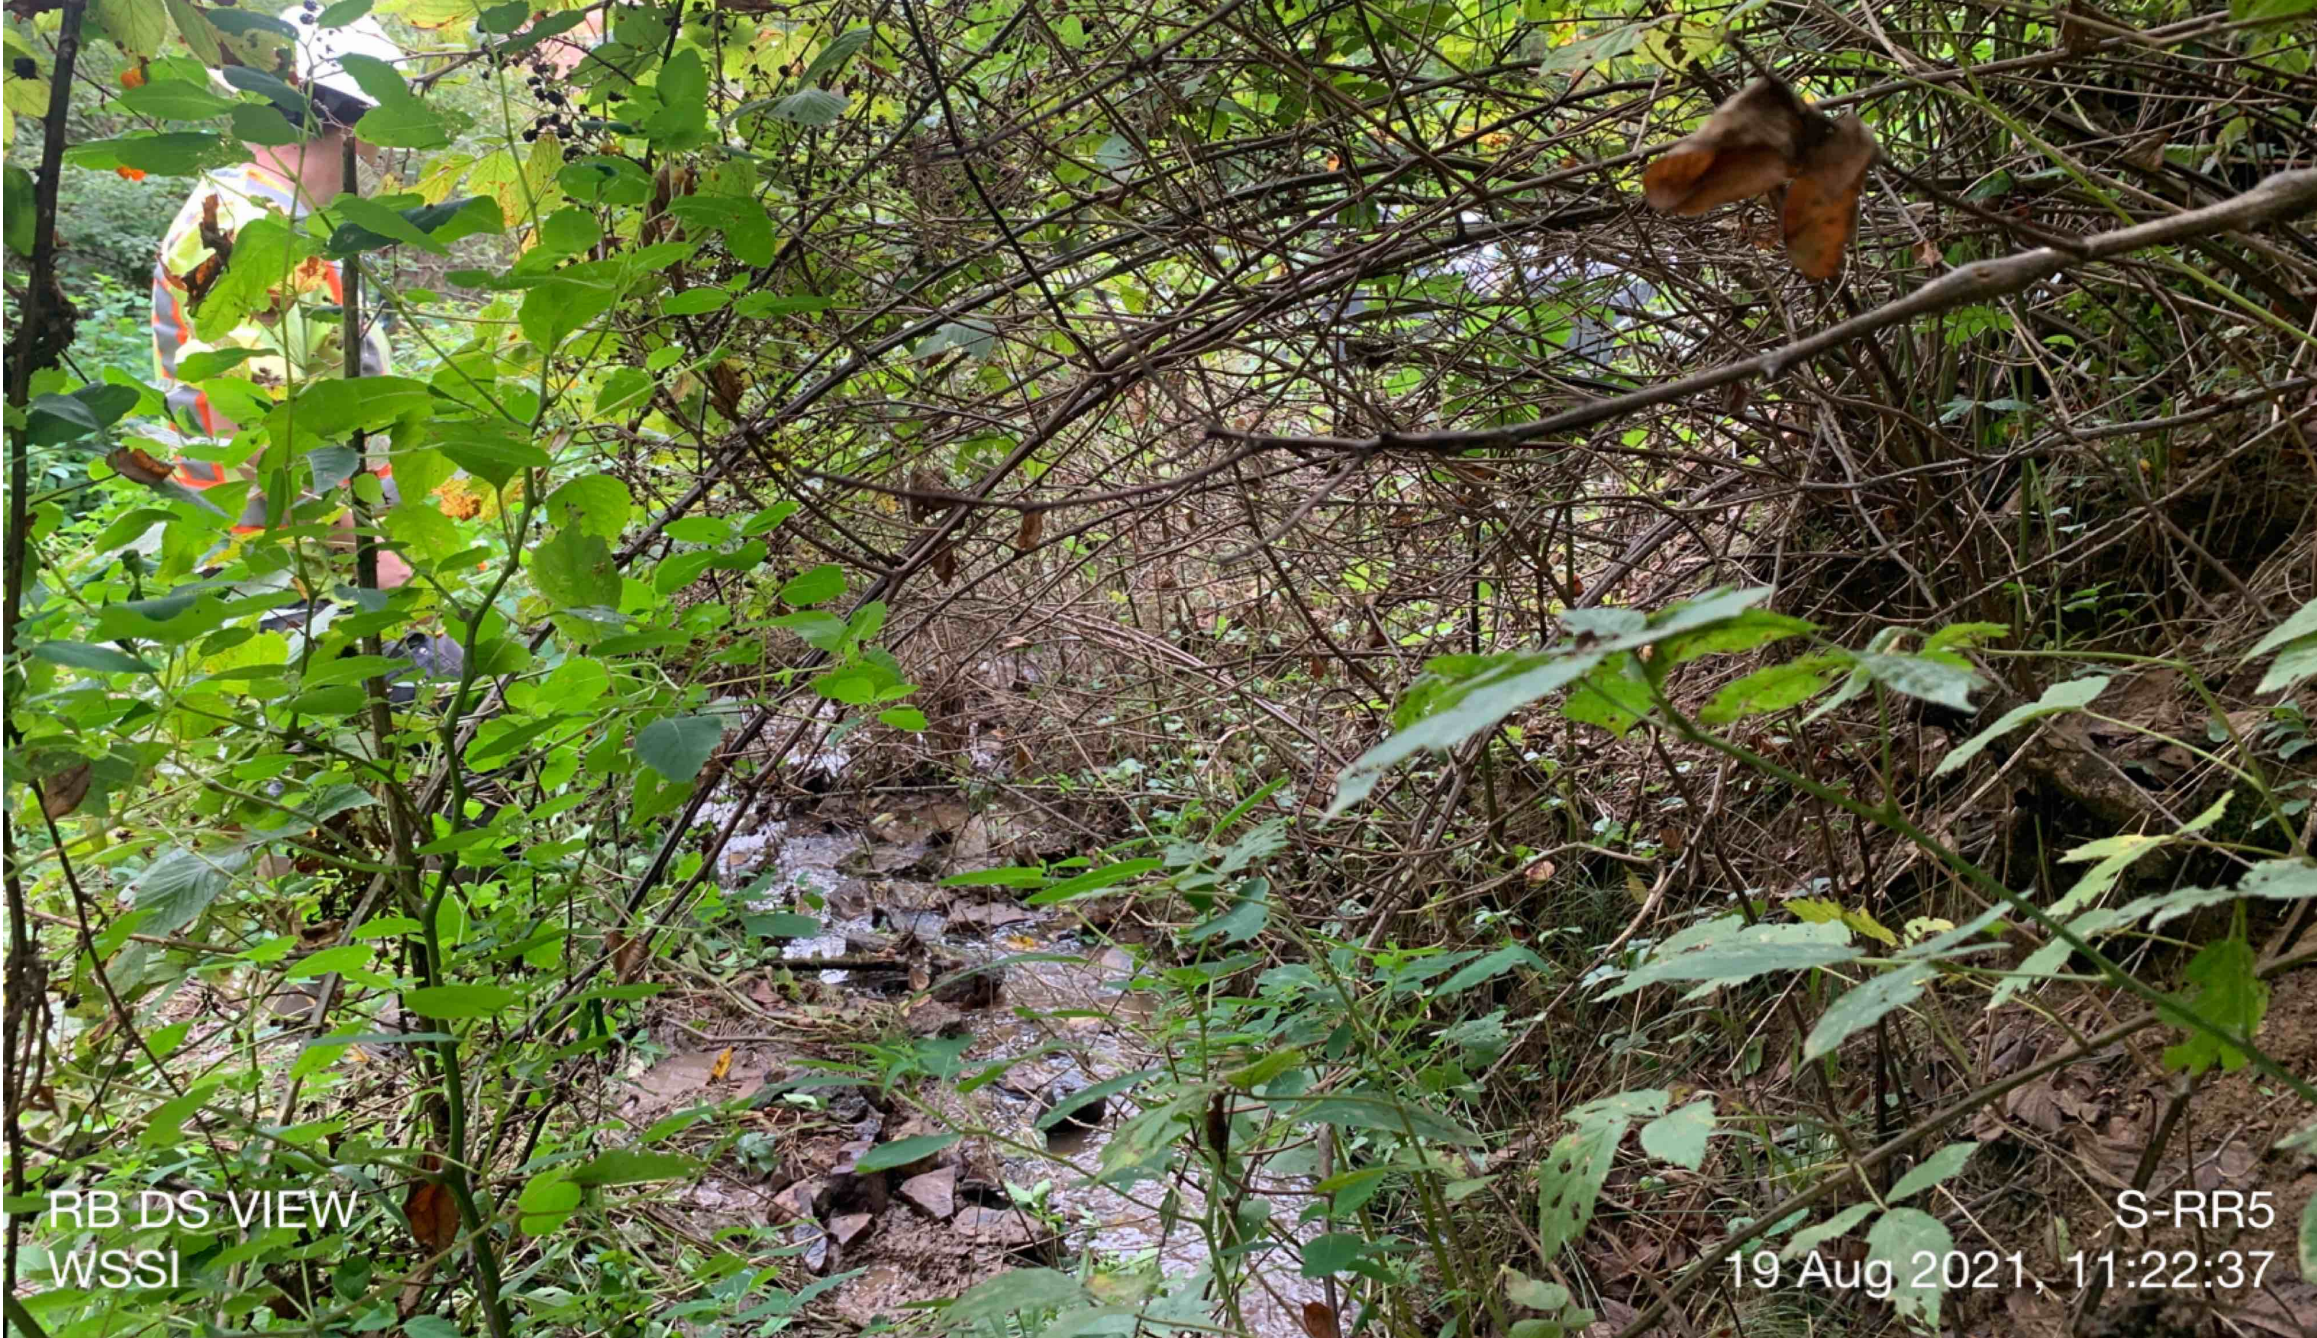
RB DS VIEW

Reach S-RR5 looking upstream within ROW. Assessment is limited to areas within the temporary ROW.
