Baseline Assessment – Stream Attributes

Reach S-A13 (Timber Mat Crossing)

Franklin County, Virginia

Project #	Project Name (Applicant)	Locality	Cowardin Class.	HUC	Date	SAR #	Impact Length	Impact Factor
22865.06	Mountain Valley Pipeline (Mountain Valley Pipeline, LLC)	Franklin County	R3	03010101	8/25/2021	S-A13	20	1
Name(s) of Evaluator(s)		Stream Name and Information					SAR Length	
AJ, VM		Spread I; Franklin County, Turkey Creek					90

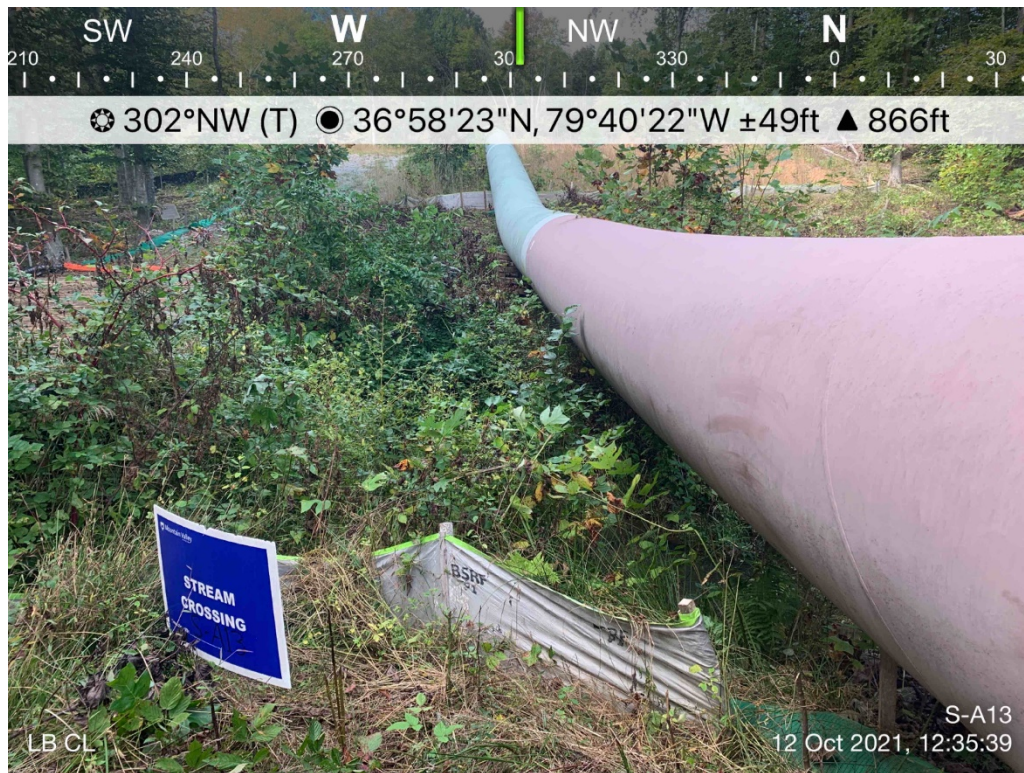
Photo Type: LB CL

Location, Orientation, Photographer Initials: On thalweg at pipe centerline looking SE at left streambank, BH

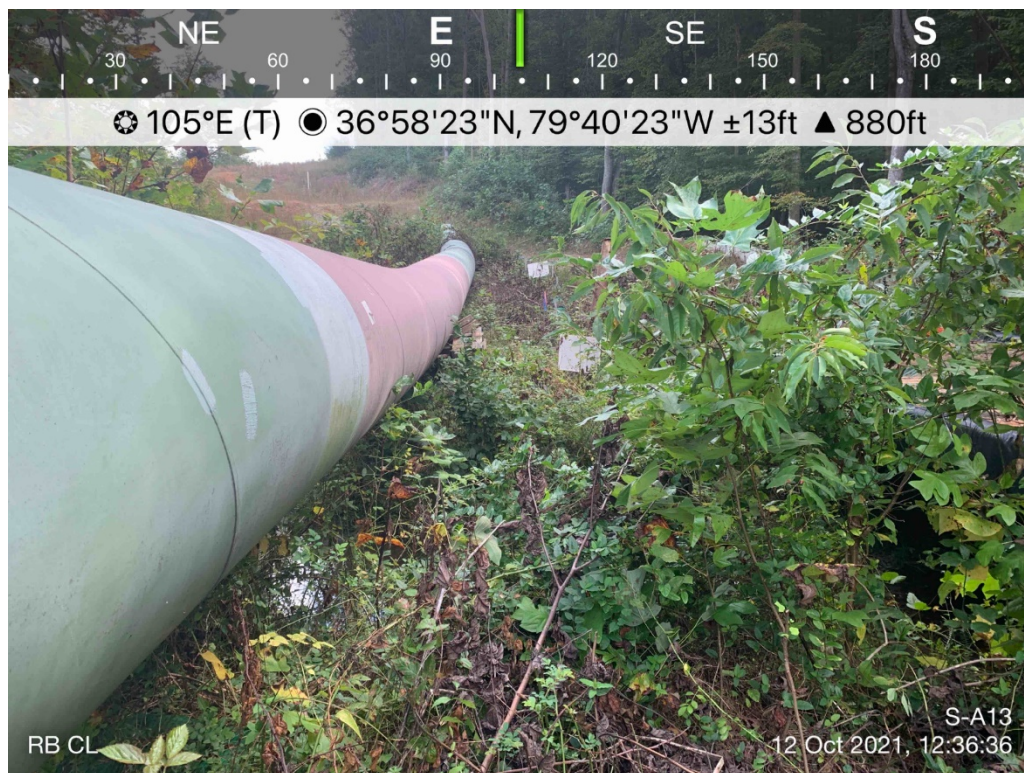
Photo Type: RB CL

Location, Orientation, Photographer Initials: On thalweg at pipe centerline looking NW at right streambank, BH

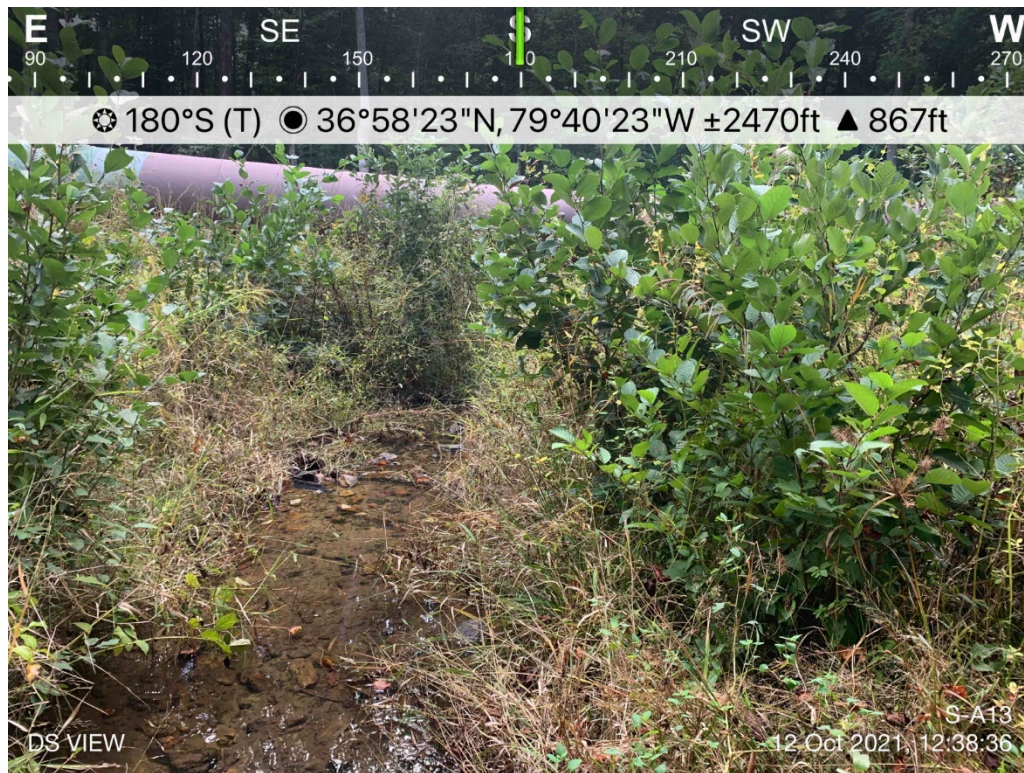
Photo Type: DS View

Location, Orientation, Photographer Initials: On thalweg at pipe centerline looking NE at left streambank, BH

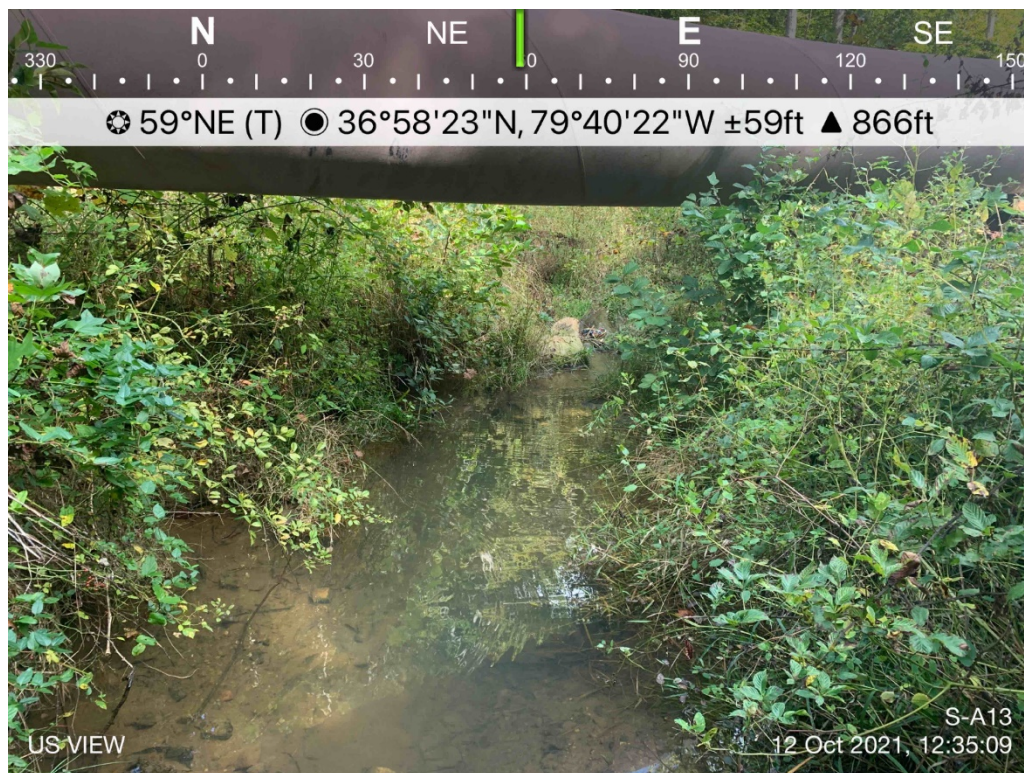
Photo Type: US View

Location, Orientation, Photographer Initials: On thalweg at pipe centerline looking SW at right streambank, BH

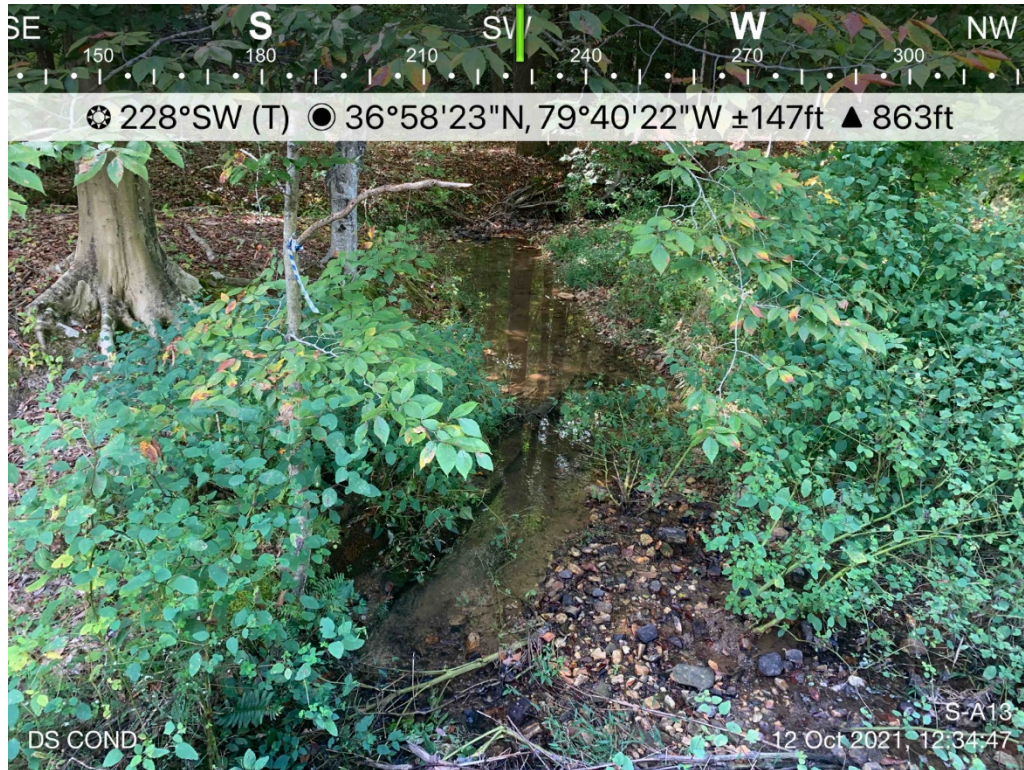
Photo Type: DS COND

Location, Orientation, Photographer Initials: Downstream at ROW/LOD looking SW upstream, BH

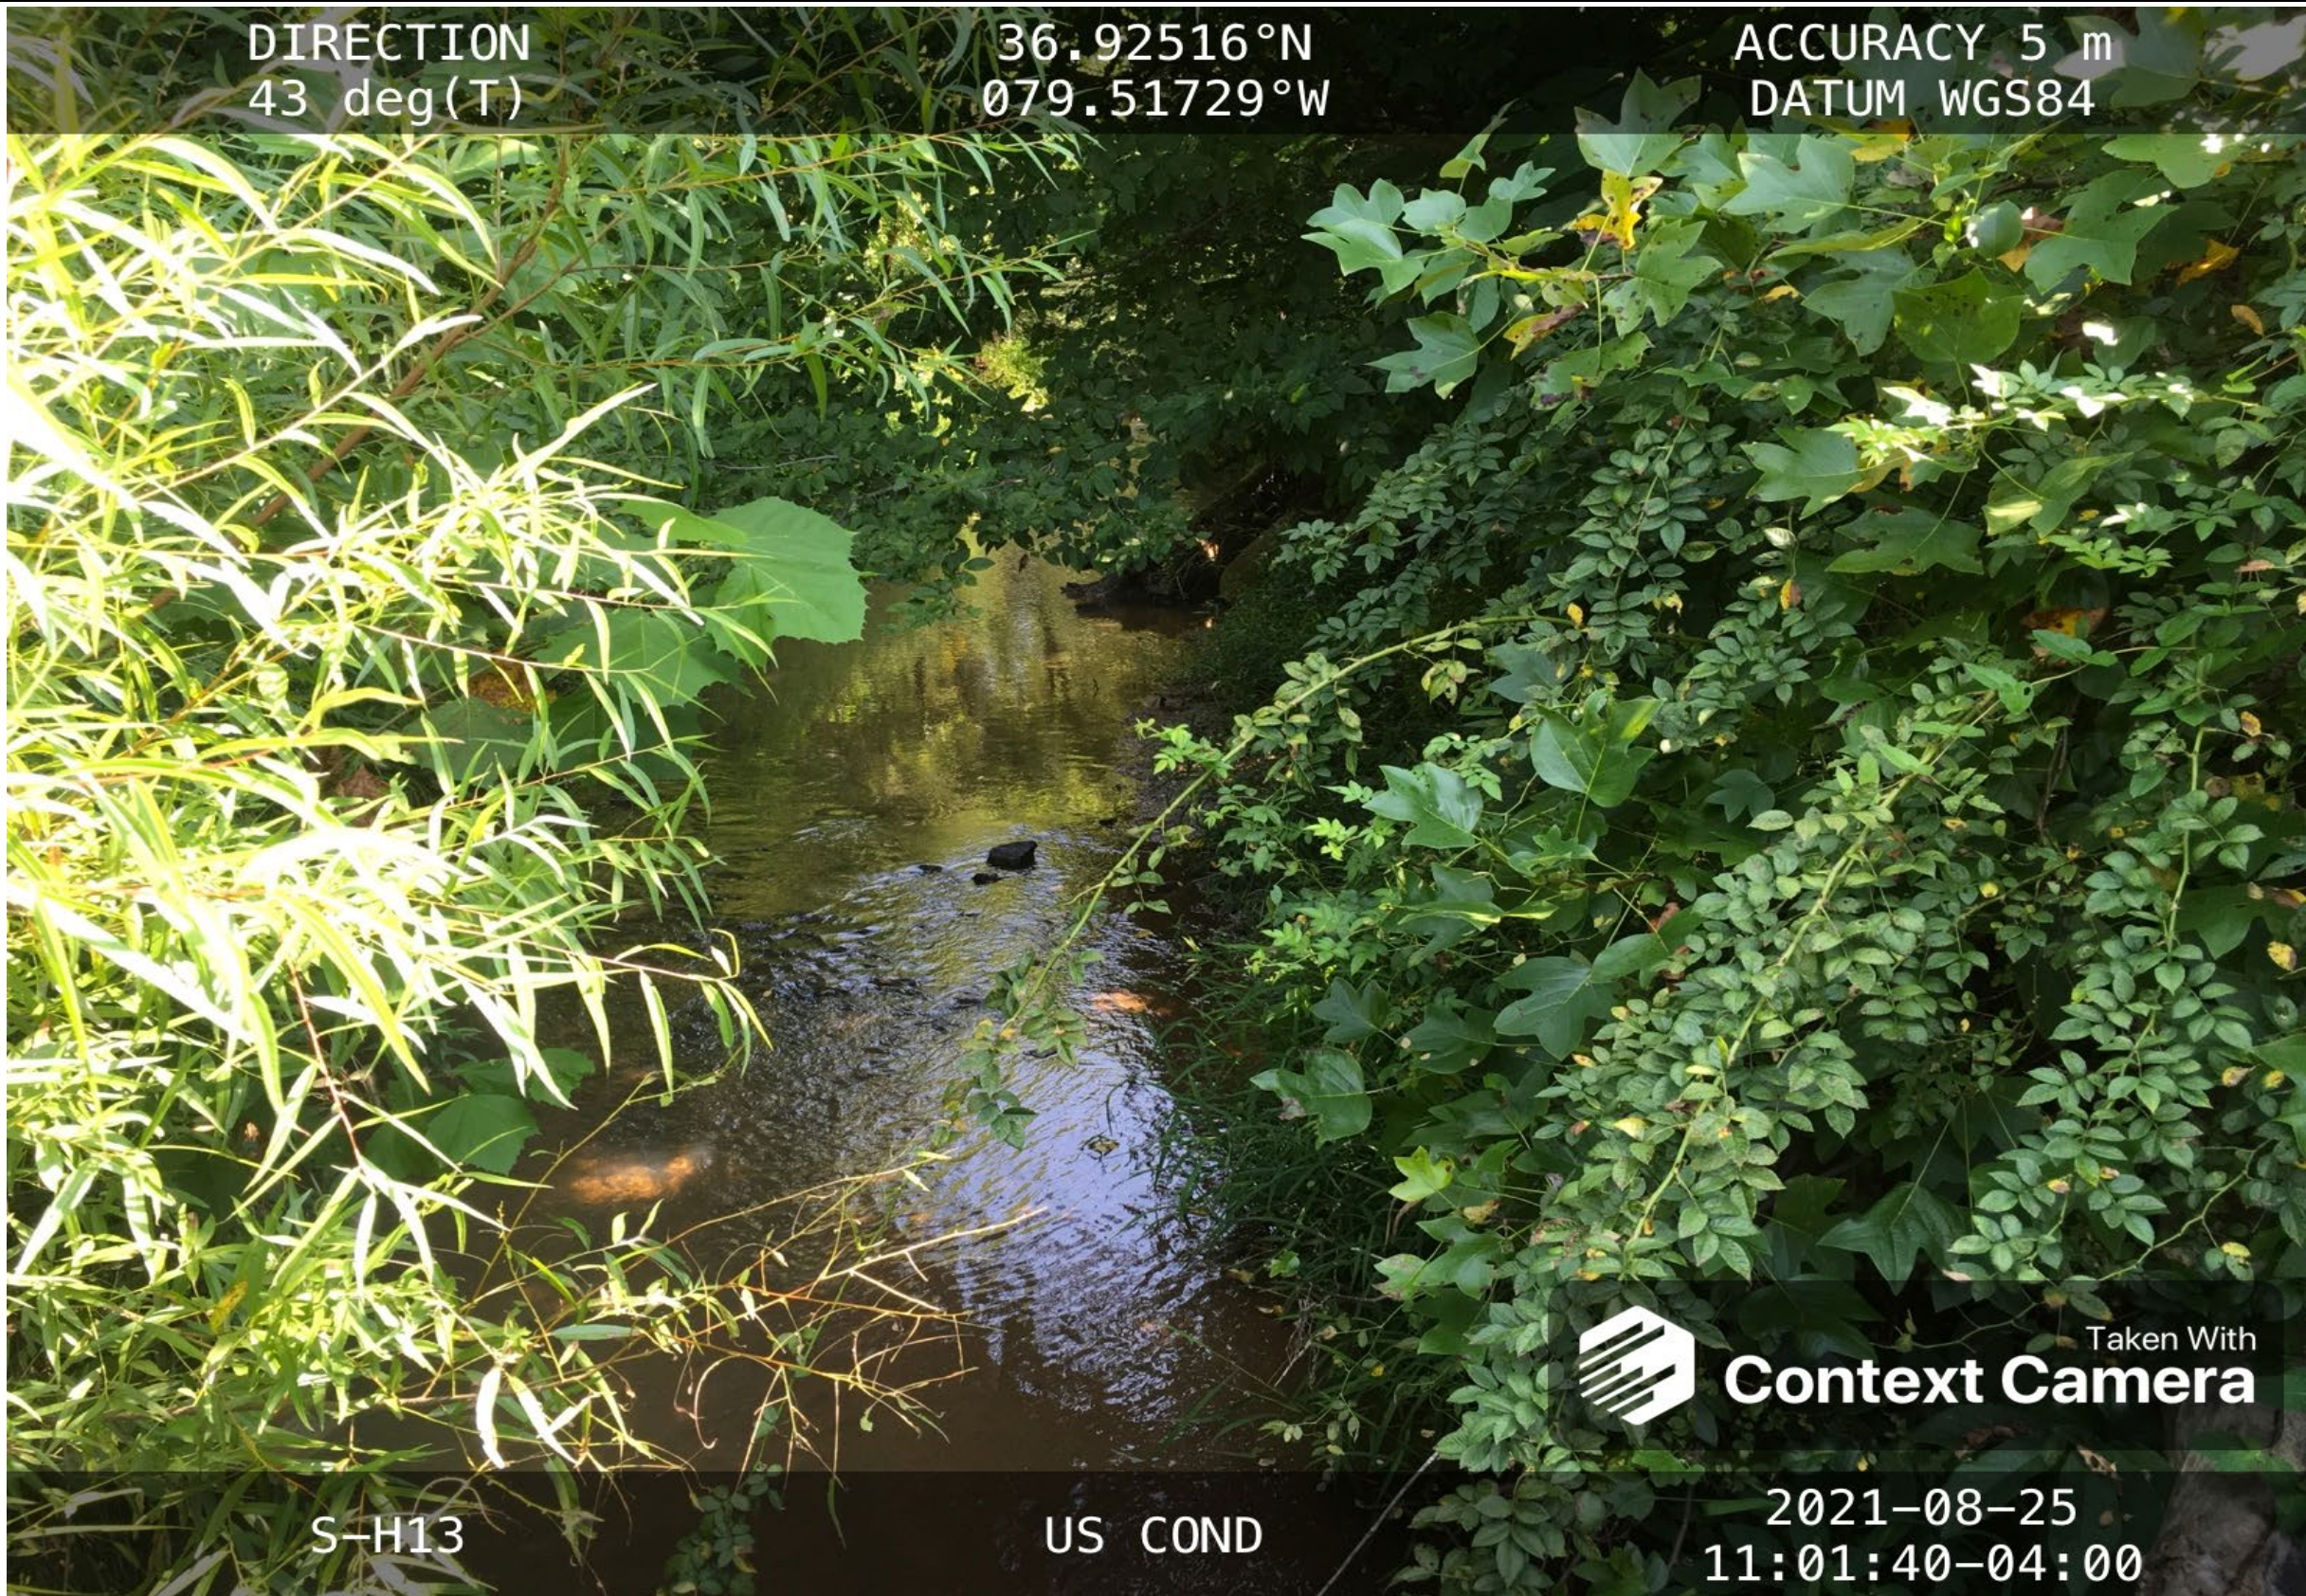
CAPTION. Assessment is limited to areas within the temporary ROW.
