Baseline Assessment – Stream Attributes

Reach S-C19 (Pipeline ROW)

Franklin County, Virginia

Spread I Stream S-C19 East (ROW) Franklin County

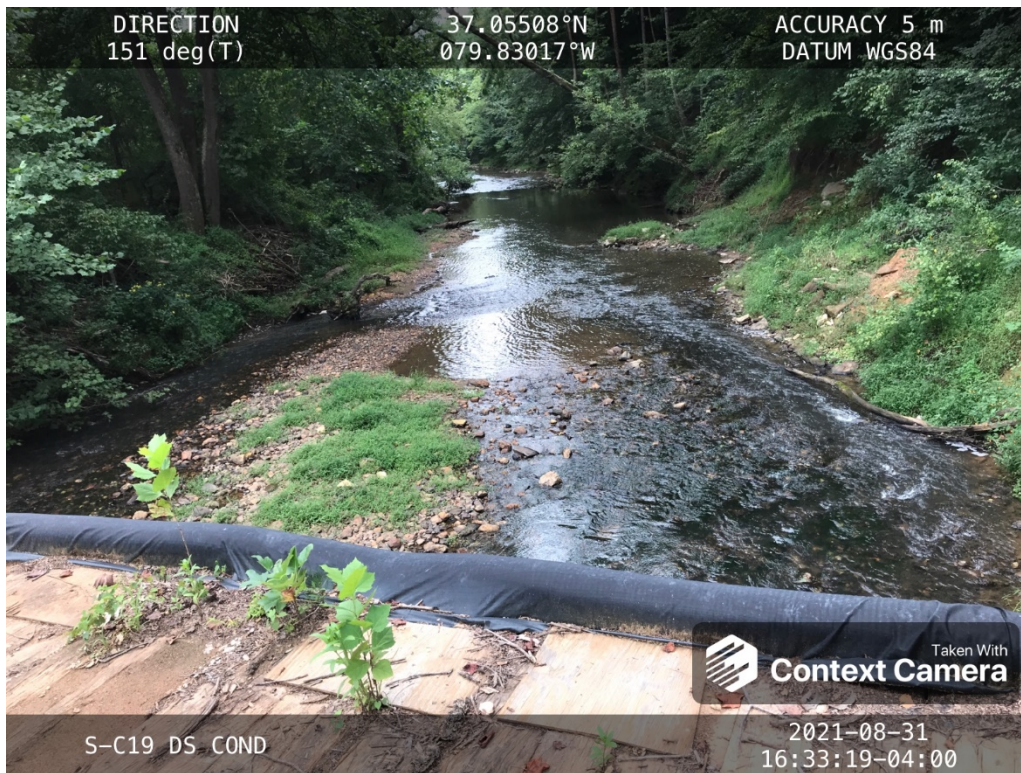
Photo Type: DS COND

Location, Orientation, Photographer Initials: Downstream at ROW/LOD looking SE downstream, RAH

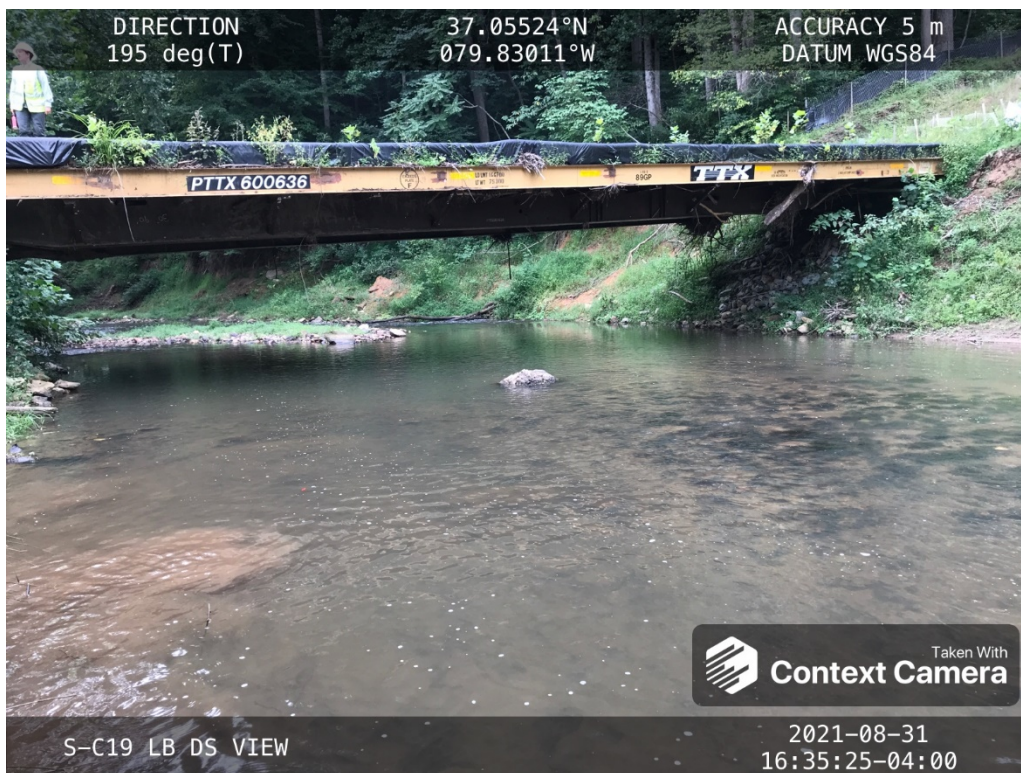
Photo Type: LB DS VIEW

Location, Orientation, Photographer Initials: Upstream at ROW/LOD on left bank looking SW downstream, RAH

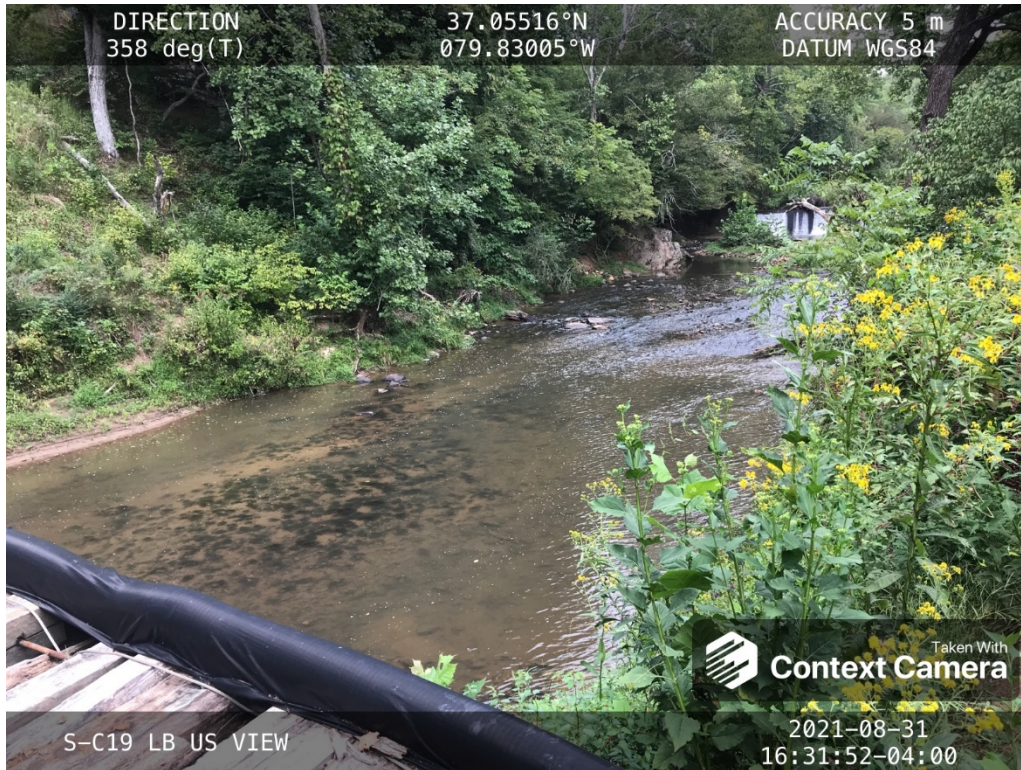
Photo Type: LB US VIEW

Location, Orientation, Photographer Initials: On ROW/LOD on left bank looking N upstream, RAH

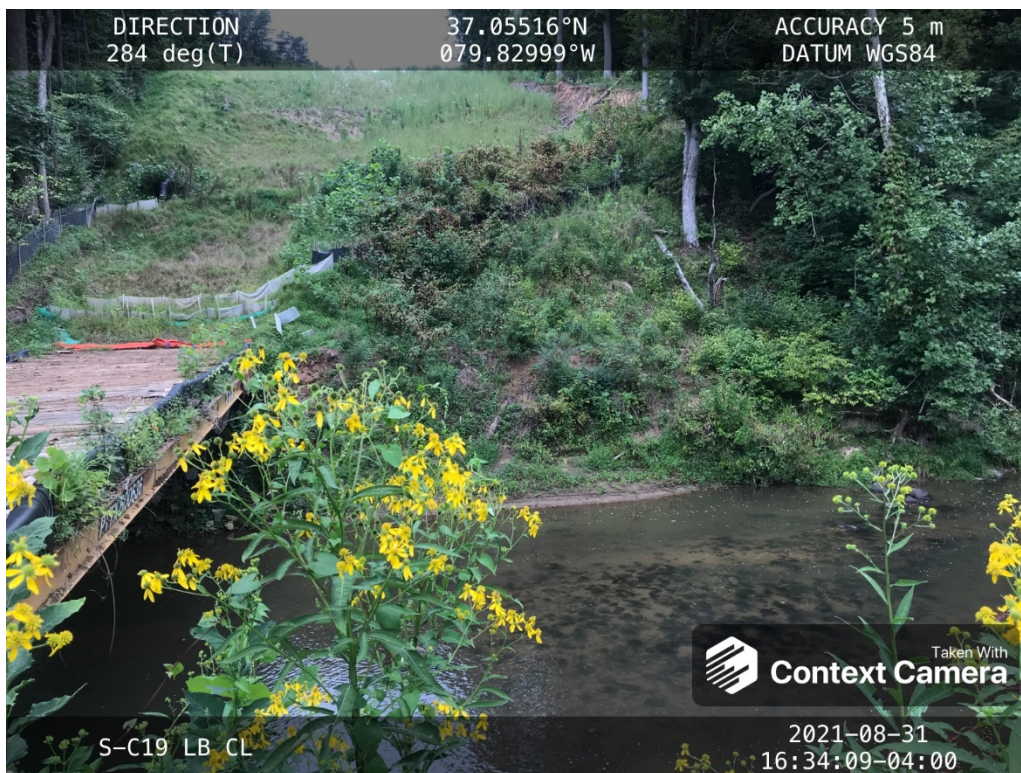
Photo Type: LB CL

Location, Orientation, Photographer Initials: On thalweg at pipe centerline looking NW at right streambank, RAH

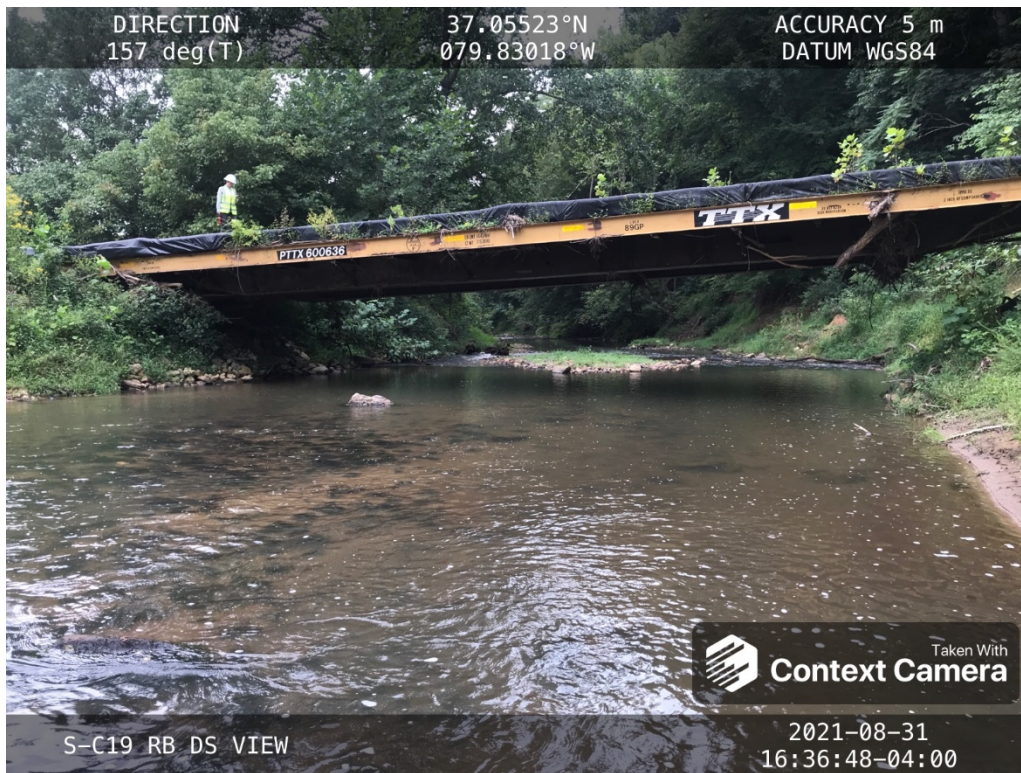
Photo Type: RB DS VIEW

Location, Orientation, Photographer Initials: Upstream at ROW/LOD on right bank looking SE downstream, RAH

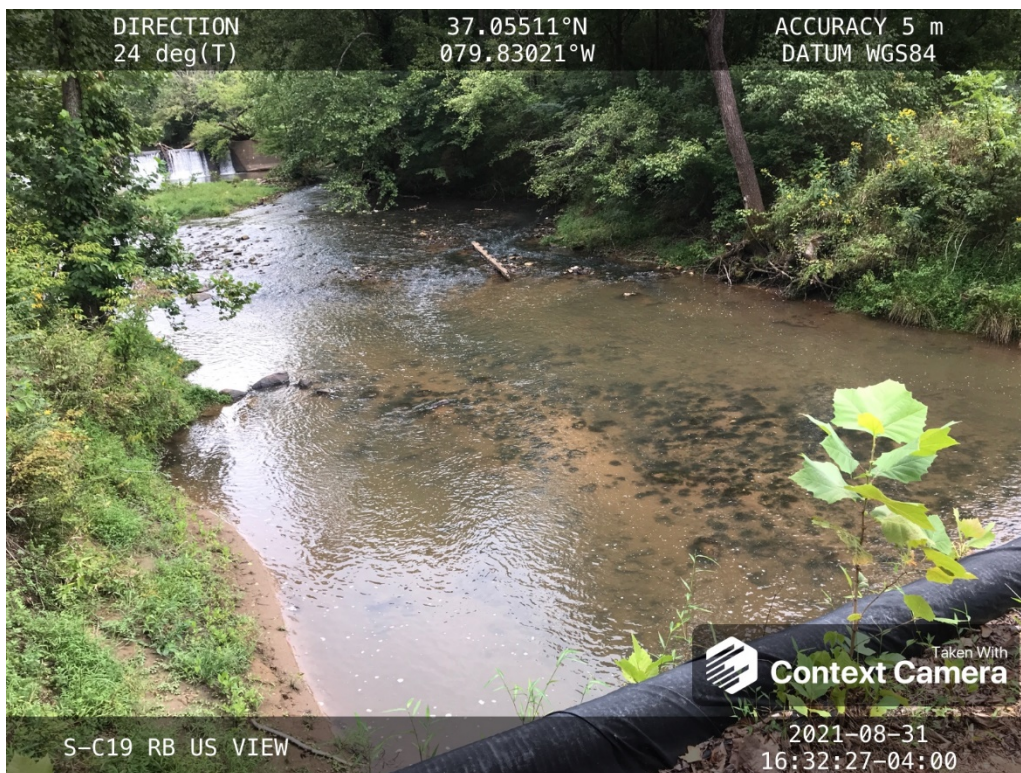
Photo Type: RB US VIEW

Location, Orientation, Photographer Initials: Downstream a ROW/LOD on right bank looking NE upstream, RAH

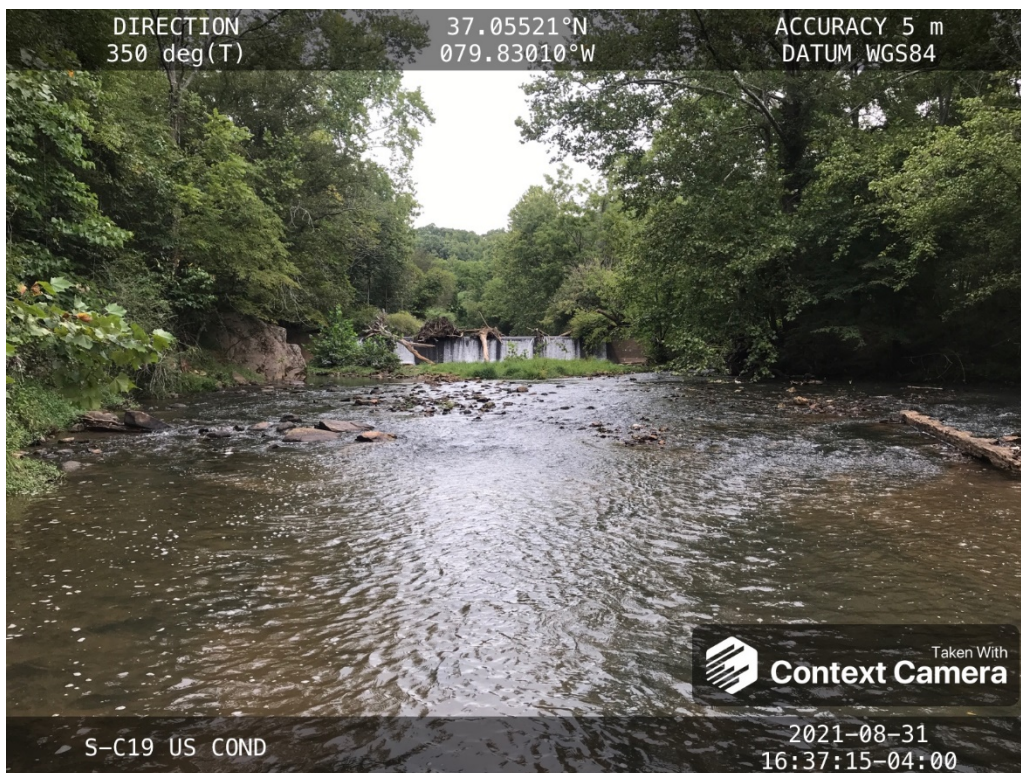
Photo Type: US COND

Location, Orientation, Photographer Initials: Upstream at ROW/LOD looking N upstream, RAH

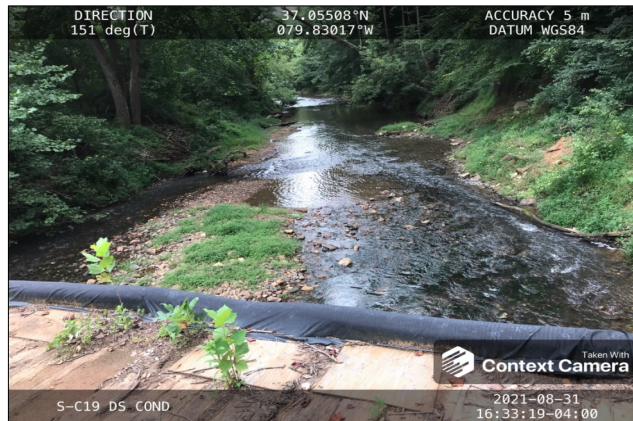
CAPTION. Assessment is limited to areas within the temporary ROW.
