Baseline Assessment – Stream Attributes

Reach S-E28-West (Pipeline ROW)

Franklin County, Virginia

Profile and Cross-Sections Baseline Survey

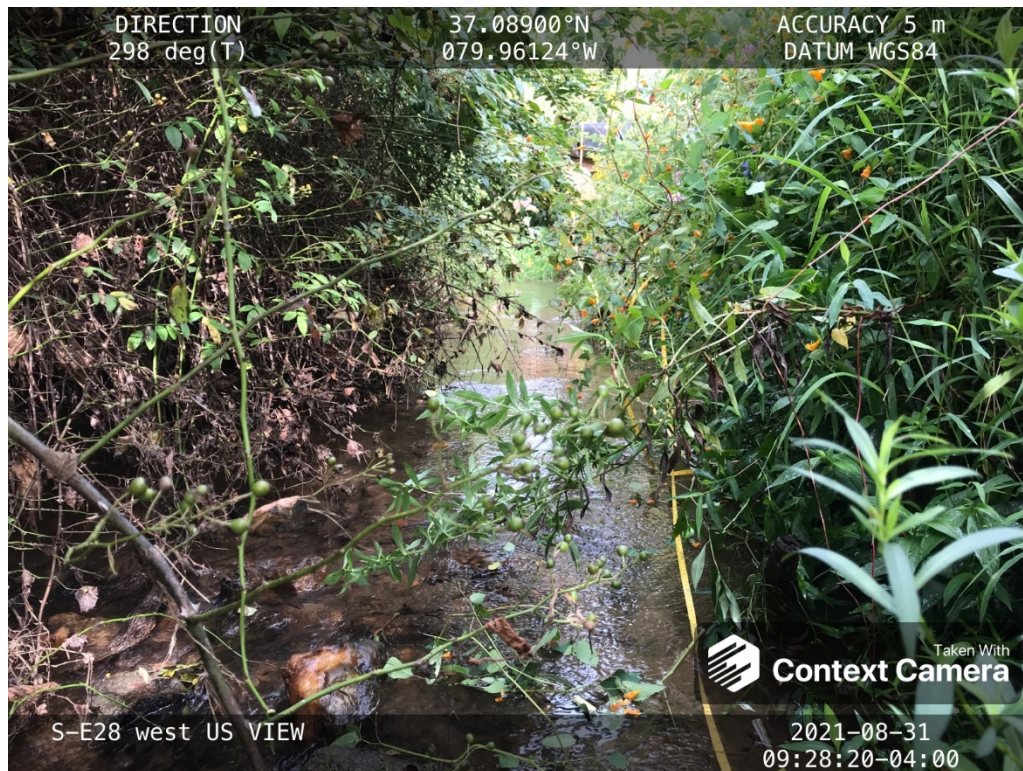
Photo Type: US VIEW

Location, Orientation, Photographer Initials: Downstream at ROW/LOD looking NW upstream, RAH

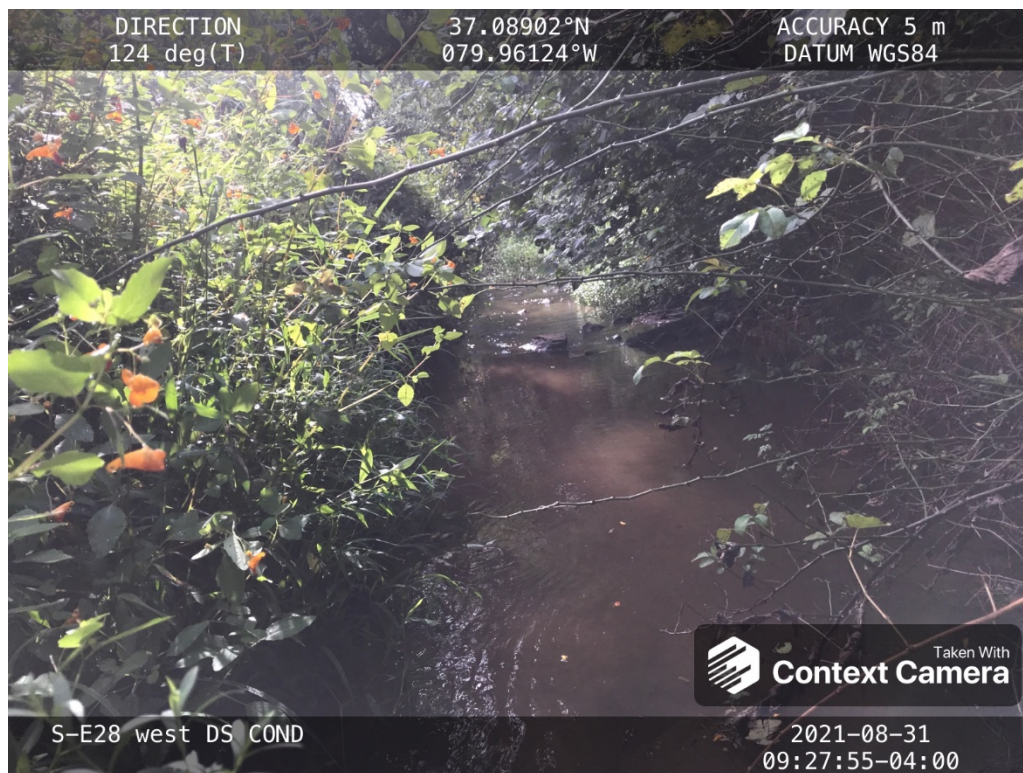
Photo Type: DS COND

Location, Orientation, Photographer Initials: Downstream at ROW/LOD looking SE downstream, RAH

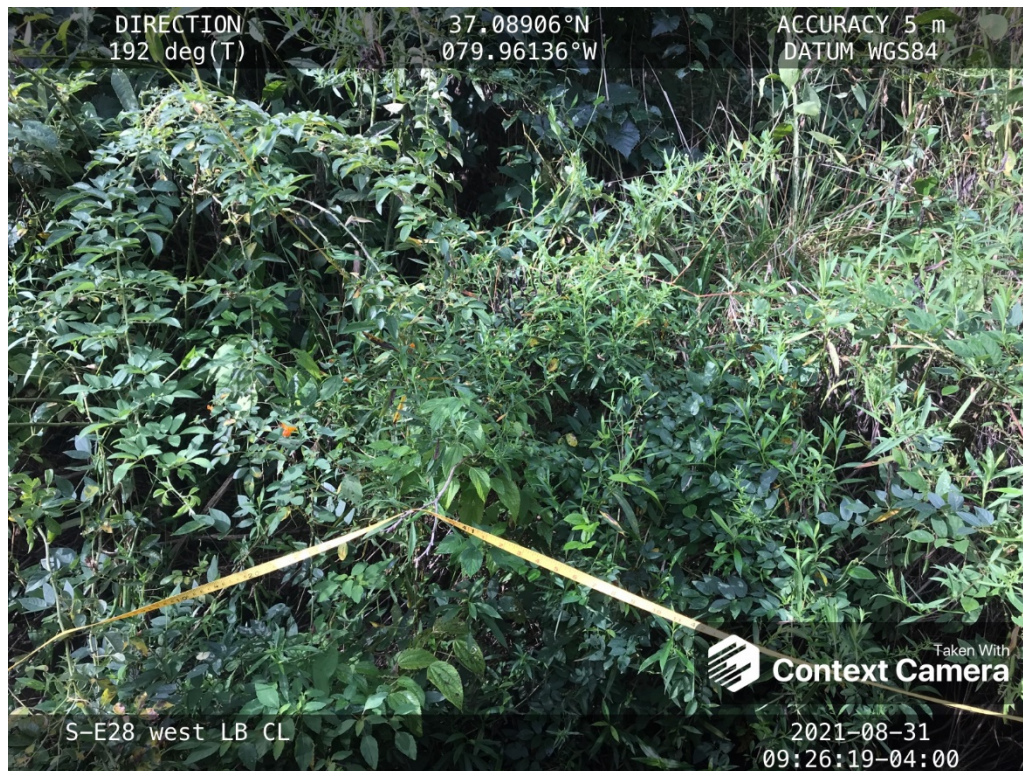
Photo Type: LB CL

Location, Orientation, Photographer Initials: On thalweg at pipe centerline looking SW at right streambank, RAH

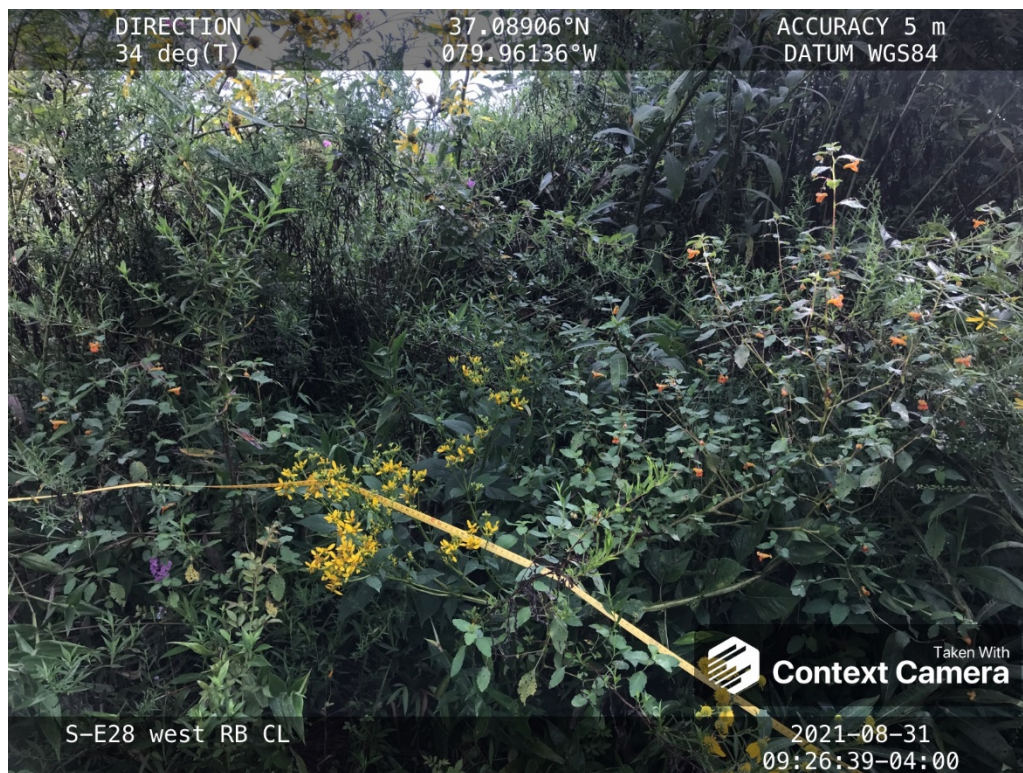
Photo Type: RB CL

Location, Orientation, Photographer Initials: On thalweg at pipe centerline looking NE at left streambank, RAH

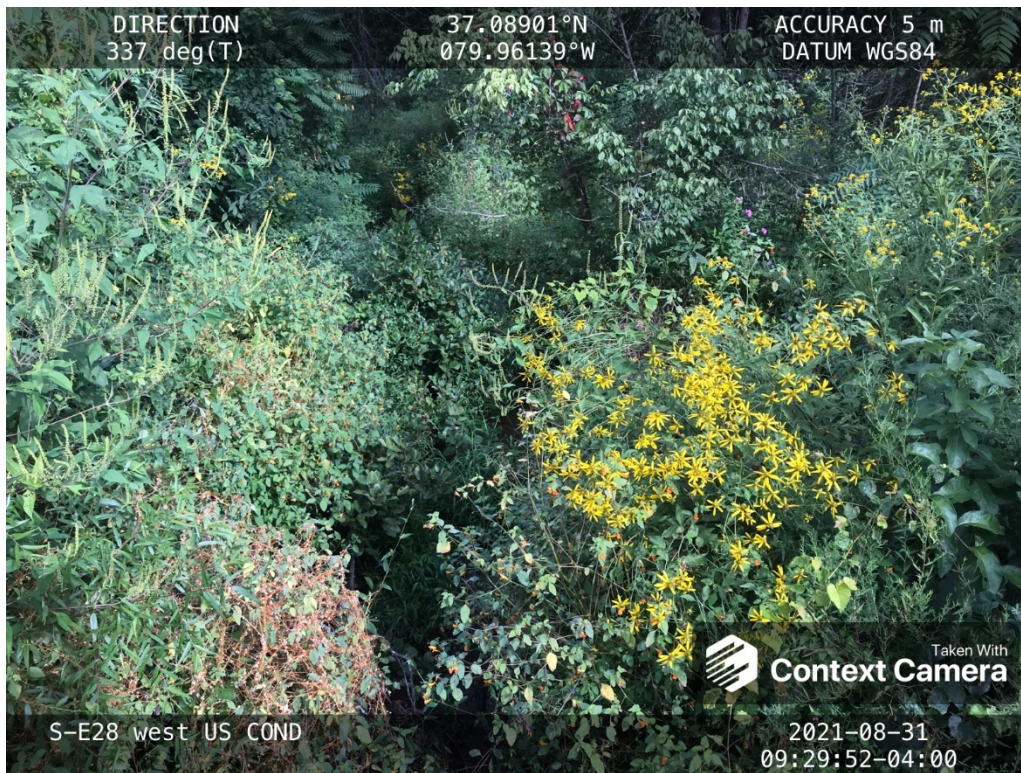
Photo Type: US COND

Location, Orientation, Photographer Initials: Upstream at ROW/LOD looking NW upstream, RAH

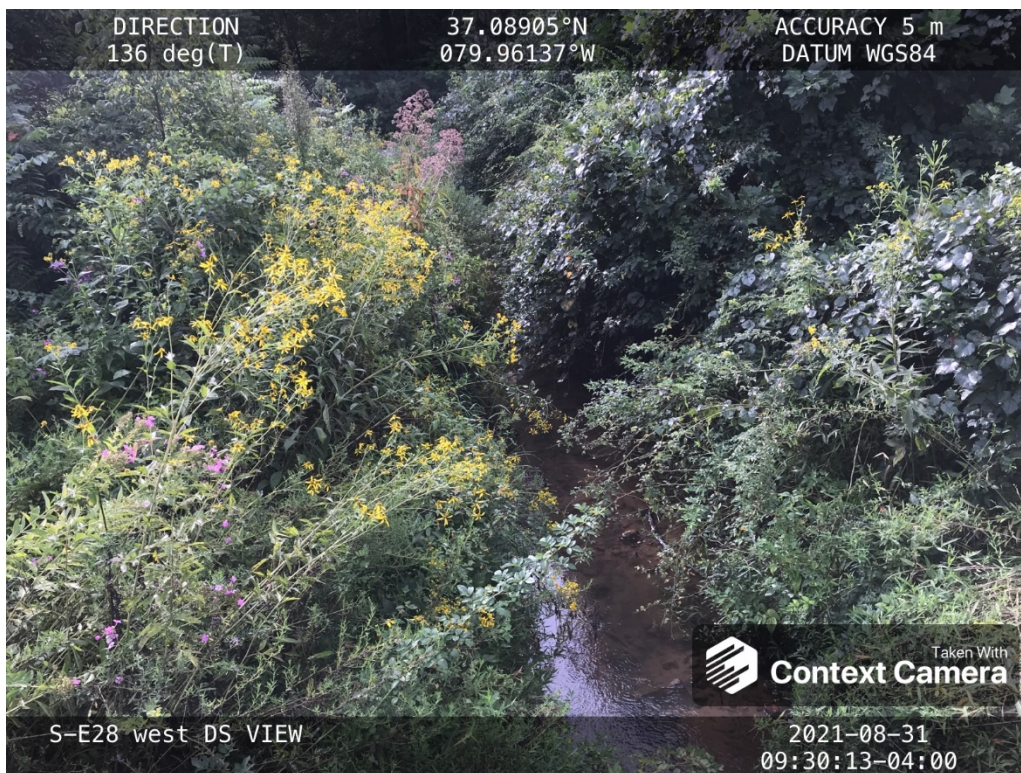
Photo Type: DS VIEW

Location, Orientation, Photographer Initials: Upstream at ROW/LOD looking SE downstream, RAH

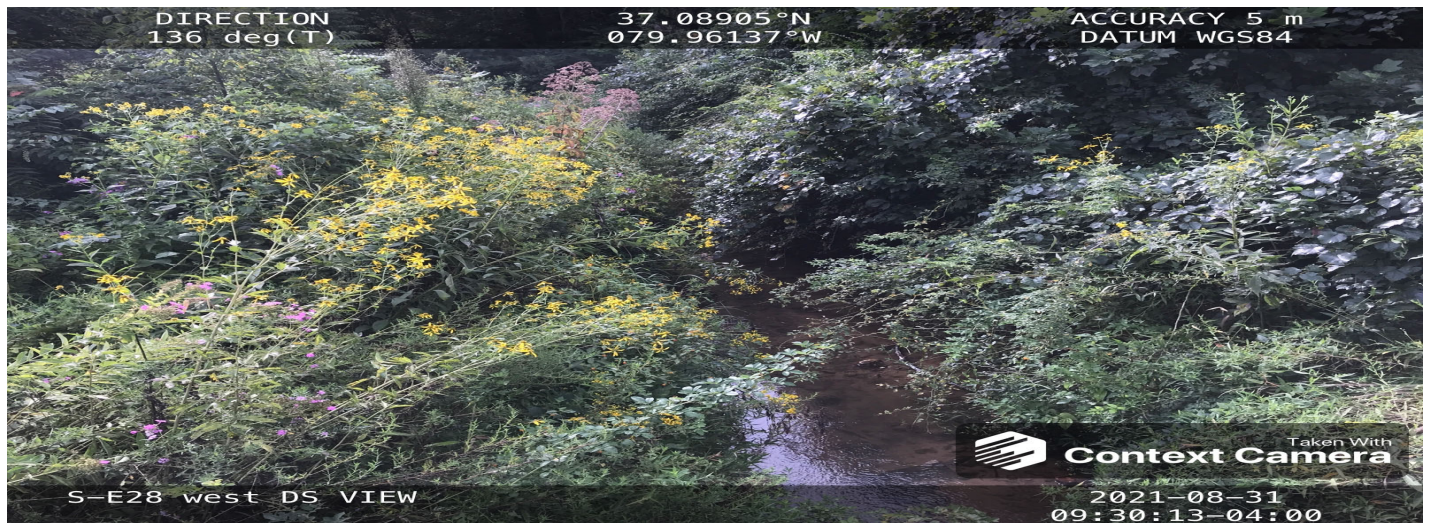
(WSSI Photo Location)

CAPTION. Assessment is limited to areas within the temporary ROW.
