Baseline Assessment – Stream Attributes

Reach S-F8 (Pipeline ROW)

Spread I

Franklin County, Virginia

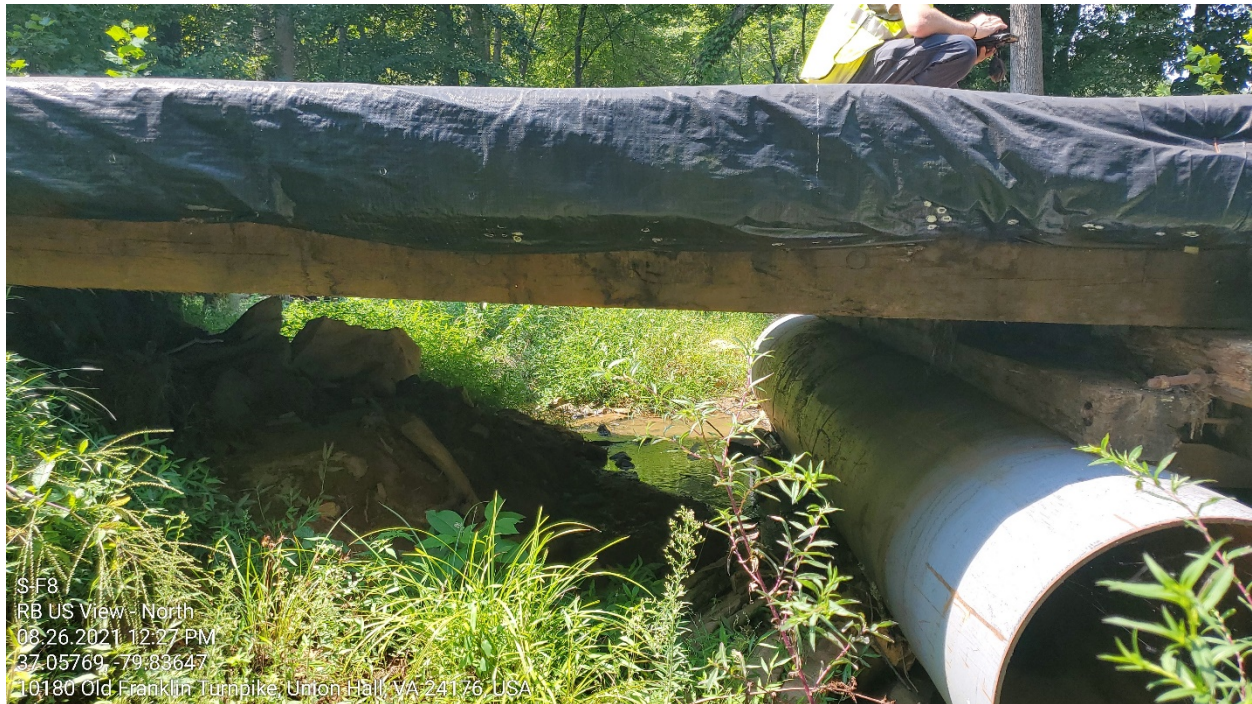
Photo Type: RB US VIEW

Location, Orientation, Photographer Initials: Downstream at ROW/LOD on right bank looking S upstream, DW

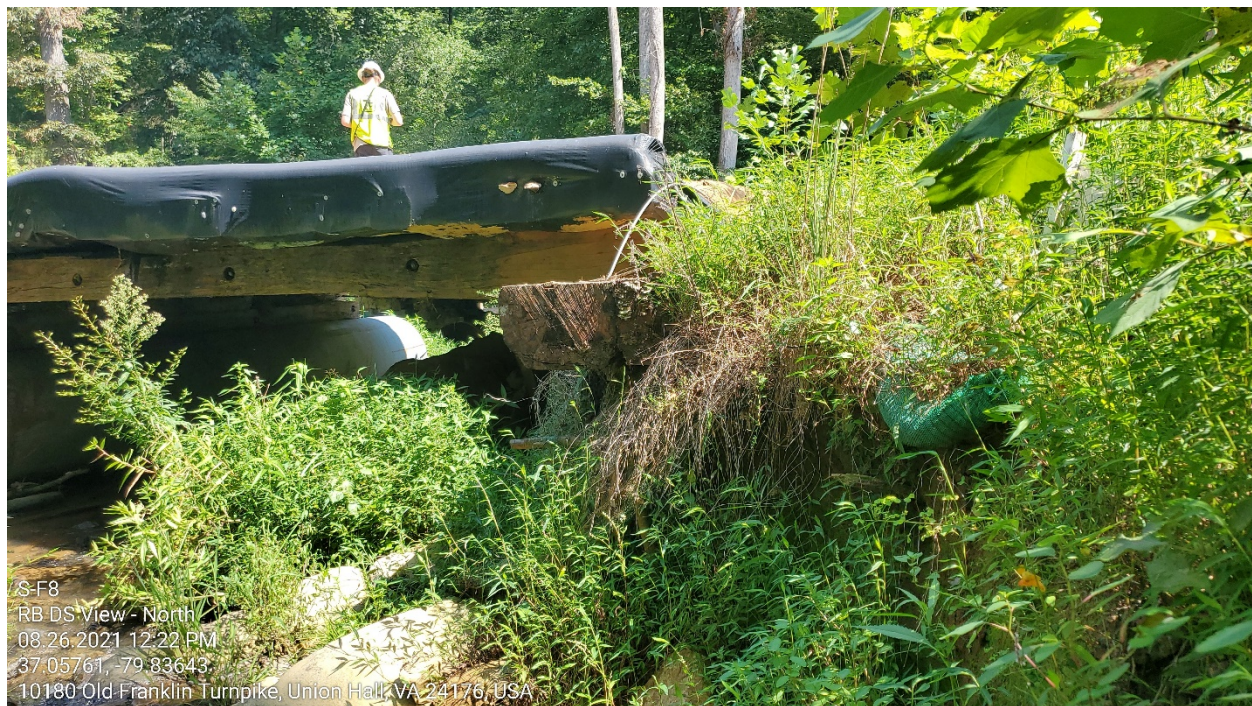
Photo Type: RB DS VIEW

Location, Orientation, Photographer Initials: Upstream at ROW/LOD on right bank looking N downstream, DW

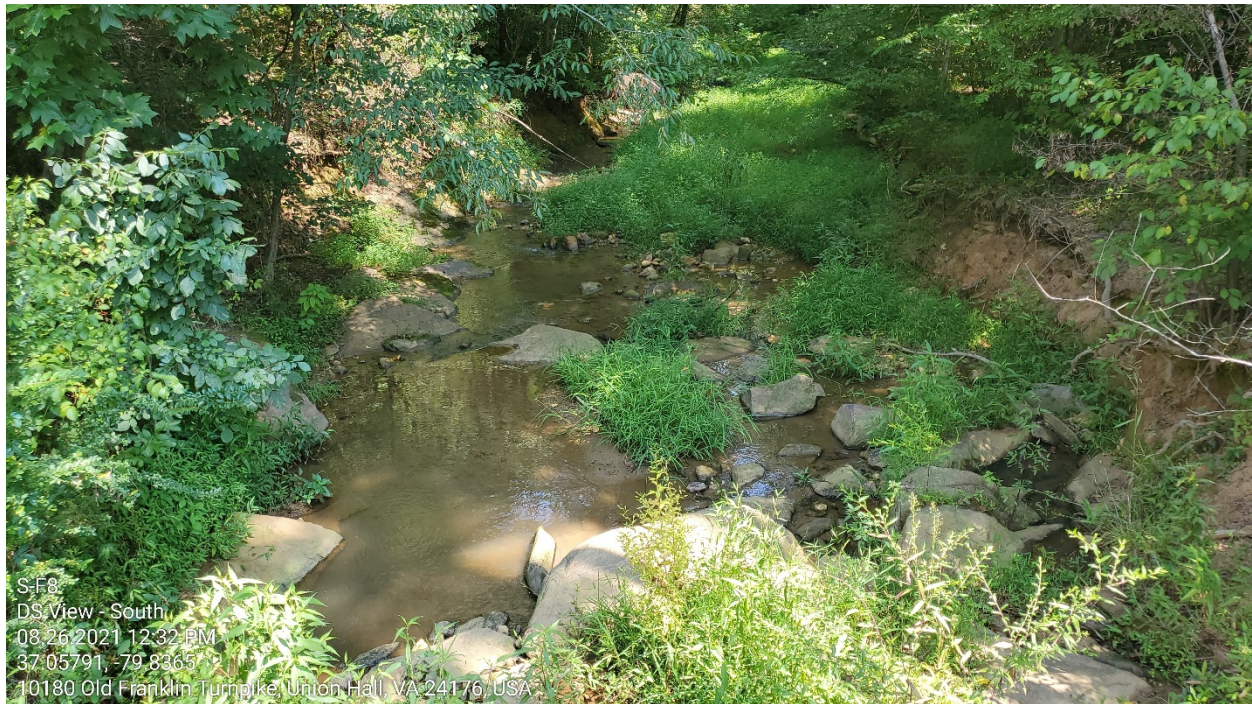
Photo Type: DS COND

Location, Orientation, Photographer Initials: Downstream at ROW/LOD looking N downstream, DW

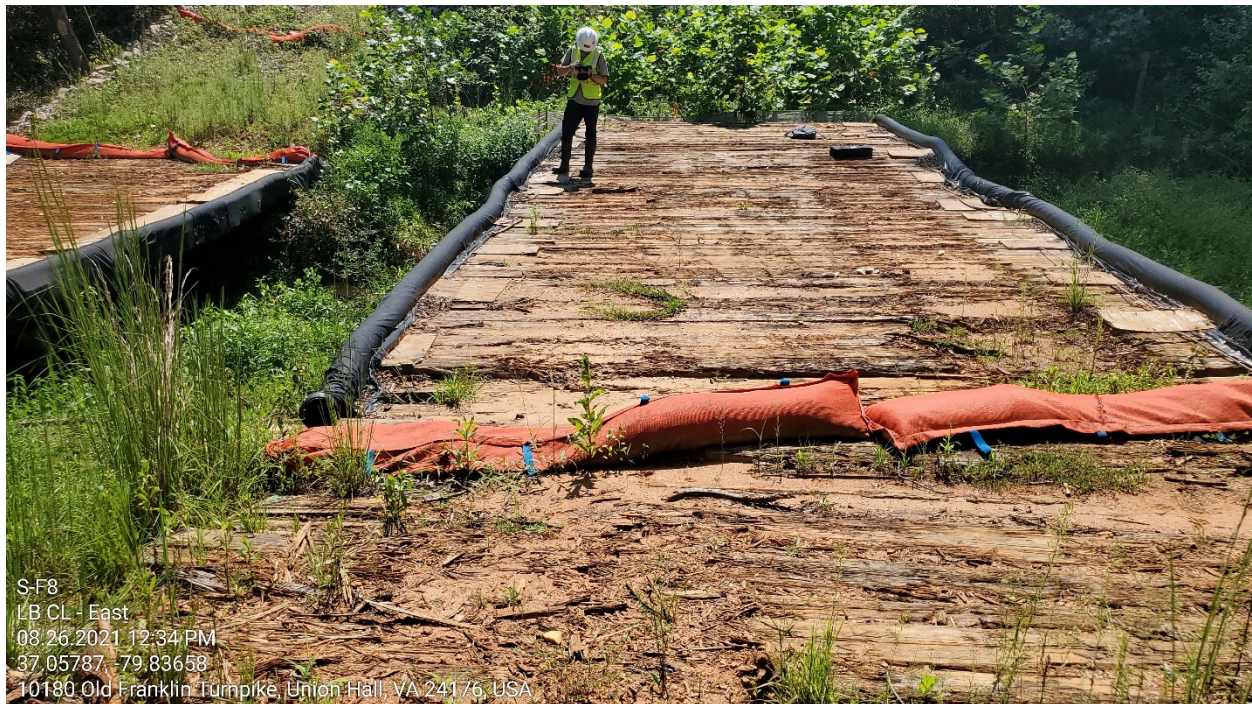
Photo Type: LB CL

Location, Orientation, Photographer Initials: On thalweg at pipe centerline looking E at right streambank, DW

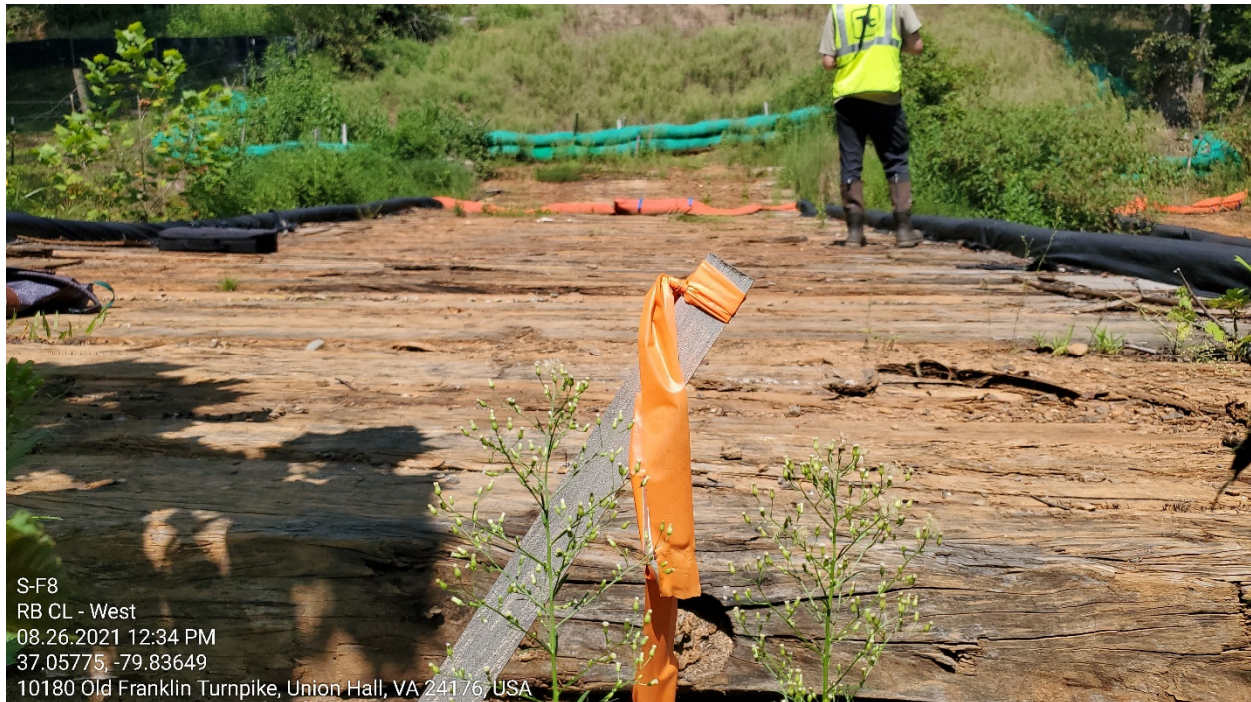
Photo Type: RB CL

S-F8
RB CL - West
08.26.2021 12:34 PM
37.05775, -79.83649
10180 Old Franklin Turnpike, Union Hall, VA 24176, USA

Location, Orientation, Photographer Initials: On thalweg at pipe centerline looking W at left streambank, DW

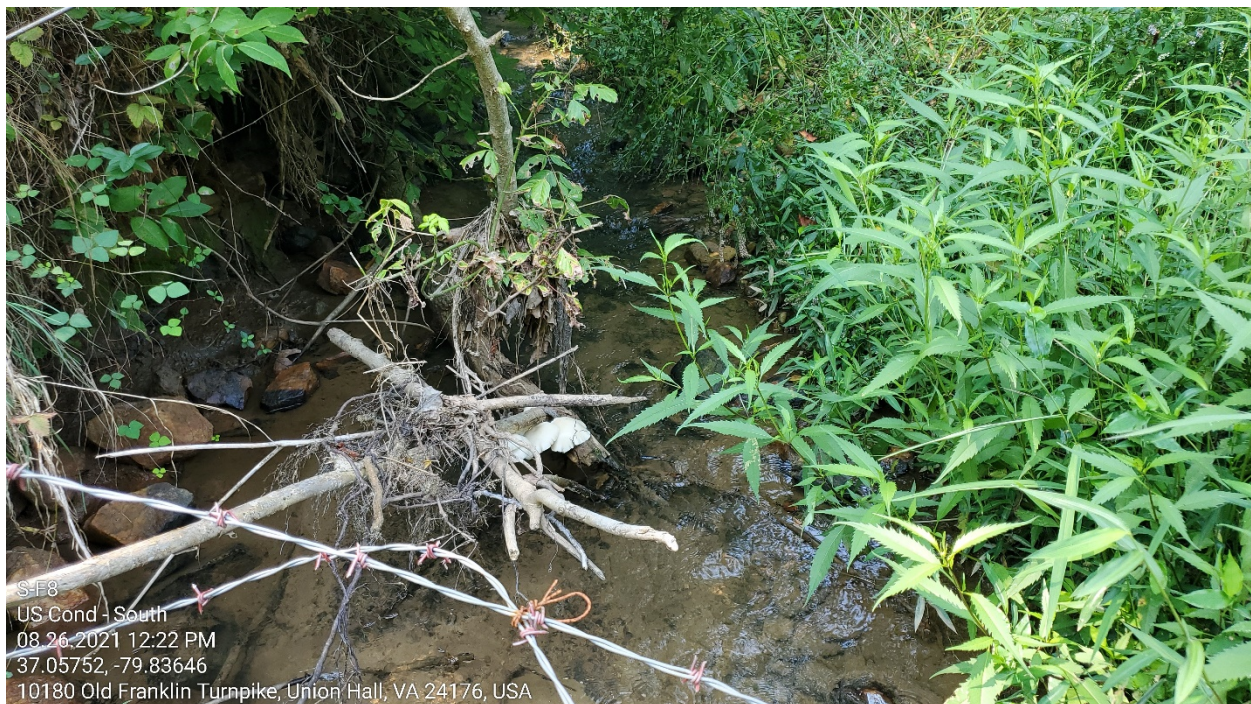
Photo Type: US COND

S-F8
US Cond - South
08.26.2021 12:22 PM
37.05752, -79.83646
10180 Old Franklin Turnpike, Union Hall, VA 24176, USA

Location, Orientation, Photographer Initials: Upstream at ROW/LOD looking S upstream, DW

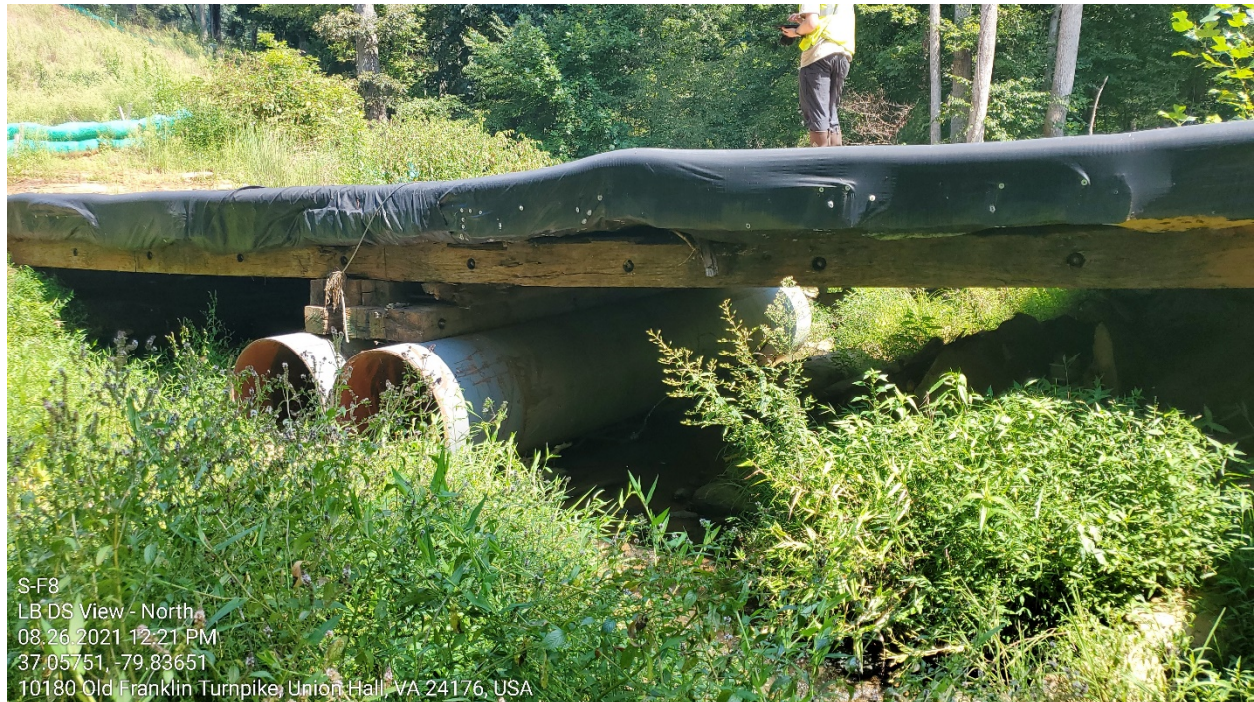
Photo Type: LB DS VIEW

S-F8
LB DS View - North
08.26.2021 12:21 PM
37.05751, -79.83651
10180 Old Franklin Turnpike, Union Hall, VA 24176, USA

Location, Orientation, Photographer Initials: Upstream at ROW/LOD on left bank looking N downstream, DW

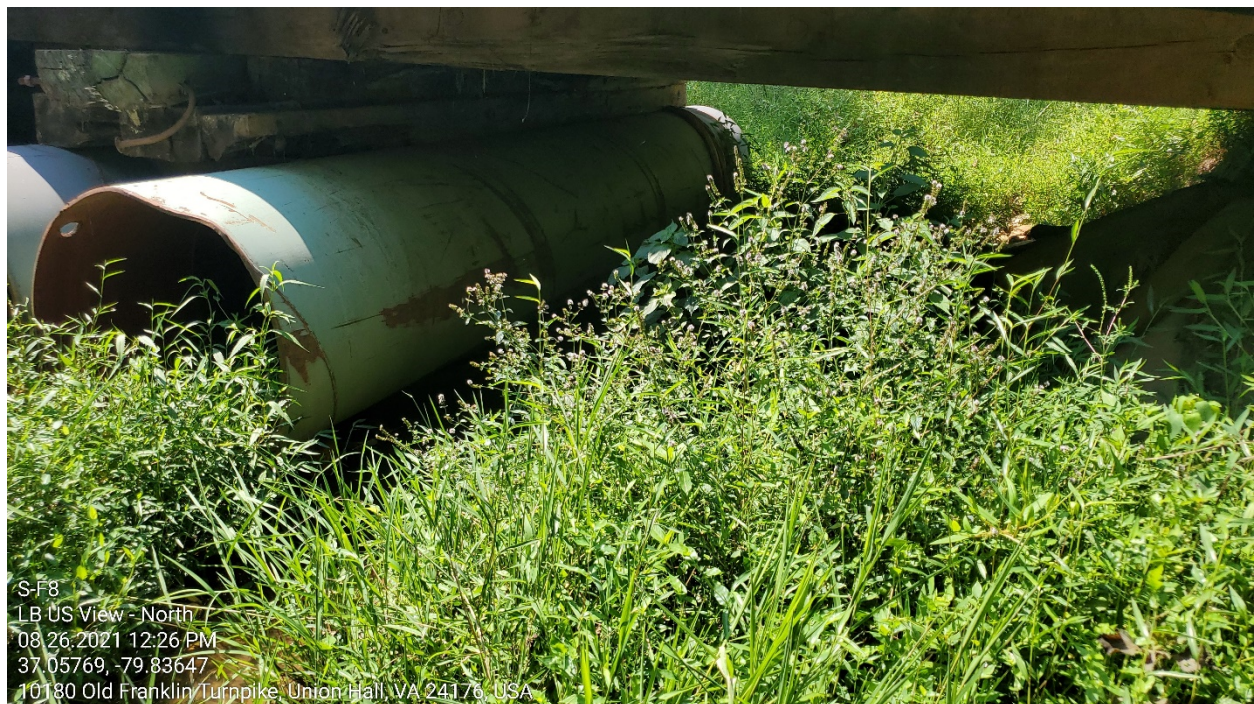
Photo Type: LB US VIEW

S-F8
LB US View - North
08.26.2021 12:26 PM
37.05769, -79.83647
10180 Old Franklin Turnpike, Union Hall, VA 24176, USA

Location, Orientation, Photographer Initials: Upstream at ROW/LOD on left bank looking S upstream, DW

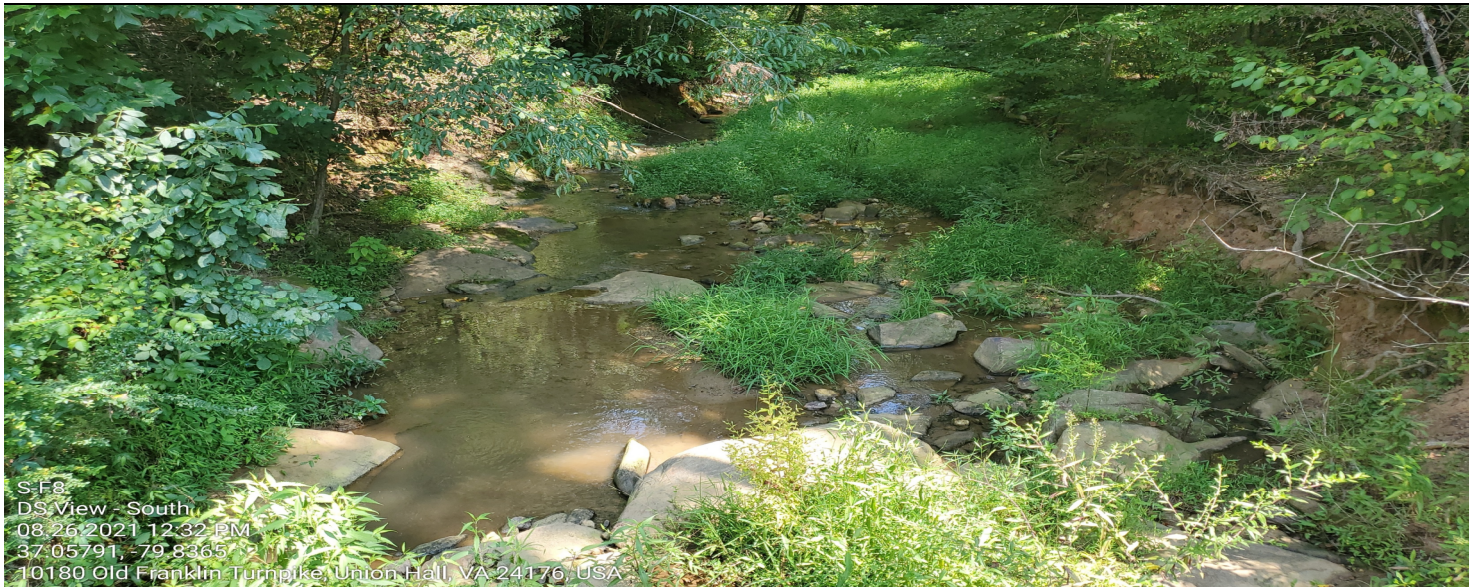
S-F8
DS View - South
08.26.2021 12:32 PM
37.05791, -79.8365
10180 Old Franklin Turnpike, Union Hall, VA 24176, USA

CAPTION. Assessment is limited to areas within the temporary ROW.
