#### **Baseline Assessment – Stream Attributes**

# Reach S-G2 (Timber Mat Crossing) Perennial Spread I Pittsylvania County, Virginia

#### Spread I Stream S-G2 (Timber Mat) Pittsylvania County

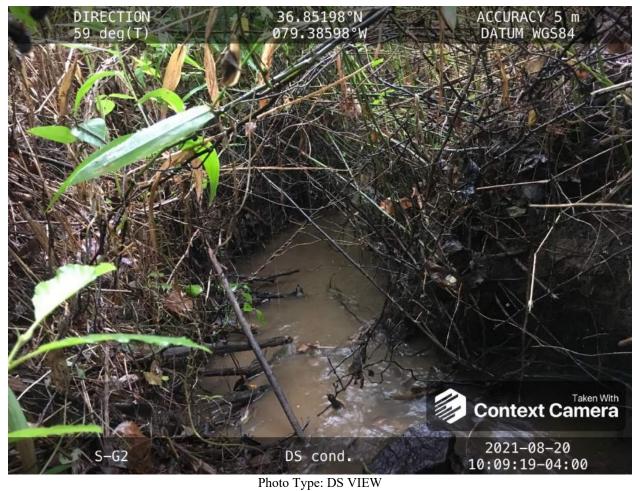
Location, Orientation, Photographer Initials: Downstream view of ROW looking SE, CB/BH

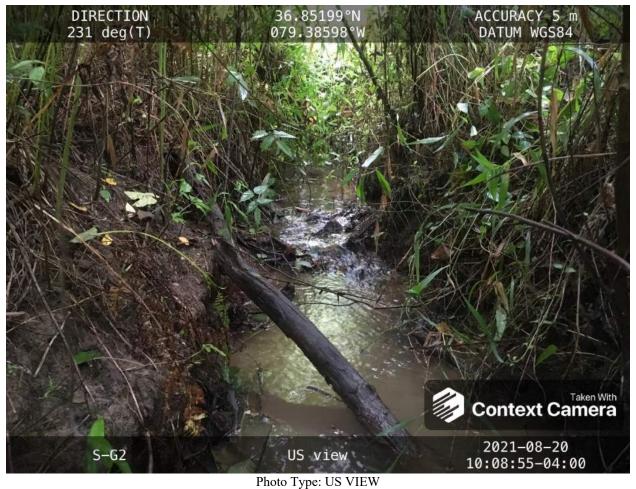
Location, Orientation, Photographer Initials: Upstream view of ROW looking NW, CB/BH

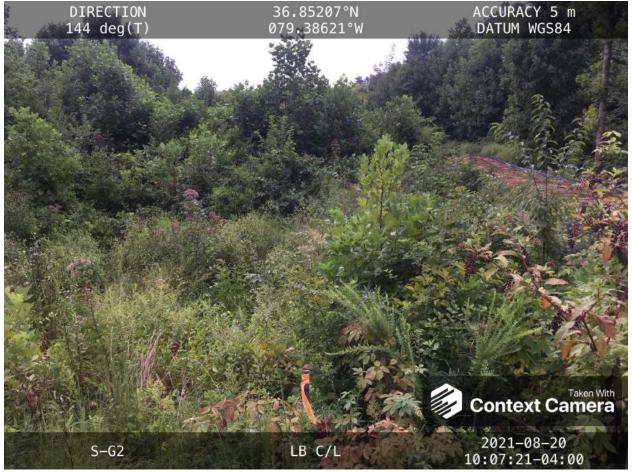
Photo Type: LB CL

Location, Orientation, Photographer Initials: Standing on LB looking at RB along pipe centerline looking N, CB/BH

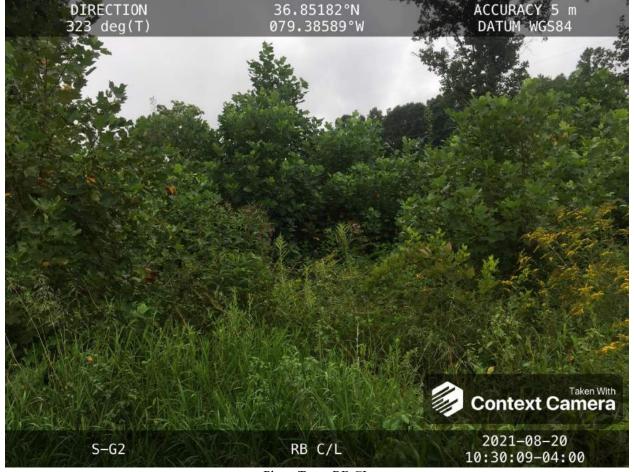
Photo Type: RB CL

Location, Orientation, Photographer Initials: Standing on RB looking at LB along pipe centerline looking S, CB/BH

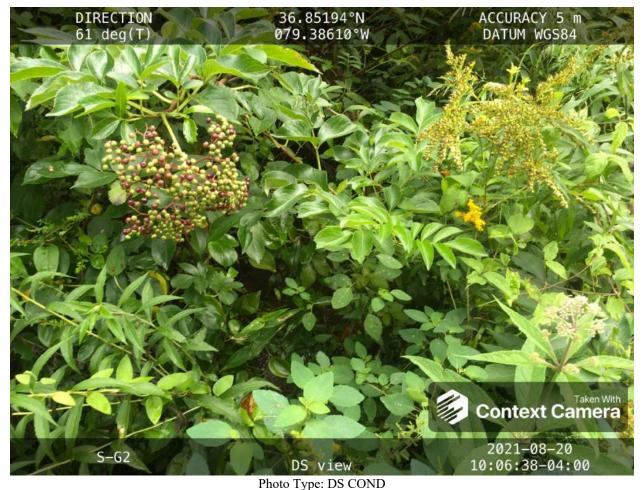
Location, Orientation, Photographer Initials: Downstream conditions outside of ROW looking SE, CB/BH
