Baseline Assessment – Stream Attributes

Reach S-G21 (Pipeline ROW) Intermittent Spread I Franklin County, Virginia

Stream Assessment Form (Form 1)

Unified Stream Methodology for use in Virginia

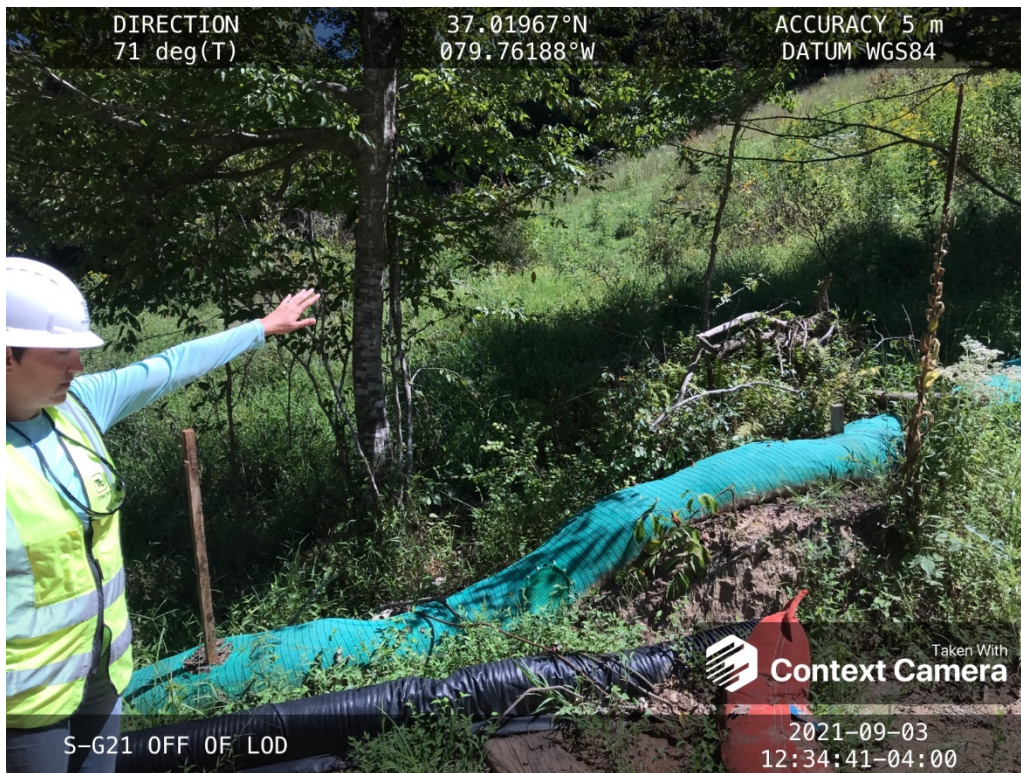
Photo Type: OFF OF LOD

Location, Orientation, Photographer Initials: At ROW/LOD, looking NE, RAH

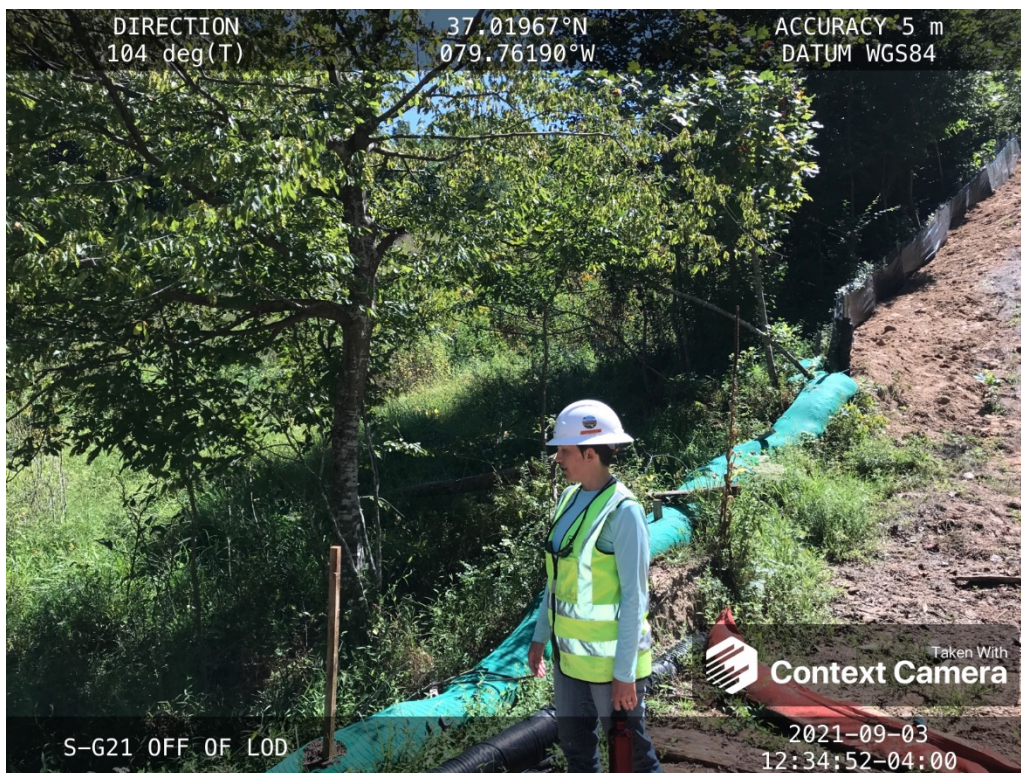
Photo Type: OFF OF LOD

Location, Orientation, Photographer Initials: At ROW/LOD looking SE, RAH

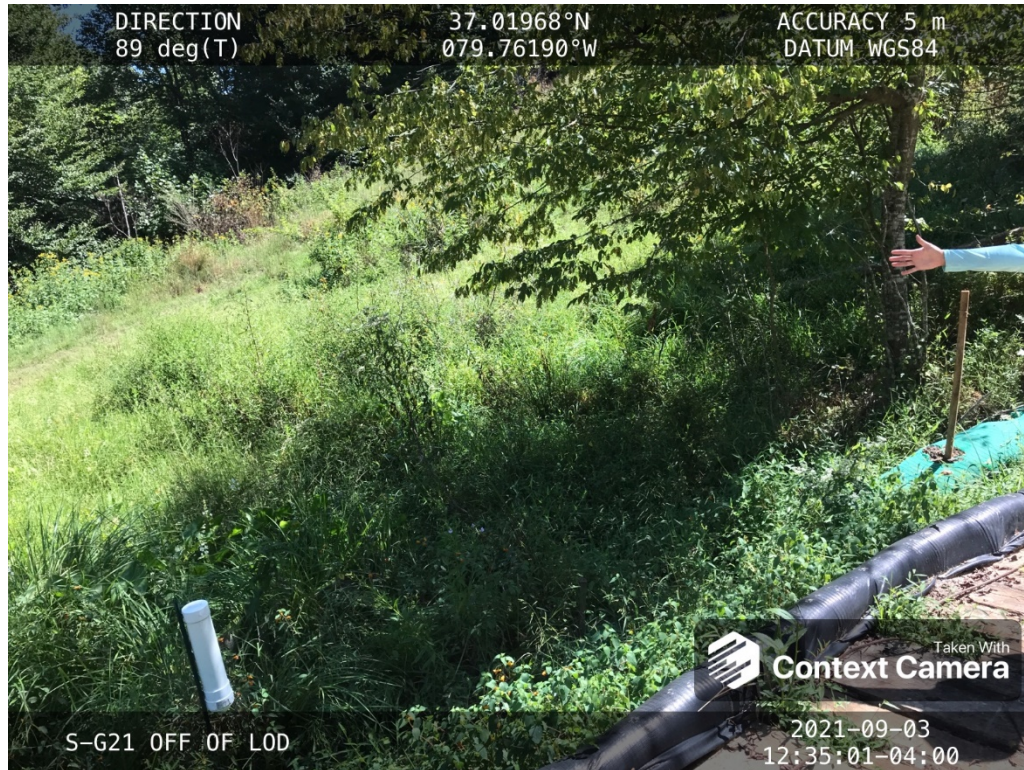
Photo Type: OFF OF LOD
Location, Orientation, Photographer Initials: At ROW/LOD looking E, RAH

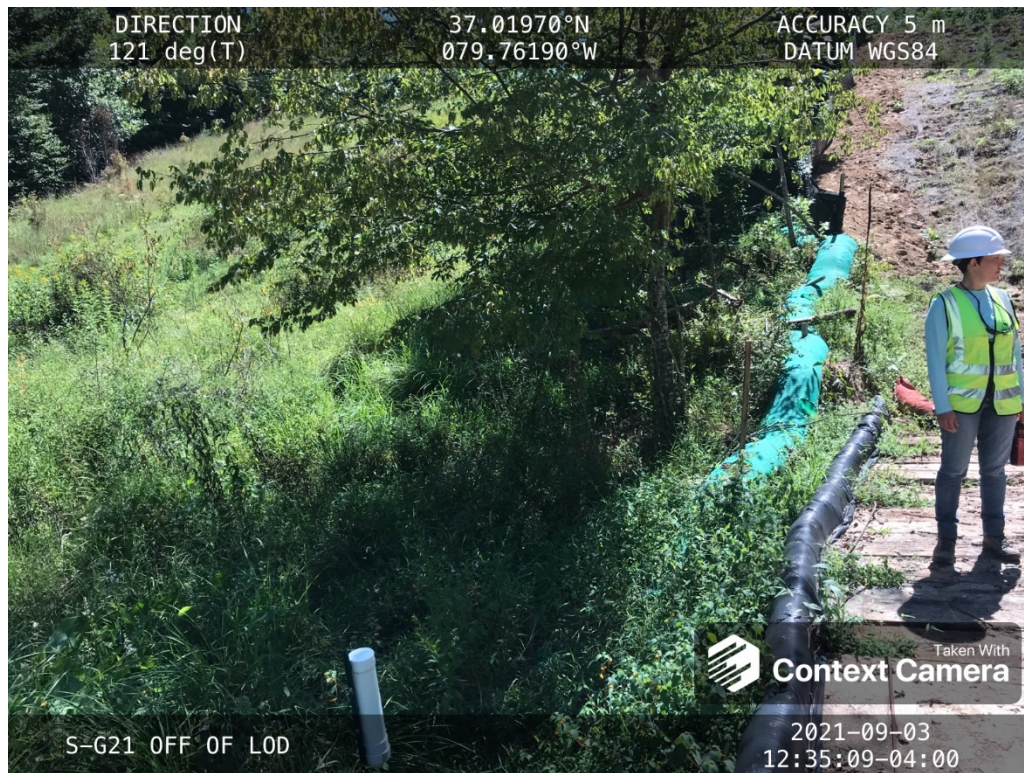
Photo Type: OFF OF LOD
Location, Orientation, Photographer Initials: At ROW/LOD looking SE, RAH

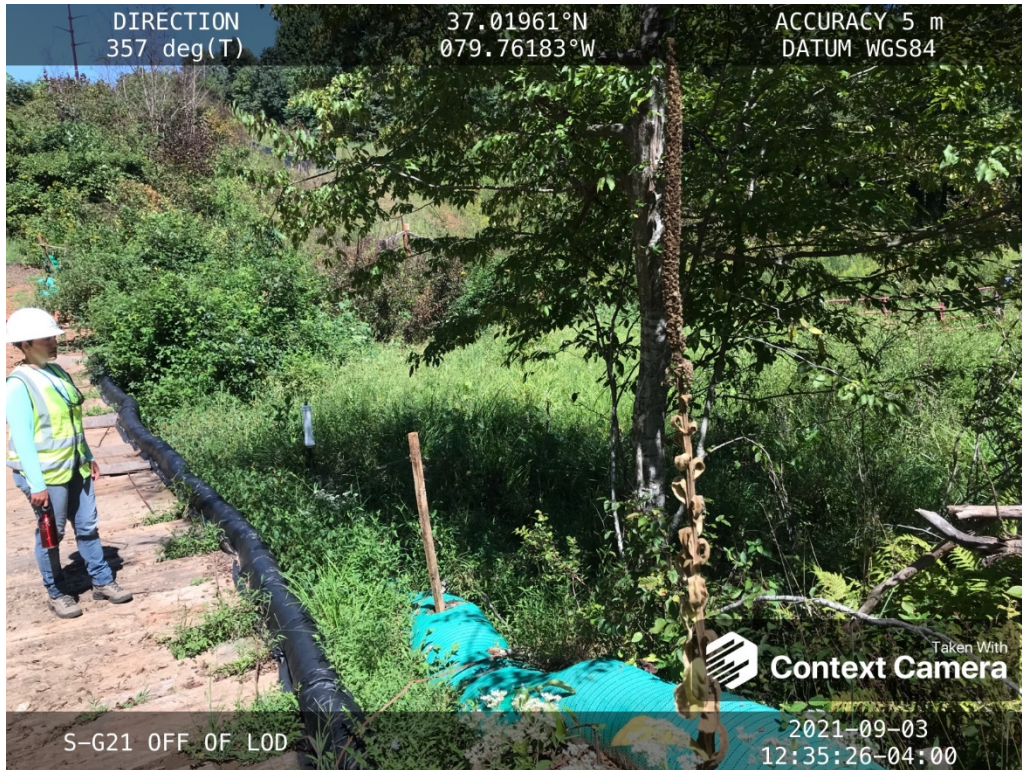
Photo Type: OFF OF LOD
Location, Orientation, Photographer Initials: At ROW/LOD looking N, RAH

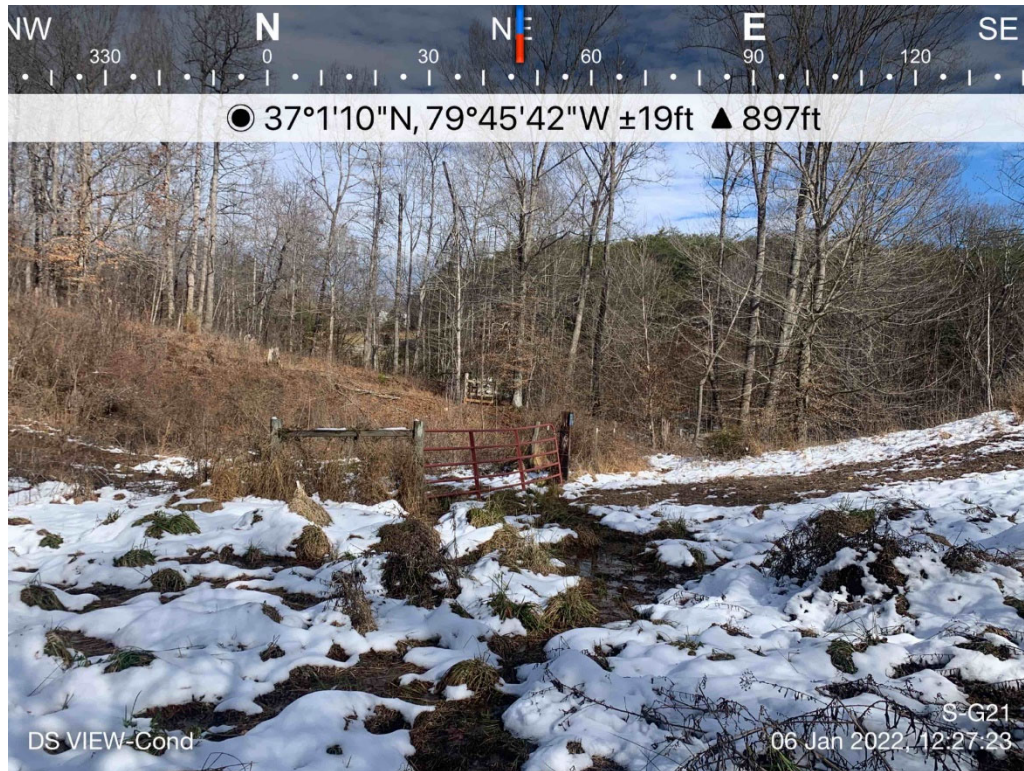
Photo Type: DS VIEW/ COND

Location, Orientation, Photographer Initials: Downstream view of LOC looking NE, KB

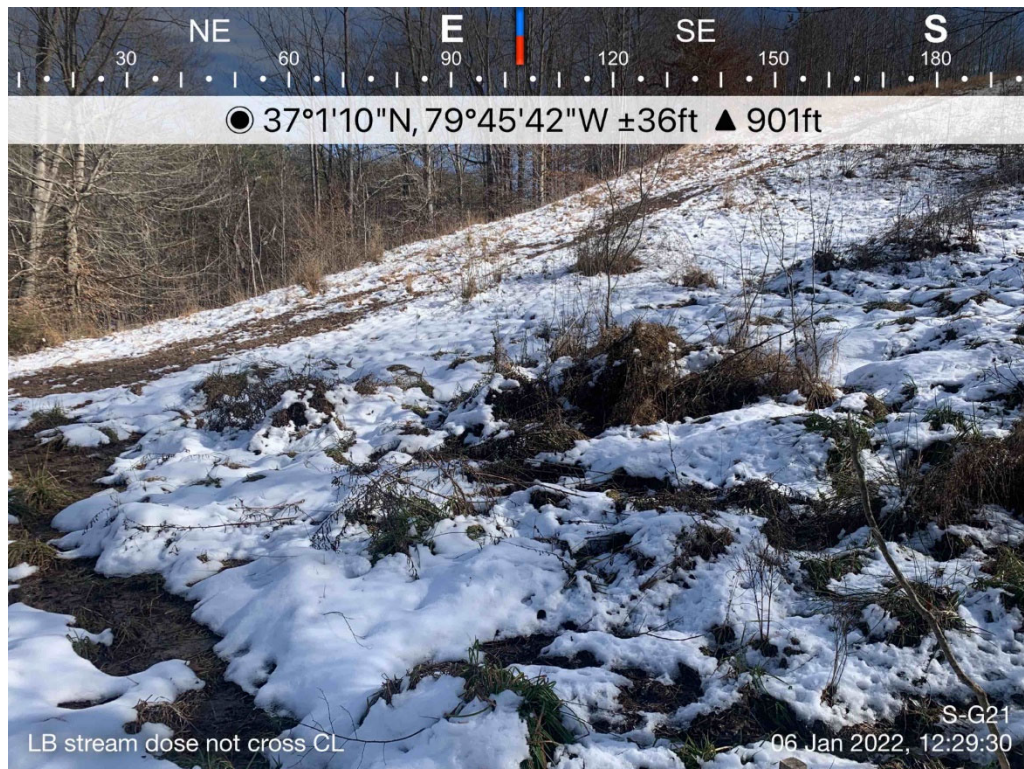
Photo Type: LB CL

Location, Orientation, Photographer Initials: Standing on LB looking at RB along pipe centerline looking E, KB
(LB stream does not cross CL)

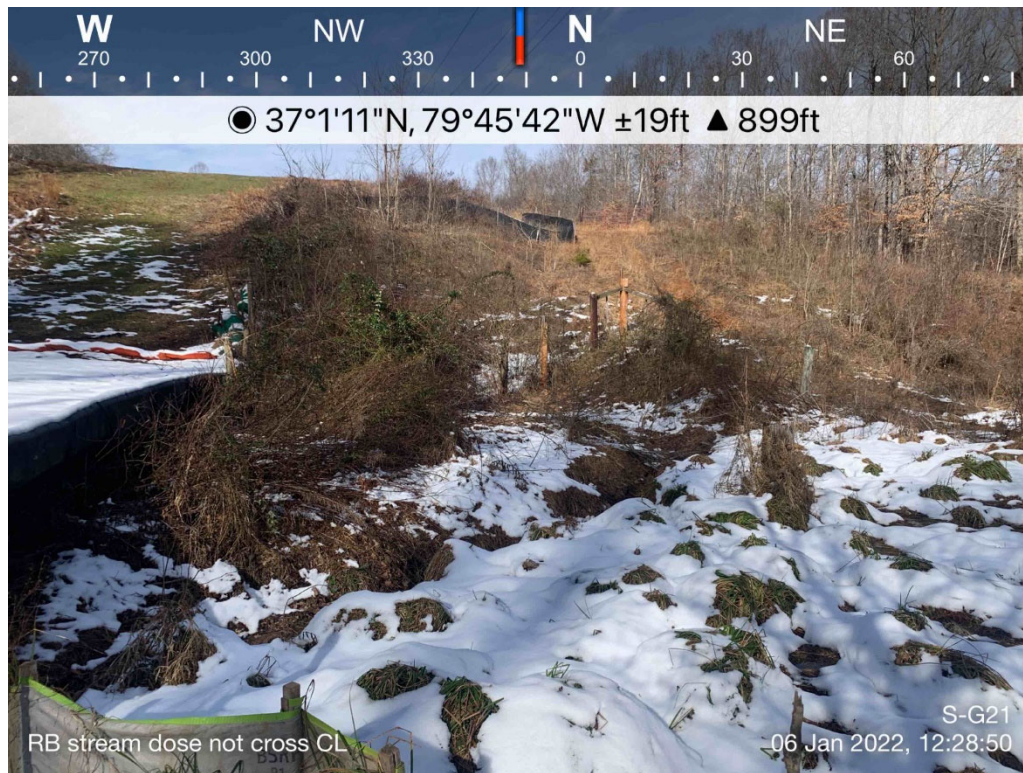
Photo Type: RB CL

Location, Orientation, Photographer Initials: Standing on RB looking at LB along pipe centerline looking N, KB
(RB stream does not cross CL)

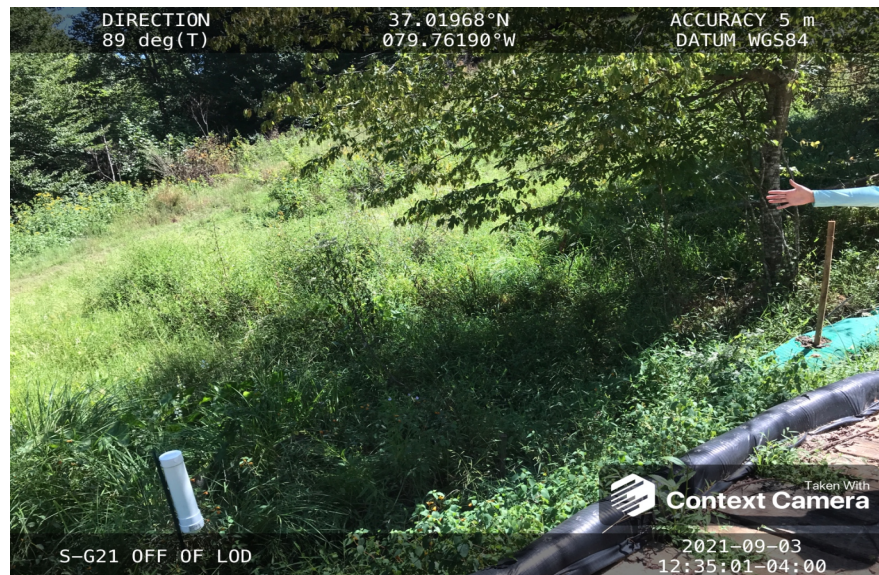
CAPTION. Assessment is limited to areas within the temporary ROW.
