Baseline Assessment – Stream Attributes

Reach S-G6 (Pipeline ROW) Intermittent Spread I Pittsylvania County, Virginia

Stream S-G6 (Pipeline ROW) Pittsylvania County

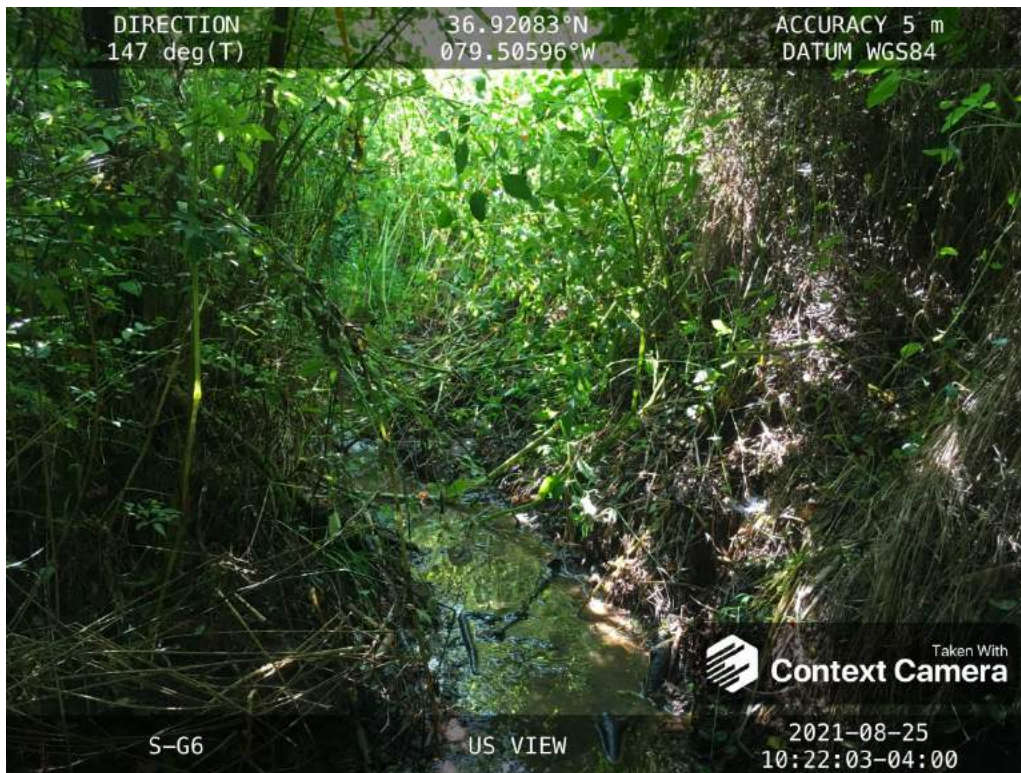
Photo Type: US VIEW

Location, Orientation, Photographer Initials: Downstream at LOC looking SE upstream, CB

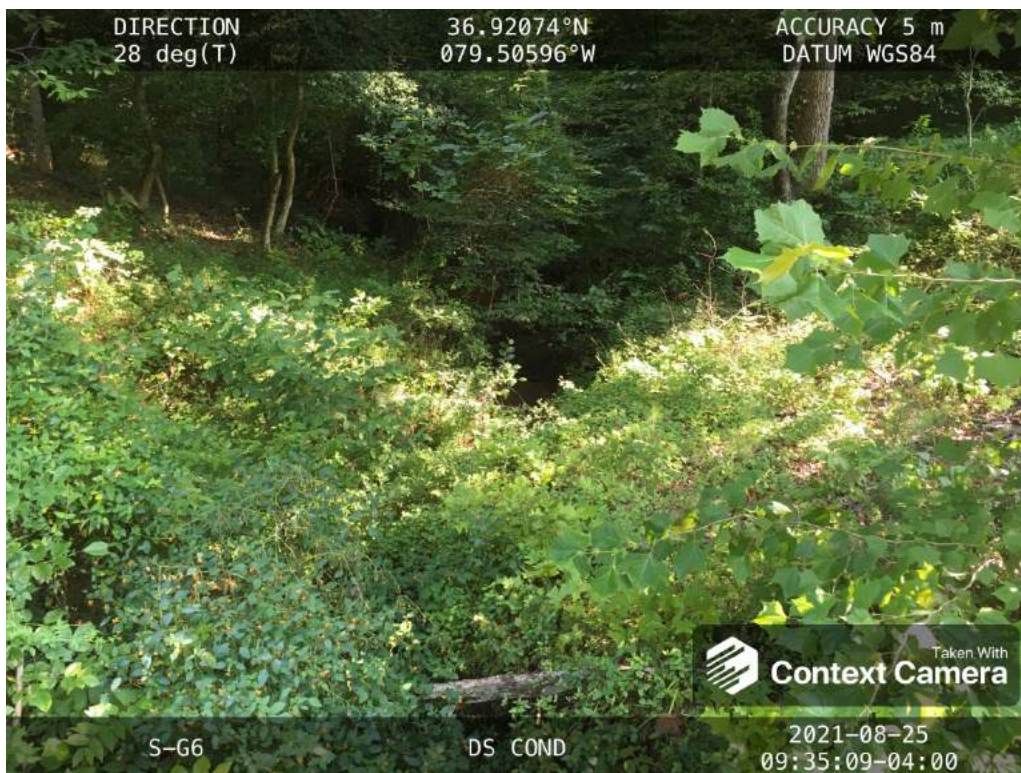
Photo Type: DS COND

Location, Orientation, Photographer Initials: Downstream at LOC looking NE downstream, CB

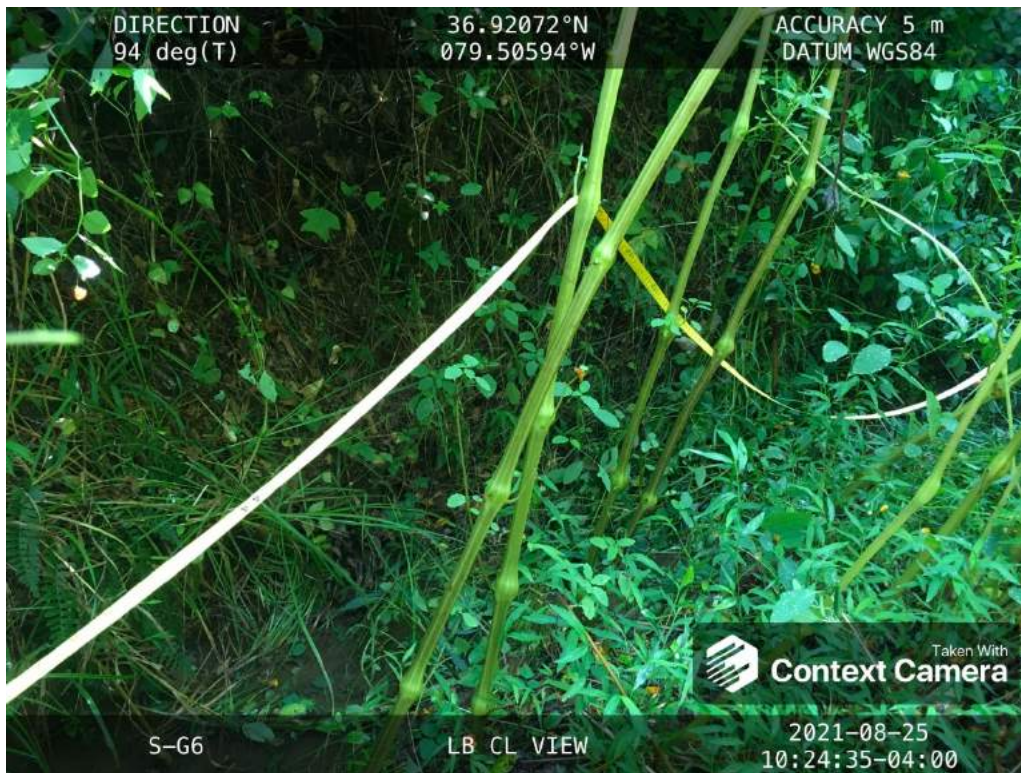
Photo Type: LB CL

Location, Orientation, Photographer Initials: On left bank at pipe centerline looking E at right streambank, CB

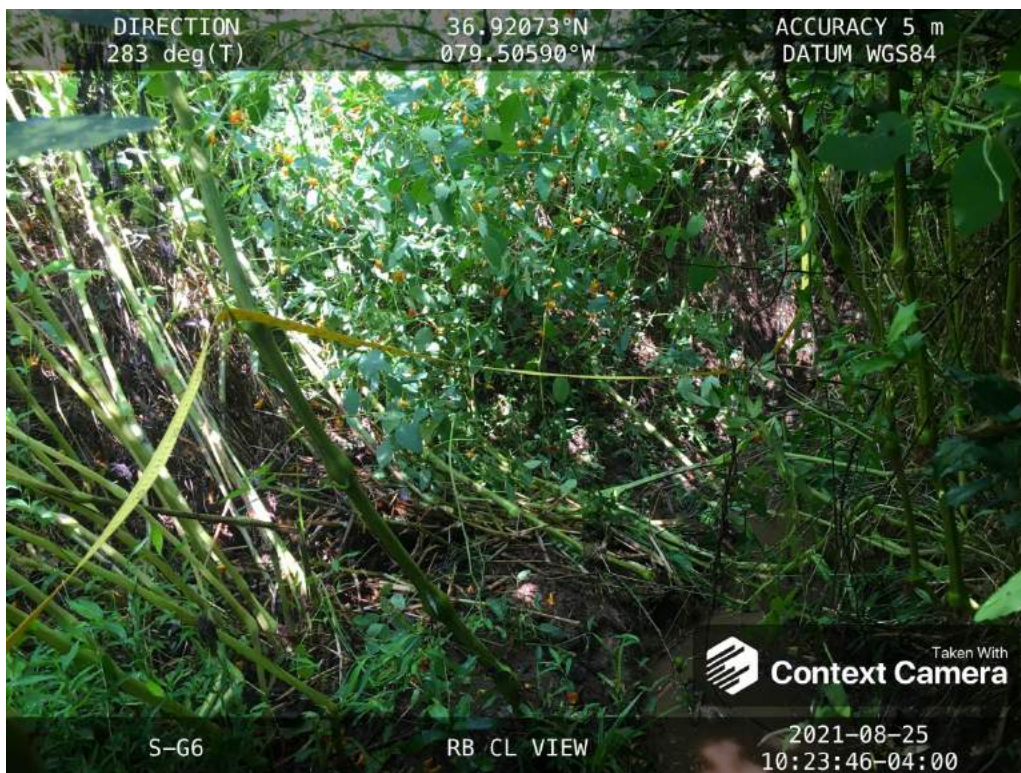
Photo Type: RB CL

Location, Orientation, Photographer Initials: On right bank at pipe centerline looking SE at left streambank, CB

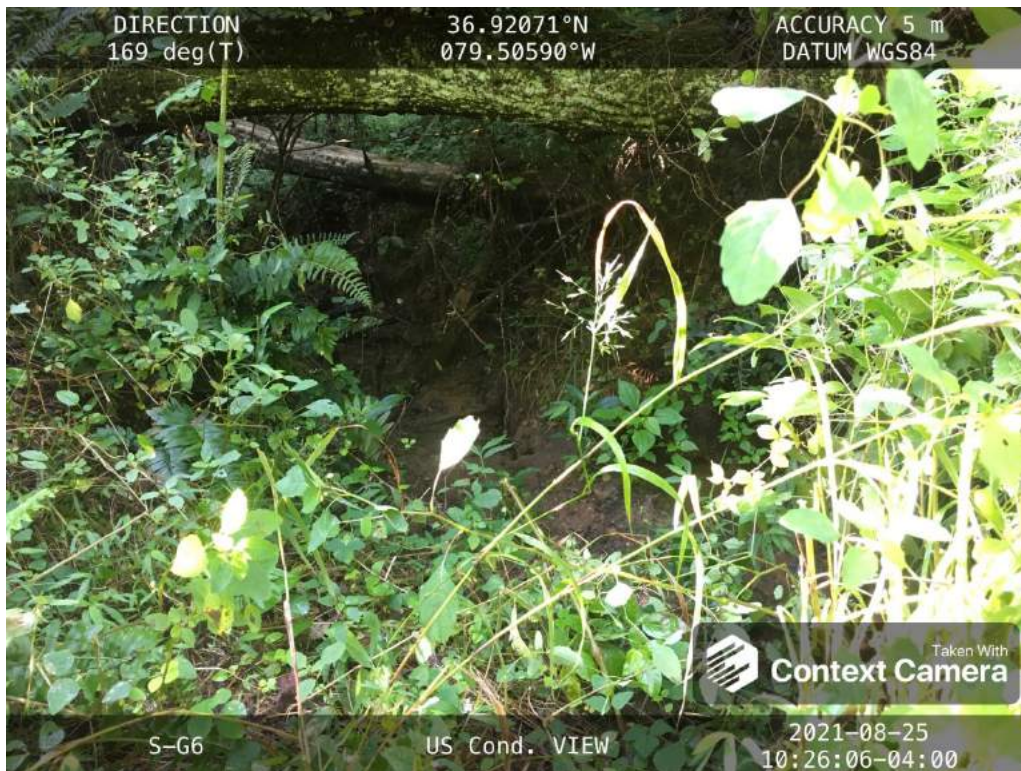
Photo Type: US COND

Location, Orientation, Photographer Initials: Upstream at LOC looking SE upstream, CB

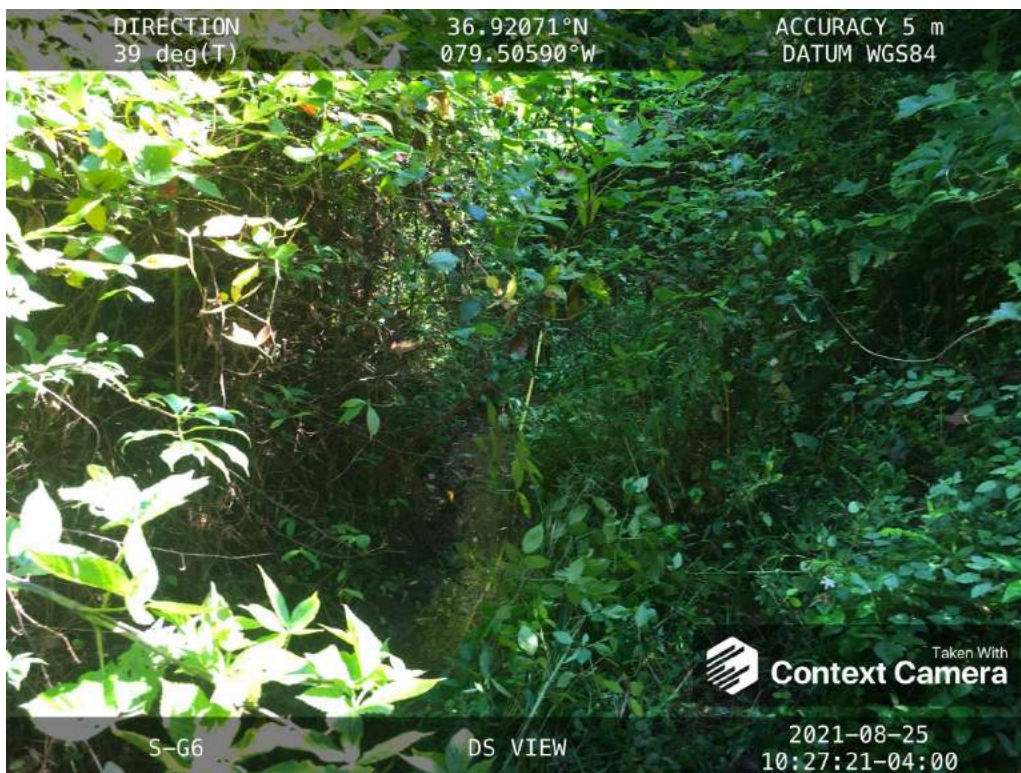
Photo Type: DS VIEW

Location, Orientation, Photographer Initials: Upstream at LOC looking NE downstream, CB

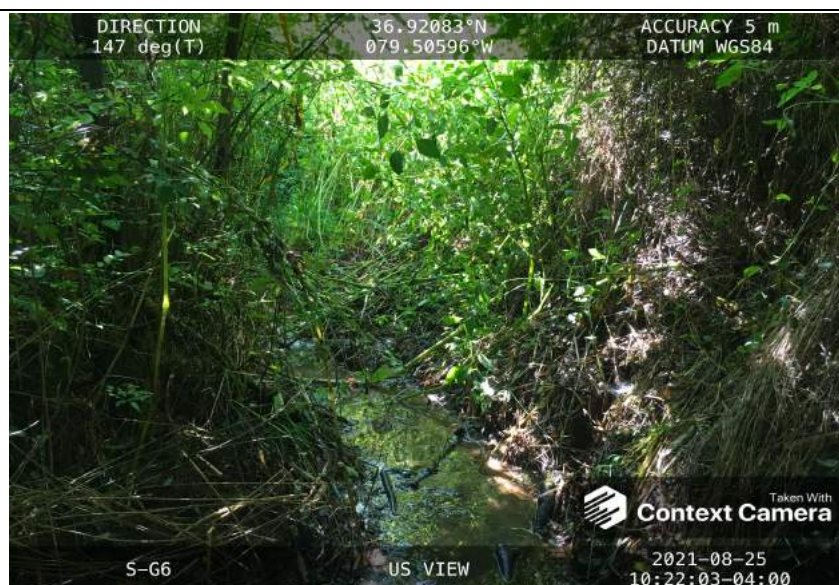
CAPTION. Assessment is limited to areas within the temporary ROW.
