Baseline Assessment – Stream Attributes

Reach S-GG11 (Timber Mat) Perennial Spread I Pittsylvania County, Virginia

Spread I Stream S-GG11 (Timber Mat Crossing) Pittsylvania County

Profile and Cross-Sections Baseline Survey

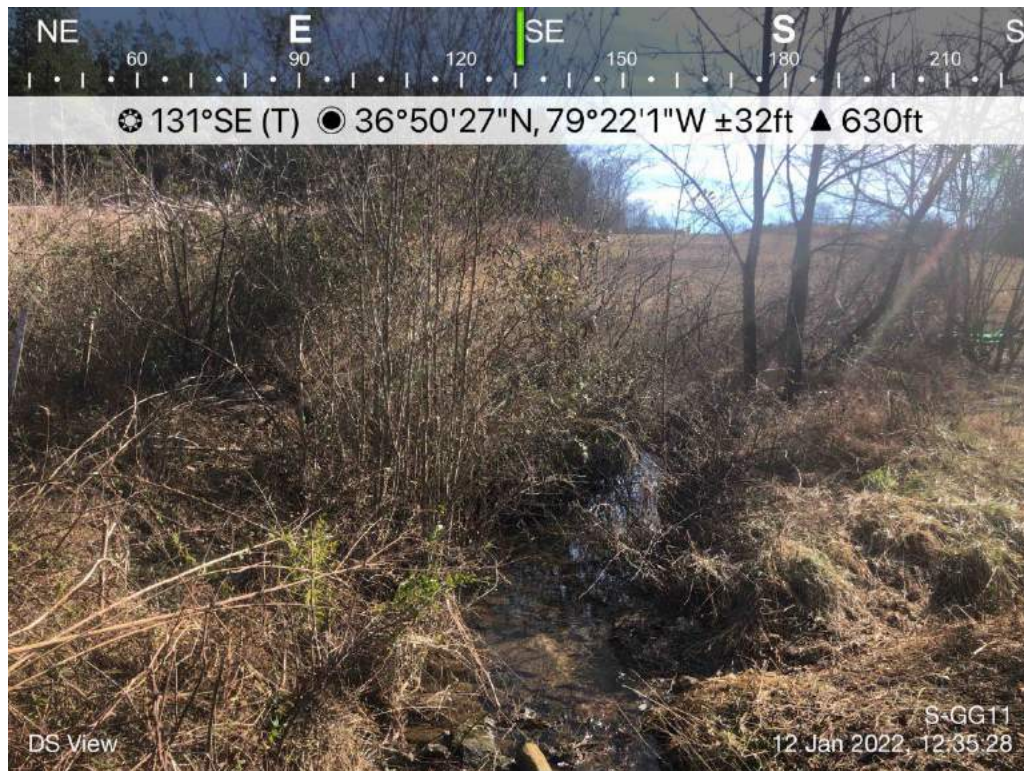
Photo Type: DS VIEW

Location, Orientation, Photographer Initials: Downstream view of LOC looking SE, KB
01/12/2022, 12:35 PM

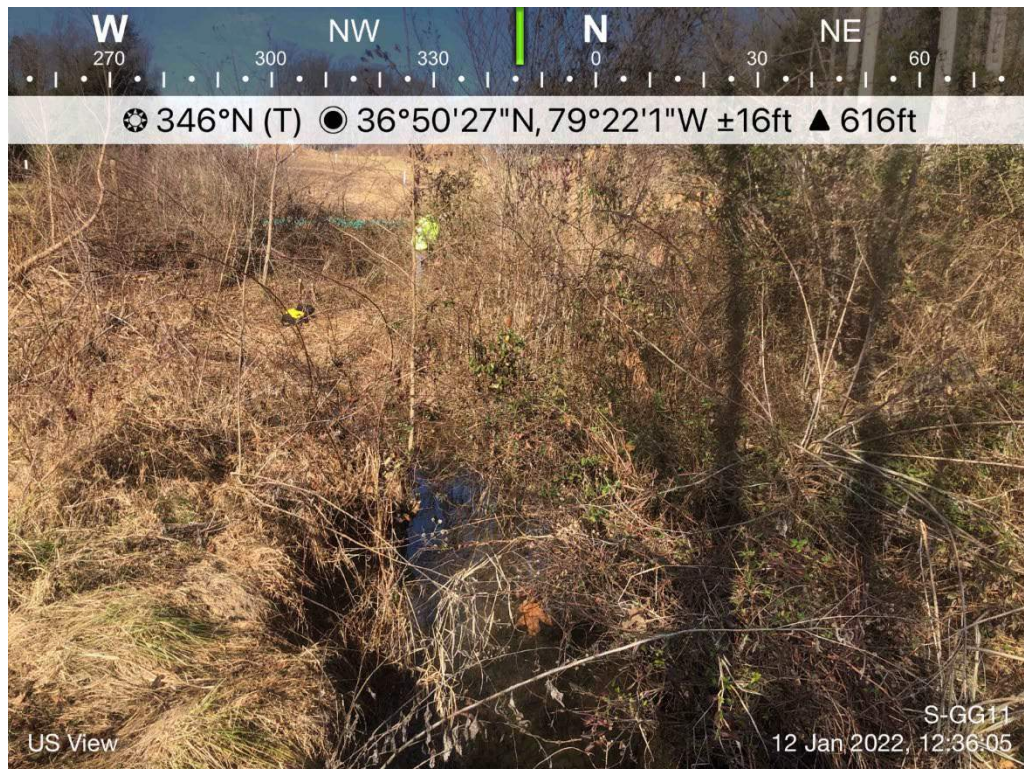
Photo Type: US VIEW

Location, Orientation, Photographer Initials: Upstream view of LOC looking N/NW, KB
01/12/2022, 12:36 PM

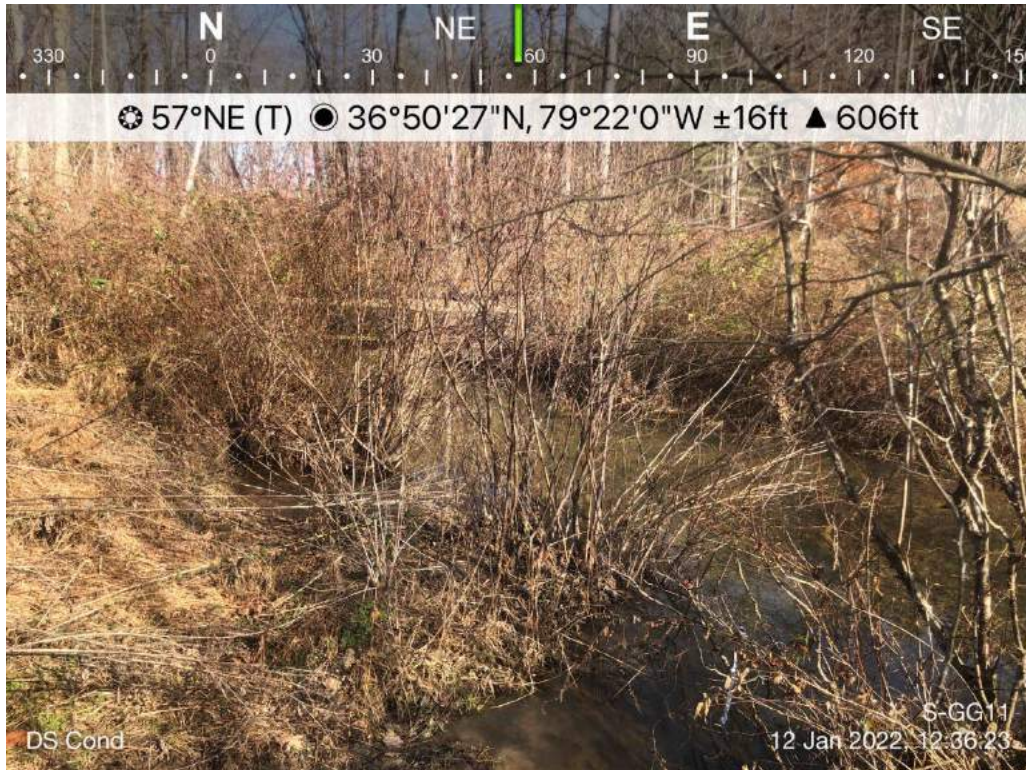
Photo Type: DS COND

Location, Orientation, Photographer Initials: Downstream conditions outside of LOC looking E/NE, KB
01/12/2022, 12:36 PM

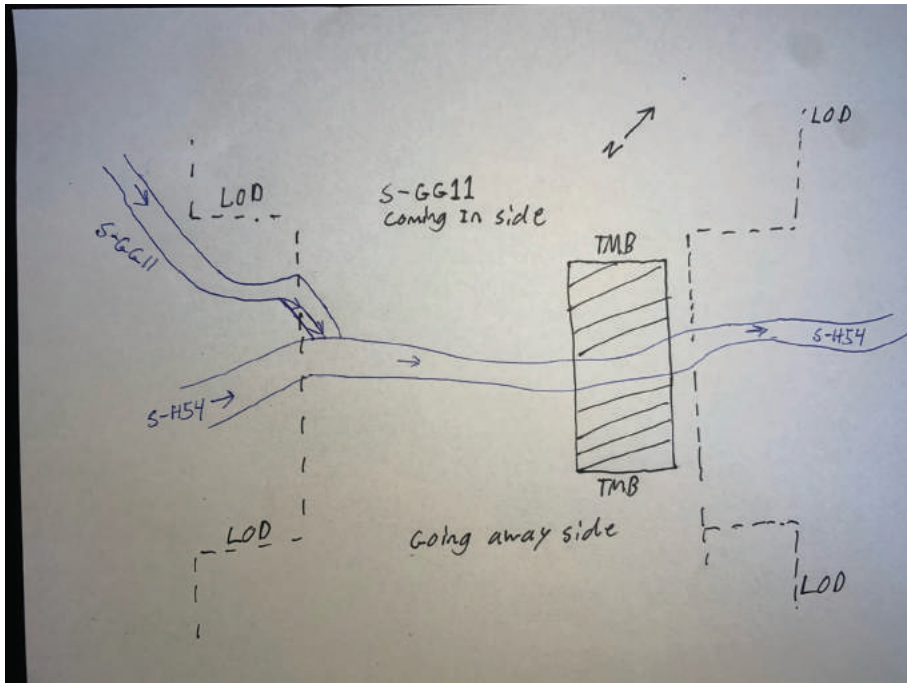
SITE LOCATION/MAP	<p>Draw a map of the site and indicate the areas sampled (or attach a photograph)</p>

Due to LOD location only approximately 10 liner feet of the left bank was within ROW.

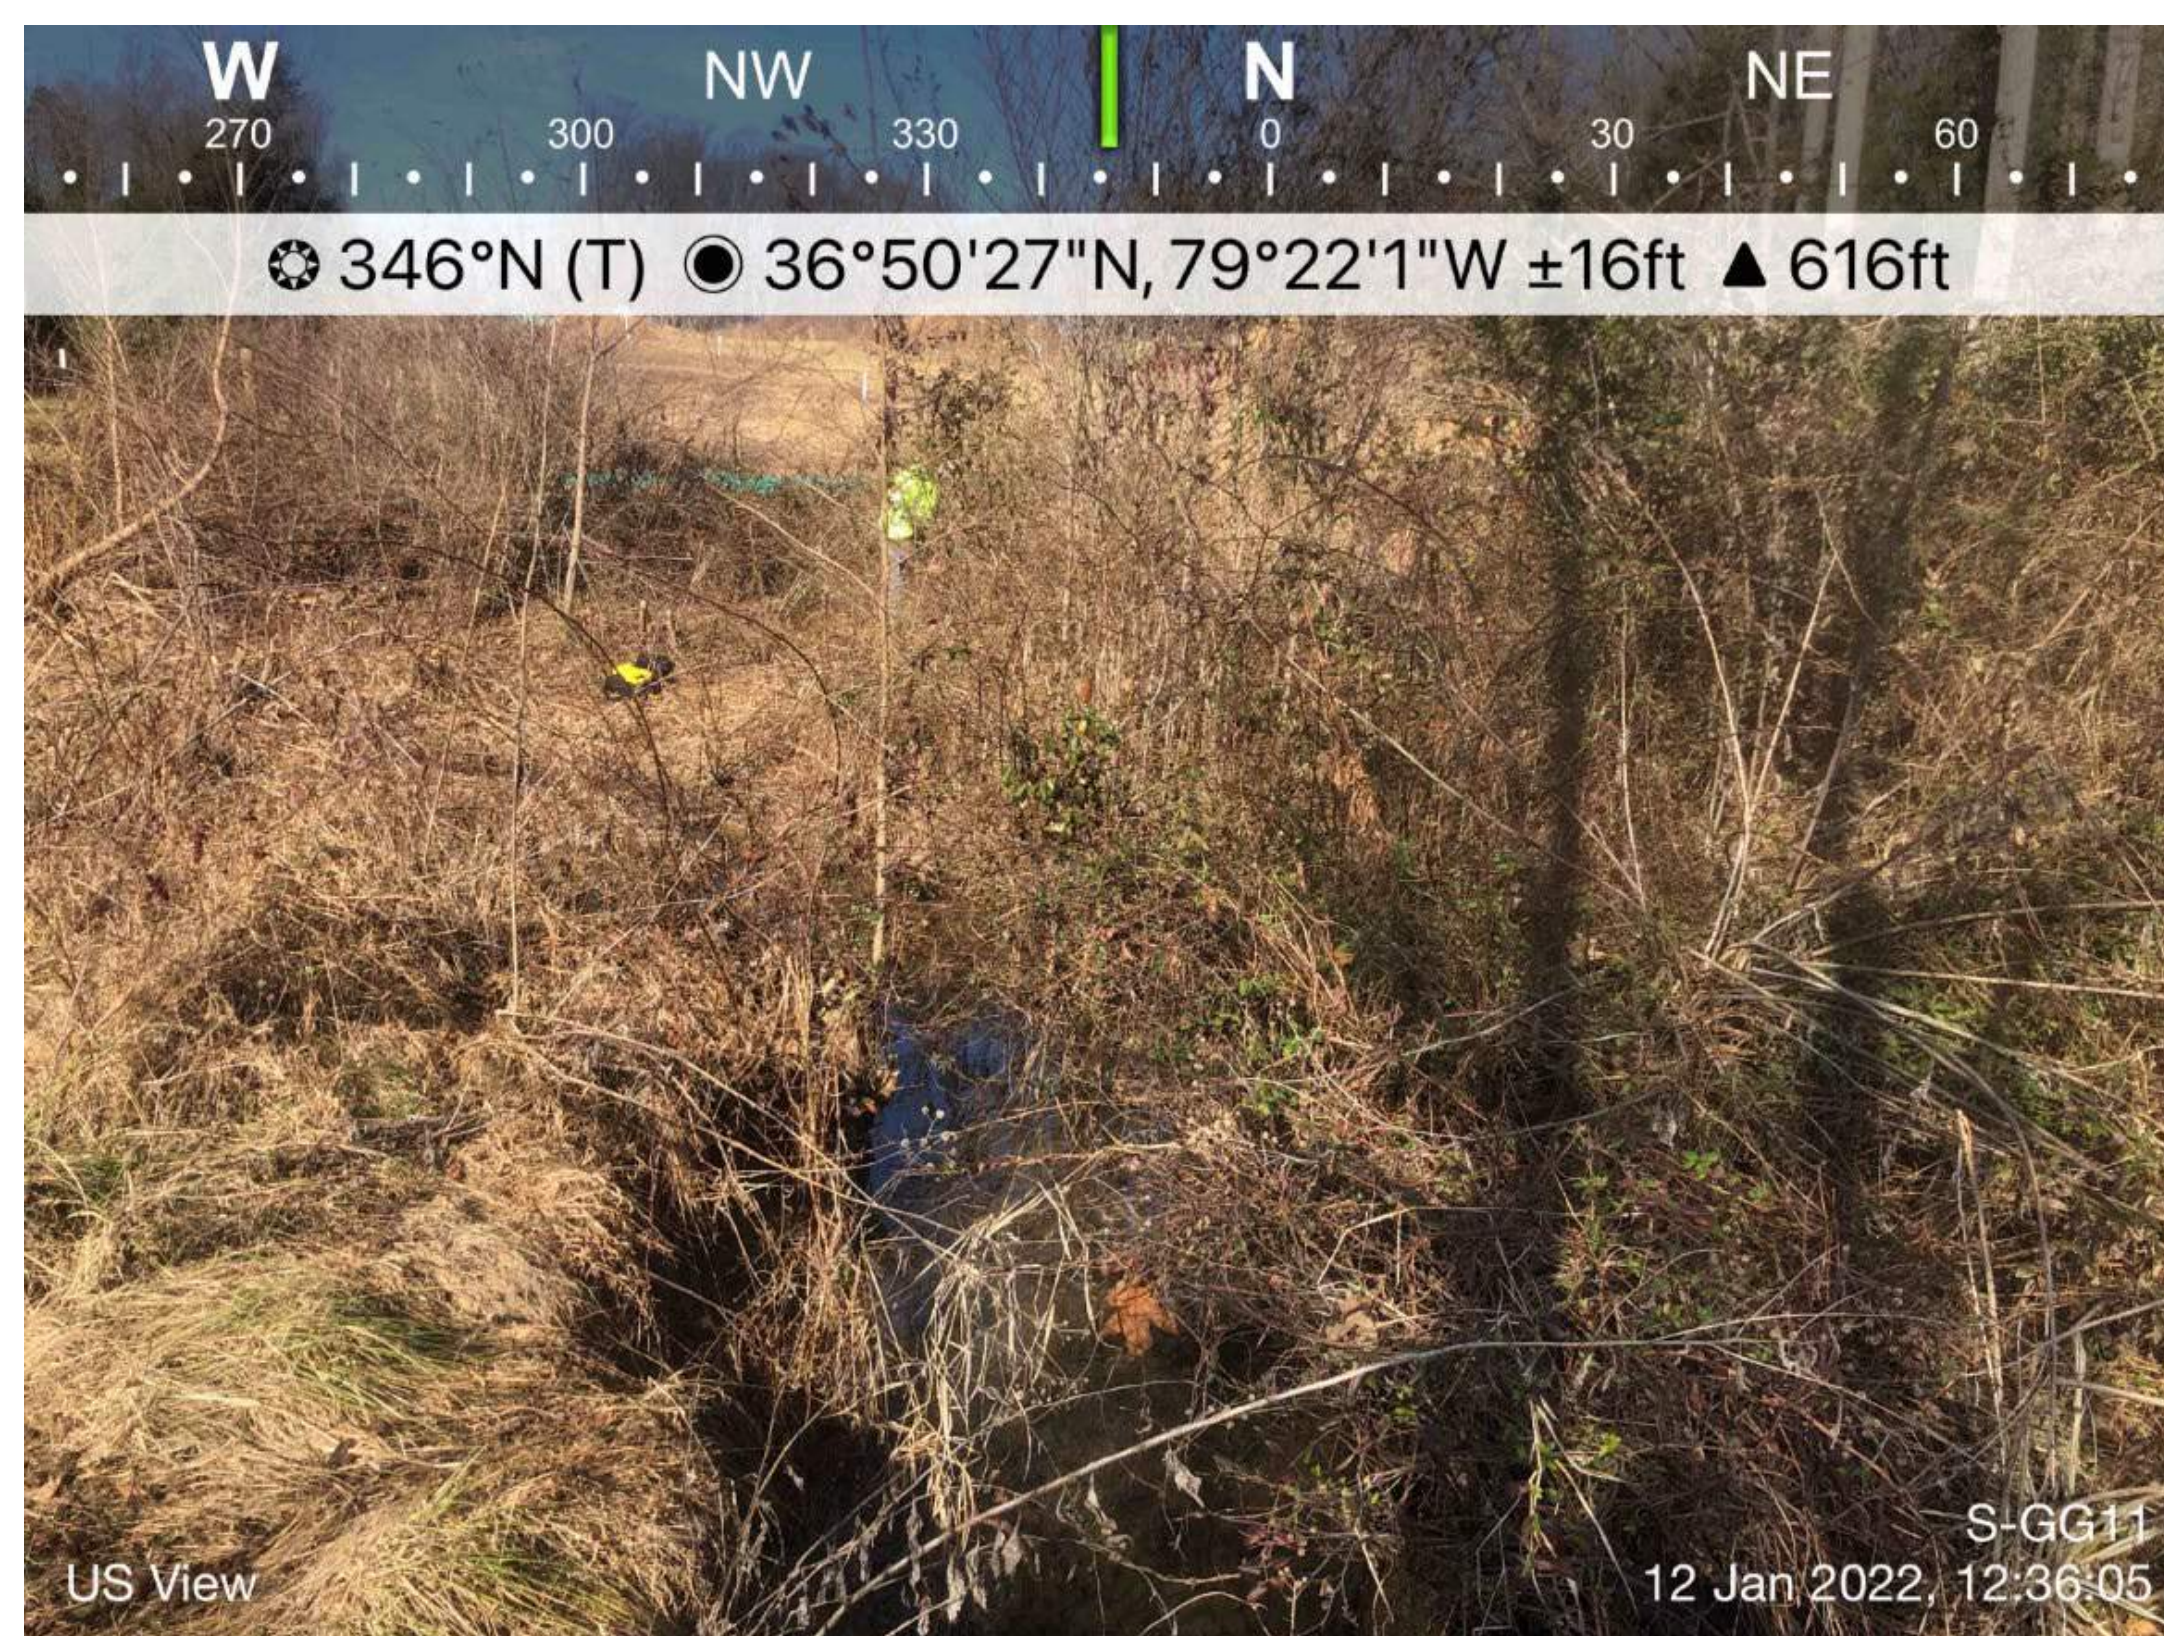
CAPTION. Assessment is limited to areas within the temporary ROW.
