Baseline Assessment – Stream Attributes

Reach S-H30 (Pipeline ROW) *

Franklin County, Virginia

Project #	Project Name (Applicant)	Locality	Cowardin Class.	HUC	Date	SAR #	Impact Length	Impact Factor
22865.06	Mountain Valley Pipeline (Mountain Valley Pipeline, LLC)	Franklin County	R4	03010101	8/25/2021	S-H30	4	1
Name(s) of Evaluator(s)		Stream Name and Information					SAR Length	
DW JM		UNT to Jacks Creek					7

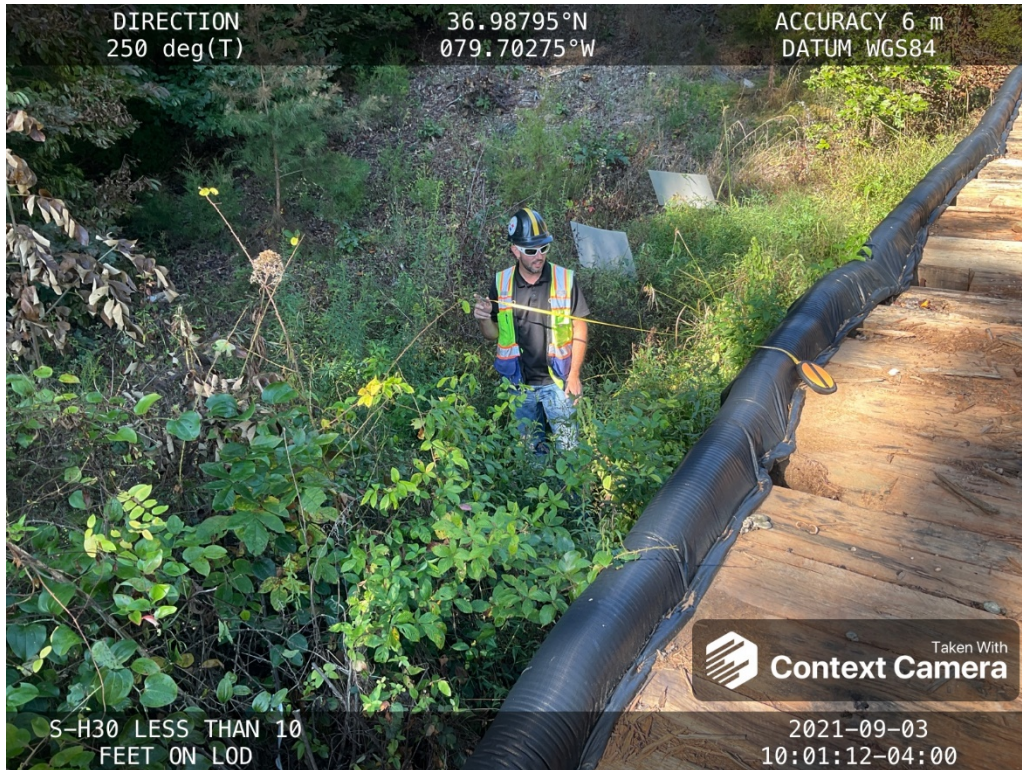
Photo Type: LESS THAN 10 FEET ON LOD

Location, Orientation, Photographer Initials: At ROW/LOD, looking SW, RAH

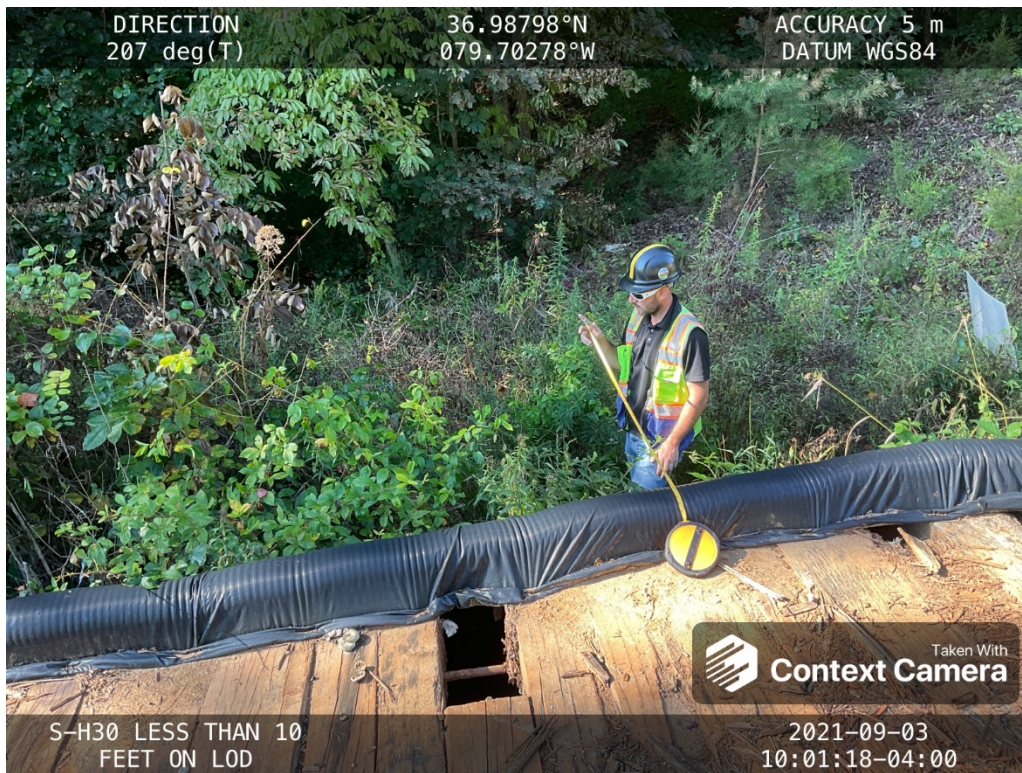
Photo Type: LESS THAN 10 FEET ON LOD

Location, Orientation, Photographer Initials: At ROW/LOD looking SW, RAH

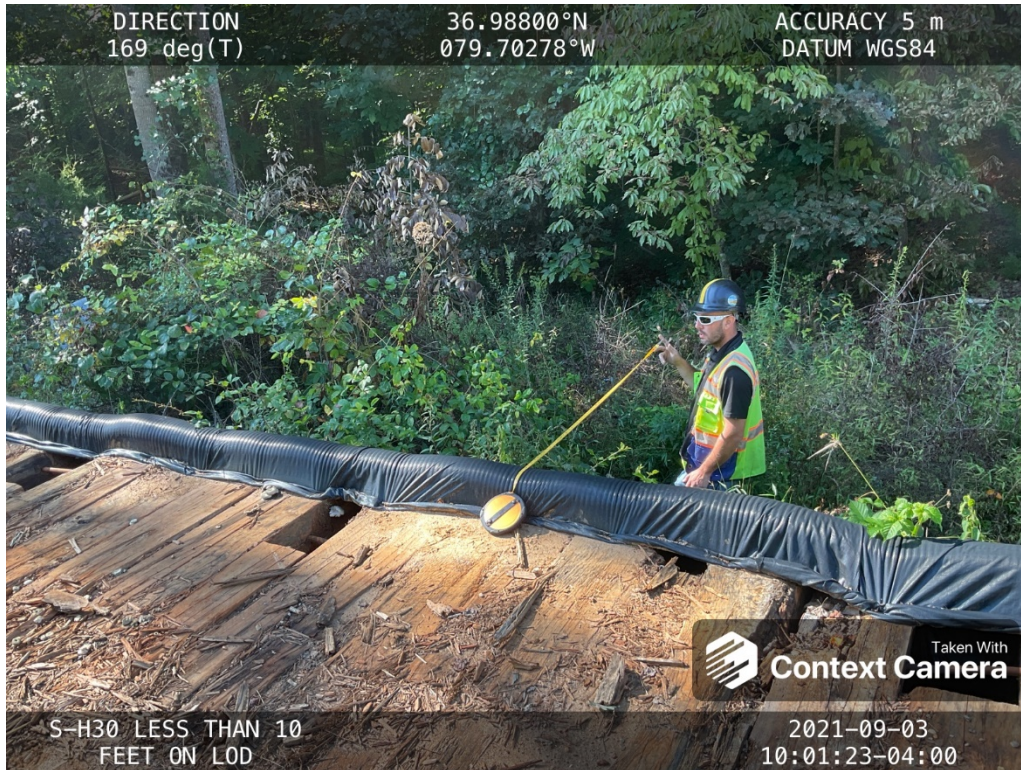
Photo Type: LESS THAN 10 FEET ON LOD

Location, Orientation, Photographer Initials: At ROW/LOD looking SE, RAH

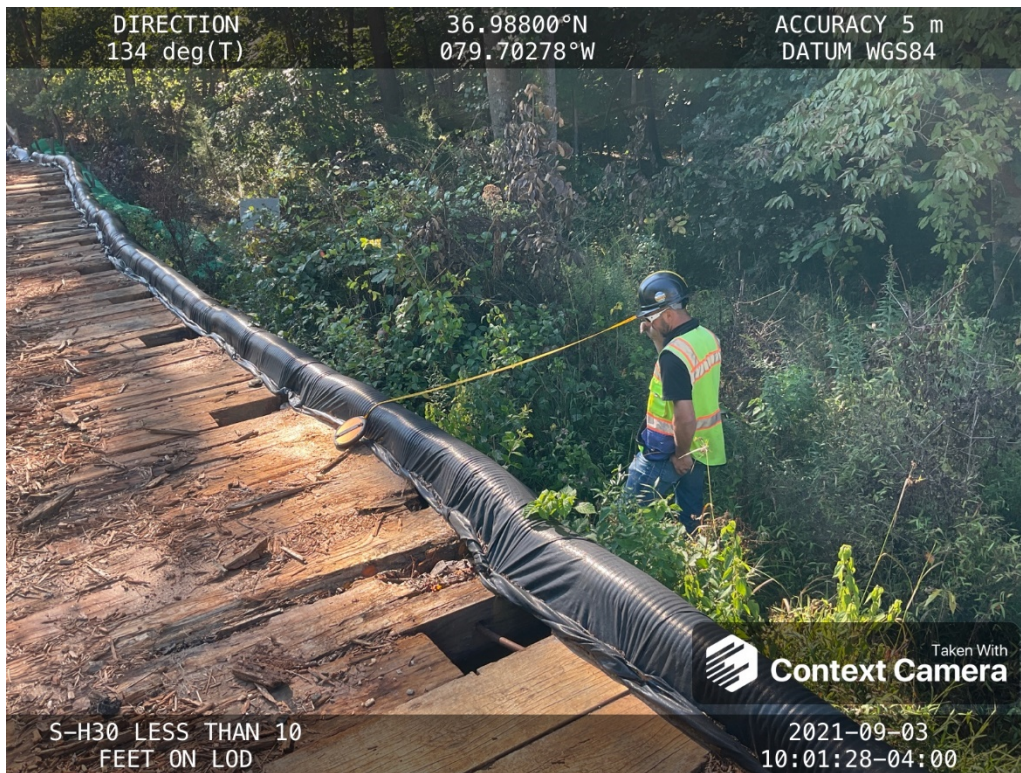
Photo Type: LESS THAN 10 FEET ON LOD

Location, Orientation, Photographer Initials: At ROW/LOD looking SE, RAH

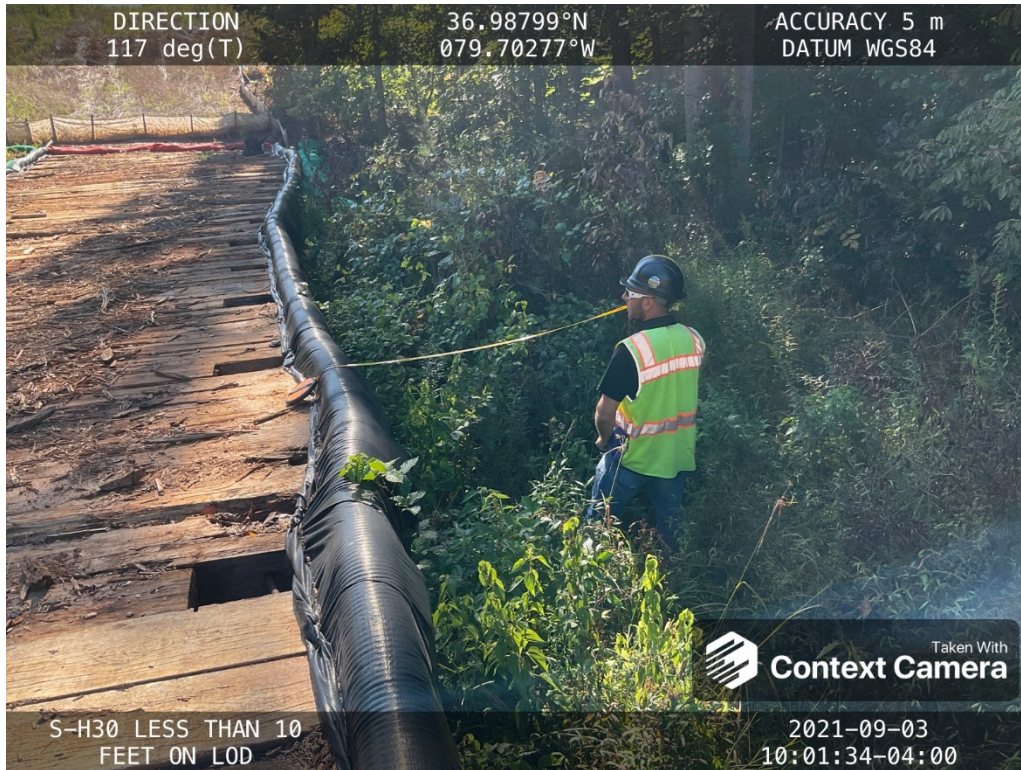
Photo Type: LESS THAN 10 FEET ON LOD

Location, Orientation, Photographer Initials: At ROW/LOD looking SE, RAH

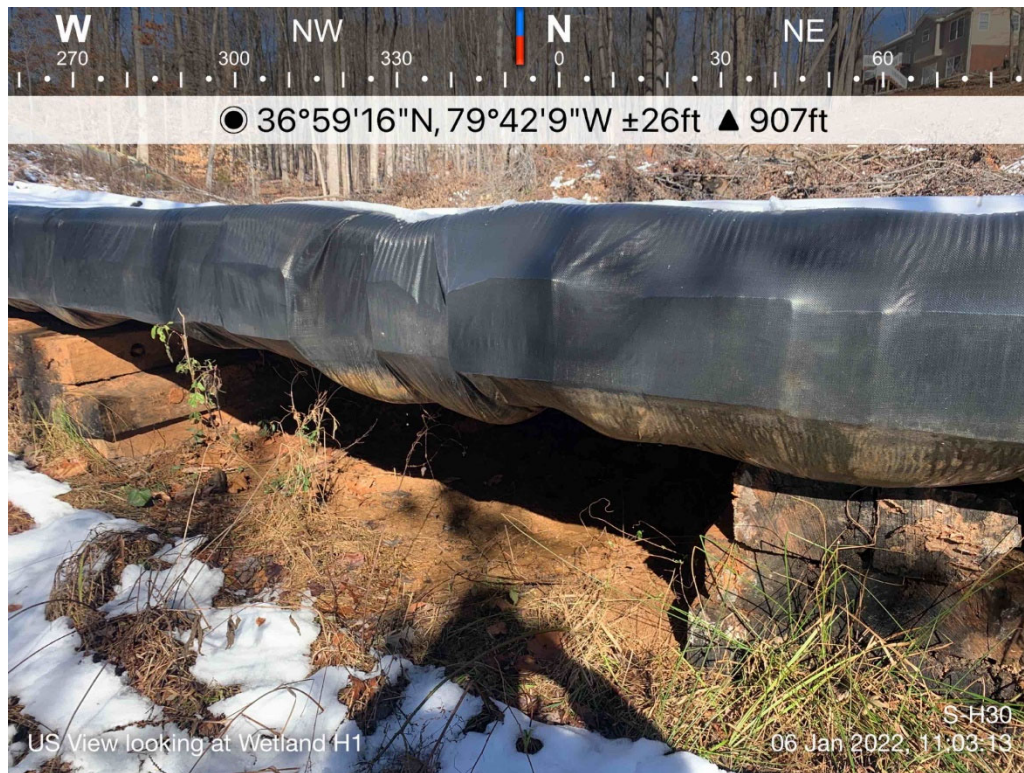
Photo Type: US VIEW

Location, Orientation, Photographer Initials: Upstream view of LOC looking N at Wetland H1, KB

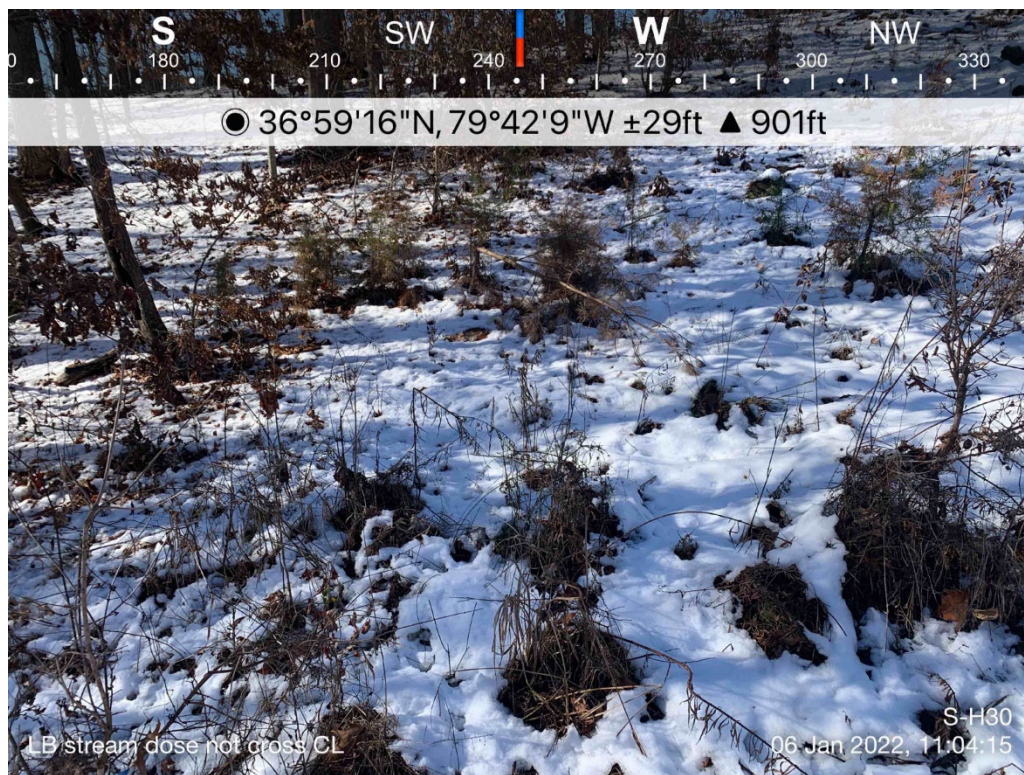
Photo Type: LB CL

Location, Orientation, Photographer Initials: Standing on LB looking at RB along pipe centerline looking W/SW, KB (LB stream does not cross CL)

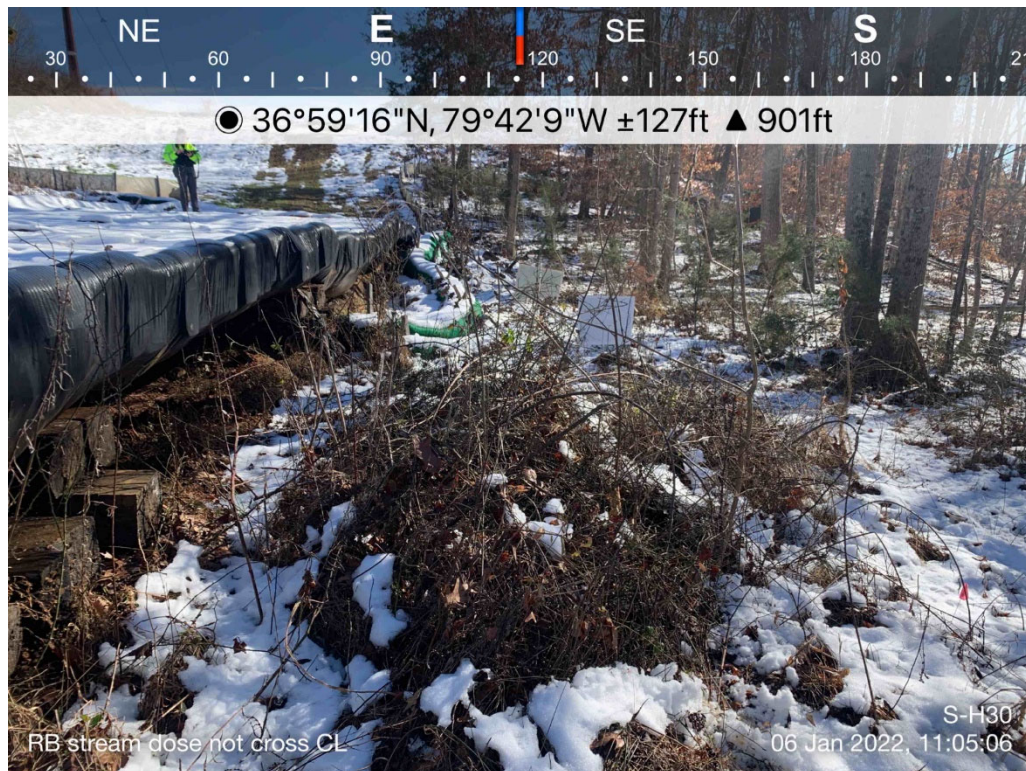
Photo Type: RB CL

Location, Orientation, Photographer Initials: Standing on RB looking at LB along pipe centerline looking E/SE, KB
(RB stream does not cross CL)

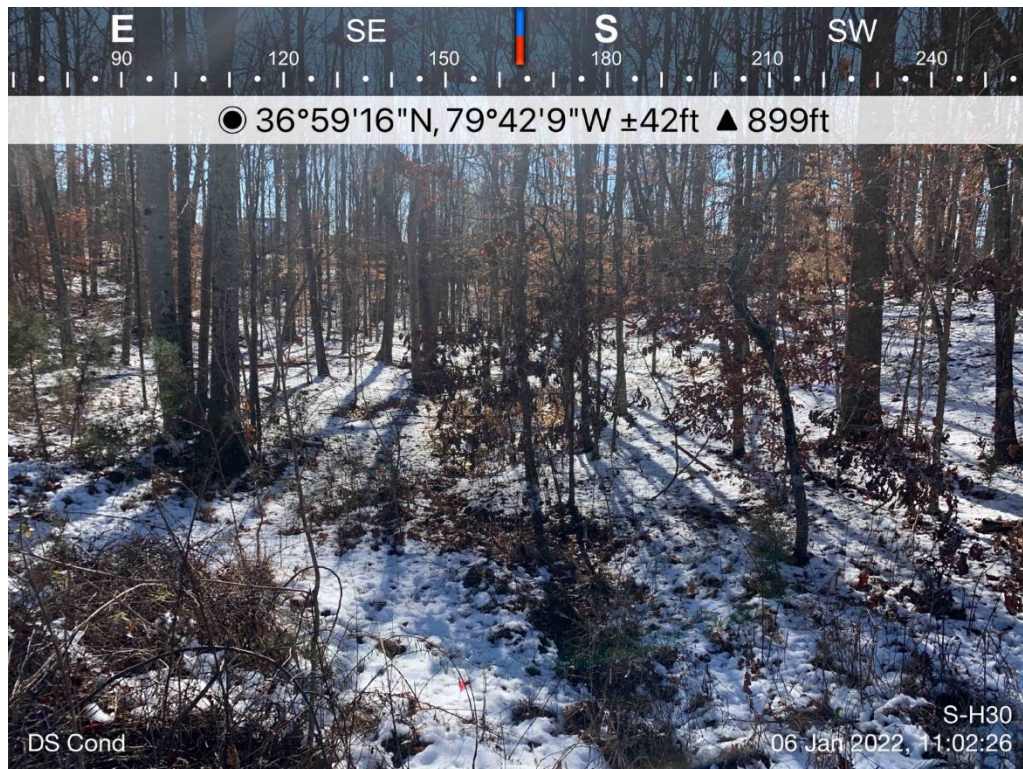
Photo Type: DS COND

Location, Orientation, Photographer Initials: Downstream conditions outside of LOC looking S/SE, KB
