Baseline Assessment – Stream Attributes

Reach S-H32 (Timber Mat Crossing)

Franklin County, Virginia

Crossing S-H32 - UNT to Jacks Creek (MP 277.9)

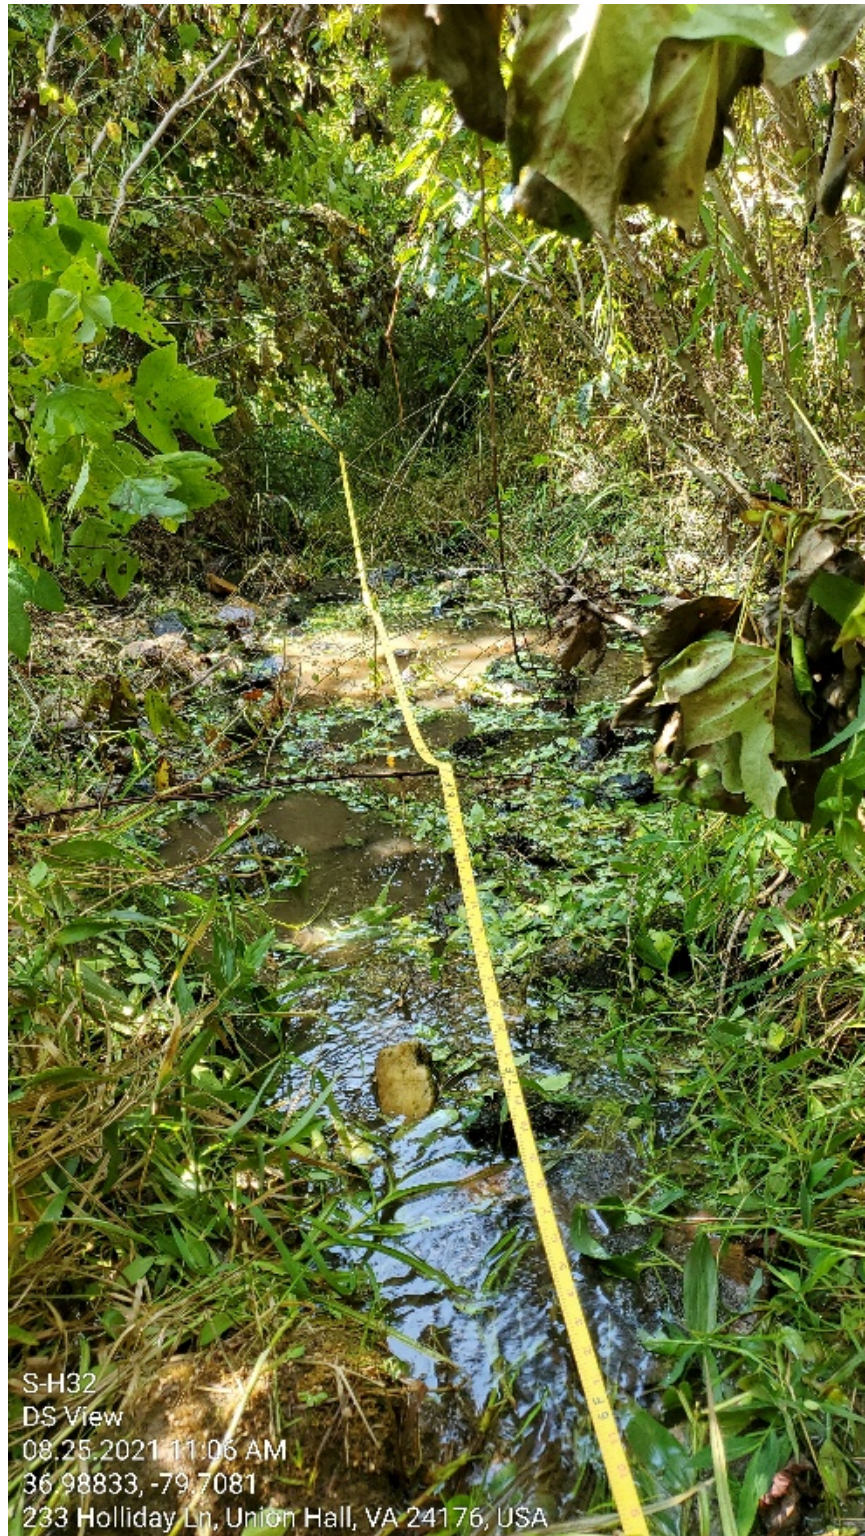
Photo Type: DS VIEW

Location, Orientation, Photographer Initials: Downstream view of ROW/LOC looking S, JM DW

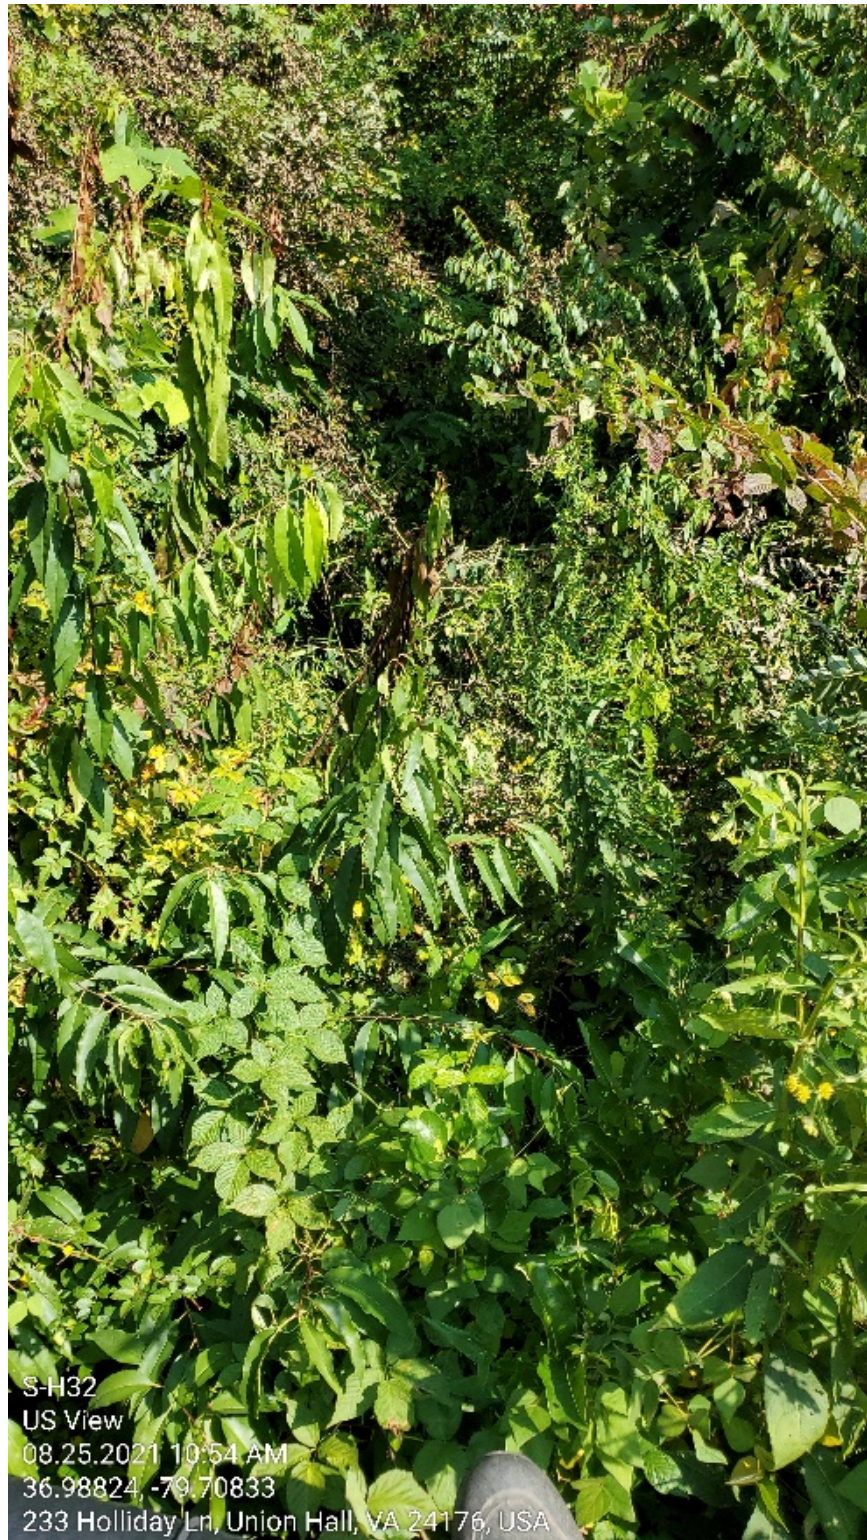
Photo Type: US VIEW

Location, Orientation, Photographer Initials: Upstream view of ROW/LOC looking N, JM DW

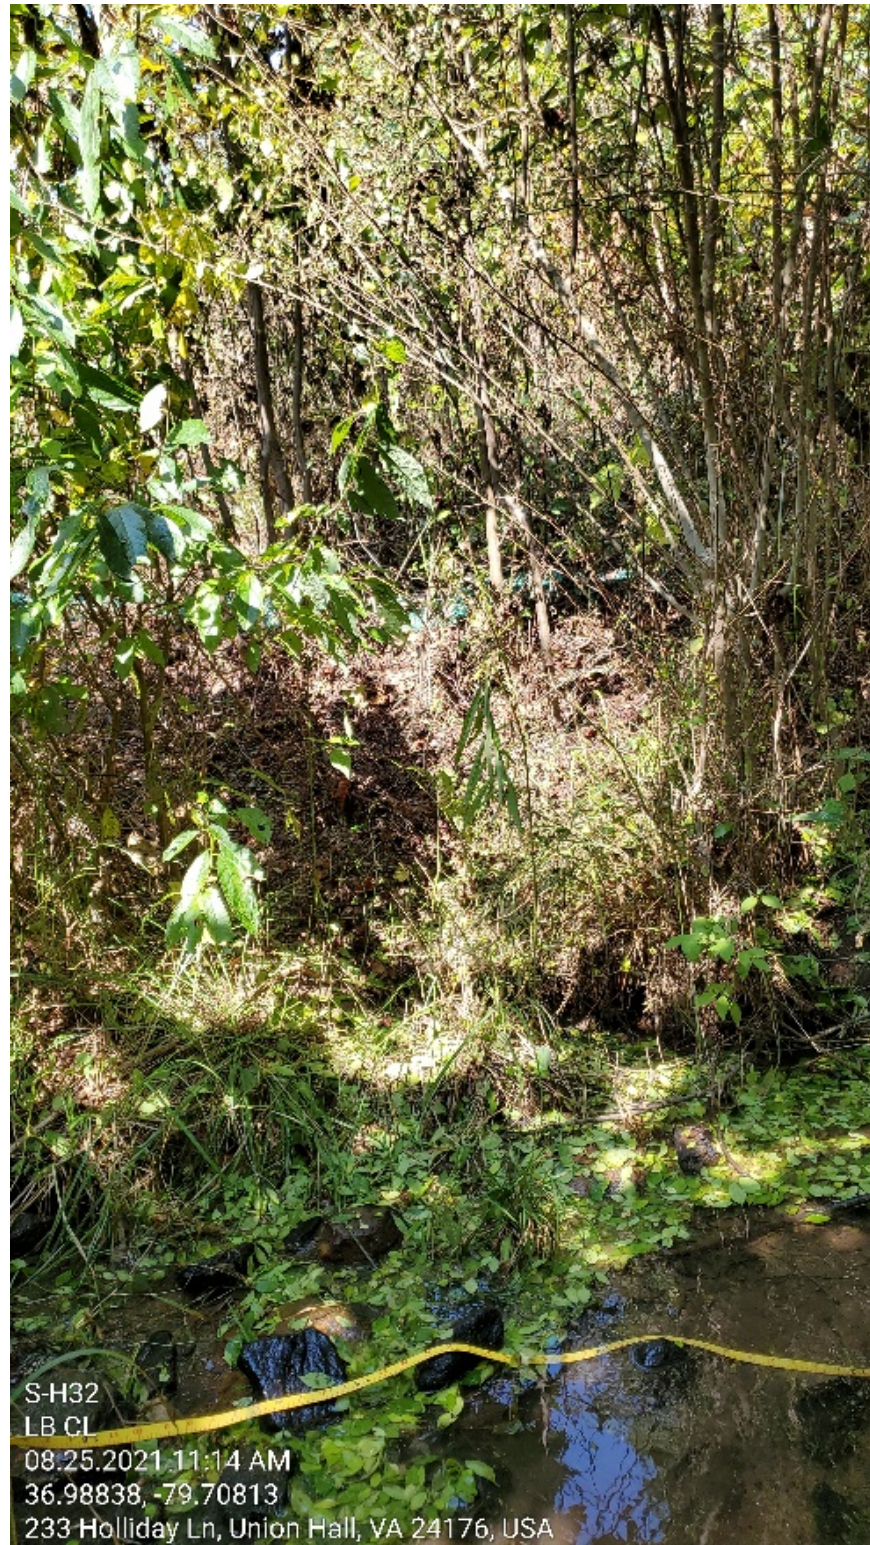
Photo Type: LB CL

Location, Orientation, Photographer Initials: Standing on LB looking at RB along pipe centerline looking E, JM DW

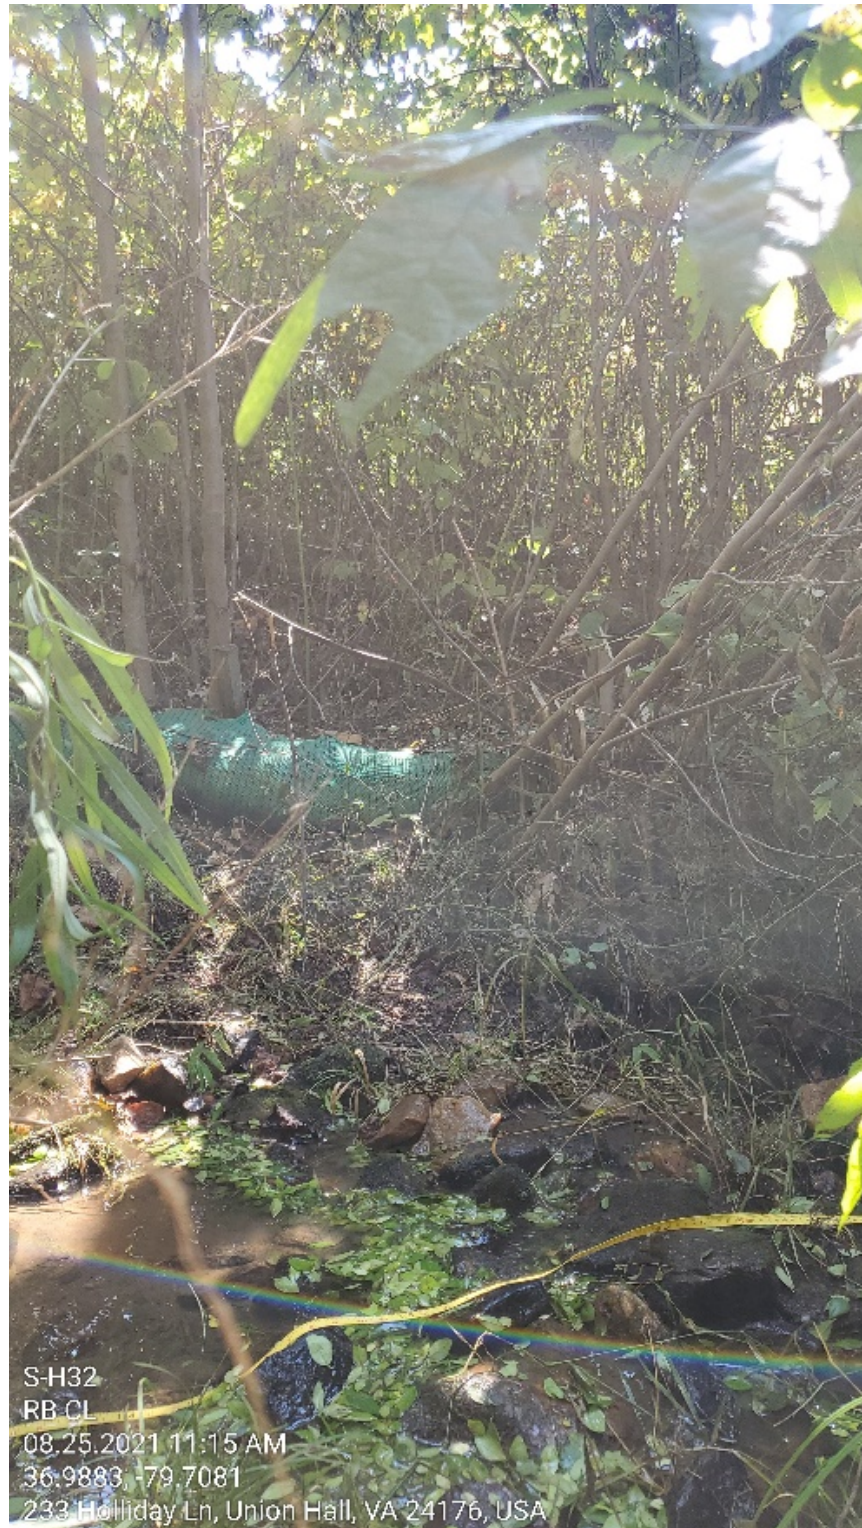
Photo Type: RB CL

Location, Orientation, Photographer Initials: Standing on RB looking at LB along pipe centerline looking W, JM
DW

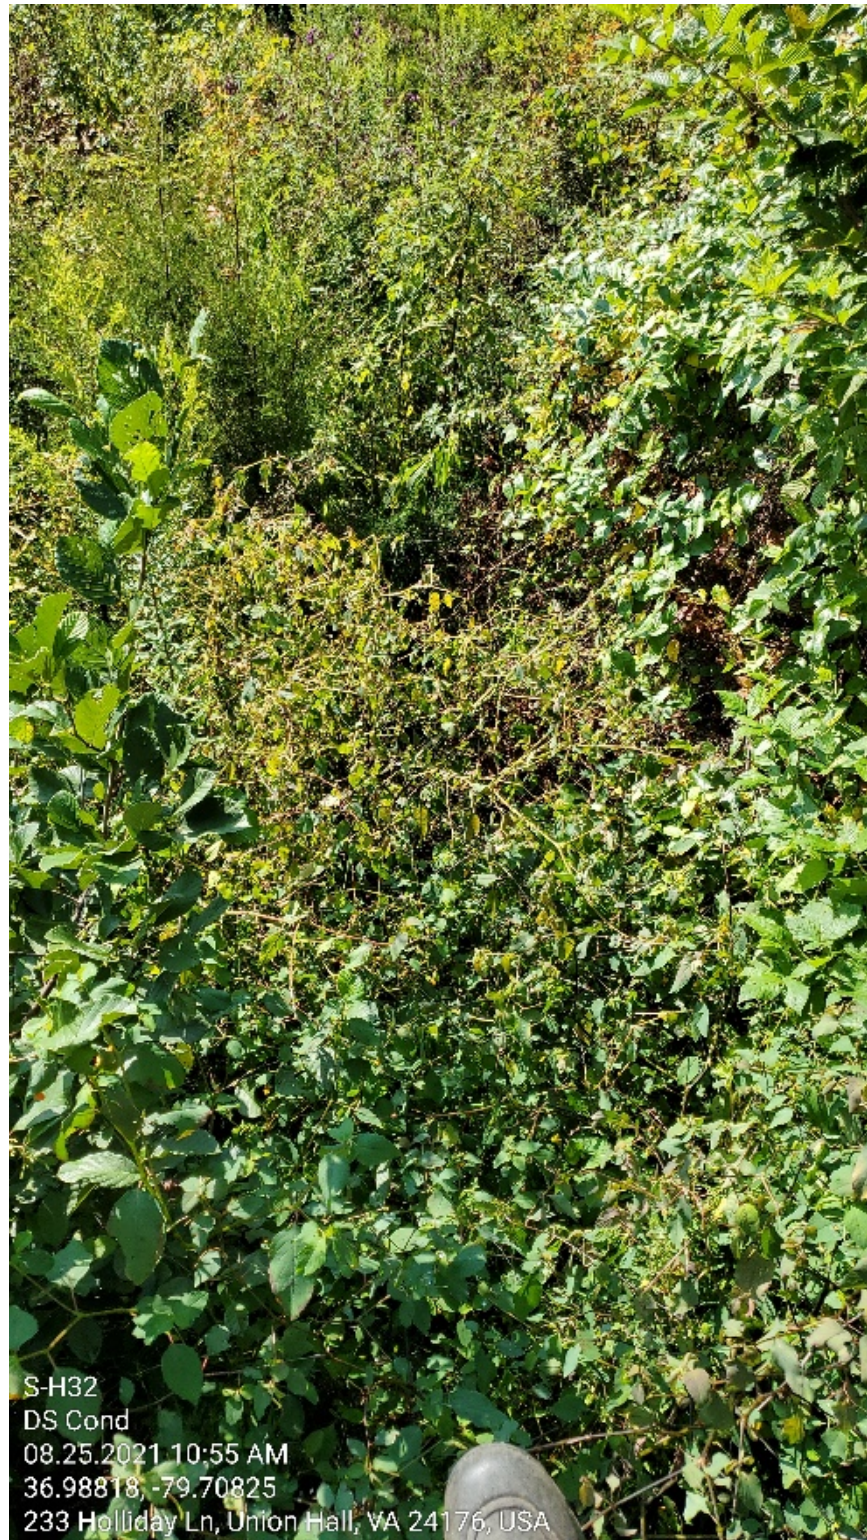
Photo Type: DS COND

Location, Orientation, Photographer Initials: Downstream conditions outside of ROW/LOC looking S, JM DW
