Baseline Assessment – Stream Attributes

Reach S-KL36 (Timber Mat Crossing) Perennial Spread I Franklin County, Virginia

Spread I Stream S-KL36 (Timber Mat Crossing) Franklin County

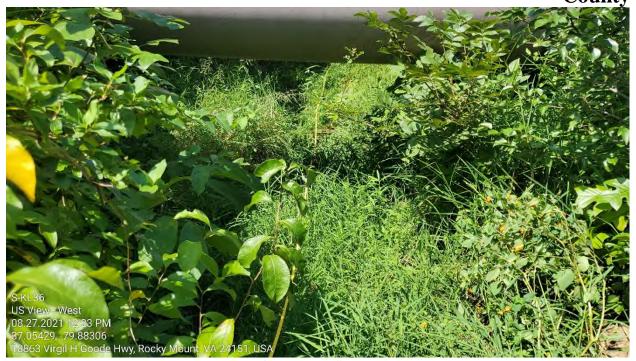
Photo Type: US VIEW Location, Orientation, Photographer Initials: Downstream at ROW/LOD looking W upstream, DW

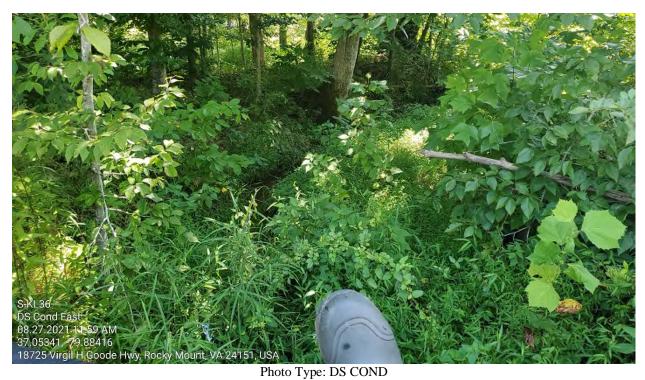
Location, Orientation, Photographer Initials: Downstream at ROW/LOD looking E downstream, DW

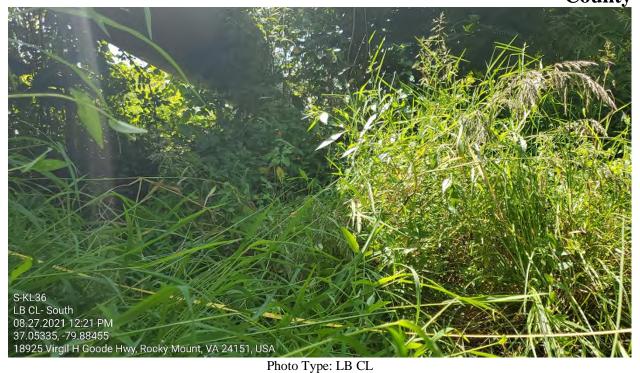
Location, Orientation, Photographer Initials: On thalweg at pipe centerline looking S at right streambank, DW

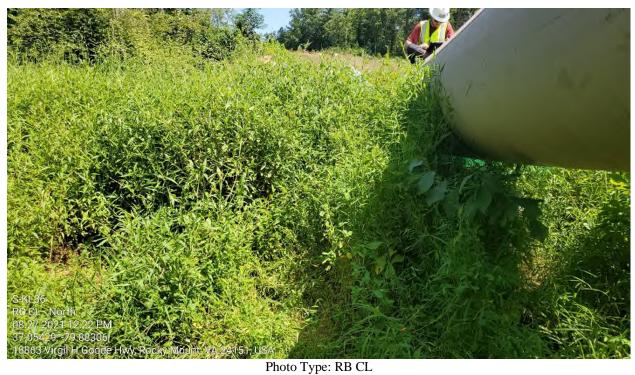
Location, Orientation, Photographer Initials: On thalweg at pipe centerline looking N at left streambank, DW

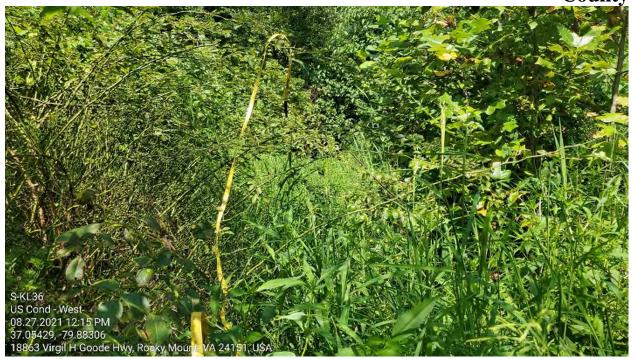
Photo Type: US COND Location, Orientation, Photographer Initials: Upstream at ROW/LOD looking W upstream, DW

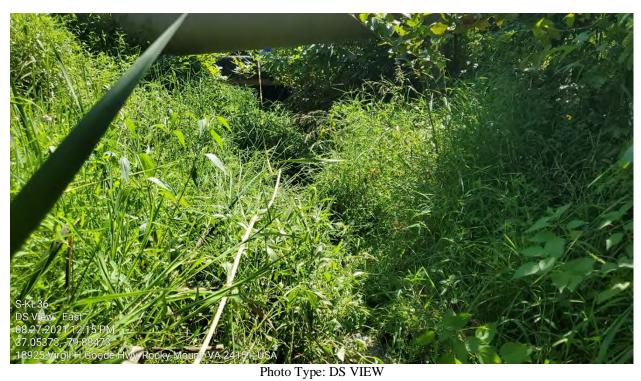
Location, Orientation, Photographer Initials: Upstream at ROW/LOD looking E downstream, DW

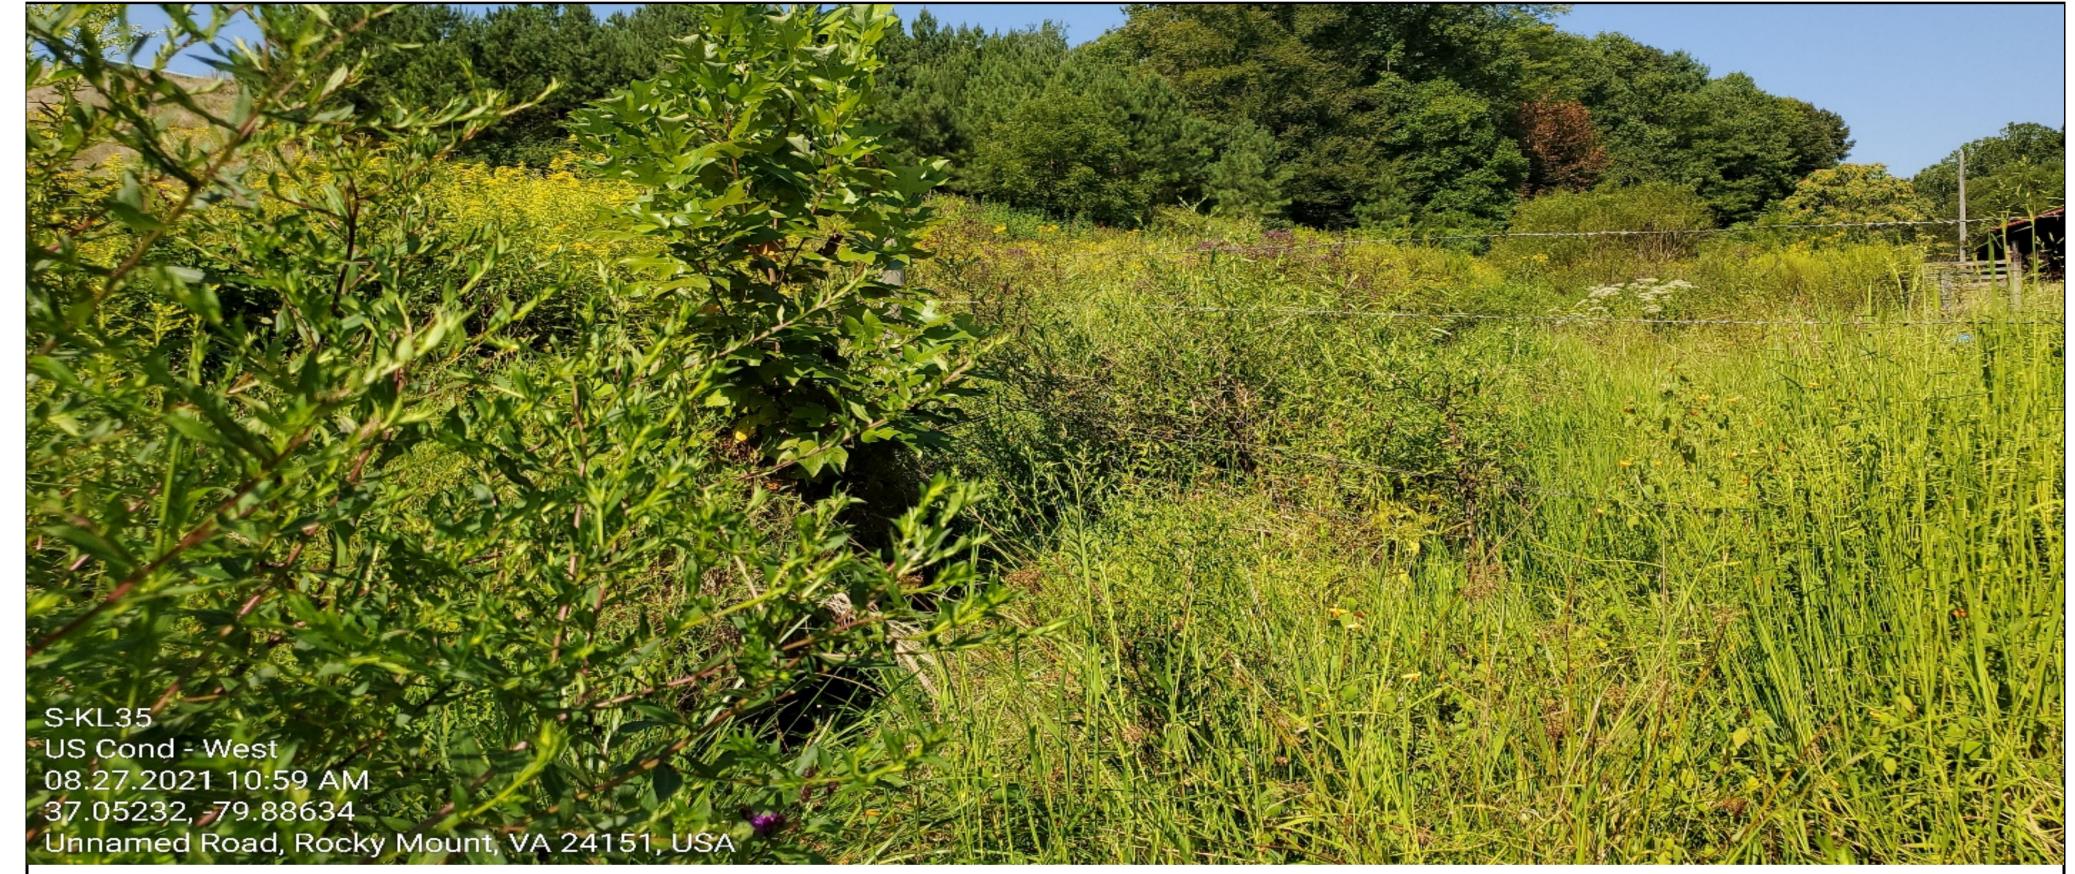
CAPTION. Assessment is limited to areas within the temporary ROW.
