Baseline Assessment – Stream Attributes

Reach S-MM44 (Timber Mat Crossing) Perennial Spread I Franklin County, Virginia

Spread I Stream S-MM44 (Timber Mat Crossing) Franklin County

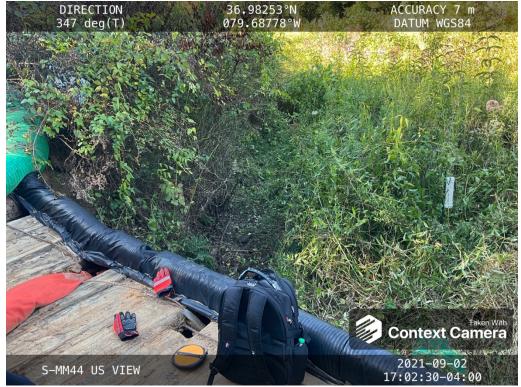
Photo Type: US VIEW

Location, Orientation, Photographer Initials: Downstream at ROW/LOD looking NW upstream, RAH

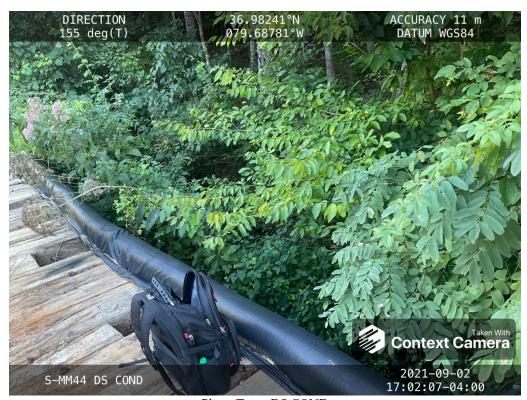
Photo Type: DS COND

Location, Orientation, Photographer Initials: Downstream at ROW/LOD looking SE downstream, RAH

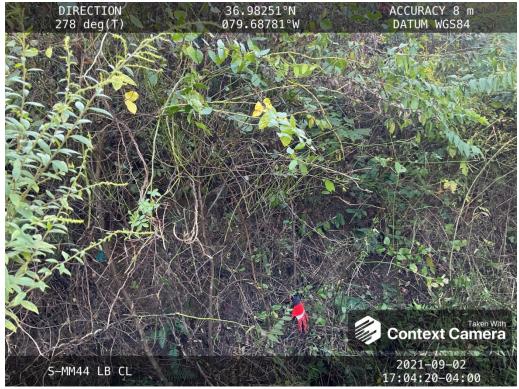
Photo Type: LB CL

Location, Orientation, Photographer Initials: On thalweg at pipe centerline looking SW at right streambank, RAH

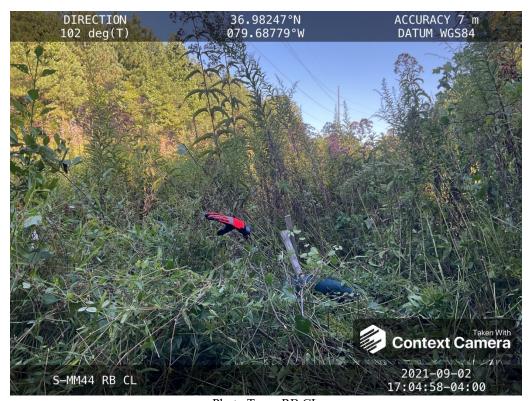
Photo Type: RB CL

Location, Orientation, Photographer Initials: On thalweg at pipe centerline looking SE at left streambank, RAH

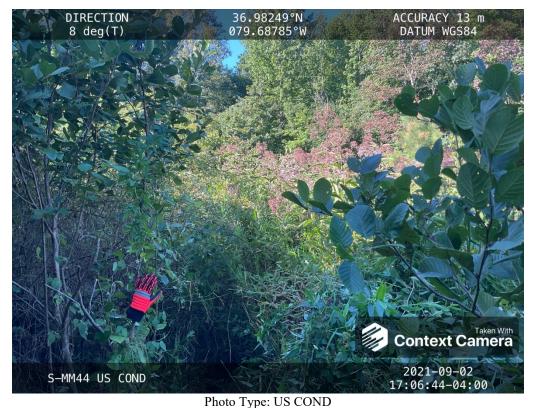
Location, Orientation, Photographer Initials: Upstream at ROW/LOD looking N upstream, RAH

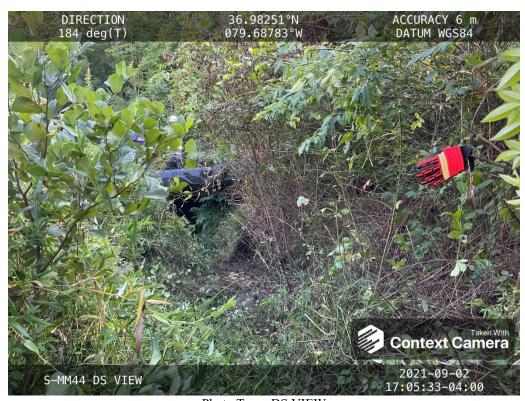
Photo Type: DS VIEW

Location, Orientation, Photographer Initials: Upstream at ROW/LOD looking S downstream, RAH
