**Mountain Valley Pipeline Project**

**Docket No. CP16-10-000**

**Attachment DR4 Geology 8**

**Electrical Resistivity Imaging Study for the Mountain Valley Pipeline  
Mount Tabor Karst Area  
Blacksburg, VA  
DAA Project Number: B14188B-02**

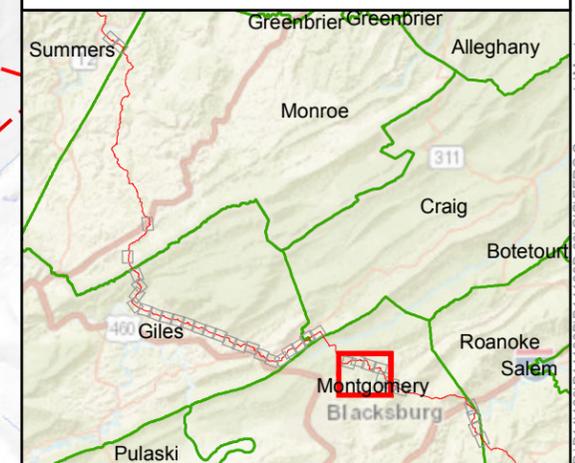
Fracture Trace and Sinkhole Lineaments  
Mount Tabor Area  
MVP October 2016 Proposed Route

Sinkholes auto-delineated from Montgomery County 2005 LiDAR data. Fracture trace and sinkhole lineaments derived from the combined observations of the following sources:

- Direct field observation,
- MVP 2015 project LiDAR,
- Blacksburg 2010 LiDAR (west edge),
- Montgomery Co. 2005 LiDAR,
- VGIN 2007-2015 digital terrain models,
- Virginia Sinkhole data, Va.DMME.

Fault locations from field observation and the Geologic map of the McDonalds Mill quadrangle, Virginia: Coiner, L.V., Spears, D.B., and Henika, W.S., 2015, Virginia Division of Mineral Resources 2015.

Background (light gray) Montgomery County 2005 LiDAR hillshade.

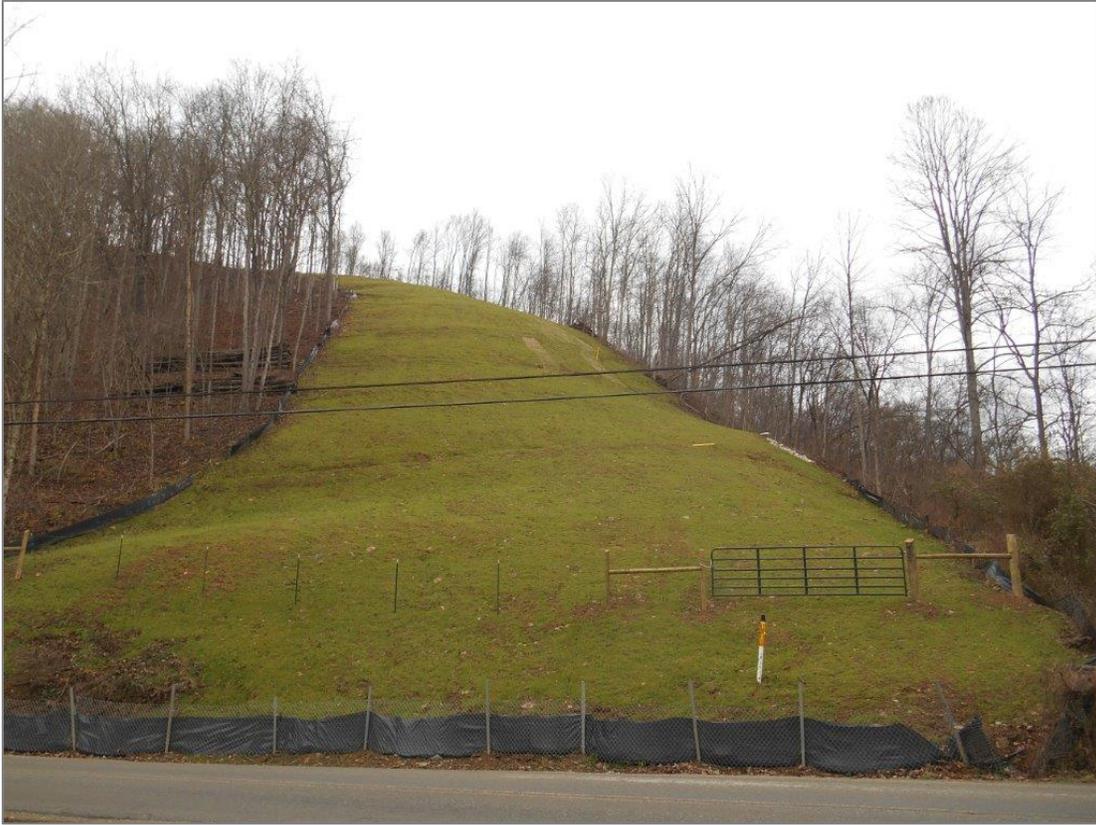
**Figure 1-1: Steep Slope at Road Crossing (photo taken 1/26/2017)**

Water migrating along the trench between trench breakers, if not properly relieved, can pond behind them and eventually saturate the trench backfill and other soils adjacent to the trench. Water saturation increases the weight of the soil while reducing the strength of the soil, which can lead to a landslide. In order to mitigate against potential landslides, trench breaker drains were installed to discharge water from the trench at intervals throughout the hillside. These controls were installed during construction in July 2016, and have undergone several freeze/thaw cycles and large precipitation events. Figure 1-2 shows a close-up of the discharge point of one trench breaker drain on the slope with a rock apron to disperse flow before going off the ROW. No landslides have occurred on this slope to date.

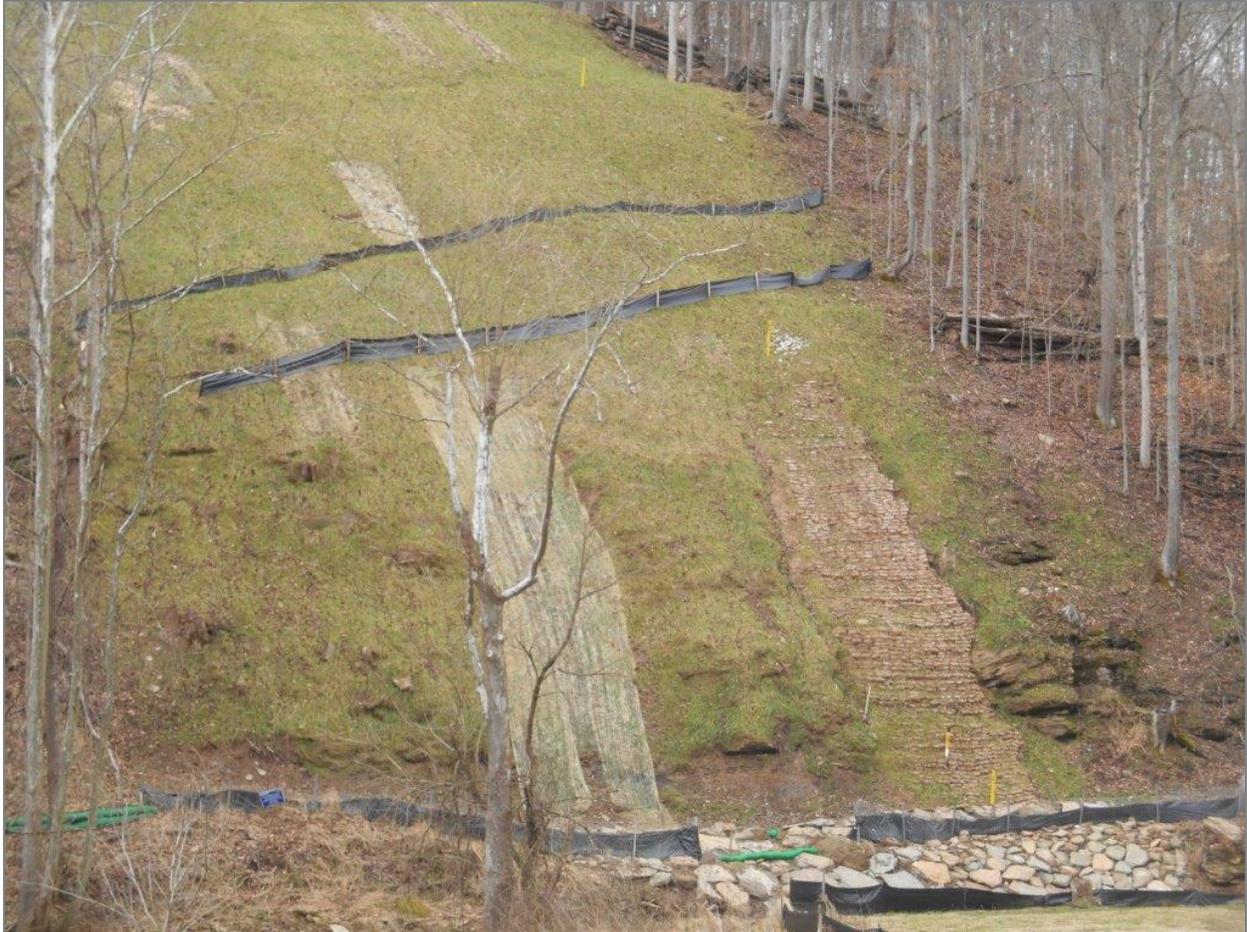
**Figure 2-1: Steep Slope Stream Crossing (photo taken 1/26/2017)**

The slope shown in Figure 2-1 was identified prior to construction as having an increased risk for sliding as it is located in an area with mapped colluvial soils (based on USGS Landslide Hazard Maps), the slope is steep (averaging approximately 34 degrees or 67.5 percent slope), and there is a stream crossing at the toe of the slope.

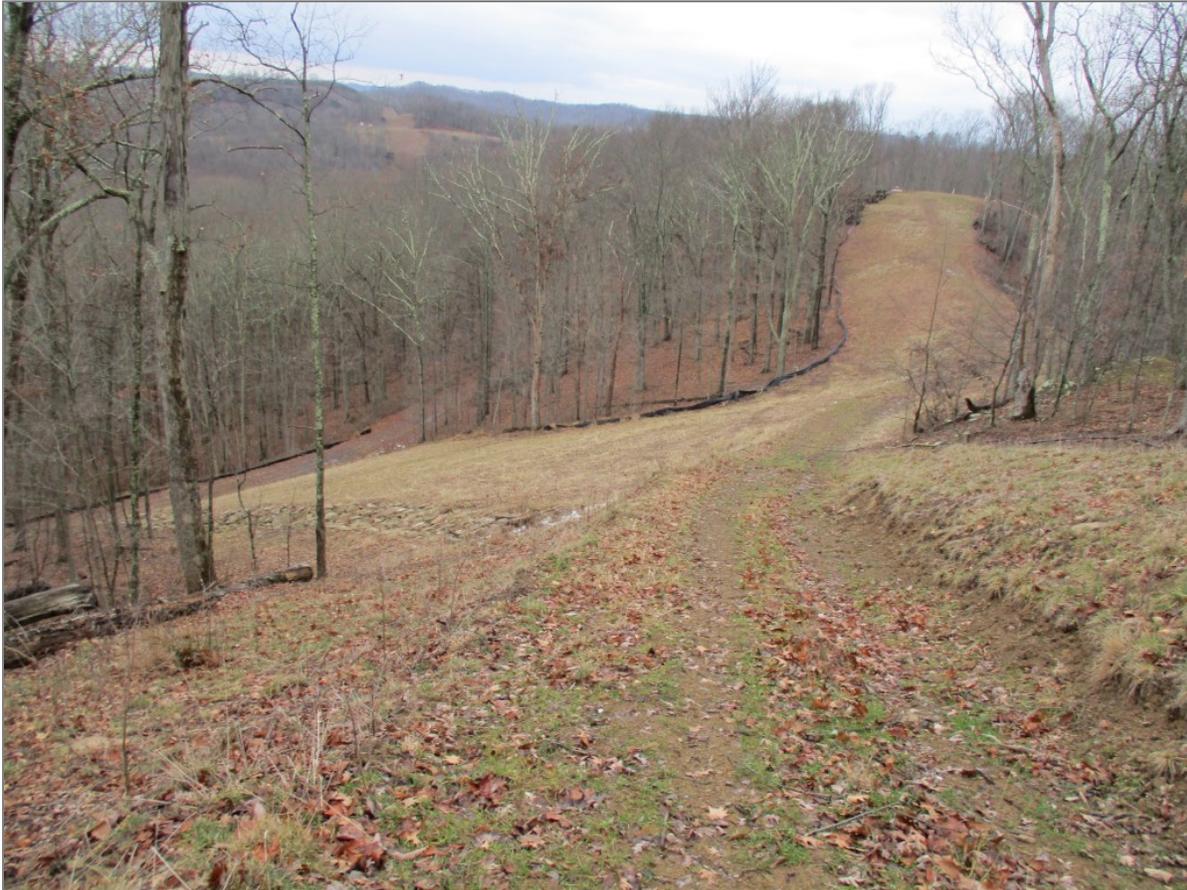
**Figure 3-1: Remediated Slope (photo taken 1/26/2017)**

During a routine pipeline inspection in March 2014, a landslide was discovered on the ROW shown in Figure 3-1. Pipeline construction was completed in November 2012. The following factors were identified as primary causes of the slide:

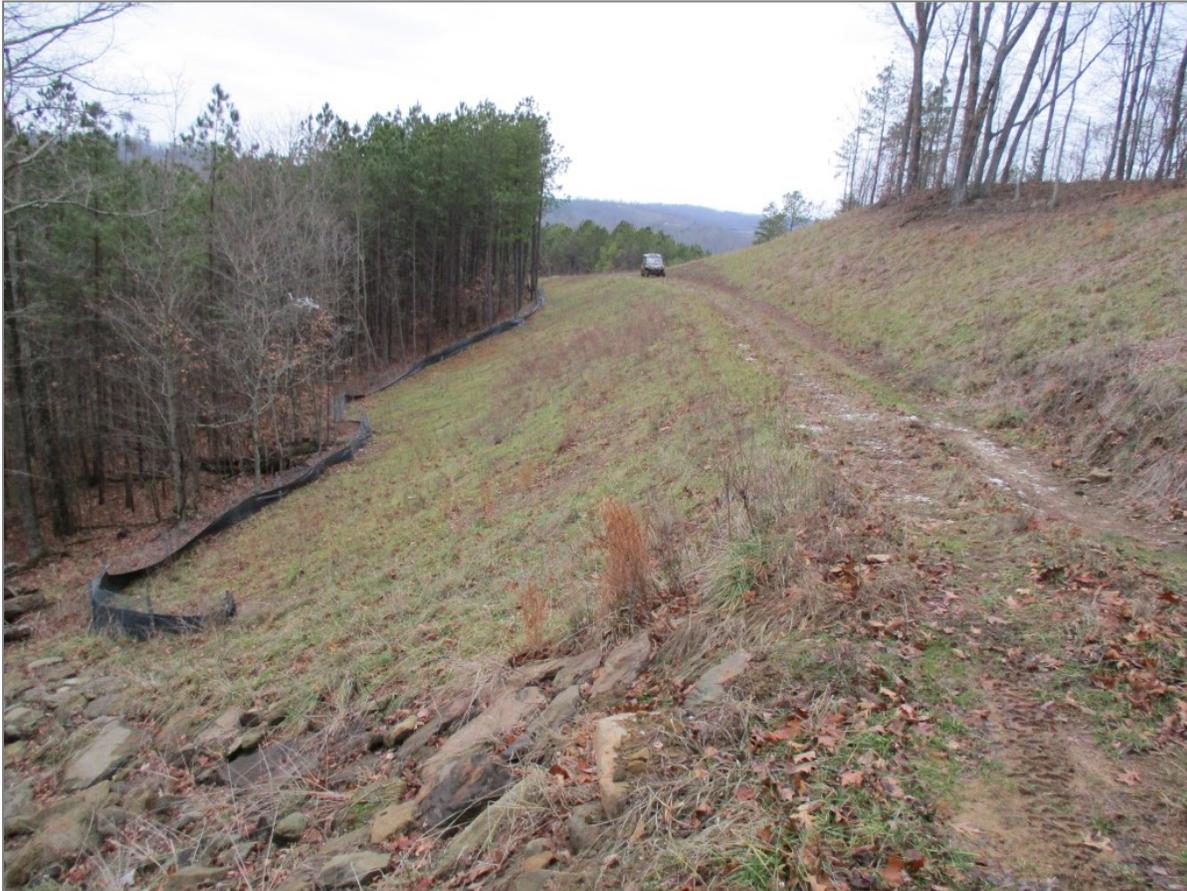
**Figure 4-1: Remediated Slope (photo taken 1/26/2017)**

During a routine pipeline inspection in March 2014, a landslide was discovered on the ROW shown in Figure 4-1. Pipeline construction was completed in November 2012. The following factors were identified as primary causes of the slide:

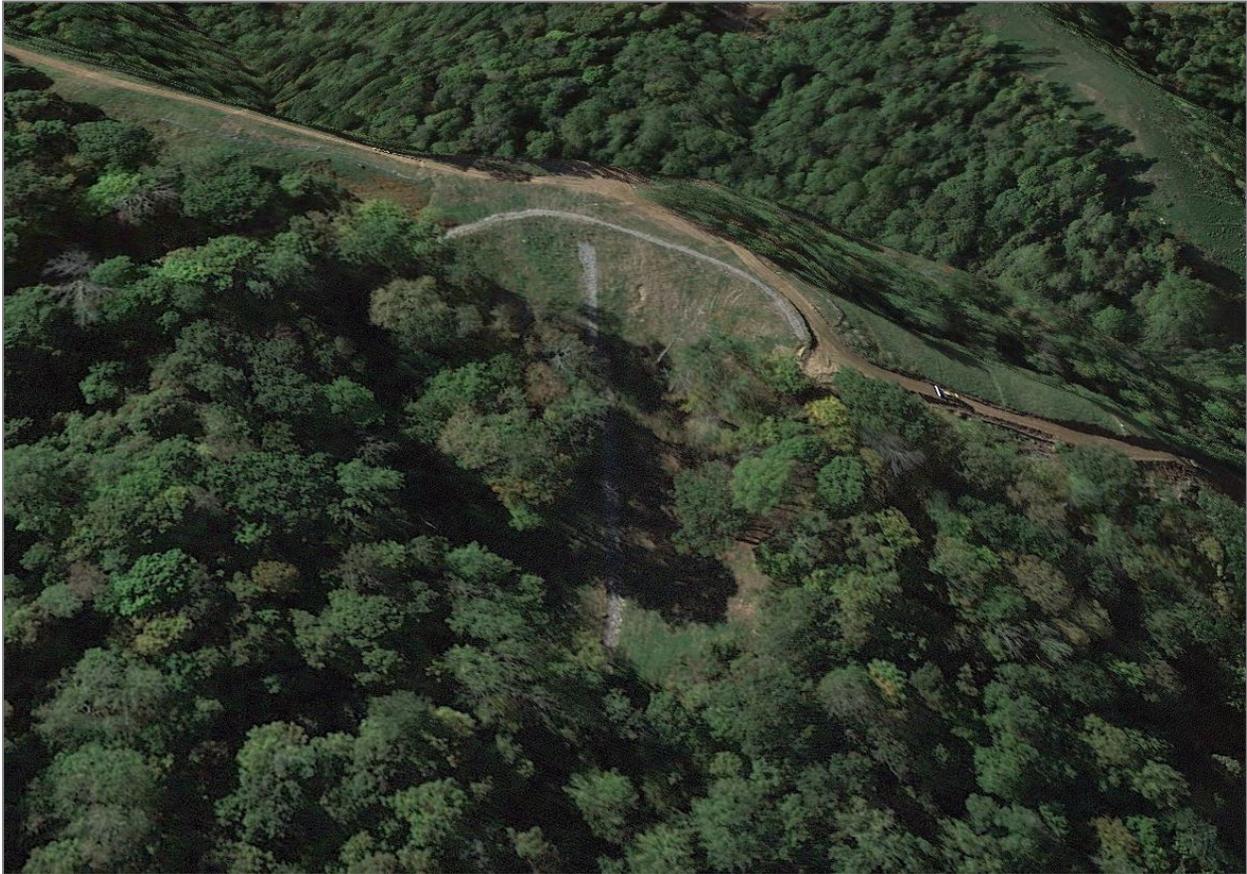
**Figure 5-1: Remediated Slope (from Google Earth 10/5/2016)**

During a routine pipeline inspection in August 2014, a landslide was discovered on the ROW shown in Figure 5-1. Pipeline construction was completed in December 2013. The following factors were identified as primary causes of the slide:

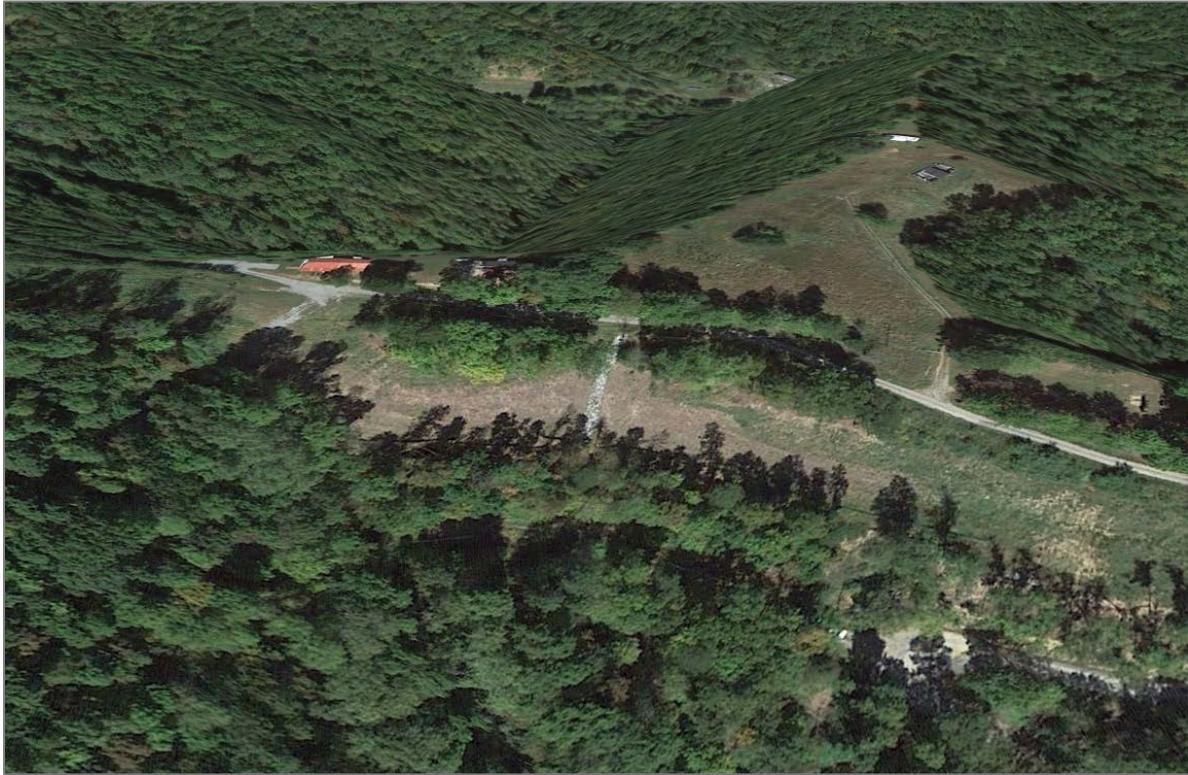
**Figure 6-1: Remediated Slope (from Google Earth 10/5/2016)**

During a routine pipeline inspection in March 2014, a landslide was discovered on the ROW shown in Figure 6-1. Pipeline construction was completed in December 2013. The following factors were identified as primary causes of the slide:
