# Visual Site Inspection Report

<b>Project Name</b>	H-600 Pipeline Spread G	<b>AFE</b>	124300137	<b>Spread</b>	H-600 Pipeline Spread G
<b>Contractor</b>	Precision			<b>Report #</b>	6102
<b>Inspector</b>	Rob Robertson			<b>Date/Time</b>	8/9/2018 6:44 PM
<b>Permit #</b>	TBD	<b>Inspection Type</b>	VA SWPP	<b>Station Begin</b>	10458+91
<b>State</b>	VA	<b>Inspection Area</b>	Full	<b>Station End</b>	10459+03
<b>County</b>	Giles	<b>Ground</b>	Damp	<b>Temperature (°F)</b>	83.00
<b>Municipality</b>	N/A	<b>Weather</b>	Cloudy	<b>Rain Gauge (in)</b>	0.00
<b>GPS Location</b>	37.1327406959954, -80.3942030948404			<b>Rain Accumulation Time (days)</b>	1.00

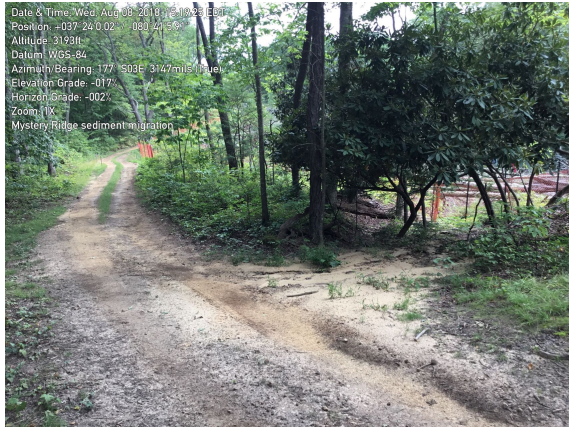
A/E	124300137	Date/Time	8/9/2018 6:44 PM	Report #	6102
Pictures					
<div><div><div>Date &amp; Time: Wed, Aug 08, 2018, 08:03 EDT Position: +037° 24' 0.02" / -080° 22' 56" Altitude: 3193ft Datum: WGS-84 Azimuth/Bearing: 122° 50SE 314.7mils (True) Elevation Grade: -012% Horizon Grade: -002% Zoom: 1X Mystery Ridge sediment migration</div><div>

</div></div></div>			
GPS Location	37.1329665044668, -80.3942559008304		GPS Location	37.1336362185302, -80.3951403592531	
Description	Sediment leaving Mystery Ridge Road and crossing the ROW. Sediment deposits migrated across ROW before settling 185'		Description	Rock skullcap in bloom along Mystery Ridge Road

E&S BMPs	Compliance Level	Corrective Action	Corrective Time Frame
Compost Filter Sock	Acceptable		
Roadside Ditch	Acceptable		
Silt Fence (Filter Fabric Fence)	Acceptable		
Waterbar	Communication	Grade surface, install new and repair e	48 Hours

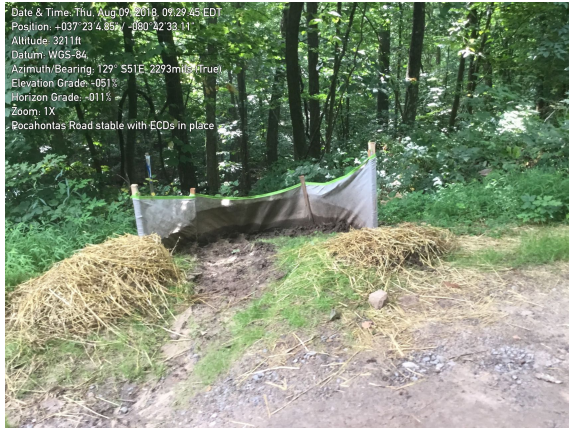
<div><div><div>Date &amp; Time: Thu, Aug 09, 2018, 09:29 EDT Position: +037° 23' 4.85" / -080° 42' 33.11" Altitude: 3211ft Datum: WGS-84 Azimuth/Bearing: 129° 551E 2293mils (True) Elevation Grade: -051% Horizon Grade: -011% Zoom: 1X Pocahontas Road stable with ECDs in place</div><div>

</div></div></div>			
GPS Location	37.1334910439673, -80.3948718868945		GPS Location	37.1334910439673, -80.3948718868945	
Description	Pocahontas Road ECDs		Description	Pocahontas Road ECDs	
Insert image here		Insert image here			
GPS Location			GPS Location		
Description			Description

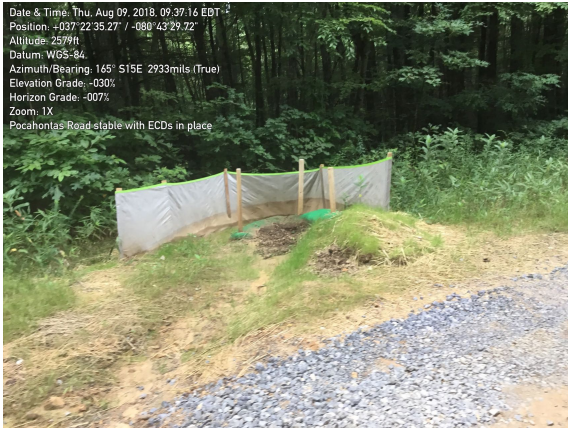
</div></div></div>		<div><div><div>Date &amp; Time: Thu, Aug 09, 2018, 09:39 EDT Position: +037° 22' 35.27" / -080° 43' 29.72" Altitude: 2579ft Datum: WGS-84 Azimuth/Bearing: 165° 51SE 2933mils (True) Elevation Grade: -030% Horizon Grade: -007% Zoom: 1X Pocahontas Road stable with ECDs in place</div><div>
