A/E	124300137	Date/Time	4/27/2018 8:30 AM	Report #	1265
6. PCSM BMPs (List BMPs and note if installed and maintained as per the plan. If corrective action is needed, a picture is required.)					
PCSM BMPs		Compliance Level	Corrective Action	Corrective Time Frame

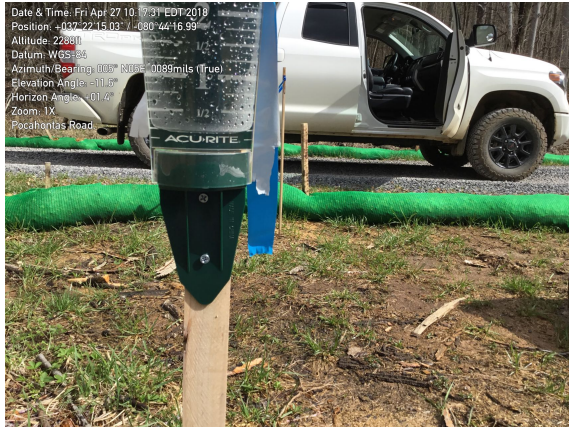
A/E	124300137	Date/Time	4/27/2018 8:30 AM	Report #	1265
Pictures					
<p>Date & Time: Fri Apr 27 10:17:31 EDT 2018 Position: +037 22 15 03 / -080 44 16 99 Altitude: 2280ft Datum: WGS-84 Azimuth/Bearing: 007° 00' 00" 0089mils (True) Elevation Angle: -01.4° Horizon Angle: -01.4° Zoom: 1X Pocahontas Road</p>

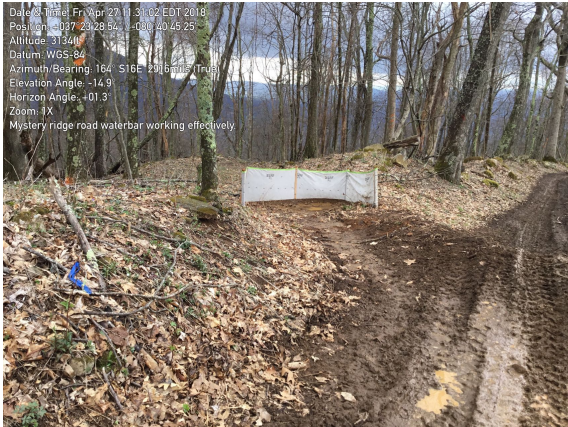
<p>Date & Time: Fri Apr 27 10:31:02 EDT 2018 Position: +037 23 28 54 / -080 20 46 25 Altitude: 3134ft Datum: WGS-84 Azimuth/Bearing: 164° 51' 00" 2016mils (True) Elevation Angle: -14.9° Horizon Angle: -01.3° Zoom: 1X Mystery ridge road waterbar working effectively.</p>

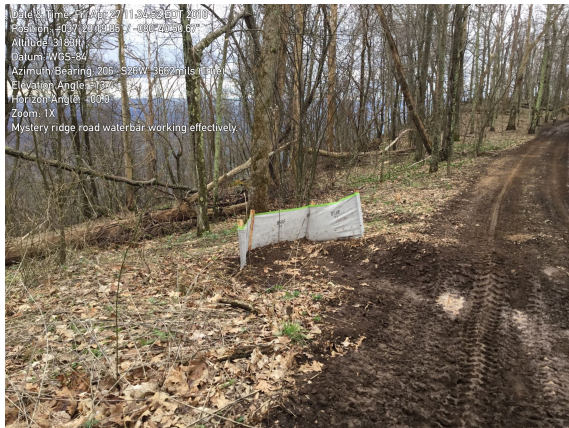
GPS Location	37.3507157335782, -80.7656977330449	GPS Location	37.350729178008, -80.7657101532123		
Description	Pocahontas Road. See photo for correct lat/long. Rain gauge had .25".	Description	Pocahontas Road. See photo for correct lat/long and details.		
<p>Date & Time: Fri Apr 27 11:40:11 EDT 2018 Position: +037 23 33 35 / -080 20 24 37 Altitude: 2820ft Datum: WGS-84 Azimuth/Bearing: 206° 58' 00" 367mils (True) Elevation Angle: -23.3° Horizon Angle: -00.0° Zoom: 1X Mystery ridge road waterbar working effectively.</p>

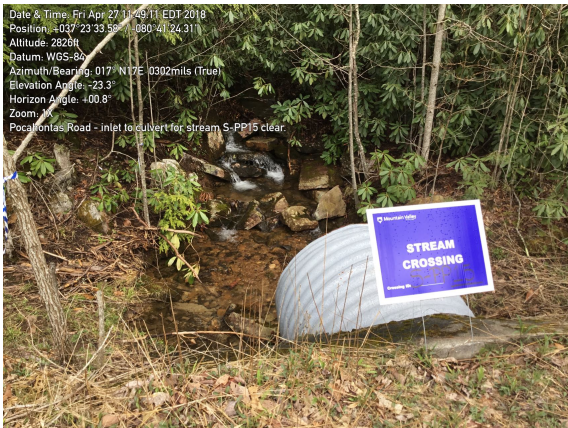
<p>Date & Time: Fri Apr 27 11:40:11 EDT 2018 Position: +037 23 33 35 / -080 20 24 37 Altitude: 2820ft Datum: WGS-84 Azimuth/Bearing: 017° 11' 00" 0302mils (True) Elevation Angle: -23.3° Horizon Angle: -00.8° Zoom: 1X Pocahontas Road - inlet to culvert for stream S-PP15 clear.</p>

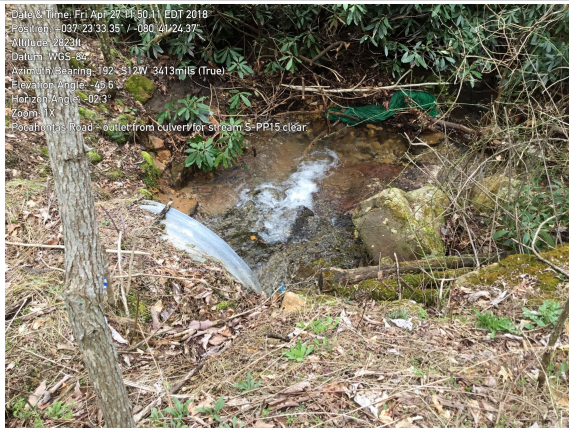
GPS Location	37.3507282650446, -80.7657182124264	GPS Location	37.3507282650446, -80.7657182124264		
Description	Mystery Ridge Road. See photo for correct lat/long and details.	Description	Pocahontas Road. See photo for correct lat/long and details.		
<p>Date & Time: Fri Apr 27 14:50:11 EDT 2018 Position: +037 23 33 35 / -080 20 24 37 Altitude: 2820ft Datum: WGS-84 Azimuth/Bearing: 192° 31' 20" 3413mils (True) Elevation Angle: -08.6° Horizon Angle: -02.3° Zoom: 1X Pocahontas Road - inlet from culvert for stream S-PP15 clear.</p>

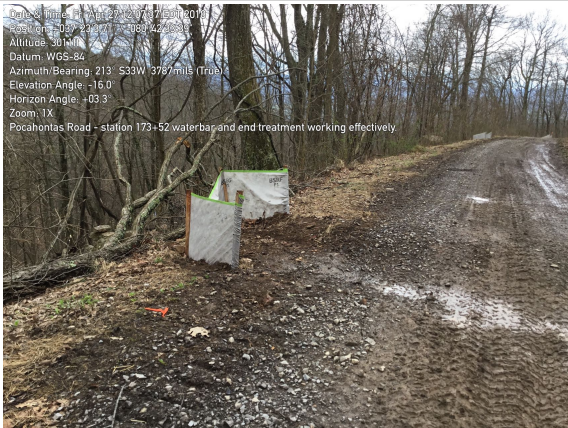
<p>Date & Time: Fri Apr 27 15:07:11 EDT 2018 Position: +037 23 33 35 / -080 20 24 37 Altitude: 3011ft Datum: WGS-84 Azimuth/Bearing: 213° 53' 30" 376mils (True) Elevation Angle: -16.0° Horizon Angle: -03.3° Zoom: 1X Pocahontas Road - station 173+52 waterbar and end treatment working effectively.</p>
