A/E	124300137	Date/Time	5/21/2018 8:05 AM	Report #	2010
6. PCSM BMPs (List BMPs and note if installed and maintained as per the plan. If corrective action is needed, a picture is required.)					
PCSM BMPs		Compliance Level	Corrective Action	Corrective Time Frame

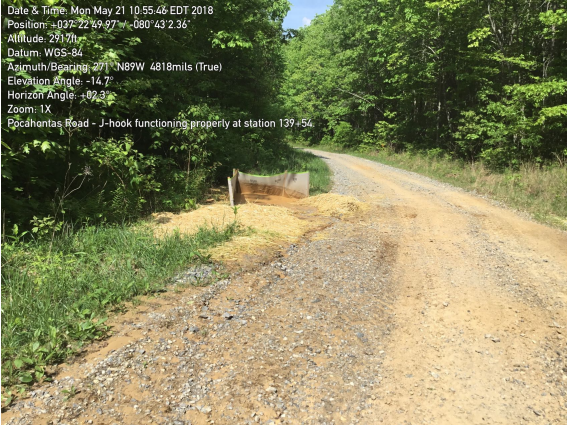
A/E	124300137	Date/Time	5/21/2018 8:05 AM	Report #	2010
Pictures					
<p>Date & Time: Mon May 21 10:55:46 EDT 2018 Position: +037° 22' 59.97" / -080° 43' 2.36" Altitude: 2917ft Datum: WGS-84 Azimuth/Bearing: 271° N89W 4818mils (True) Elevation Angle: -14.7° Horizon Angle: -02.3° Zoom: 1X Pocahontas Road - J-hook functioning properly at station 139+54.</p>

GPS Location	37.3804591270512, -80.717379609198	GPS Location	37.3804591270512, -80.717379609198		
Description	Pocahontas Road - J-hook at station 139+54 functional.	Description	Pocahontas Road - J-hook at station 170+60 functional.		
<p>Date & Time: Mon May 21 07:57:46 EDT 2018 Position: +037° 22' 14.67" / -080° 44' 16.65" Altitude: 2365ft Datum: WGS-84 Azimuth/Bearing: 013° N13E 0231mils (True) Elevation Angle: -03.3° Horizon Angle: -02.3° Zoom: 1X Pocahontas Road - Rain gauge indicates approximately .3 inches.</p>

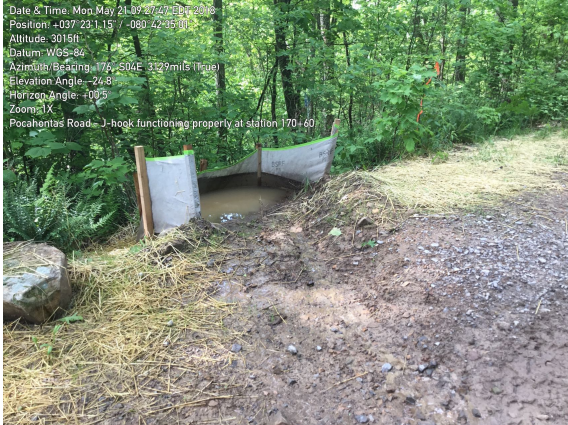
<p>Date & Time: Mon May 21 09:07:27 EDT 2018 Position: +037° 23' 1.15" / -080° 42' 05.00" Altitude: 3015ft Datum: WGS-84 Azimuth/Bearing: 175° S04E 3129mils (True) Elevation Angle: -24.8° Horizon Angle: -10.5° Zoom: 1X Pocahontas Road - J-hook functioning properly at station 170+60.</p>

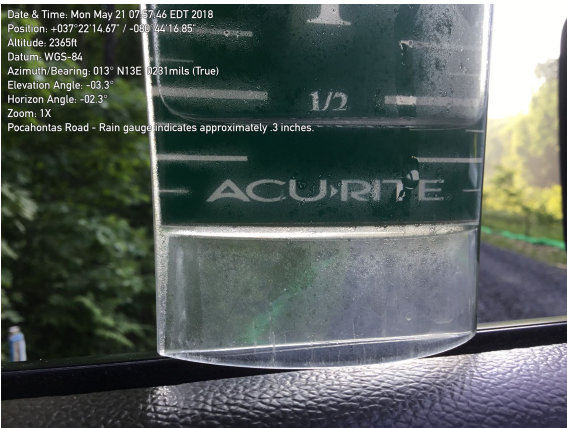
GPS Location	37.3804591270512, -80.717379609198	GPS Location			
Description	Pocahontas Road - Rain gauge indicates approximately .4 inches.	Description			
Insert image here		Insert image here			
GPS Location			GPS Location		
Description			Description
