Visual Site Inspection Report

Project Name	H-600 Pipeline Spread H	AFE	124300138	Spread	H-600 Pipeline Spread H
Contractor	Precision			Report #	3168
Inspector	Tracey Hilbun			Date/Time	6/15/2018 1:57 PM
Permit #	TBD	Inspection Type	VA SWPP	Station Begin	13415+51
State	VA	Inspection Area	Full	Station End	13670+00
County	Franklin	Ground	Dry	Temperature (°F)	83.00
Municipality	N/A	Weather	Sunny	Rain Gauge (in)	0.50
GPS Location	36.971830719873, -79.8699949916706			Rain Accumulation Time (days)	1.00

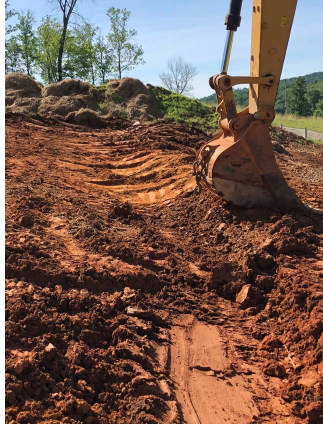
GPS Location	36.9716944919069, -79.8700754586164	GPS Location	36.9720813213261, -79.8699717969446		
Description	Crew cleaning Frith driveway after rain event Wednesday. Heavy rains occurred.	Description	Crew repairing breaker on Frith Tract

7. Identify all remedial measures that have been taken since the previous inspection was conducted.					
Comments (Reference above questions as appropriate.)					
Spread was inspected with improvements made especially on Frith Tract. Wednesday evening heavy rain in short time period occurred on spread. Several issues noted to SWPP book with request for extension made to MBP inspector. Environmental crews continue making repairs based on punch list.					
Note: It is a condition of National Pollutant Discharge Elimination System and Erosion and Sediment permits that a maintenance program be conducted to provide for the operation and maintenance of all BMPs to be inspected on a weekly basis and after each stormwater event. Please list in the space provided comments to note if repairs or replacement are needed or have been made for BMPs as a result of the inspection. Failure to conduct the required inspection may result in permit suspension or the imposition of civil penalties. If supplemental monitoring is required as part of a permit condition this form may be used to meet those monitoring requirements.

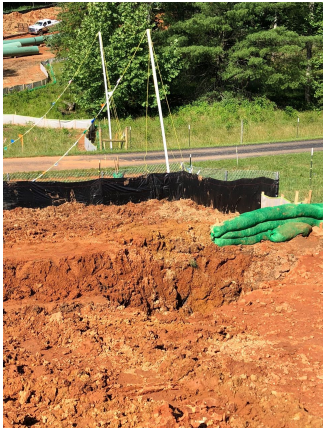
Insert image here			
GPS Location	36.9720813213261, -79.8699717969446	GPS Location			
Description	Frith Tract end treatment in compliance. New SSF in background.	Description			
Insert image here		Insert image here			
GPS Location		GPS Location			
Description		Description
