*Spread H section
Report # 7806
SWIN 1369
ESIN 0946*

Visual Site Inspection Report

Project Name	H-600 Pipeline Spread H	AFE	124300138	Spread	H-600 Pipeline Spread H
Contractor	Precision			Report #	7806
Inspector	Glenn Mike Renfro			Date/Time	9/13/2018 10:10 AM
Permit #	TBD	Inspection Type	VA SWPP	Station Begin	13415+00
State	VA	Inspection Area	Full	Station End	13670+00
County	Franklin	Ground	Wet	Temperature (°F)	75.00
Municipality	N/A	Weather	Cloudy	Rain Gauge (in)	11.50
GPS Location	36.9719701353805, -79.8700609803944			Rain Accumulation Time (days)	6.00

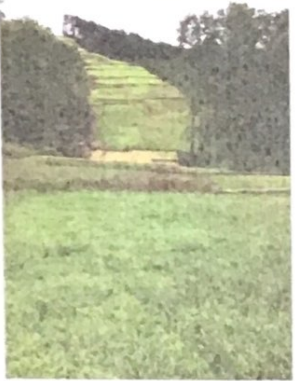
GPS Location	36.9719221408728, -79.8701314560676	GPS Location	36.9719935627999, -79.8700481560825
Description	Permanent stabilization grow in from 13423+00 to 13437+00	Description	Area on northeast side of RoW at 13418+00 that will need to be restabilize with permanent seed.

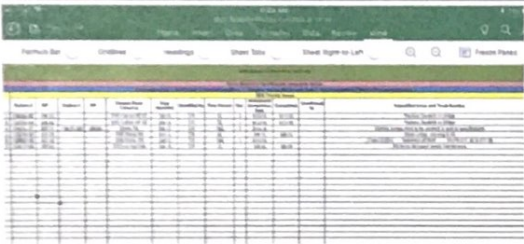
GPS Location	36.9719207770051, -79.8701310478945	GPS Location	36.9719197756727, -79.8701317704544
Description	Punch list for Spread H section	Description	Sediment build up on ECD's at 13339+00
