Virtual Site Inspection Report

*Spread I  
Report # 7040  
D1110847*

<b>Project Name</b>	H-600 Pipeline Spread I	<b>AFE</b>	124300139	<b>Spread</b>	H-600 Pipeline Spread I
<b>Contractor</b>	Precision	<b>Report #</b>	7040		
<b>Inspector</b>	Casey McGaha	<b>Date/Time</b>	8/27/2018 5:00 PM		
<b>Permit #</b>	TBD	<b>Inspection Type</b>	VA SWPP	<b>Station Begin</b>	13670+00
<b>State</b>	VA	<b>Inspection Area</b>	Full	<b>Station End</b>	15299+00
<b>County</b>	Franklin/Pittsylvania	<b>Ground</b>	Dry	<b>Temperature (°F)</b>	83.00
<b>Municipality</b>	Chatham	<b>Weather</b>	Sunny	<b>Rain Gauge (in)</b>	0.00
<b>GPS Location</b>	36.9719427463988, -79.8701333737296			<b>Rain Accumulation Time (days)</b>	0.00

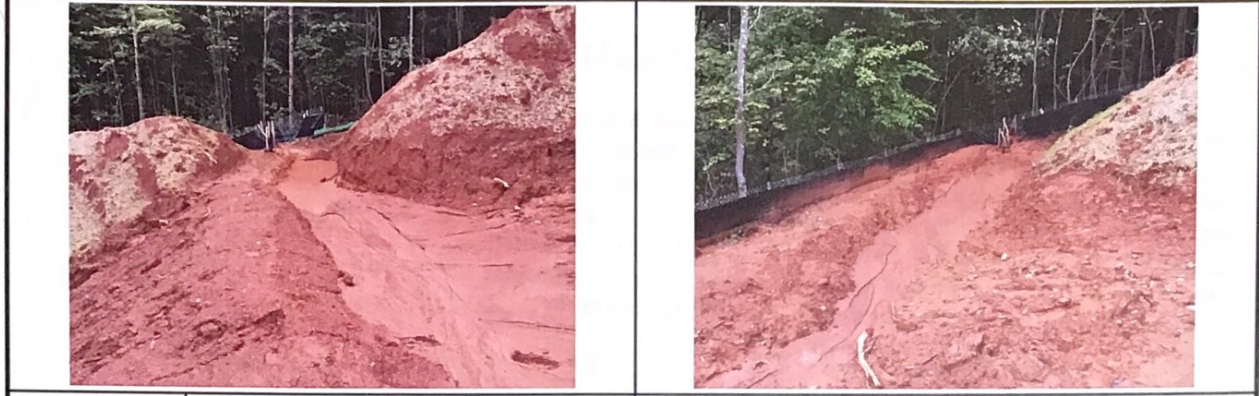
<b>GPS Location</b> 36.9879204361113, -79.7179308627543	<b>GPS Location</b> 36.9879001938151, -79.7178066429493
<b>Description</b> Breaker maintenance required sta 14672+50	<b>Description</b> Breaker maintenance required sta 14672+75

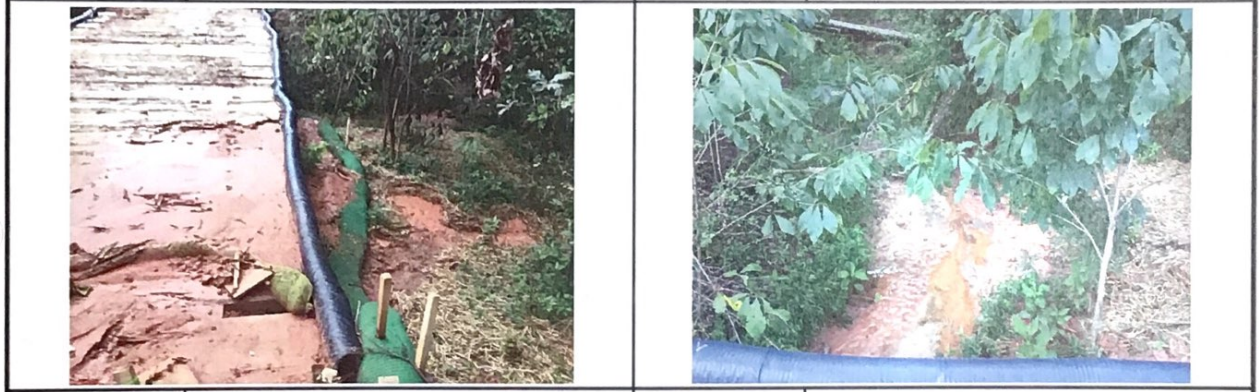
<b>GPS Location</b> 36.9880330988395, -79.7175883761436	<b>GPS Location</b> 36.9879872398795, -79.7175165452805
<b>Description</b> Silt off ROW and in stream S-H37 sta14673+10	<b>Description</b> Silt off ROW sta14673+72

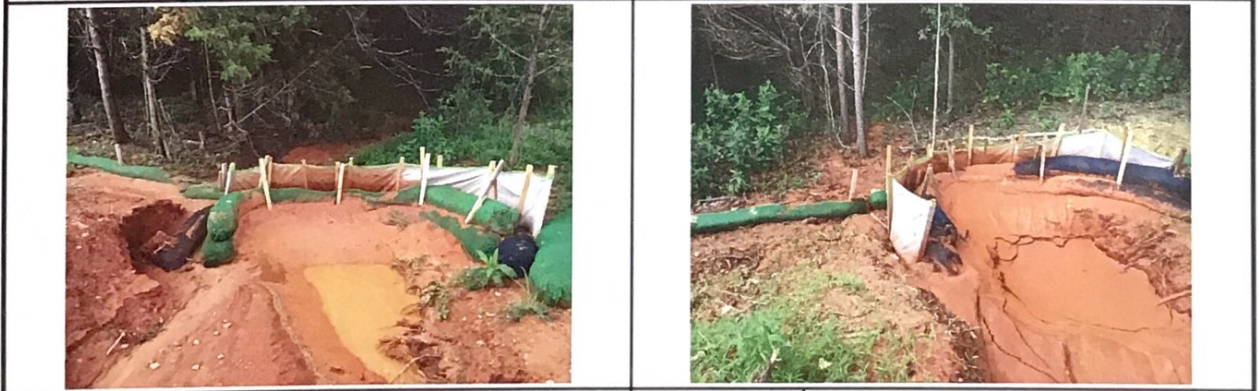
<b>GPS Location</b> 36.9878407242121, -79.7160807252673	<b>GPS Location</b> 36.9875792926522, -79.7155926470456
<b>Description</b> Breaker maintenance required sta 14677+00	<b>Description</b> Breaker maintenance required sta 14677+50

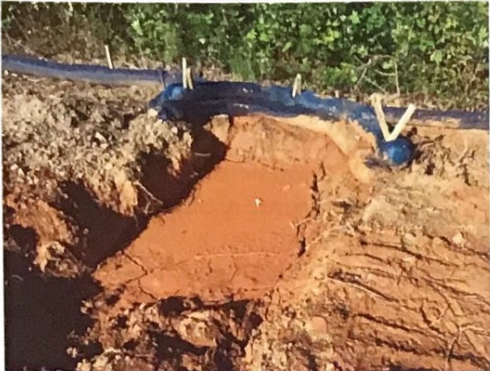
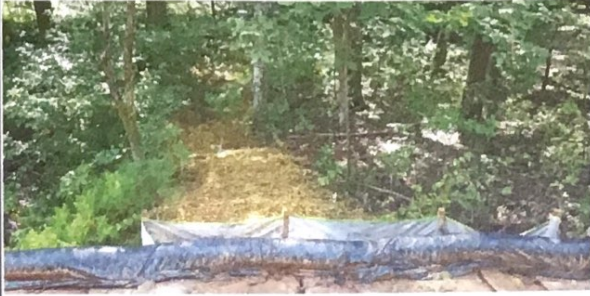
<b>GPS Location</b>	36.9479702739389, -79.5786315948512	<b>GPS Location</b>	37.0100321134056, -79.5674114991294
<b>Description</b>	Remove silt from sump sta. 15143+00	<b>Description</b>	Silt pulled back onto ROW at stream S-KL51 sta. 14157+55.

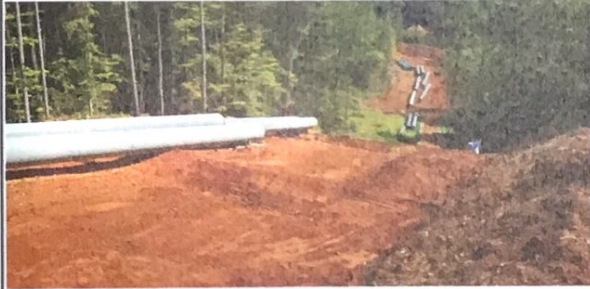
<b>GPS Location</b>	37.0259582251655, -79.5906826761361	<b>GPS Location</b>	37.0258549601184, -79.5907716081288
<b>Description</b>	Clean bridge across stream S-G13 sta. 14932+89	<b>Description</b>	Maintenance performed on ROW at sta.

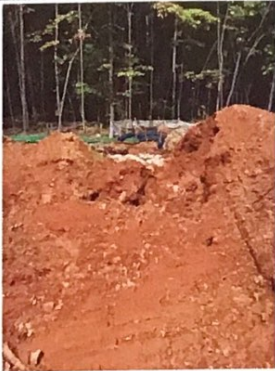
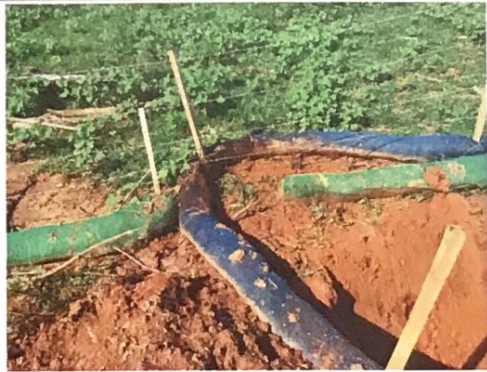
<b>GPS Location</b>	36.9970006372079, -79.689974091455	<b>GPS Location</b>	36.9975952059375, -79.73862360239
<b>Description</b>	Maintenance required at breaker end sta 14226+44	<b>Description</b>	Upgrade BMP at end treatment required sta 14609+00

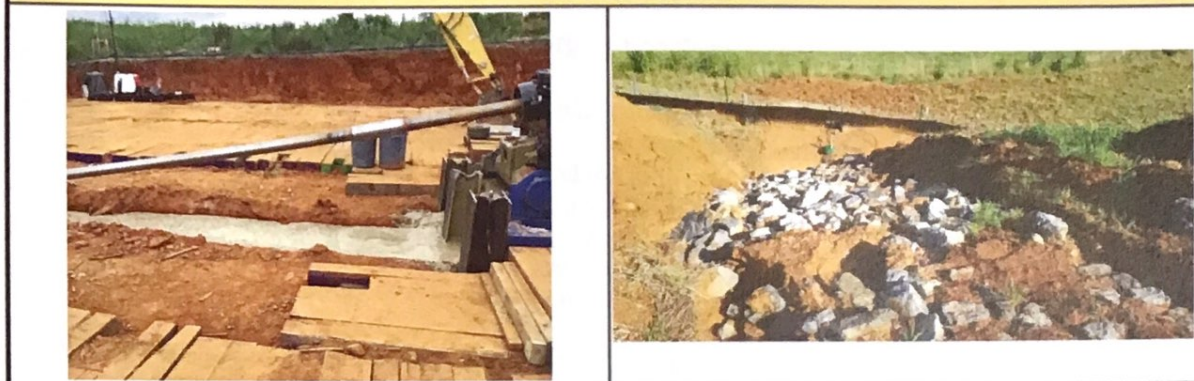
<b>GPS Location</b>	36.9347378693598, -79.5438111171064	<b>GPS Location</b>	36.9718824107535, -79.8702260914637
<b>Description</b>	Drilling mud contained sta. 15260+00	<b>Description</b>	Maintenance at end treatment required and silt off ROW sta. 13943+00

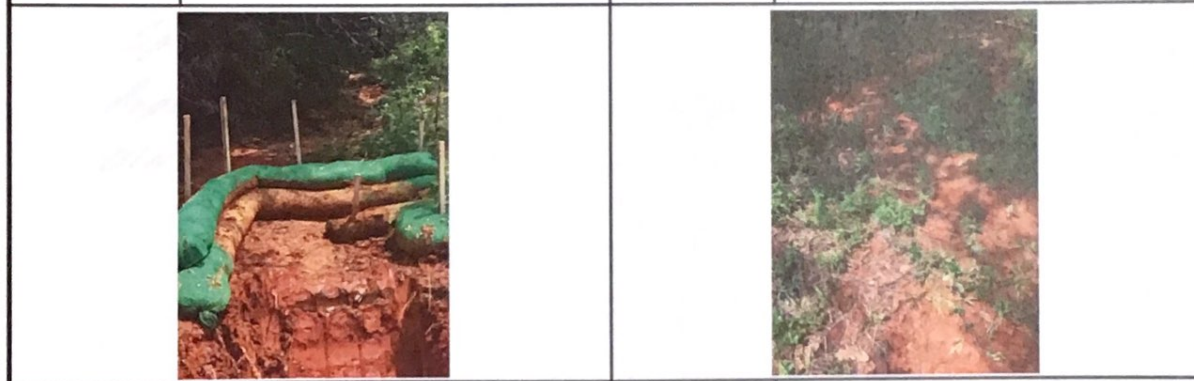
<b>GPS Location</b>	36.9720040401788, -79.870004654005	<b>GPS Location</b>	36.9719499769034, -79.8700254411249
<b>Description</b>	Maintenance on end treatment required sta. 14675+00	<b>Description</b>	Silt off ROW sta. 14675+00
