HOW SAINT BERNARD'S CHURCH PROPERTY WAS ACQUIRED
AND SOME HISTORY OF THE EARLY SETTLERS OF THE SANDFORK REGION.

LOVEBERRY - St. Bernard Chapel
Connected w/ St. Patrick, Weston

The Repair of Historic Wooden Windows

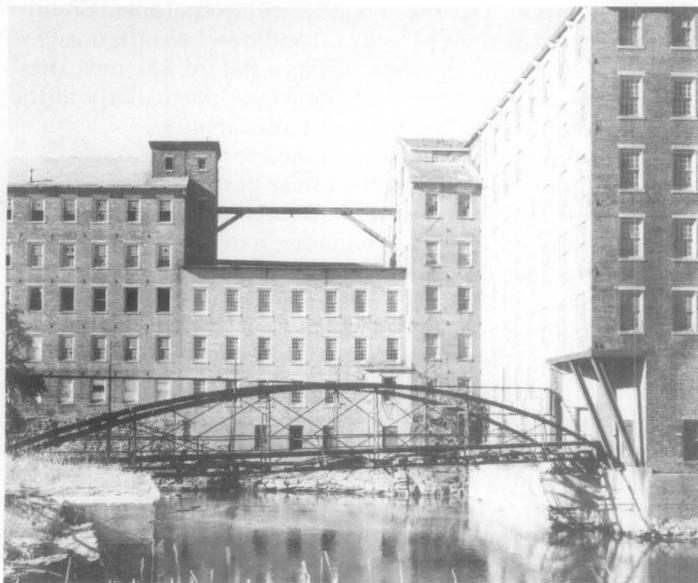
Figure 1. Windows are frequently important visual focal points, especially on simple facades such as this mill building. Replacement of the multi-pane windows here with larger panes could dramatically change the appearance of the building. The areas of missing windows convey the impression of such a change. Photo: John T. Lowe

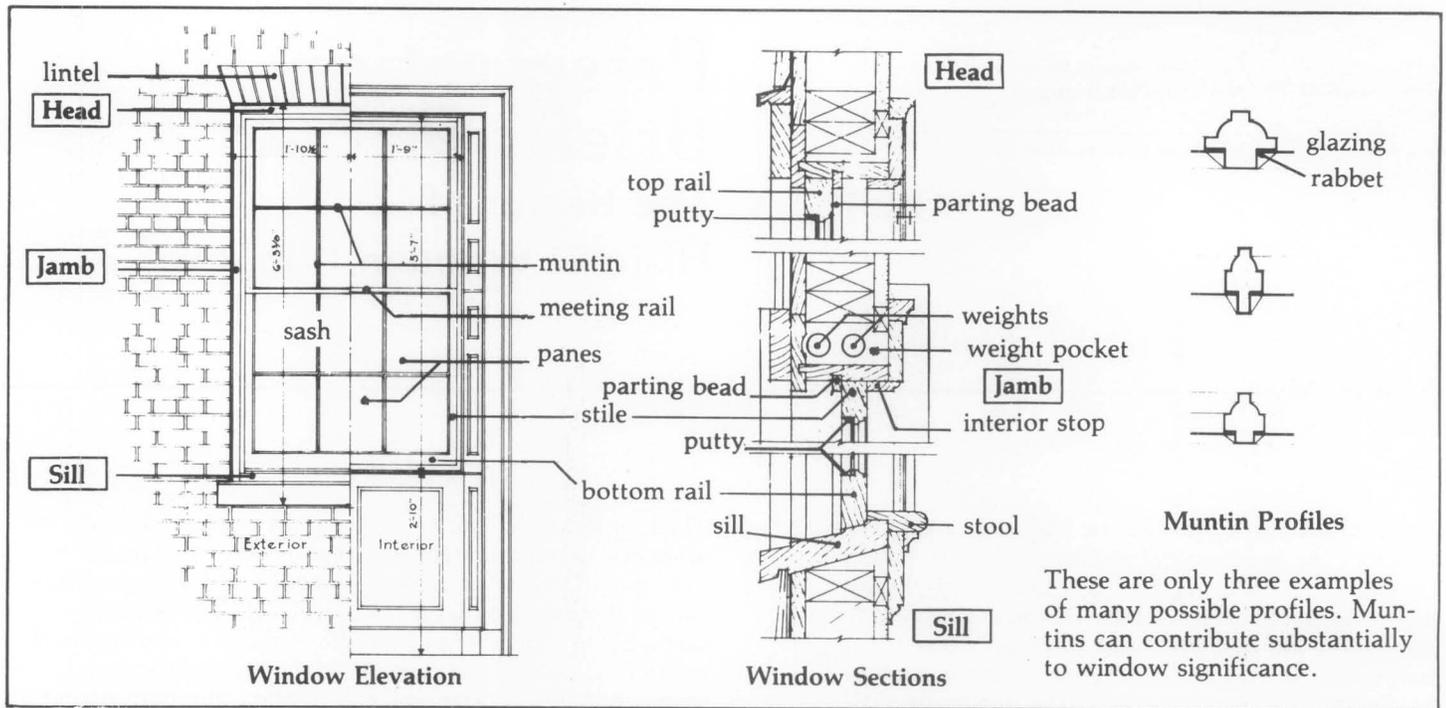
Figure 2. These drawings of window details identify major components, terminology, and installation details for a wooden double-hung window.

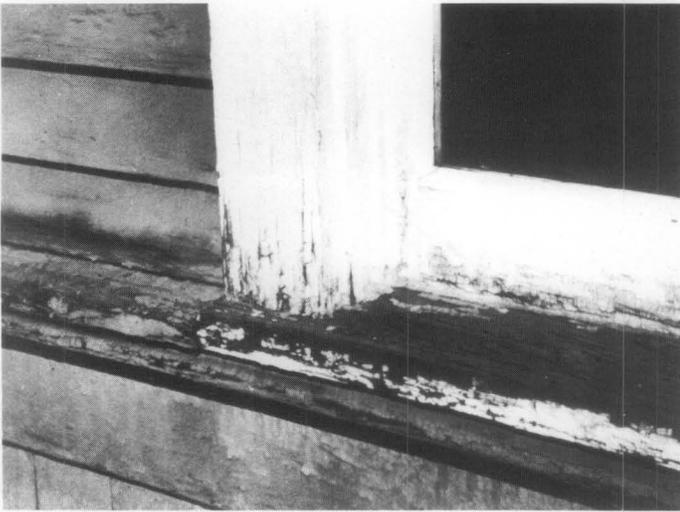
Figure 3. Deterioration of poorly maintained windows usually begins on horizontal surfaces and at joints where water can collect and saturate the wood. The problem areas are clearly indicated by paint failure due to moisture. Photo: Baird M. Smith, AIA

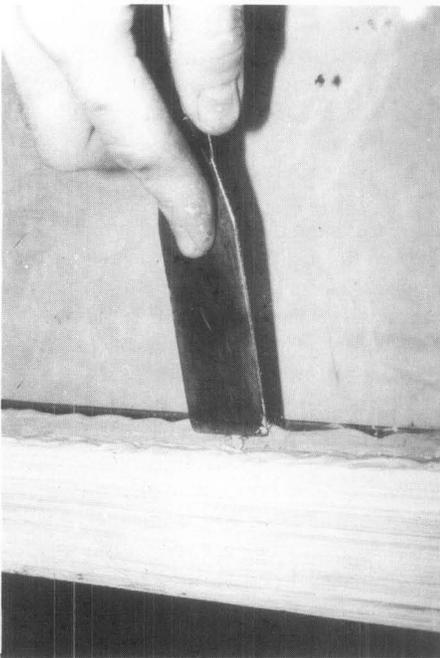
Figure 4d. Reglazing or replacement of the putty requires that the existing putty be removed manually, the glazing points be extracted, the glass removed, and the back putty scraped out. To reglaze, a bed of putty is laid around the perimeter of the rabbet, the pane is pressed into place, glazing points are inserted to hold the pane (shown), and a final seal of putty is beveled around the edge of the glass. Photo: John H. Myers

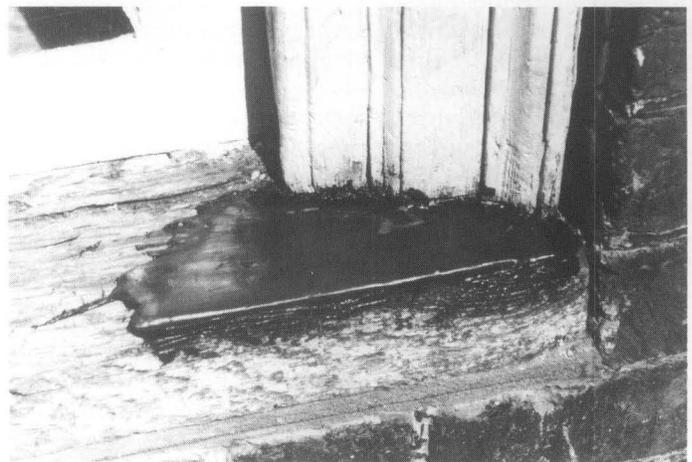
Figure 5. This illustrates a two-part epoxy patching compound used to fill the surface of a weathered sill and rebuild the missing edge. When the epoxy cures, it can be sanded smooth and painted to achieve a durable and waterproof repair. Photo: John H. Myers

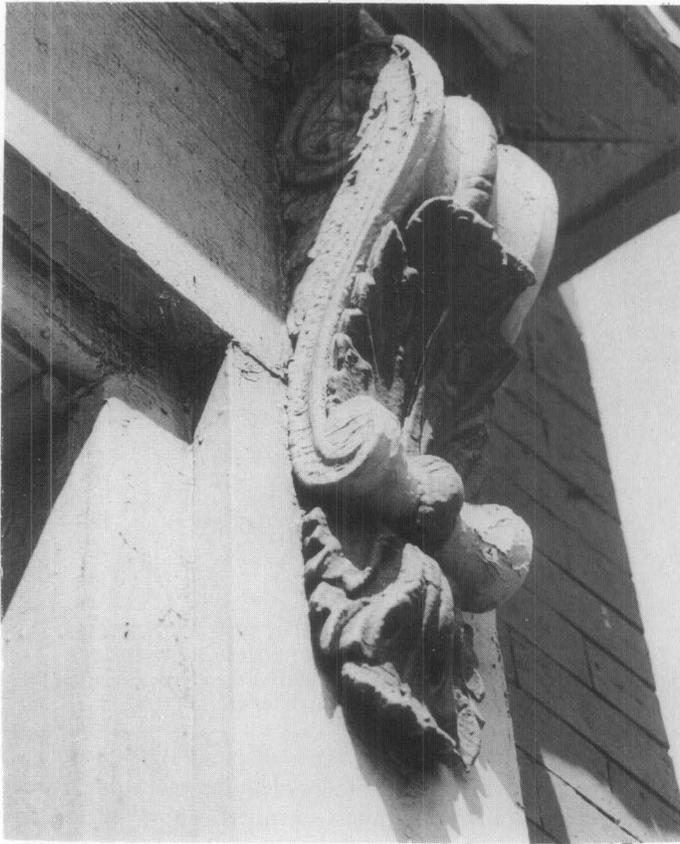
Fig. 1 Excessive paint build-up on architectural details such as this ornamental bracket does not in itself justify total paint removal. If paint is cracked and peeling down to bare wood, however, it should be removed using the gentlest means possible. Photo: David W. Look, AIA.

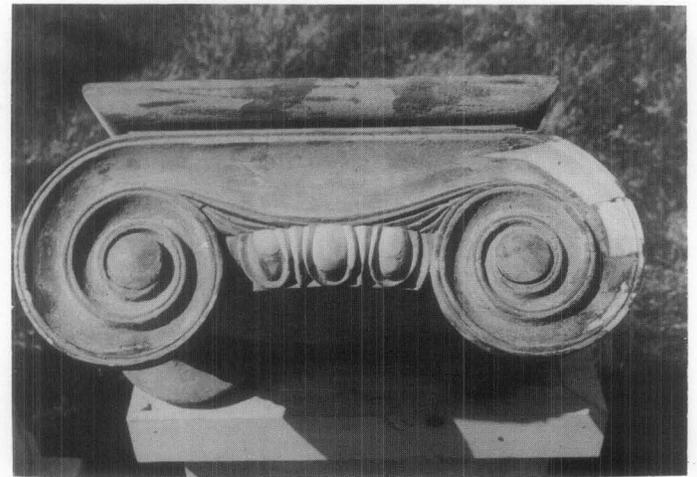
Fig. 3 If damage to parts of a wooden element is severe, new sections of wood will need to be pieced-in. When such piecing is required, paint on the adjacent woodwork should be removed so that the old and new woods will make a smooth profile when joined. After repainting, the repair should be virtually impossible to detect. Photo: Morgan W. Phillips.

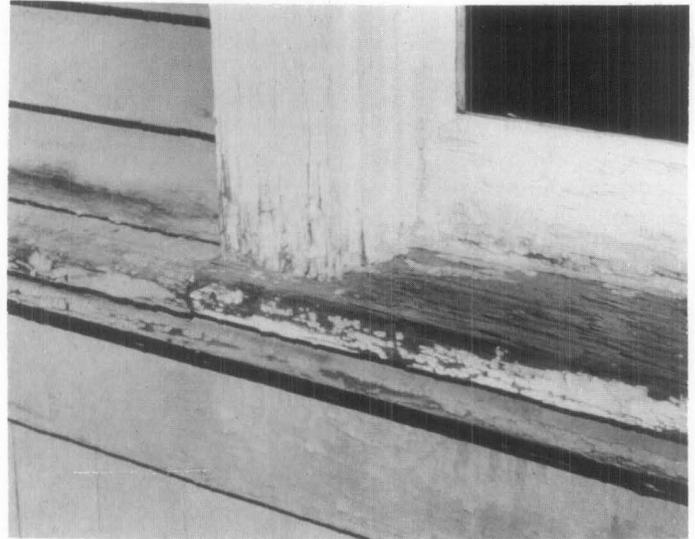
Fig. 4 Paint films wear unevenly depending on exposure and location. Exterior locations which are susceptible to accelerated deterioration are horizontal surfaces such as window sills. These and similar areas will require repainting more often than less vulnerable surfaces. In the case of this window sill where paint has peeled off and adjacent areas have cracked and alligatored, the paint should be totally removed. Prior to repainting, any weathered wood should be rejuvenated using a solution of 3 cups exterior varnish, 1 oz. paraffin wax, and mineral spirits/paint thinner/or turpentine to make 1 gallon. Liberal brush application should be made. This formula was tested over a 20-year period by the U.S. Department of Agriculture's Forest Products Laboratory and proved to be just as effective as water-repellent preservatives containing pentachlorophenol. After the surface has thoroughly dried (2-3 days of warm weather), the treated surface can be painted. A high quality oil-base primer followed by two top coats of a semi-gloss oil-enamel or latex-enamel paint is recommended. Photo: Baird M. Smith, AIA.

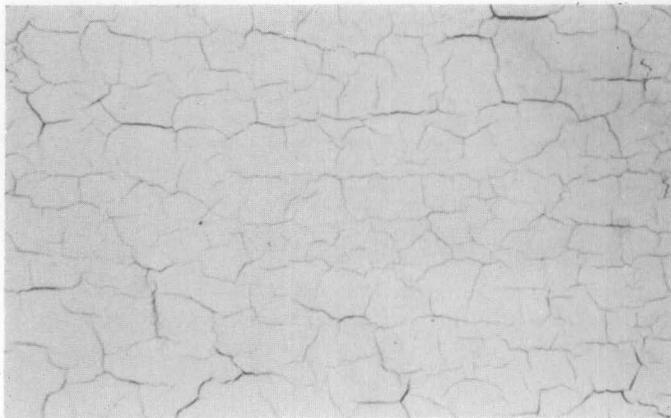
Fig. 5 Crazing—or surface cracking—is an exterior surface condition which can be successfully treated by sanding and painting. Photo: Courtesy, National Decorating Products Association.

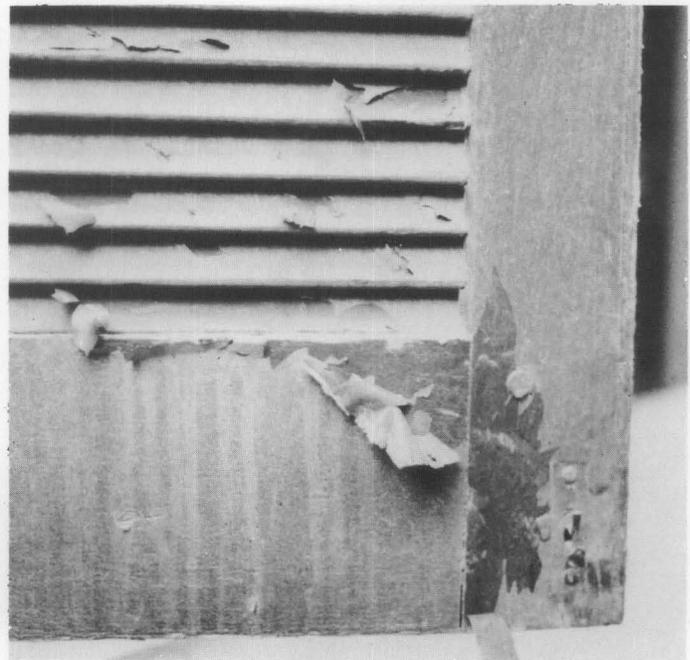
Fig. 6 This is an example of intercoat peeling. A latex top coat was applied directly over old oil paint and, as a result, the latex paint was unable to adhere. If latex is being used over oil, an oil-base primer should be applied first. Although much of the peeling latex paint can be scraped off, in this case, the best solution may be to chemically dip strip the entire shutter to remove all of the paint down to bare wood, rinse thoroughly, then repaint. Photo: Mary L. Oehrlein, AIA.

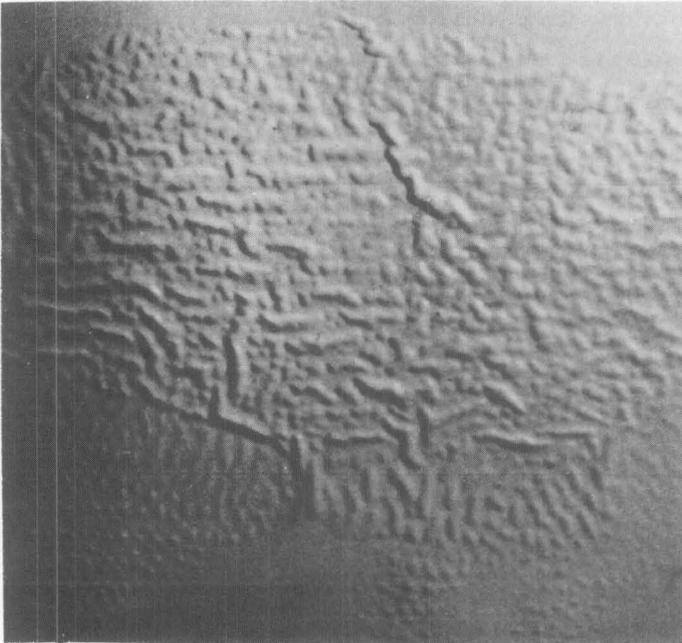
Fig. 7 Wrinkled layers can generally be removed by scraping and sanding as opposed to total paint removal. Following manufacturers' application instructions is the best way to avoid this surface condition. Photo: Courtesy, National Decorating Products Association.

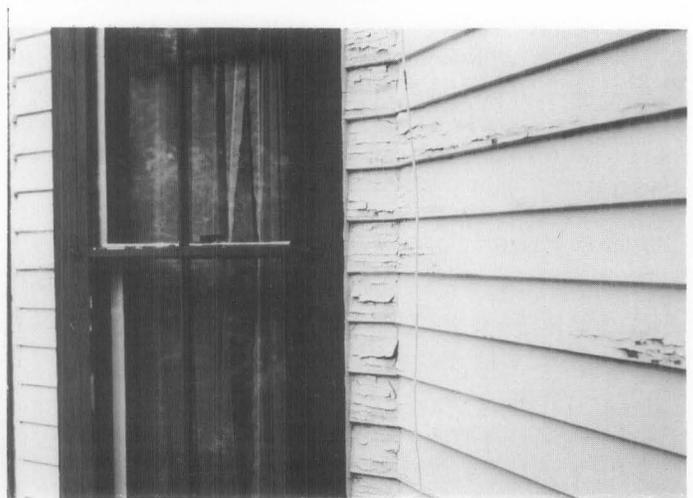
Fig. 8 Peeling to bare wood—one of the most common types of paint failure—is usually caused by an interior or exterior moisture problem. Photo: Anne E. Grimmer.

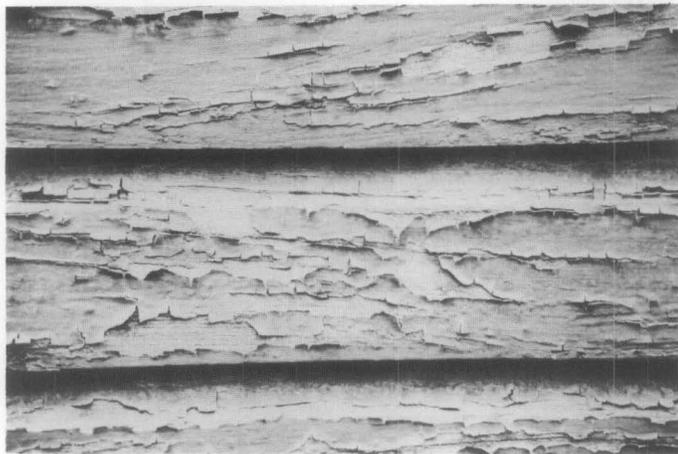
Fig. 9 Cracking, alligatoring, and flaking are evidence of long-term neglect of painted surfaces. The remaining paint on the clapboard shown here can be removed with an electric heat plate and wide-bladed scraper. In addition, unsound wood should be replaced and moisture problems corrected before primer and top coats of paint are applied. Photo: David W. Look, AIA.

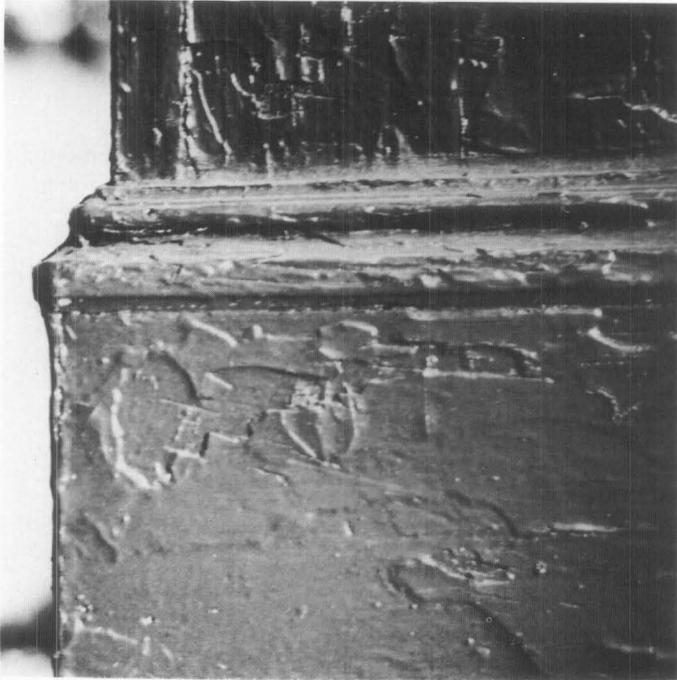
Fig. 10 An excellent example of inadequate scraping before repainting, the problems here are far more than cosmetic. This improperly prepared surface will permit moisture to get behind the paint film which, in turn, will result in chipping and peeling. Photo: Baird M. Smith, AIA.

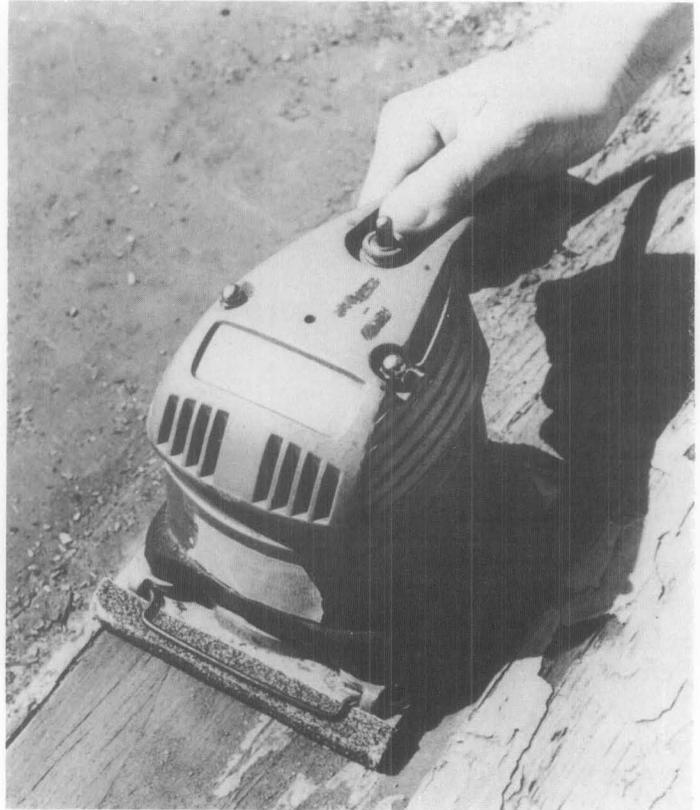
Fig. 11 The orbital sander can be used for limited paint removal, i.e., for smoothing flat surfaces after the majority of deteriorated paint has already been scraped off. Photo: Charles E. Fisher, III.

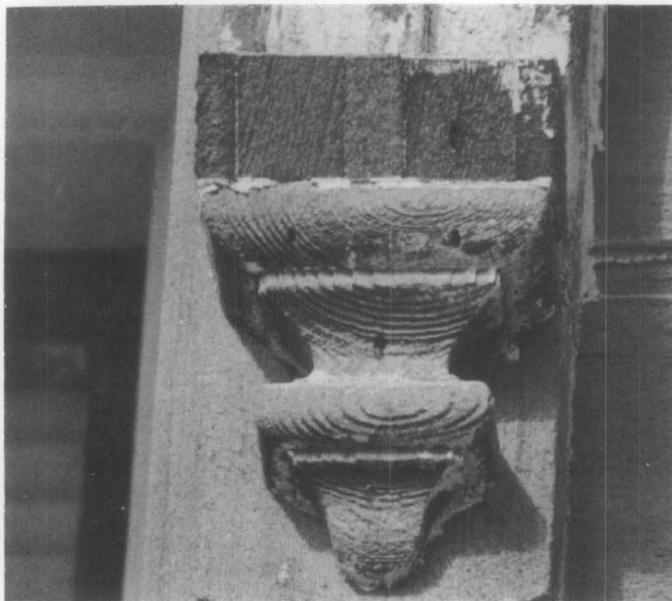
Fig. 12 Sandblasting has permanently damaged this ornamental bracket. Even paint will not be able to hide the deep erosion of the wood. Photo: David W. Look, AIA.

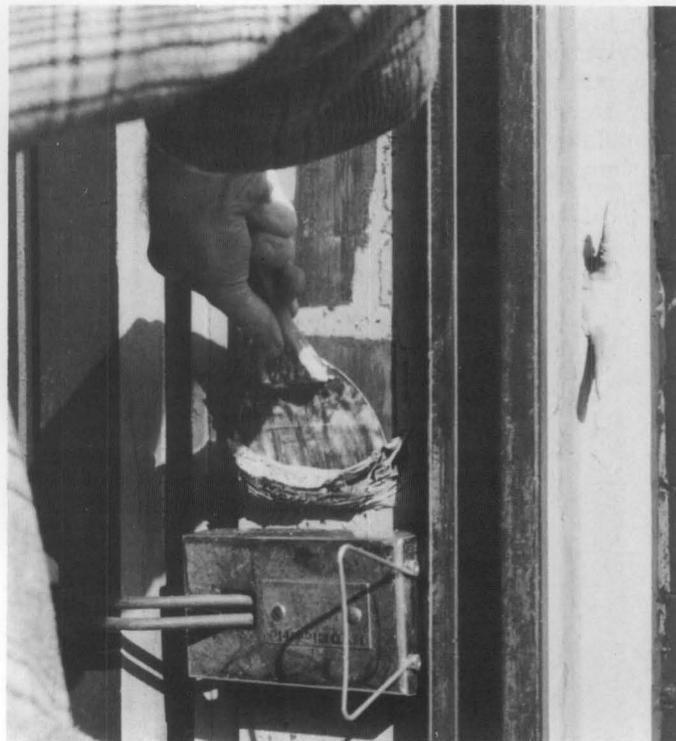
Fig. 13 The electric heat plate (with paint scraper) is particularly useful for removing paint down to bare wood on flat surfaces such as doors, window frames, and siding. After scraping, some light sanding will probably be necessary to smooth the surface prior to application of primer and top coats. Photo: David W. Look, AIA.

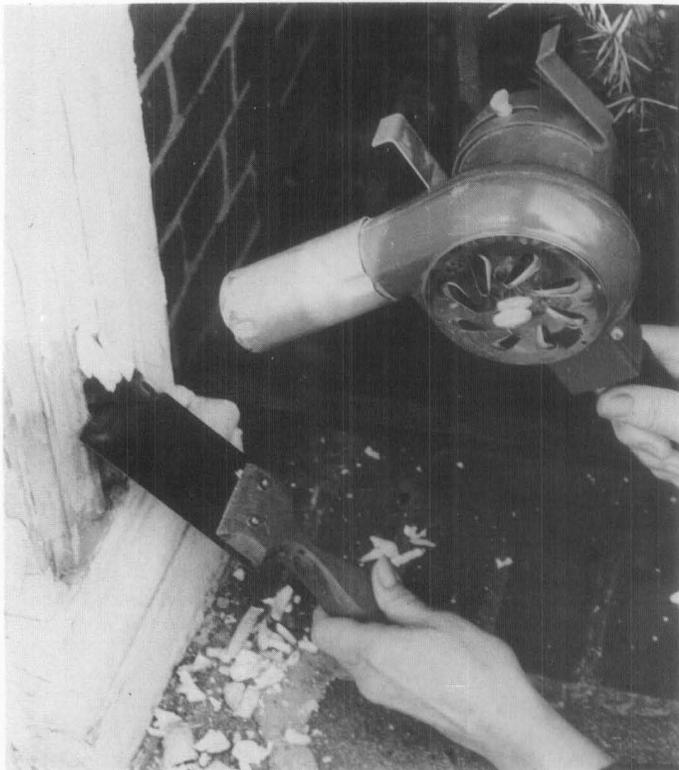
Fig. 14 The nozzle on the electric heat gun permits hot air to be aimed into cavities on solid decorative elements such as this applied column. After the paint has been sufficiently softened, it can be removed with a profiled scraper. Photo: Charles E. Fisher, III.

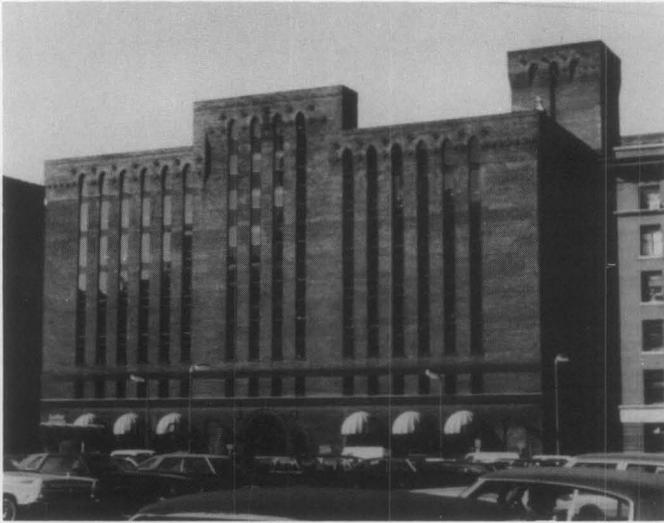
Overall Visual Character: Shape

The shape of a building can be an important aspect of its overall visual character. The building illustrated here, for example, has a distinctive horizontal box-like shape with the middle portion of the box projecting up an extra story. This building has other visual aspects that help define its overall character, including the pattern of vertical bands of windows, the decorative horizontal bands which separate the base of the building from the upper floors, the dark brown color of the brick, the large arched entranceway, and the castle-like tower behind the building.

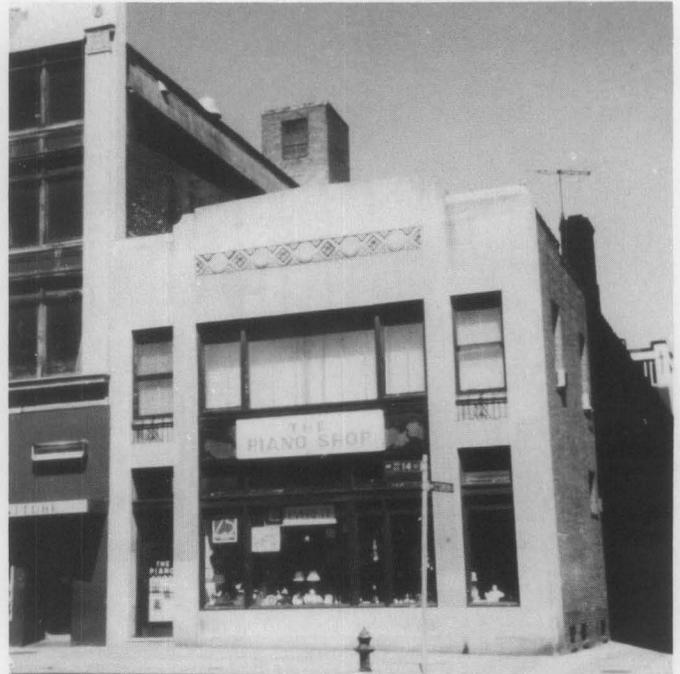
Overall Visual Character: Shape

It should not be assumed that only large or unusual buildings have a shape that is distinctive or identifiable. The front wall of this modest commercial building has a simple three-part shape that is the controlling aspect of its overall visual character. It consists of a large center bay with a two story opening that combines the storefront and the windows above. The upward projecting parapet and the decorative stonework also relate to and emphasize its shape. The flanking narrow bays enframe the side windows and the small iron balconies, and the main entrance doorway into the store. Any changes to the center portion of this three-part shape, could drastically affect the visual character of this building. Photo by Emogene A. Bevitt

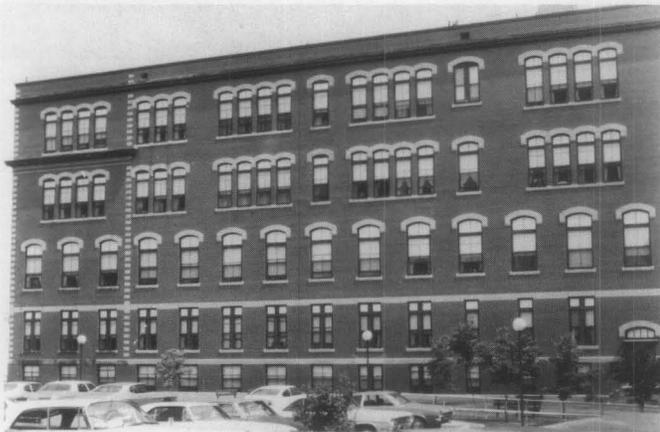
Overall Visual Character: Openings

Window and door openings can be important to the overall visual character of historic buildings. This view shows only part of a much larger building, but the windows clearly help define its character, partly because of their shape and rhythm: the upper floor windows are grouped in a 4,3,4,1,4 rhythm, and the lower floor windows are arranged in a regular 1,1,1,... rhythm. The individual windows are tall, narrow and arched, and they are accented by the different colored arched heads, which are connected where there are multiple windows so that the color contrast is a part of its character. If additional windows were inserted in the gap of the upper floors, the character would be much changed, as it would if the window heads were painted to match the color of the brick walls. Photo by Susan I. Dynes

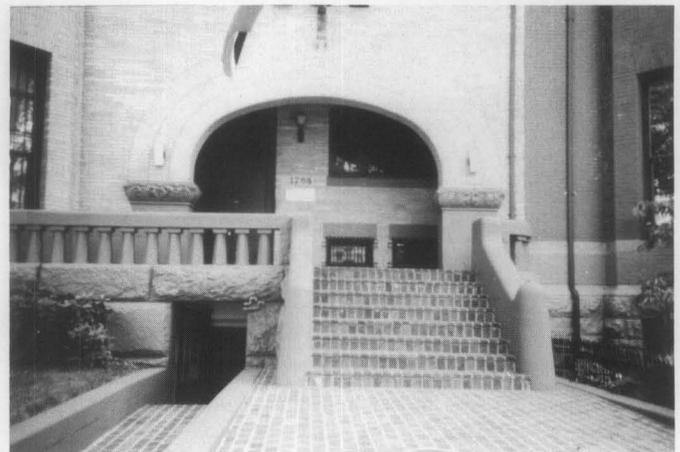
Overall Visual Character: Openings

The opening illustrated here dominates the visual character of this building because of its size, shape, location, materials, and craftsmanship. Because of its relation to the generous staircase, this opening places a strong emphasis on the principal entry to the building. Enclosing this arcade-like entry with glass, for example, would materially and visually change the character of the building. Photo by Lee H. Nelson.

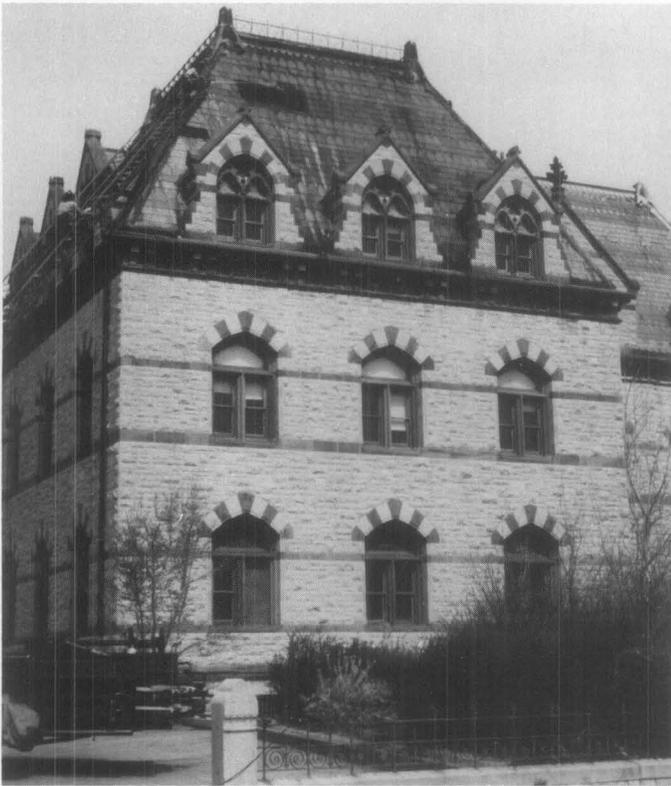
Overall Visual Character: Roof and Related Features

This building has a number of character-defining aspects which include the windows and the decorative stonework, but certainly the roof and its related features are visually important to its overall visual character. The roof is not only highly visible, it has elaborate stone dormers, and it also has decorative metalwork and slatework. The red and black slates of differing sizes and shapes are laid in patterns that extend around the roof of this large and freestanding building. Any changes to this patterned slatework, or to the other roofing details would damage the visual character of the building. Photo by Laurie R. Hammel

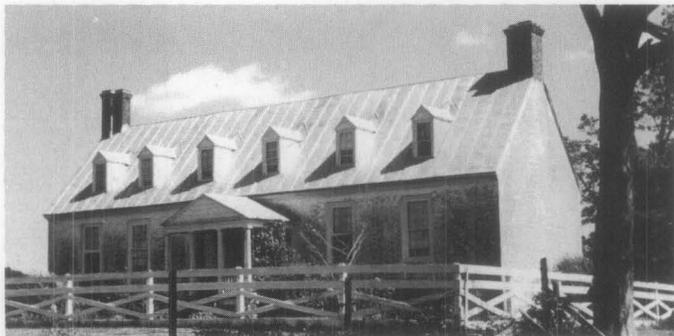
Overall Visual Character: Roof and Related Features

On this building, the most important visual aspects of its character are the roof and its related features such as the dormers and chimneys. The roof is important to the visual character because its steepness makes it highly visible, and its prominence is reinforced by the patterned tinwork, the six dormers and the two chimneys. Changes to the roof or its features, such as removal or alterations to the dormers, for example, would certainly change the character of this building. This does not discount the importance of its other aspects, such as the porch, the windows, the brickwork, or its setting; but the roof is clearly crucial to understanding the overall visual character of this building as seen from a distance. Photo by Lee H. Nelson

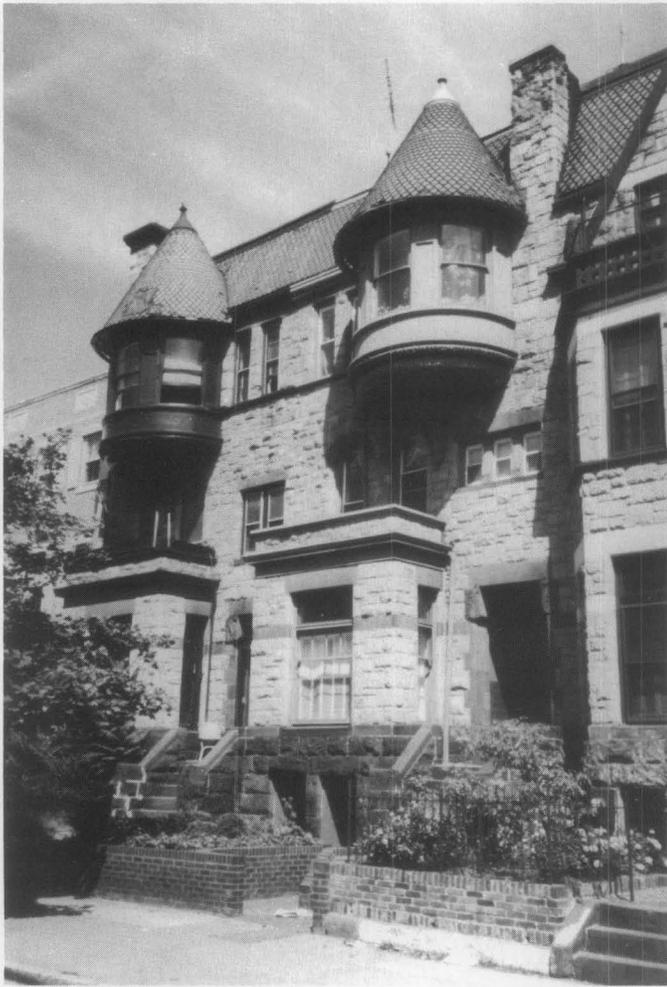
Overall Visual Character: Projections

Since these are row houses, any evaluation of their visual exterior character is necessarily limited to the front and rear walls; and while there are a number of things competing for attention in the front, it is the half round projecting bays with their conical roofs that contribute most prominently to the visual character. Their removal would be a devastating loss to the overall character, but even if preserved, the character could be easily damaged by changes to their color (as seen in the left bay which has been painted a dark color), or changes to their windows, or changes to their tile roofs. Though these houses have other fine features that contribute to the visual character and are worthy of preservation, these half-round bays demonstrate the importance of projecting features on an already rich and complex facade. Because of the repetitive nature of these projecting bays on adjacent row houses, along with the buildings' size, scale, openings, and materials, they also contribute to the overall visual character of the streetscape in the historic district. Any evaluation of the visual character of such a building should take into account the context of this building within the district. Photo by Lee H. Nelson

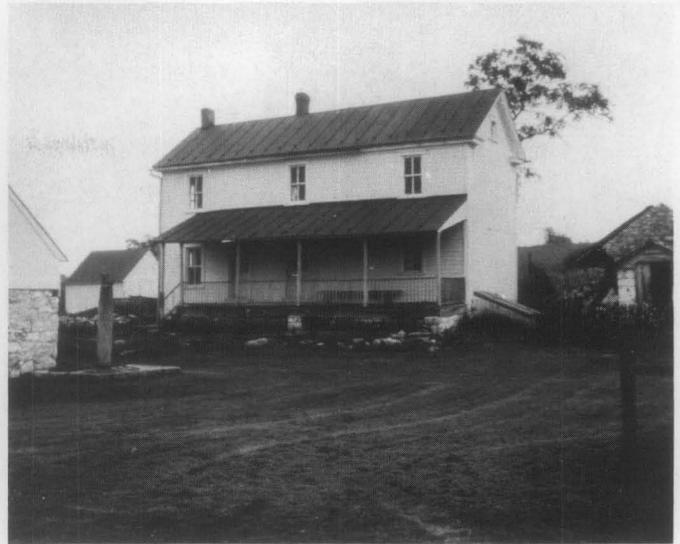
Overall Visual Character: Projections

Many buildings have projecting features such as porches, bay windows, or overhanging roofs, that help define their overall visual character. This projecting porch because of its size and shape, and because it copies the pitch and material of the main roof, is an important contributor to the visual character of this simple farmhouse. The removal or alteration of this porch would drastically alter the character of this building. If the porch were enclosed with wood or glass, or if gingerbread brackets were added to the porch columns, or if the tin roof was replaced with asphalt, or if the porch railing was opened to admit a center stairway, the overall visual character could be seriously damaged. Although this projecting porch is an important feature, almost any other change to this house, such as changes to the window pattern, or changes to the main roof, or changes to the setting, would also change its visual character. Photo by Hugh C. Miller

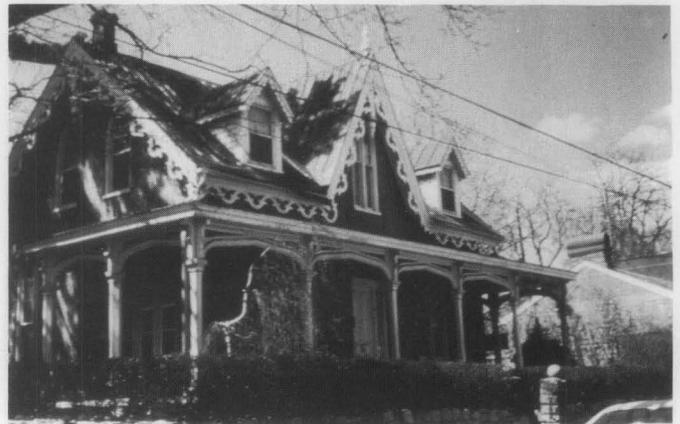
Overall Visual Character: Trim

If one were to analyze the overall shape or form of this building, it would be seen that it is a gable-roofed house with dormers and a wrap-around porch. It is similar to many other houses of the period. It is the wooden trim on the eaves and around the porch that gives this building its own identify and its special visual character. Although such wooden trim is vulnerable to the elements, and must be kept painted to prevent deterioration; the loss of this trim would seriously damage the overall visual character of this building, and its loss would obliterate much of the close-up visual character so dependent upon craftsmanship for the moldings, carvings, and the see-through jigsaw work. Photo by Hugh C. Miller

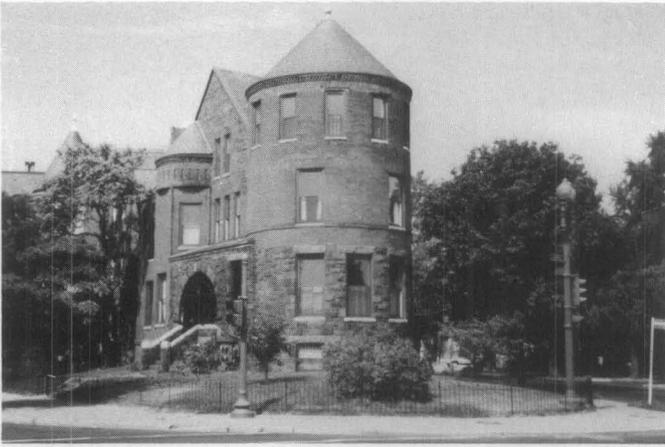
Overall Visual Character: Setting

In the process of identifying the overall visual character, the aspect of setting should not be overlooked. Obviously, the setting of urban row houses differs from that of a mansion with a designed landscape. However, there are many instances where the relationship between the building and its place on the streetscape, or its place in the rural environment, in other words its setting, may be an important contributor to its overall character.

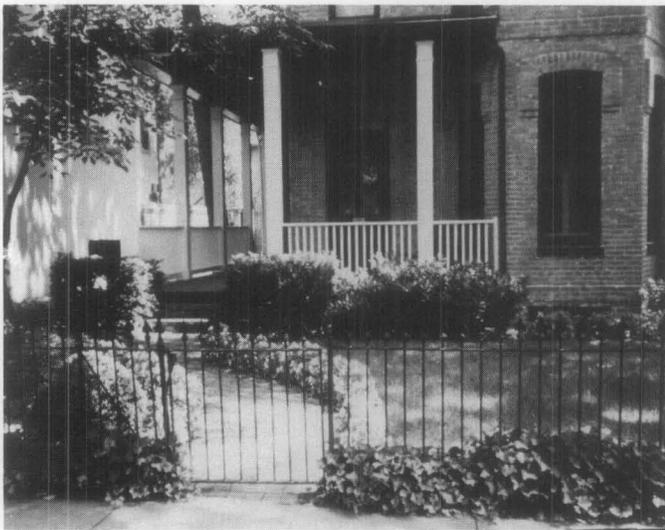
Overall Visual Character: Setting

Even architecturally modest buildings frequently will have a setting that contributes to their overall character. In this very urban district, set-backs are the exception, so that the small front yard is something of a luxury, and it is important to the overall character because of its design and materials, which include the iron fence along the sidewalk, the curved walk leading to the porch, and the various plantings. In a district where parking spaces are in great demand, such front yards are sometimes converted to off-street parking, but in this instance, that would essentially destroy its setting and would drastically change the visual character of this historic property. Photo by Lee H. Nelson

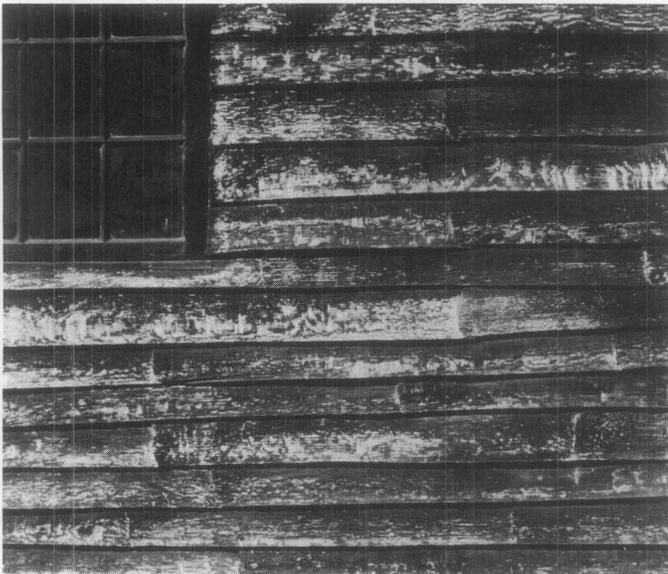
Arm's Length Visual Character: Craft Details

On some buildings, there are subtle aspects of visual character that cannot be perceived from a distance. This is especially true of certain craft details that can be seen only at close range. On this building, it is easily understood that the narrow, unpainted, and weathered clapboards are an important aspect of its overall visual character; but at close range there are a number of subtle but very important craft details that contribute to the handmade quality of this building, and which clearly differentiate it from a building with machine sawn clapboards. The clapboards seen here were split by hand and the bottom edges were not dressed, so that the boards vary in width and thickness, and thus they give a very uneven shadow pattern. Because they were split from oak that is unpainted, there are occasional wavy rays in the wood that stand against the grain. Also noticeable is the fact that the boards are of relatively short lengths, and that they have feather-edged ends that overlap each other, a detail that is very different from butted joints. The occasional large nail heads and the differential silver-gray weathering add to the random quality of the clapboards. All of these qualities contribute to the arm's length visual character. Photo by Lee H. Nelson

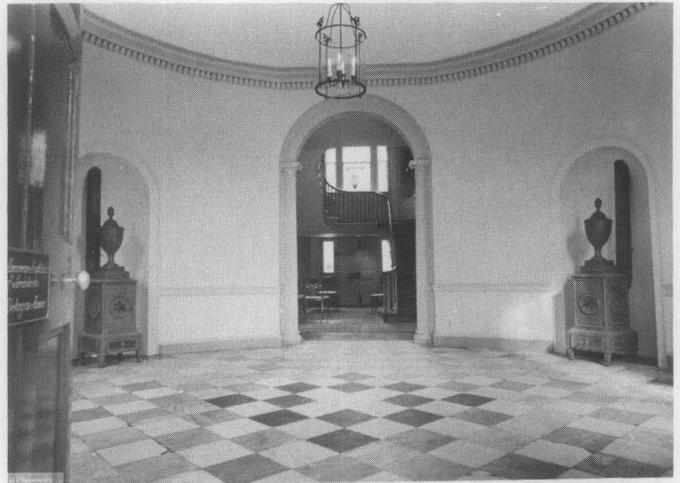
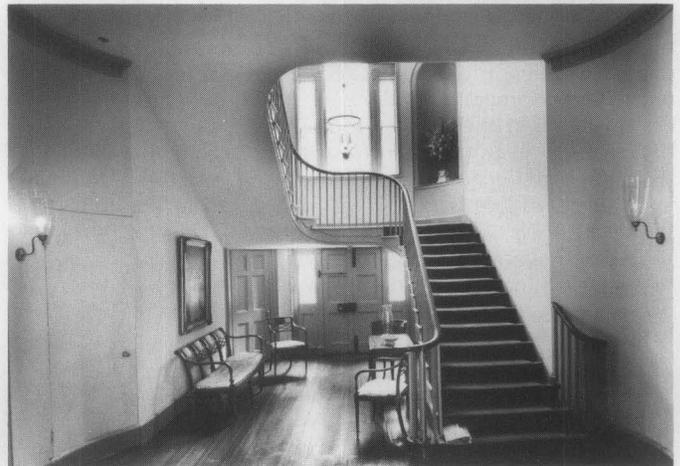
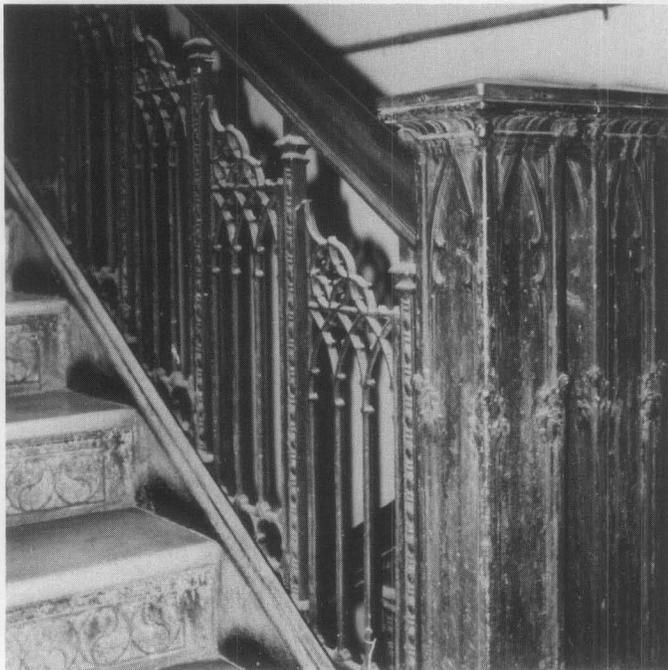
The stairway is the third part of this sequence of related spaces, and it provides continuing access to the upper floors.

These related spaces are very important in defining the interior character of this building. Almost any change to these spaces, such as installing doors between the vestibule and the hallway, or enclosing the stair would seriously impact their character and the way that character is perceived. Top photo by Mel Chamowitz, others by John Tennant

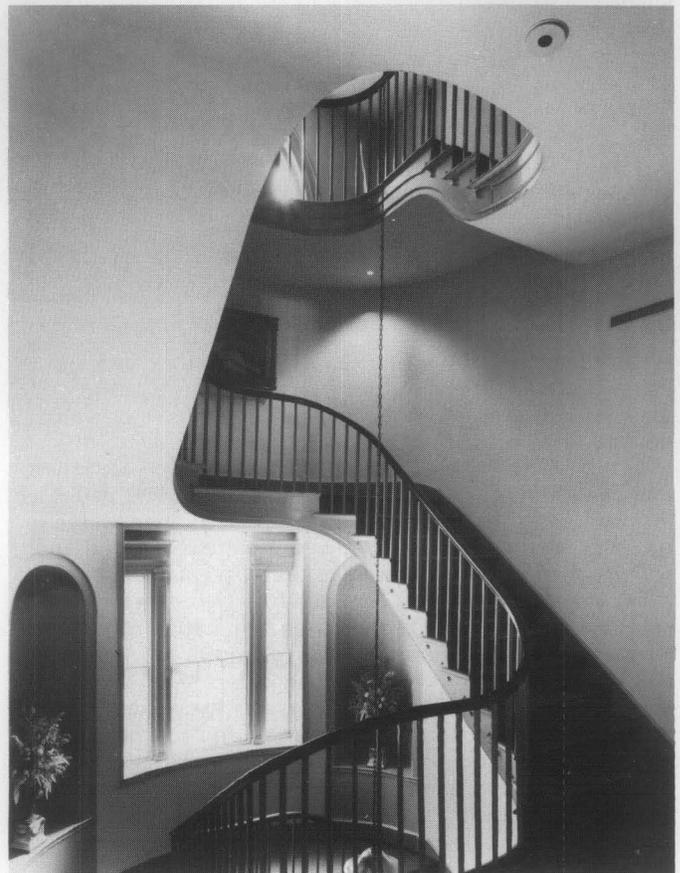
Interior Visual Character: Interior Features

Interior features are three-dimensional building elements or architectural details that are an integral part of the building as opposed to furniture. Interior features are often important in defining the character of an individual room or space. In some instances, an interior feature, like a large and ornamental open stairway may dominate the visual character of an entire building. In other instances, a modest iron stairway (like the one illustrated here) may be an important interior feature, and its preservation would be crucial to preserving the interior character of the building. Such features can also include the obvious things like fireplace mantles, plaster ceiling medallions, or panelling, but they also extend to features like hardware, lighting fixtures, bank tellers cages, decorative elevator doors, etc. Photo by David W. Look

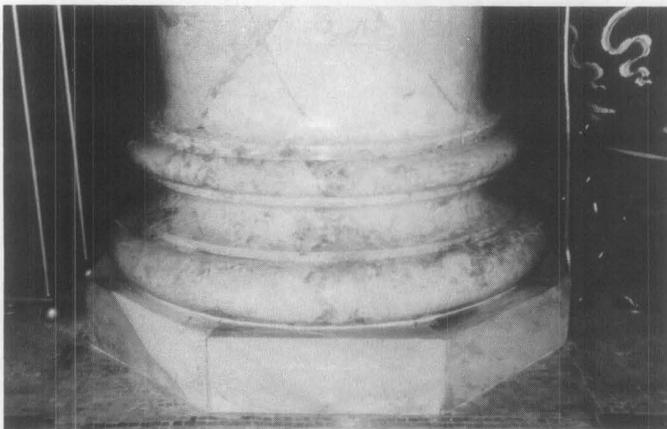
Interior Visual Character: Surface Materials and Finishes

When identifying the visual character of historic interior spaces one should not overlook the importance of those materials and finishes that comprise the surfaces of walls, floors and ceilings. The surfaces may have evidence of either hand-craft or machine-made products that are important contributors to the visual character, including patterned or inlaid designs in the wood flooring, decorative painting practices such as stenciling, imitation marble or wood grain, wallpapering, tinwork, tile floors, etc.

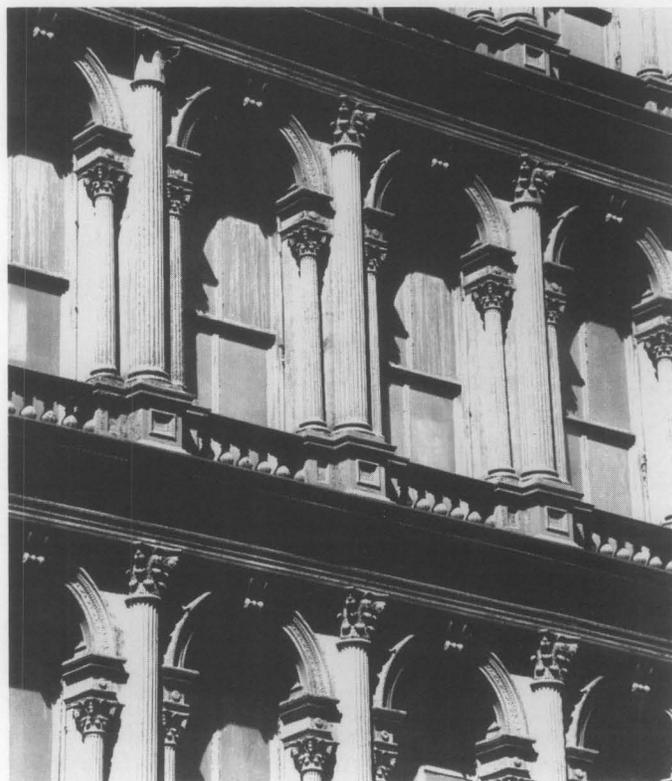
Fig. 1. The Haughwout Building in New York City is an excellent example of the quality and character of mass-produced cast-iron architecture. Once wood patterns were made, any number of elements could be cast, as was done with each of these repetitive bays. Photo: New York City Landmarks Preservation Commission.

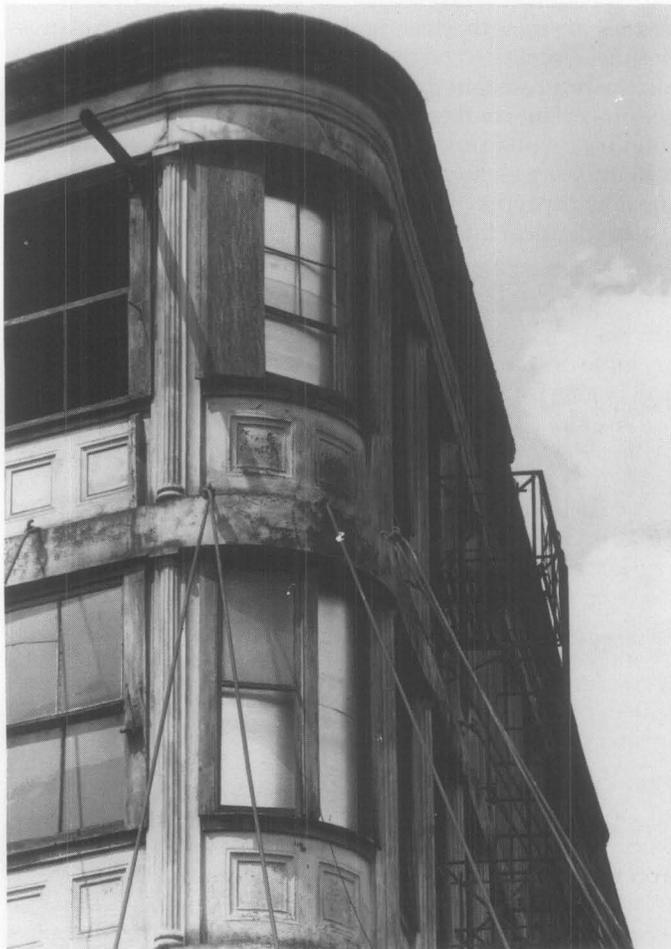
Fig. 2. The Edgar Laing Stores Block in New York City was designed by James Bogardus. It was the first building constructed with facades of self-supporting cast iron. This corner view shows the Doric-style engaged columns, panels, and spandrel beams; the loss of most of the original ornamental castings give it an austere look. As part of an urban renewal project, the facades were carefully disassembled in 1971 for later re-erection in another location—only to have its iron parts stolen for scrap. Photo: Jack E. Boucher, HABS Collection.

In 1849 Bogardus created something uniquely American when he erected the first structure with self-supporting, multi-storied exterior walls of iron. Known as the Edgar Laing Stores, this corner row of small four-story warehouses that looked like one building was constructed in lower Manhattan in only two months. Its rear, side, and interior bearing walls were of brick; the floor framing consisted of timber joists and girders. One of the cast-iron walls was load-bearing, supporting the wood floor joists. The innovation was its two street facades of self-supporting cast iron, consisting of multiples of only a few pieces—Doric-style engaged columns, panels, sills, and plates, along with some applied ornaments (cover photo and Fig. 2). Each component of the facades had been cast individually in a sand mold in a foundry, machined smooth, tested for fit, and finally trundled on horse-drawn drays to the building site. There they were hoisted into position, then bolted together and fastened to the conventional structure of timber and brick with iron spikes and straps (Fig. 3).

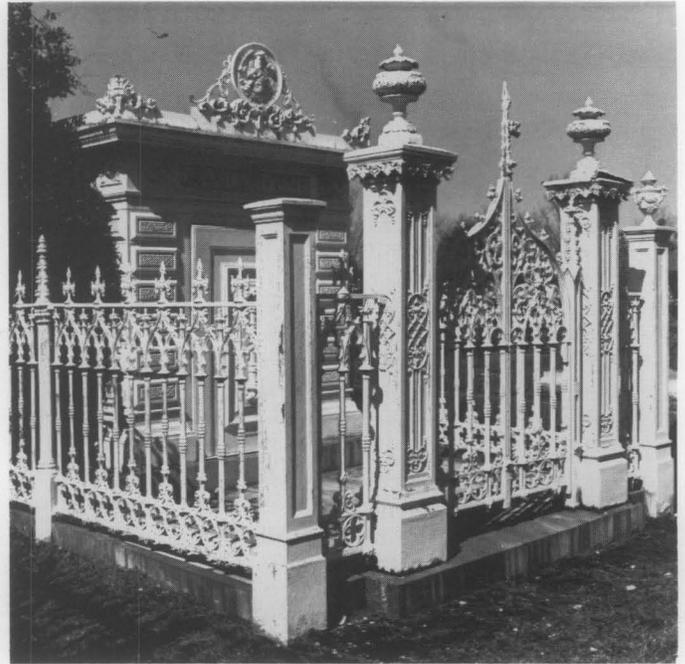
Fig. 5. The Slatter Family Tomb in Mobile, Alabama, consisting of a cast-iron mausoleum and fence, exhibits the wide range of uses of the material in the 19th century. Photo: Jack E. Boucher, HABS Collection.

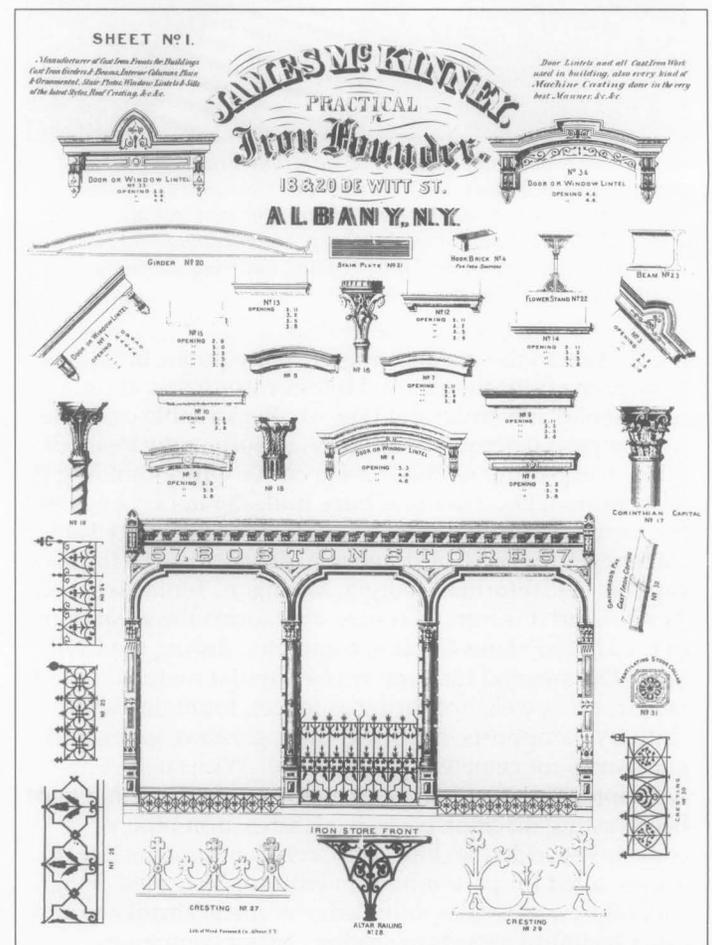
Fig. 6. Sheet from a late 19th century manufacturer's trade catalog illustrates some of the products available from foundries, such as storefronts, girders and beams, columns, stairs, window lintels and sills, and roof crestings. Courtesy: Albany Institute of History and Art.

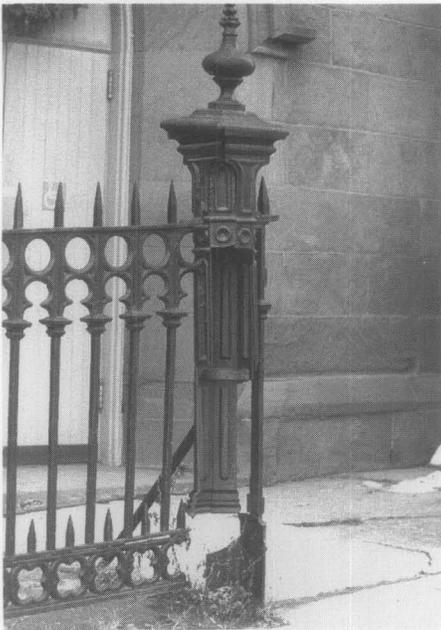
Fig. 7. Despite an impact that shattered the main castings, this fence post remains upright, demonstrating the great strength of cast iron. Originally, the post was held together by a long bolt that extended from the finial to the base. Photo: John G. Waite.
