HOW SAINT BERNARD'S CHURCH PROPERTY WAS ACQUIRED
AND SOME HISTORY OF THE EARLY SETTLERS OF THE SANDFORK REGION.

LOVEBERRY - St. Bernard Chapel
Connected w/ St. Patrick, Weston

The Repair of Historic Wooden Windows

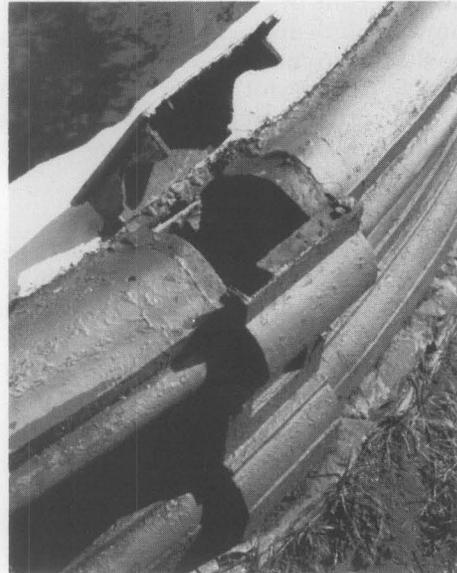
Fig. 9. Galvanic corrosion occurred where a patch of copper was installed alongside the cast-iron cap at the base of a fountain. The use of terne-coated stainless flashings with appropriate caulking would have been a more suitable repair. Photo: John G. Waite.

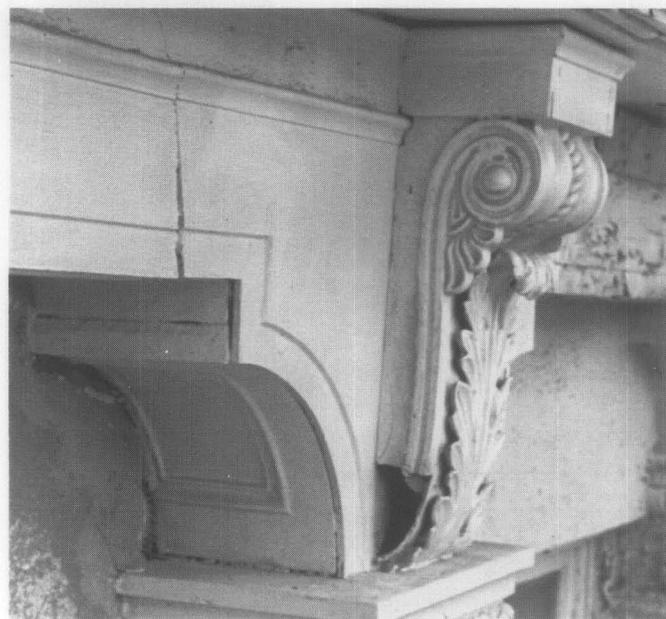
Fig. 8. Structural cracks, gaps at joints between components, and a large opening where part of the console bracket is missing are the problems evident in this cast-iron assembly. Photo: Ford, Powell & Carson.

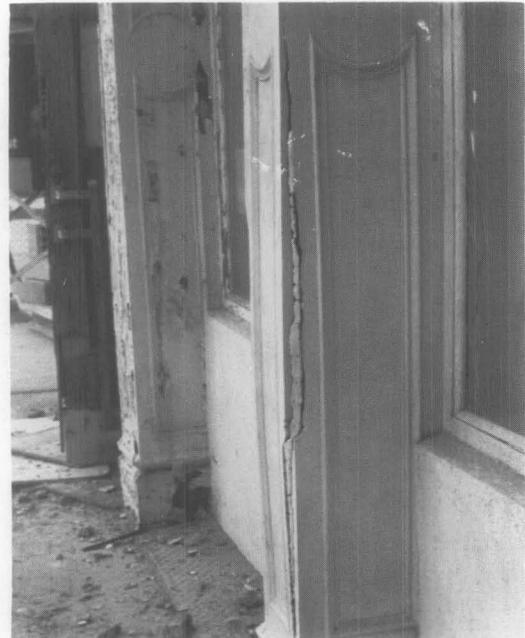
Fig. 11. Major cracks in the piers of this cast-iron storefront in Galveston, Texas resulted from the transfer of load onto the iron from internal brick piers eroded by rising damp. This crack was inappropriately filled with concrete, which trapped moisture and accelerated internal corrosion, pushing the iron further apart. Photo: Ford, Powell & Carson.

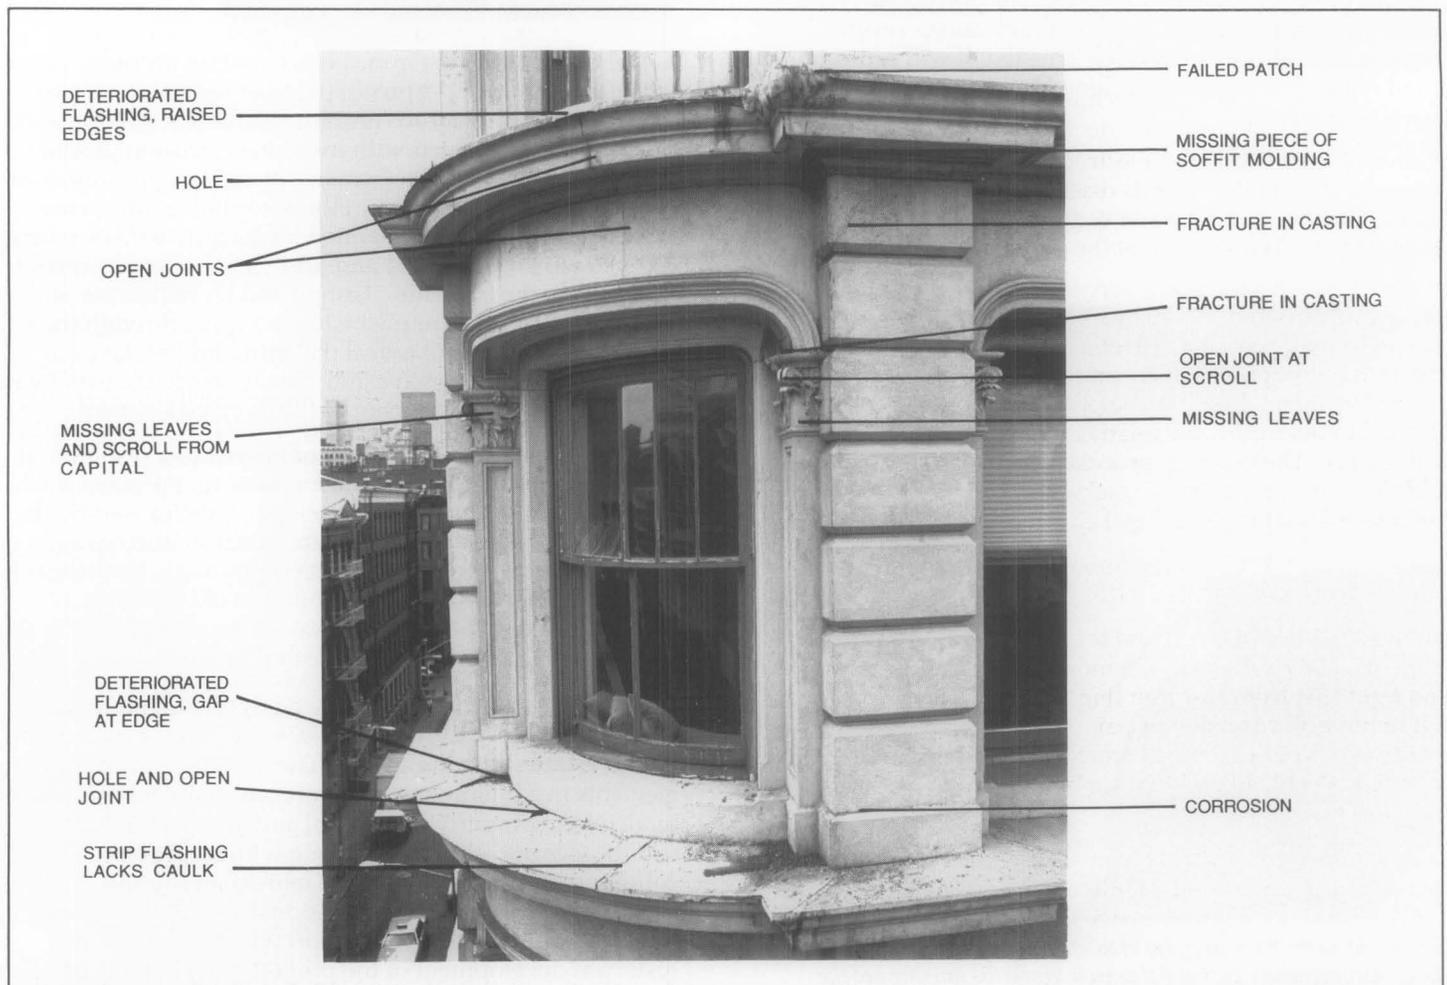
Fig. 10. During close-up inspection of the Gunther Building in New York City, photographs of each bay were taken to use in a survey of existing conditions. Photo: Willcox Dunn.

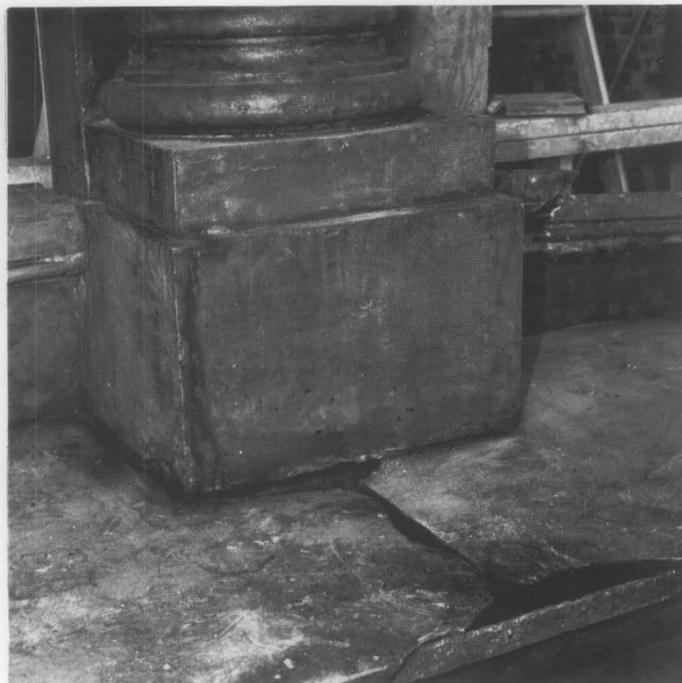
Fig. 12. Paint stripping exposed a large defect under a faulty patch at a joint of this wide cast-iron watertable. The damage can be repaired mechanically by splicing in a cast-iron replacement piece. Photo: Peter Jensen, Kapell and Kostow Architects.

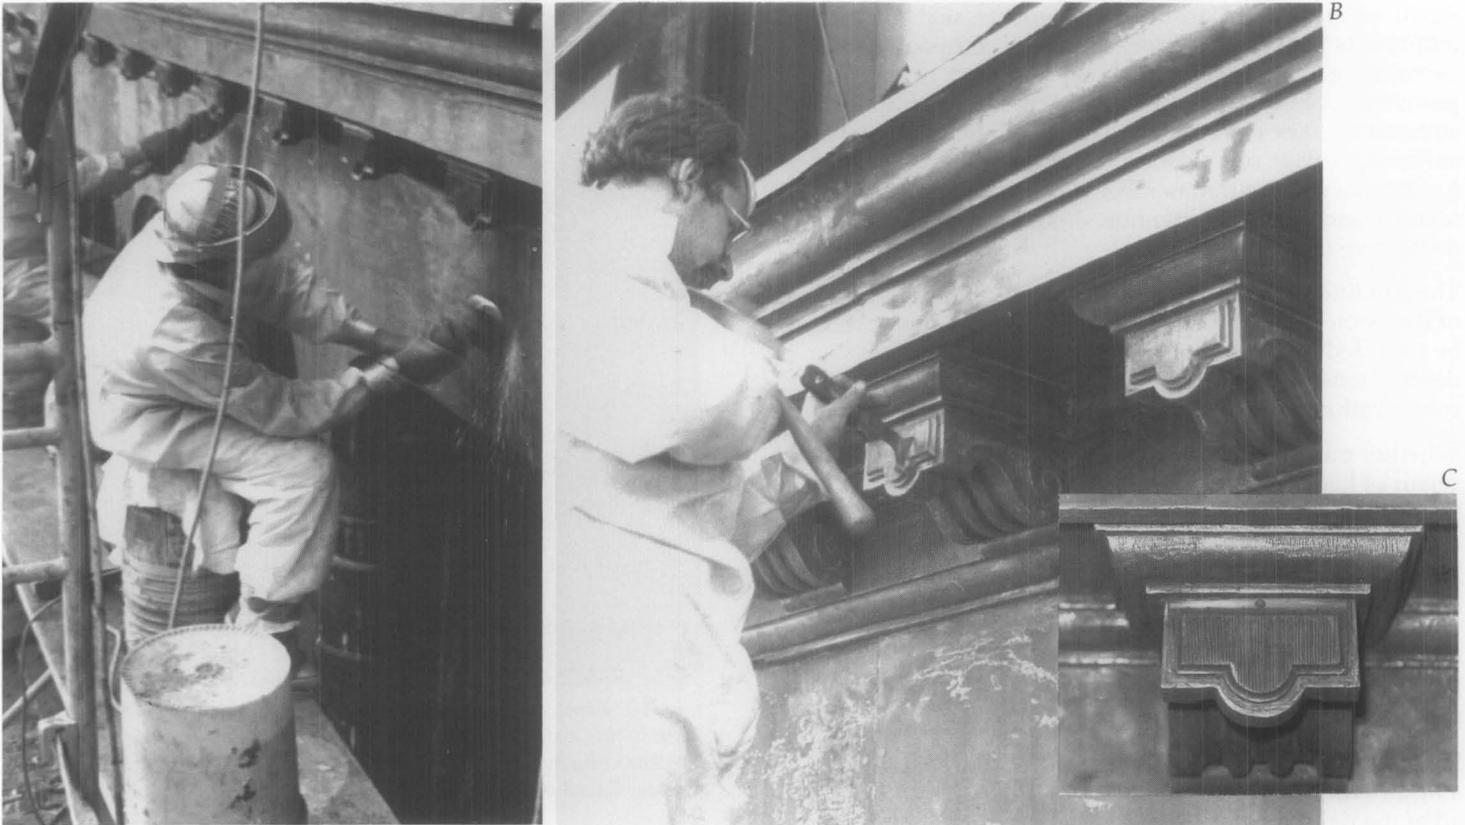
Fig. 13. Surface preparation may involve several different techniques. Where chemical paint stripping is involved, careful planning of the sequence of work and inspection by an architect or conservator to ensure strict compliance with the contract documents is important to minimize the risk of problems. After the chemical paste and paint was scraped off, the remaining paint and chemical residue were removed with a wire brush (a) and scrapers selected or cut to fit the shape of the iron surfaces (b). The surface was then wiped with solvent to create a completely clean surface prior to repainting (c). Photos: Raymond M. Pepi, Building Conservation Associates.

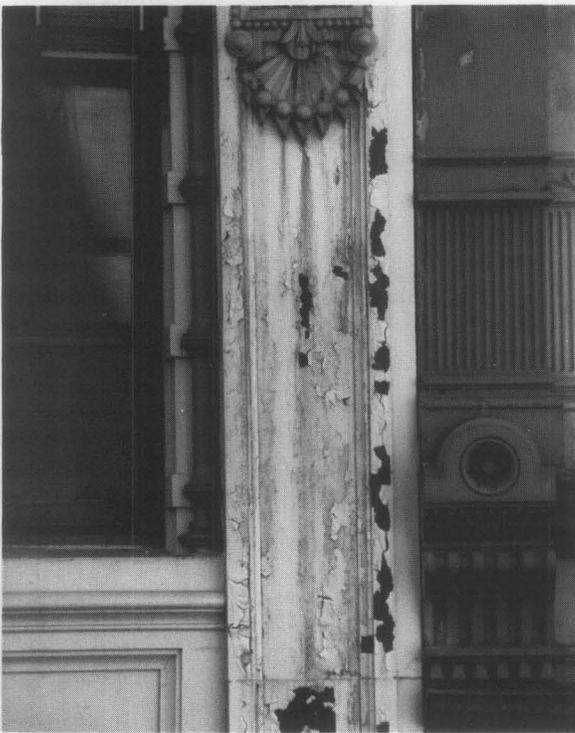
Fig. 14. Major problems can result if work is undertaken without proper sequencing and precautions. On this building, a strong alkaline paint remover was used, and apparently was not adequately rinsed or neutralized. Over a period of months, the newly applied paint began to peel and streaks of rust appeared on the iron. Photo: Kim Lovejoy.

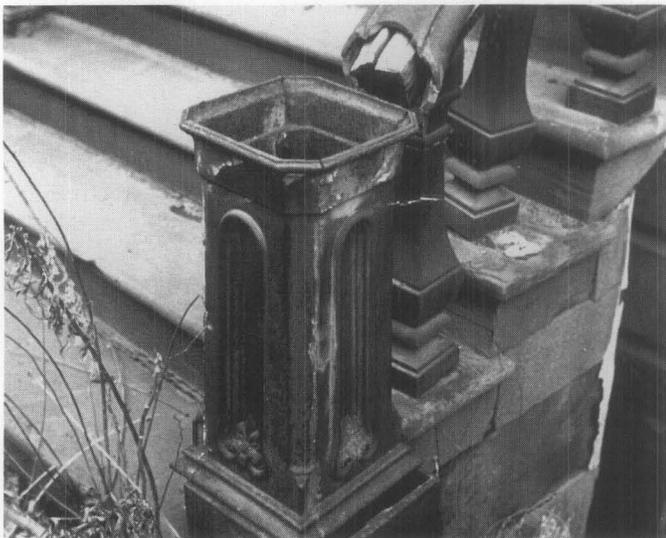
Fig. 15. In an effort to repair this stair railing, concrete was poured around the wood spacer inside the railing casting. Water penetrated the railing and reacted with the concrete to accelerate the corrosion of the iron. Photo: John G. Waite.

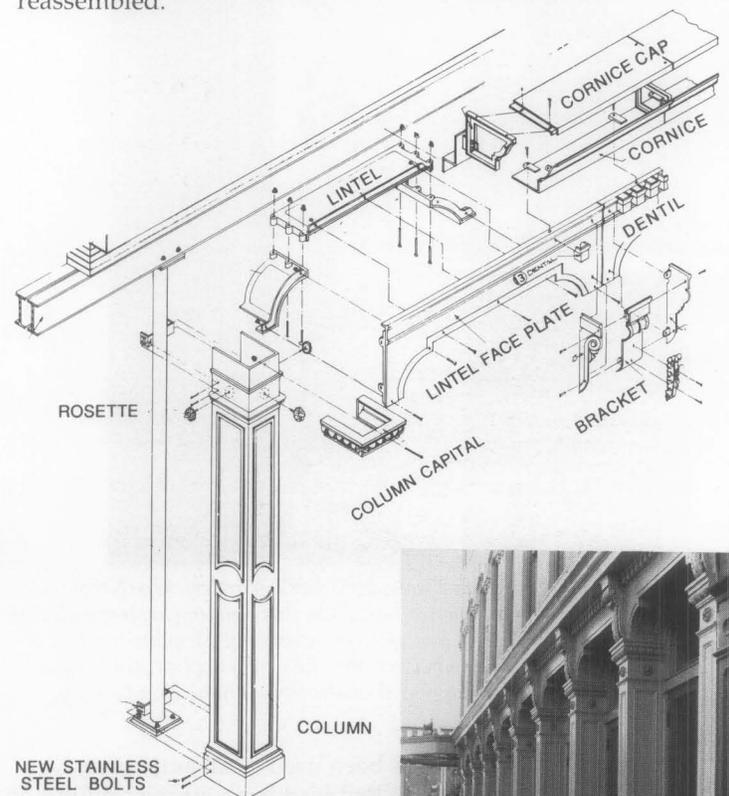
Fig. 16. Architectural cast iron is made of many small components bolted and screwed together. (a) This exploded view of a storefront illustrates the variety of elements, including brackets, fasteners, and holes for bolts. (b) The storefront was replicated in cast iron because of the extensive damage and structural failure, a detail of which is shown in Fig. 11. Drawing and photo: Historical Arts & Casting, Inc.

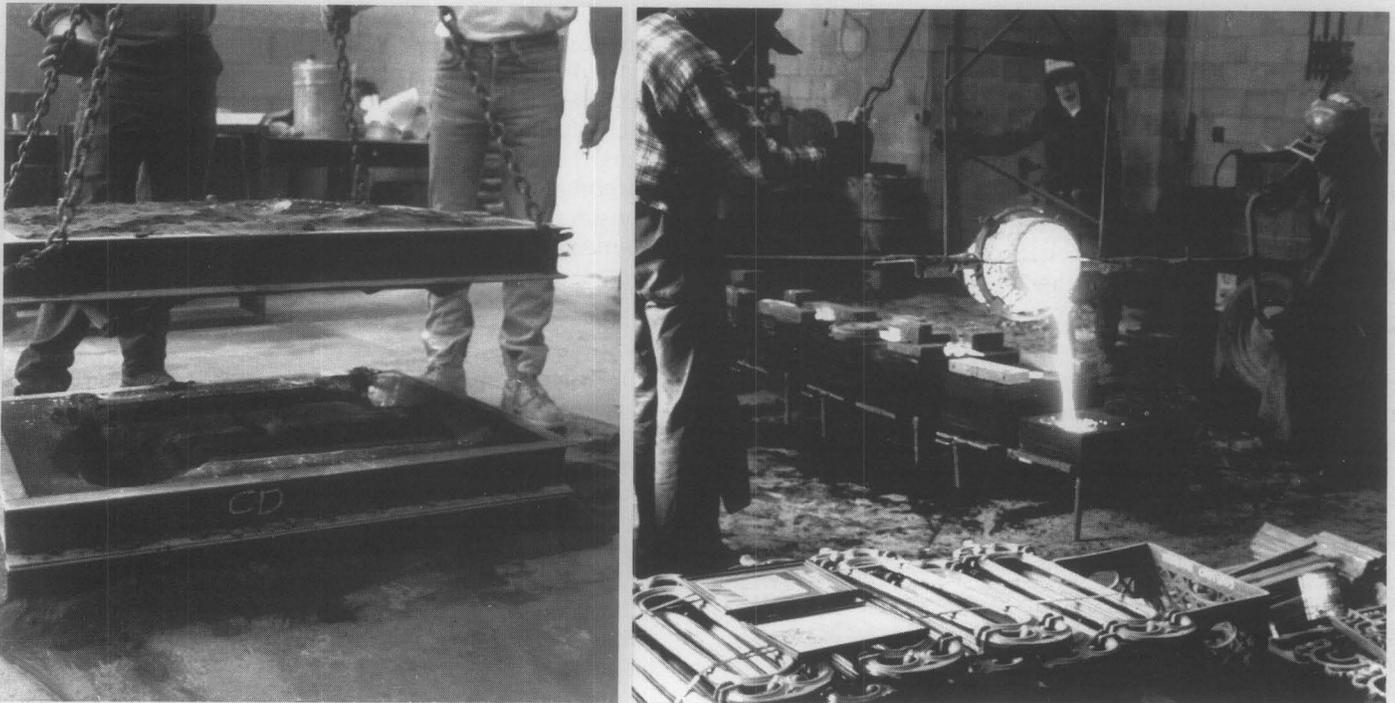
Fig. 17. (a) A two-part mold, consisting of a cope (top) and drag (bottom) for a newel post. Photo: Architectural Iron Company, Inc. (b) Molten iron being poured into a mold containing sand at a foundry. The iron casting process has changed little in the past two centuries. Photo: Karen Huebner.

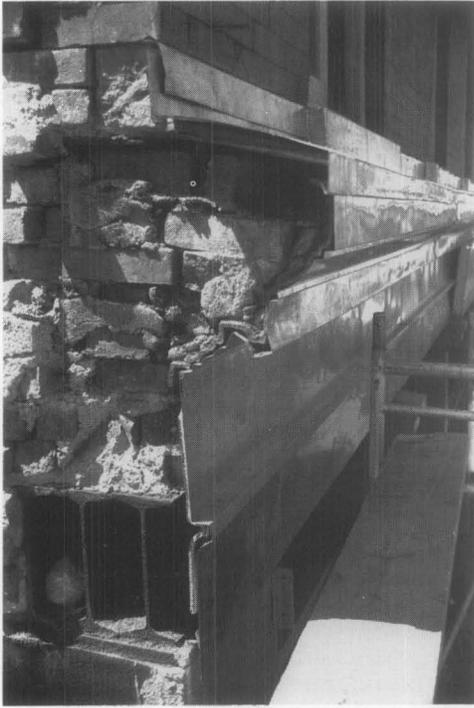
Fig. 18. This cast-iron storefront cornice was corroded beyond the point of repair, and could not be removed easily for replacement. Terne-coated stainless steel, the most durable metal for flashing cast iron, was applied to the cornice and fitted as closely as possible to the historic profile. Although painting is not necessary to protect terne-coated stainless steel, the cornice should be painted to be consistent with the historic character of the building. A primer which is compatible with the terne coating should be used. Photo: Dean Koga, Robert E. Meadows, P.C., Architects.

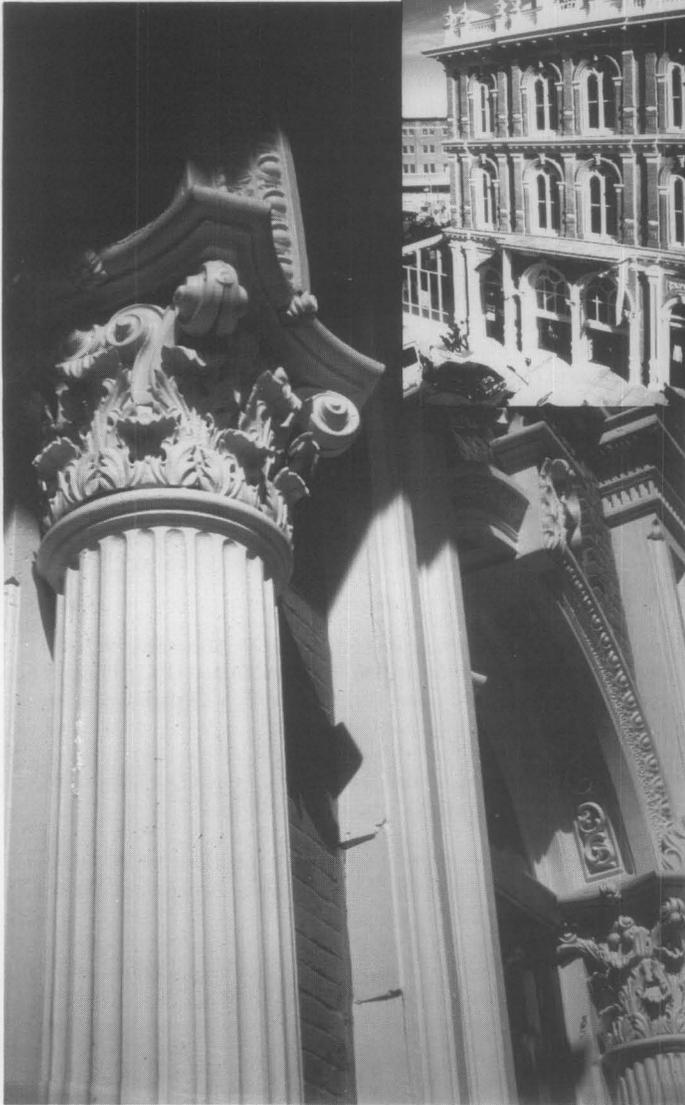
Fig. 19. (a) Fiberglass columns and aluminum capitals were installed to replicate the ornamental features on the east facade of the New Market Theater in Portland, Oregon, that had been destroyed by previous occupants. Like cast iron, crisp ornamental details can be achieved with cast aluminum. Although aluminum may be in contact with fiberglass, galvanic corrosion may result when aluminum is in direct contact with cast iron. Photo: William J. Hawkins, III. (b) The west facade of the theatre retains its original cast iron features. Photo: George McMath.

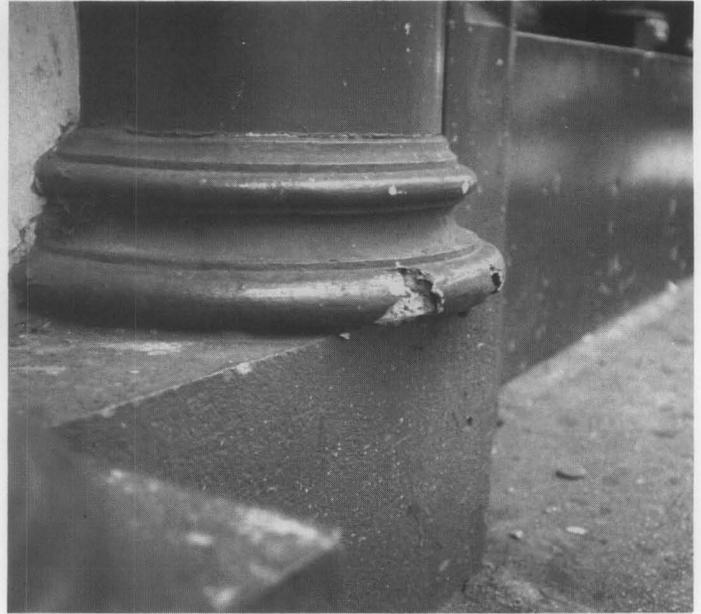
Fig. 20. The location of the feature must be taken into account if a substitute replacement material is being considered. This lightweight fiberglass column at street level sustained damage from impact within a few years of installation. The great strength of cast iron makes it ideal for storefronts and elements that must withstand heavy use. Photo: Building Conservation Associates.

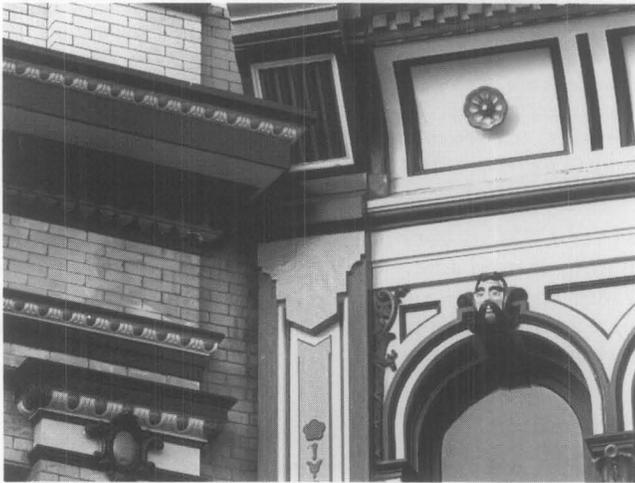
Detail of polychromed cast-iron facade at 23 Petaluma Boulevard, Petaluma, Calif. (1886; O'Connell and Lewis, *Architectural Iron Work*, San Francisco). Photo: Don Meacham.

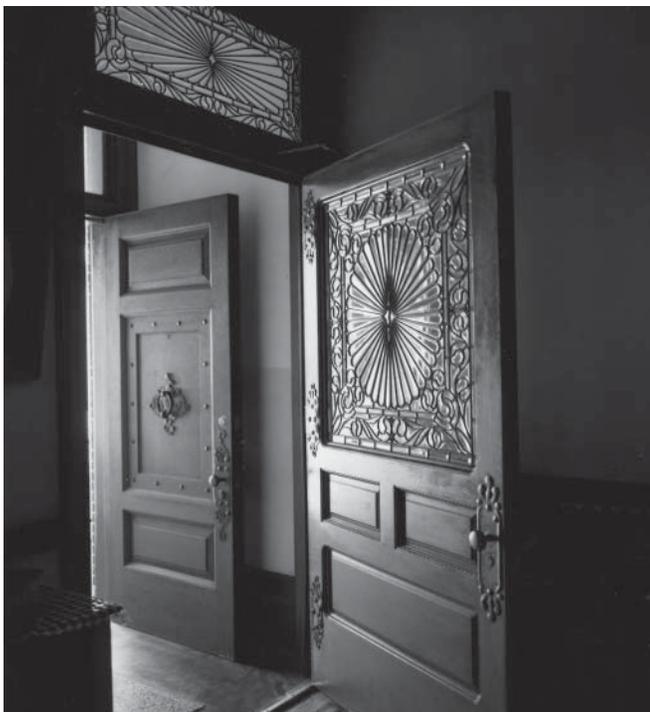
Figure 1. This door and transom suggest the richness of 19th century leaded glass. Photo: Jack E. Boucher, HABS.

Stained and leaded glass can be found throughout America in a dazzling variety of colors, patterns, and textures (Fig. 1). It appears in windows, doors, ceilings, fanlights, sidelights, light fixtures, and other glazed features found in historic buildings (Fig. 2). It appears in all building types and architectural styles—embellishing the light in a great cathedral, or adding a touch of decoration to the smallest rowhouse or bungalow. A number of notable churches, large mansions, civic buildings, and other prominent buildings boast windows or ceilings by LaFarge, Tiffany, Connick, or one of many other, lesser-known, American masters, but stained or leaded glass also appears as a prominent feature in great numbers of modest houses built between the Civil War and the Great Depression.

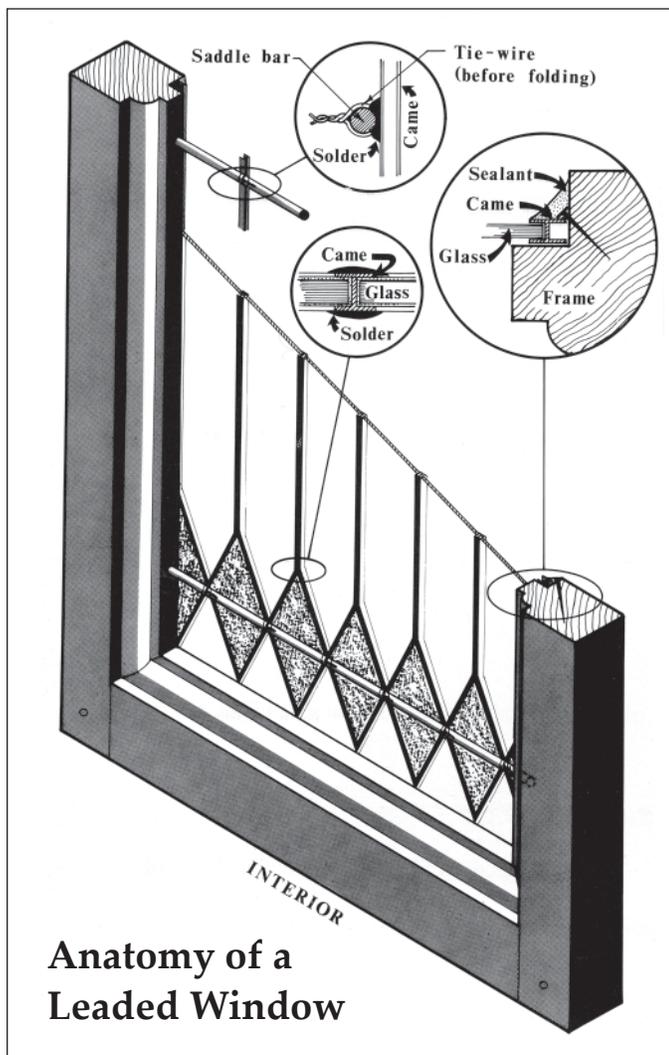
Figure 2. Components of a leaded glass window.

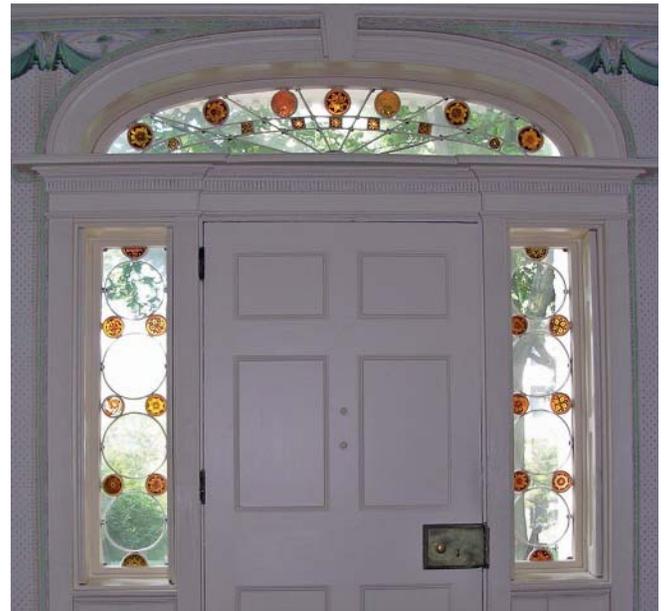
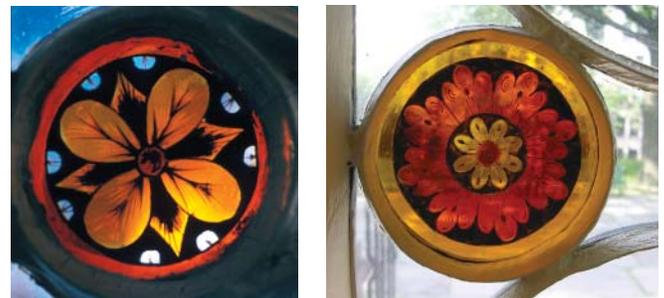
Figure 3. The entrance to the Morris-Jumel Mansion, New York City, is one of the earliest surviving installations of stained glass in the country. It features a fanlight and sidelights of large clear roundels and small bulls-eyes of red and orange glass tinted with silver stains from ca. 1810. Photo: Ken Moss.

from these periods is very significant (Fig. 3). Every effort should be made to document and preserve it.

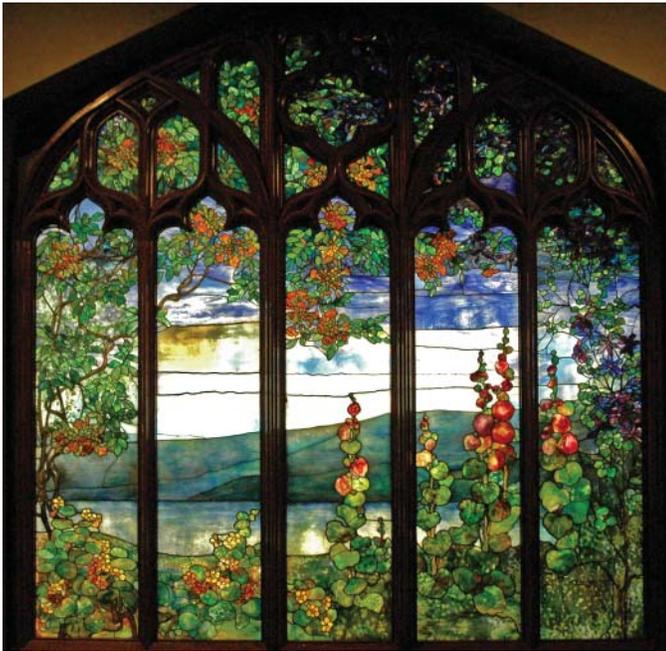
Figure 6. This 1907 landscape window is typical of those produced by Tiffany Studios. Characteristics include the use of opalescent glass, intricate leading and organic copper foil work, acid-etching, plating (i.e., several layers of glass), and a sense of perspective.

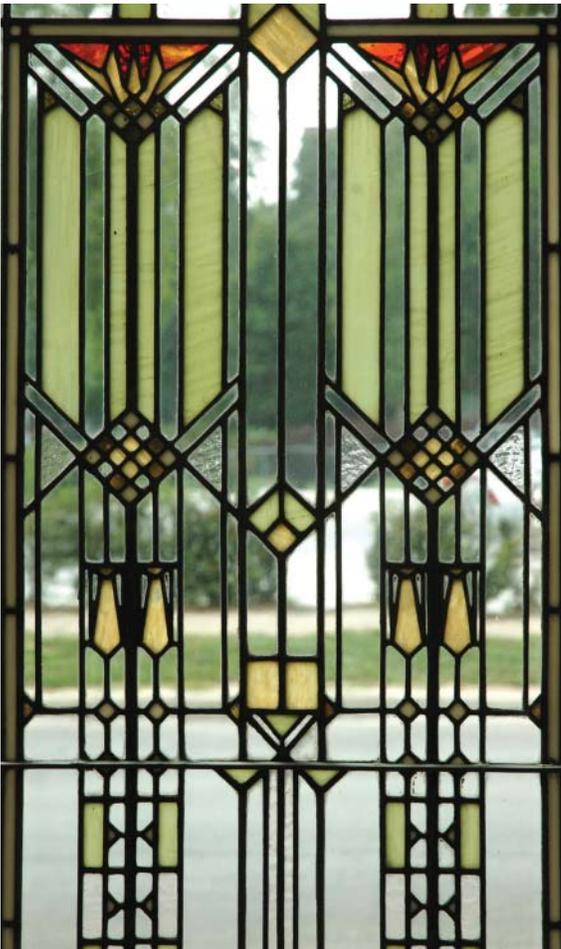
Figure 8. This 1902 window by Henry Webster Tomlinson reflects the Prairie School philosophy of providing ornamentation while retaining a view through the window.

Advocates of the Prairie Style, of whom Frank Lloyd Wright is the best known, rejected Tiffany's naturalistic scenes and Connick's Gothic imitations. (Fig. 8). Wright's rectilinear organic abstractions developed simultaneously with the similar aesthetic of the various European Secessionists. The creation of this style was aided by the development of zinc and copper comes in 1893. These comes—much stiffer than lead—made it possible to carry out the linear designs of Prairie School windows with fewer support bars. At first, these windows had only an elitist following, but they were soon widely accepted and proliferated during the early 20th century.

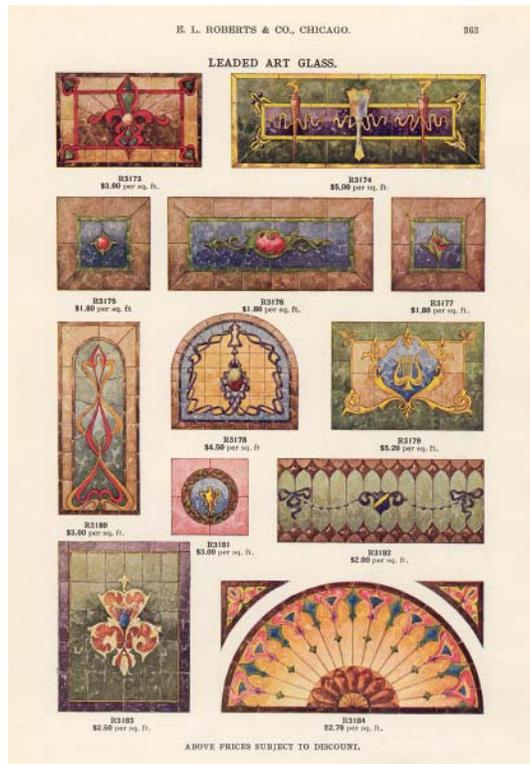
Figure 9. A typical mail-order catalog page of art glass windows available in 1903 from the E. L. Roberts Company, Chicago.

some offering over 100 low-cost, mass produced designs (although the same catalogs assured buyers that their leaded glass was “made to order”) (Fig. 9).

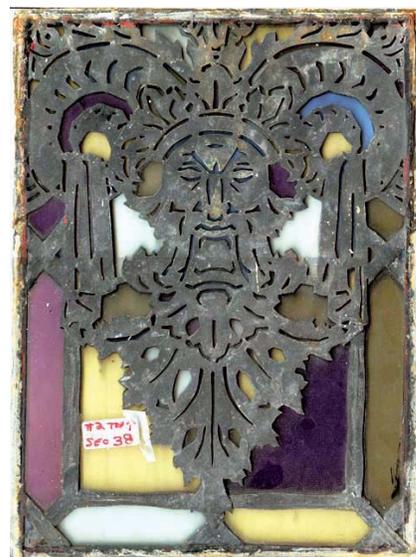
Figure 10. This lead-silhouette stained glass face graces a 1928 coach house in Buffalo, and is attributed to D'Ascenzo Studios of Philadelphia.

Some creative efforts expanded leaded glass media in new directions. Lead-overlay or “silhouette” glass was one novelty that climaxed in the late 1920s and early 1930s. Some designers sandwiched glass between layers of hand-cut sheet lead, while others sandwiched the perforated sheet lead between layers of glass. These windows present a playful reversal from traditional stained glass; in “silhouette” glass the lead metalwork, rather than the glass, becomes the primary art form (Fig. 10). However, such novelties failed to catch on during the Depression. World War II delivered the final blow and ornamental glass is seldom found in residential, commercial, and secular architecture after circa 1940. The great age of American stained glass was over. Fortunately, leaded glass panels survived in uncounted numbers throughout the country, and are now once again appreciated as virtually irreplaceable features of historic buildings.

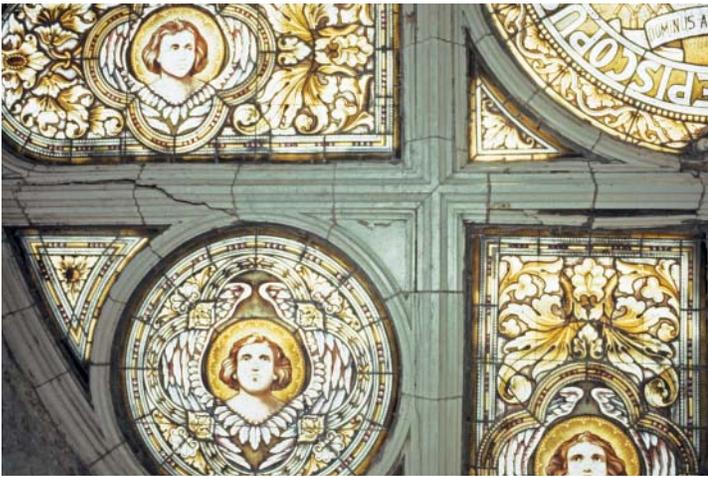
Figure 12. Stained glass frames are typically wood, steel or stone; however, other materials, and their inherent problems, can also be found as seen in this photograph of cracked terra cotta frames from 1926.

The greatest and the most common threat to leaded glass is deterioration of the skeletal structure that holds the glass. The structure consists of frame members, and lead or zinc (and occasionally brass or copper) came that secures individual pieces of glass. Frame members include wood sash and muntins that decay, steel t-bars and “saddle bars” that corrode, and terra cotta or stone tracery that can fracture and spall (Fig. 12). When frames fail, leaded glass sags and cracks due to insufficient bracing; it may even fall out from wind pressure or vibration.
