Cleaning, Repair and Protection

Repair

Repairs to Glass

Repairs to Structural Support Systems

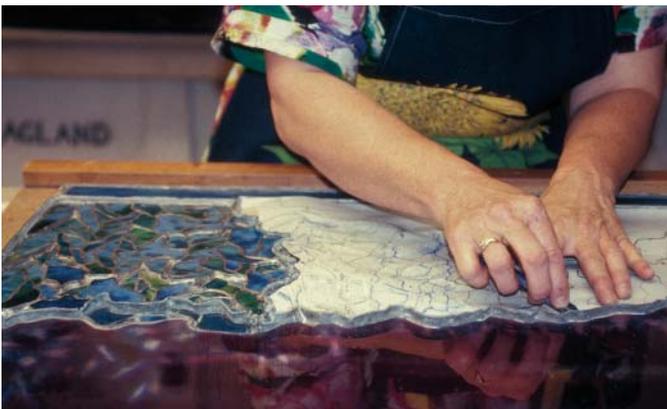
Figure 14. The external glass plate has been removed to clean the interlayer of this plated Tiffany Studios window.

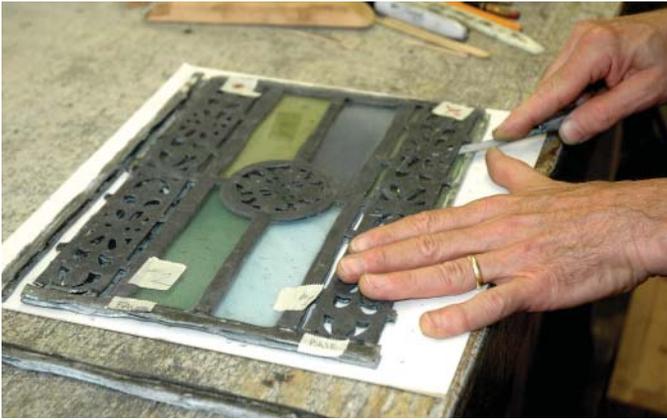
Figure 15. To permit repair of the cracked glass, the original lead overlay is first salvaged from this historic leaded panel of silhouette glass to retain as much of the original work as possible.

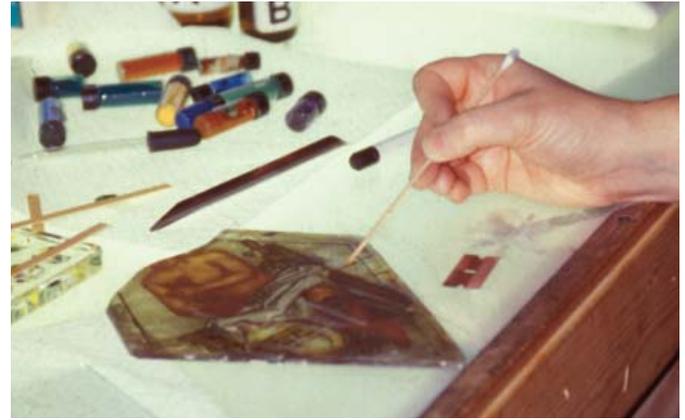
Figure 16. A valuable historic piece of original hand-painted glass is carefully edge-glued with epoxy.

Epoxy Edge-Gluing: This technique produces a nearly invisible line and is often used on painted glass, particularly focal points of a window such as a face, or a portion of sky intended to be one continuous piece. Epoxy can even be tinted to match the glass. It is also used for infusing shattered glass or microscopic cracks caused by intense heat from a fire. Epoxy produces a very strong repair, but will deteriorate in sunlight and requires secondary glazing to protect it from UV degradation. Epoxy is the least reversible of the three techniques, and usually the most expensive.

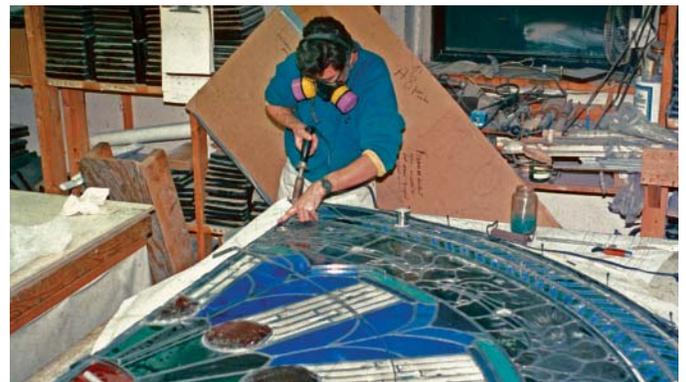
Figure 17. Total releading is very time consuming and costly and should only be undertaken when the original lead is exhausted beyond repair.

Rebuilding or releading a window is an expensive and involved process. The releading process requires that a window be disassembled before it can be reassembled (Fig. 17). The glass pieces must be removed from the cames, the old cement must be cleaned from each piece of glass, and all the pieces must be rejoined precisely. At every step the process involves the risk of damaging the glass. Furthermore, exceptional studios had unique leading techniques, and thus the cames should not be replaced casually. Total releading should only be undertaken when necessary to avoid or slow the loss of historic fabric. (It is essential to request a copy of all window rubbings if the windows are to be completely reled.)

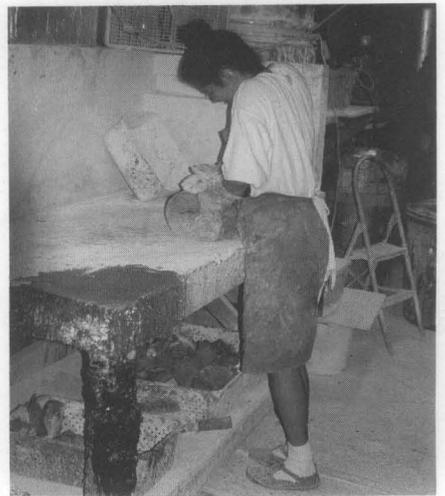
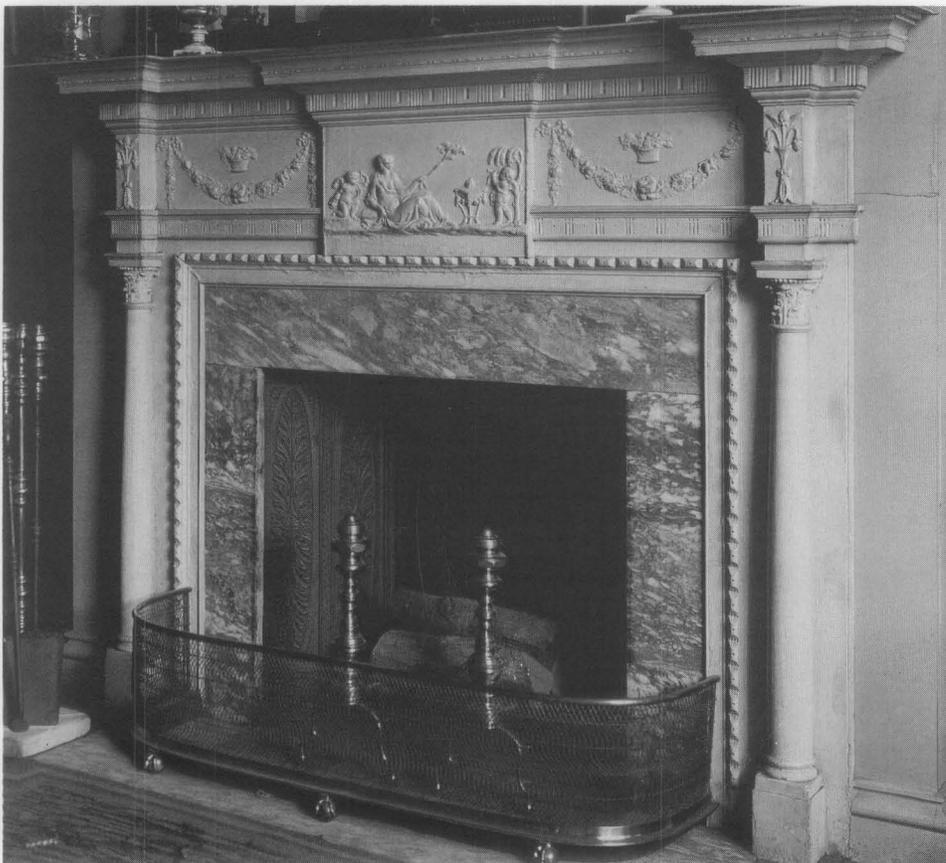
Figure 1. An American mantelpiece in the Adam style dating from the early 19th century illustrates composition ornament's reputation as a first-rate imitator of wood. Only the allegorical design, flower baskets, floral swags or festoons, flanking fleur-de-lis ornamentation and pilaster capitals are compo; the panels and simple moldings are carved wood. Photo: Courtesy, Philadelphia Museum of Art; Given by Mrs. Thurston Mason in memory of her sister, Miss Anna P. Stevenson.

the eye of the viewer (see Fig. 1). The confusion has been heightened over time by makers who claimed to be the sole possessors of secret recipes and by the variety of names and misnomers associated with the material, including *plaster*, *French stucco*, and *Swedish putty*, to name a few.

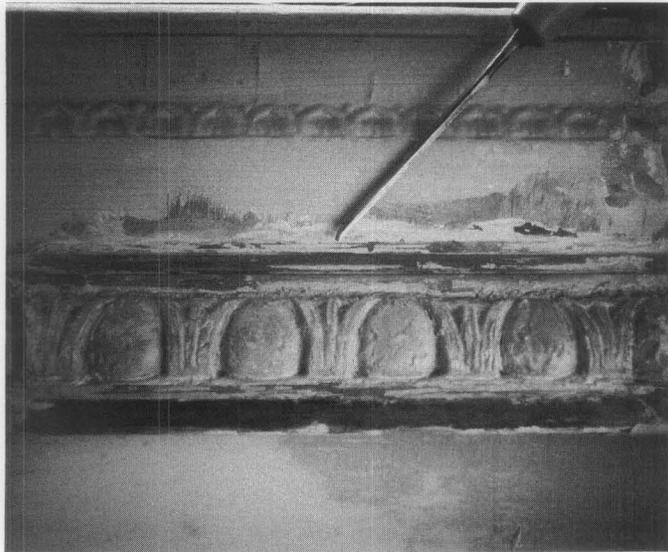
Figure 3. When this historic composition window surround was mistakenly identified as plaster, then treated with a caustic paint stripper, a section of it was destroyed. Photo: Bryan Blundell.

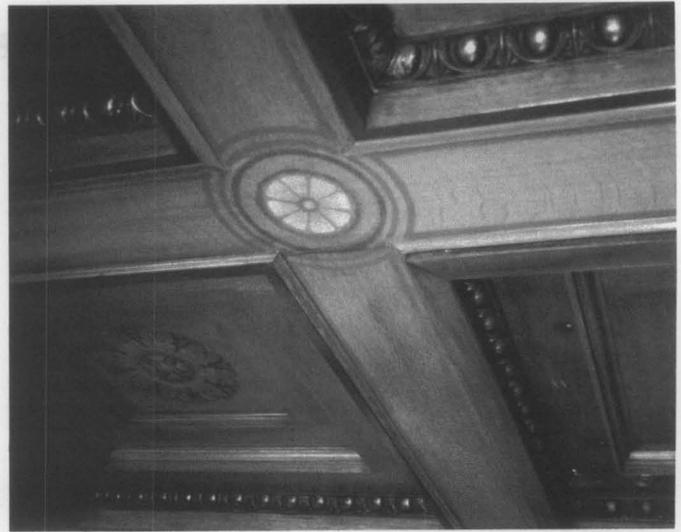
Figure 7. The coffered ceiling of the 1938 National Archives library in Washington, D.C. features egg-and-dart composition molding finished with a dark brown stain. While compo design is more often light and delicate, here, it has a bold, massive quality. Photo: Bryan Blundell.

Finally, when completely hard, it could be given a polished marble shine with nothing but a damp cloth. It could be stained, coated with any sort of paint, varnish, or oil gilded without any further preparation (see Fig. 7).

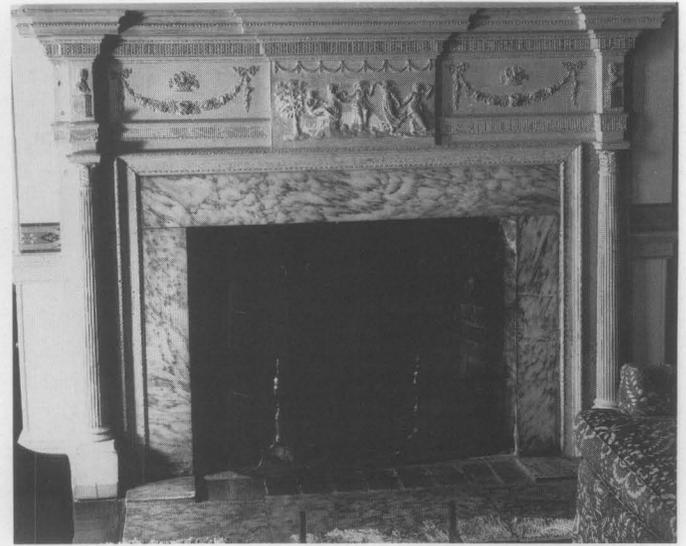
Figure 13. Top: Since rooms with fireplaces were centers of social activity in early American houses, mantelpieces often received special decorative attention. This early 19th century mantelpiece in a Philadelphia residence features a panel depicting A Country Dance flanked by floral swags and sculptural busts of Milton and Shakespeare. Bottom: Several American and English makers produced versions of a frieze entitled, *The Triumph of Mars*. This one, ca. 1800-1810, is in a modest "single" house on John Street in Charleston, South Carolina. Note how several layers of paint are obscuring the detail. Photo top: Gold Leaf Studios, Inc. Photo bottom: Jonathan Thornton.

The 19th Century. During the early decades of the nineteenth century, Neoclassical—encompassed in America by the terms Federal, Empire, and Greek Revival—was in the ascendancy. Composition makers continued to increase and also to find new uses for their material. Composition picture and mirror frames became common and some makers advertised the suitability of composition ornaments for casting iron firebacks and stoves. Composition ornament was explicitly advertised for exterior use as well, although very little has survived. The interiors of houses and public buildings in every prosperous American city were decorated with composition (see Fig. 13).

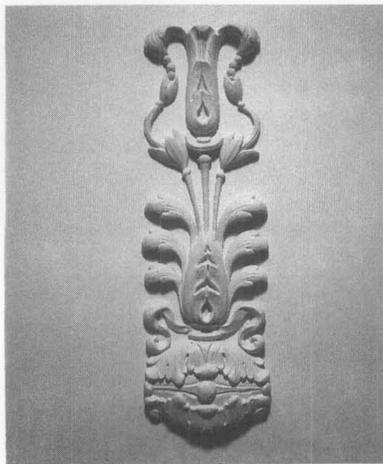
Figure 15. Naturally carved lily pattern molds reflect the early 20th century Arts and Crafts movement in the United States. Photo: Jonathan Thornton.

The 20th Century. The Arts and Crafts and related styles, such as the more decorative Art Nouveau, were well rooted in America by the beginning of the century (see Fig. 15). Pitch molds made from relief-carved patterns had become common in America. The carving tool marks could be accentuated in these patterns in keeping with current vogue. Open-grained woods, such as mahogany, were often chosen so that the finished composition ornaments would have a wood-like grain that showed through stains and varnishes (see Fig. 16). A uniquely 20th century application of composition ornament was in the lavishly decorated movie palaces of the Depression era (see Fig. 17).

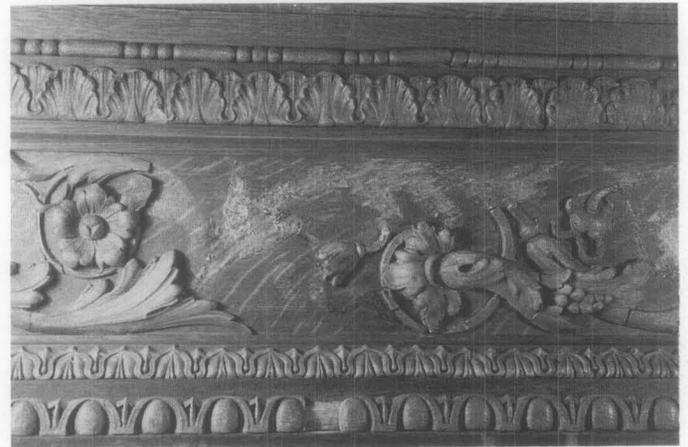
Figure 16. The Austin Morey residence, in the Indian Village Historic District of Detroit, Michigan, was designed by architect Louis Kamper, and built between 1902 and 1903. Part of Kamper's design included this grand oak staircase that was decorated with composition ornament. Note the "ghost marks" of missing composition in the close-up. Photo: Robert J. Rucinski.

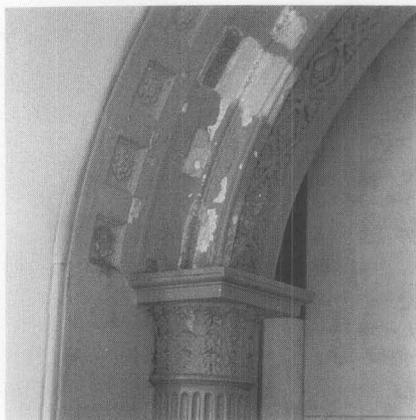
Figure 20. The Octagon House, in Washington, D.C., was constructed between 1801-1802. During recent project work, it was discovered that early repairs to the composition ornament in this doorway had been made with plaster. The plaster repairs were removed during restoration of the doorway to its original appearance. Photo: Lonnie J. Hovey, AIA.

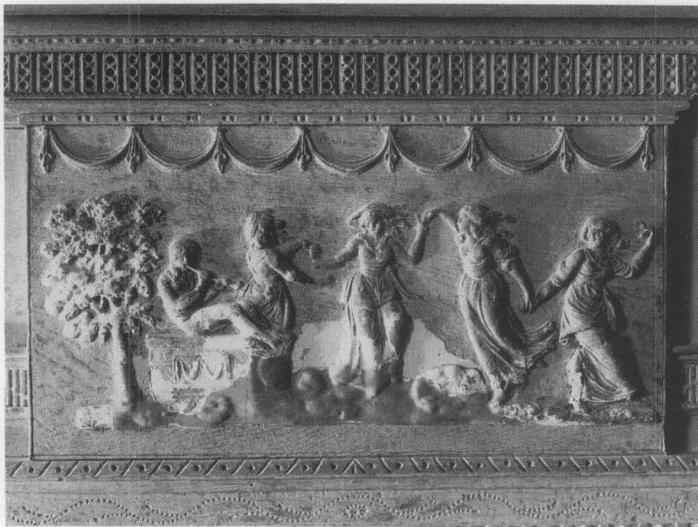
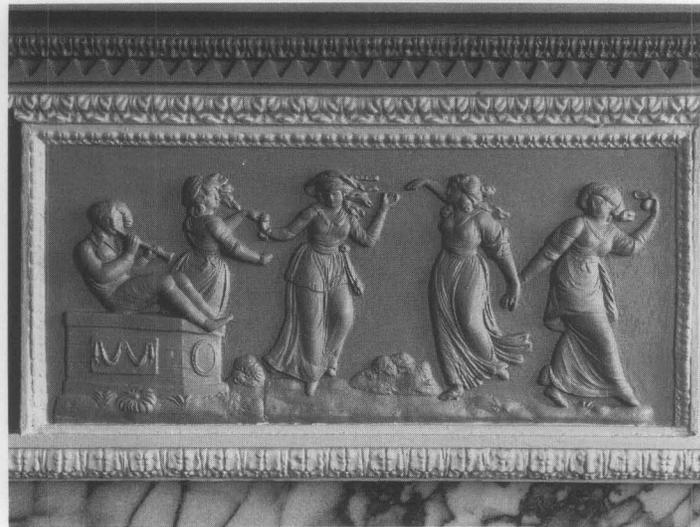
Figure 21. The same theme on two early mantelpieces, *A Country Dance*, dramatically illustrates the visual difference between cleaned and uncleaned composition ornament. When old paint layers are removed, the exquisite detailing is revealed. Left: George Read II House, 1801-1803, New Castle, Delaware; Right: First Harrison Gray Otis House, 1796, Boston, Massachusetts. Photo left: Gold Leaf Studios, Inc. Photo right: David Bohl. Courtesy, Society for the Preservation of New England Antiquities.

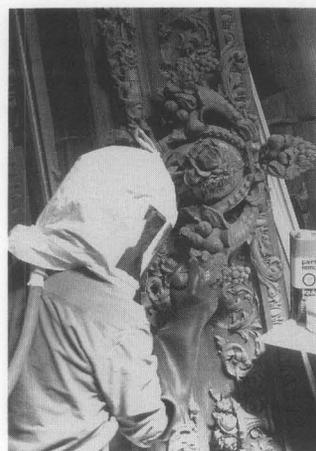
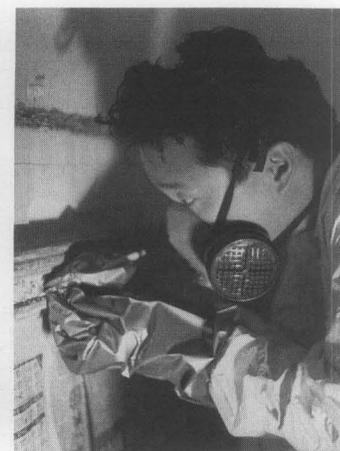
Figure 23. Methylene chloride fumes can be deadly, so protecting the worker is imperative. Left: a hooded, air-fed unit. Right: a vapor mask with organic solvent cartridges. Photo left: William Adair. Photo right: Lonnie J. Hovey, AIA.

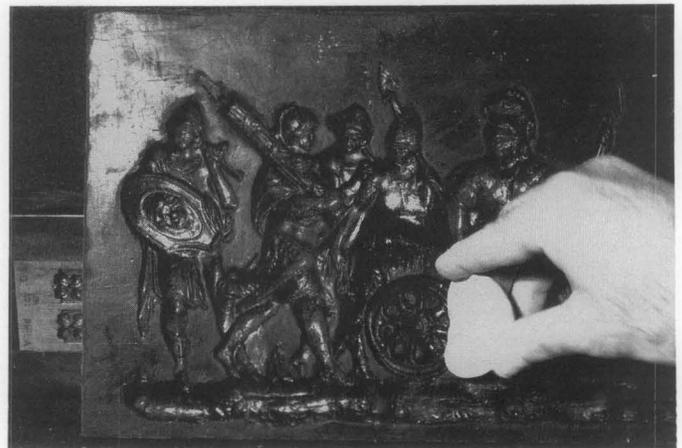
Figure 27. When a compo frieze depicting *The Triumph of Mars* was found to be damaged, improperly restored, and its intricate design clogged with paint, the first step was to replace a missing wheel on the chariot. Because molds depicting classical themes are part of many professional studio collections, it was possible to fabricate a new wheel from the rubber mold shown here. Photo: William Adair.

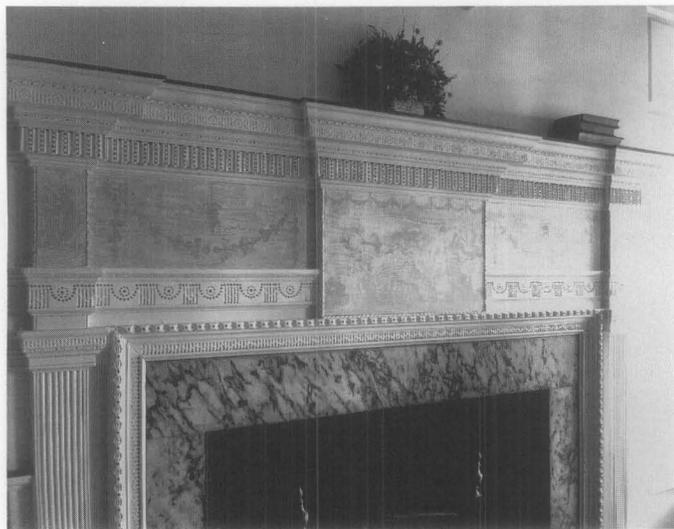
Figure 29. The ghost marks of compo past—floral swags or festoons—are in clear evidence on a mantelpiece in the back bedroom of the George Read II House, New Castle, Delaware. This physical evidence will be used to assure their accurate re-creation in a restoration project. Photo: Courtesy, Gold Leaf Studios, Inc.

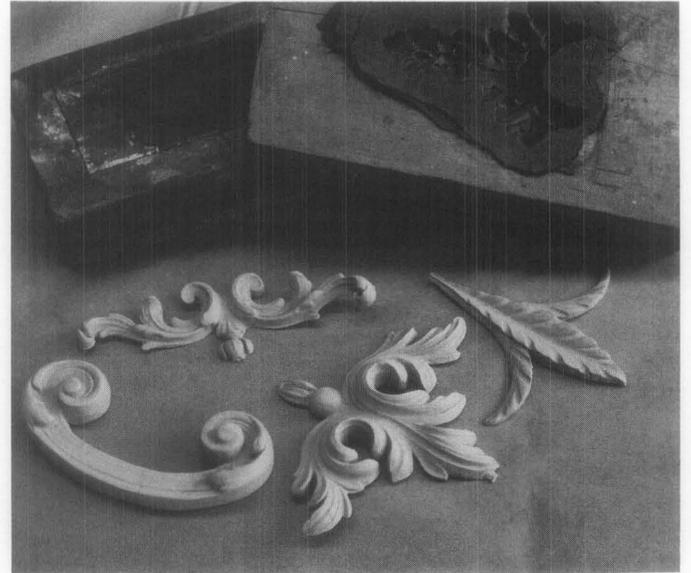
a.

Figure 30. Based on documentary and physical evidence, missing composition ornament was accurately re-created for the Miles-Brewton House, Charleston, South Carolina. First (a) the conservator used molds to fabricate ornament in small pieces and lengths; and (b) the new ornament was attached to thin birch plywood backing with glue and brads to create larger sections. These sections were then fastened to the original paneling with stainless steel screws. Photos: Jonathan Thornton

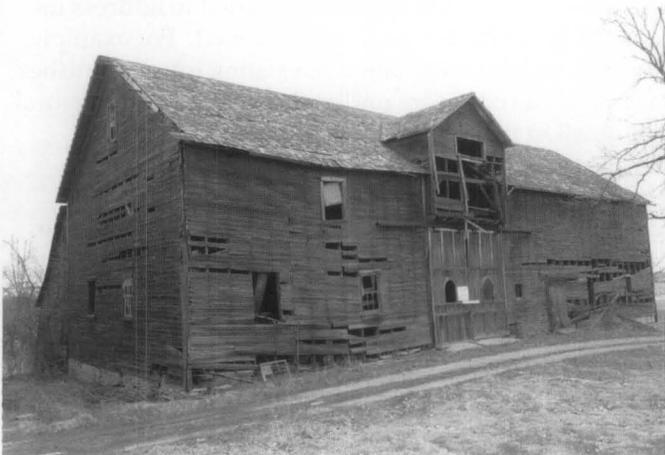
Figure 4. For small or simple projects, the project team may include only one or two specialists while complex projects may involve a large number of investigators and specialists. For example, evaluation of this barn may primarily involve a historian, an architectural conservator, and a structural engineer. Photo: Wiss, Janney, Elstner Associates, Inc.

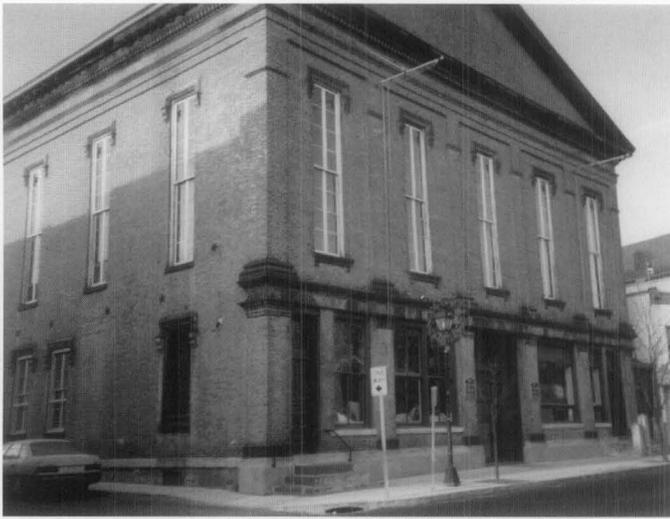
Figure 5. At the Hudson Opera House, a multi-arts center in Hudson, New York, the historic structure report was prepared incrementally. The first phase of the report focused on assessment and recommendations for repair of the roofing, the most critical issue in preservation of the building. Photo: Gary Schiro.

Incremental preparation. If budgetary constraints preclude completing the historic structure report as one project, it can be prepared incrementally (Fig. 5). The work recommendations should not be developed or implemented prior to completion of research and investigation, except for emergency stabilization to prevent immediate failure or damage, or temporary measures to address critical health and safety issues. A partial historic structure report can be completed in preparation for anticipated work that must be initiated to preserve or protect the building. This type of report includes analysis of only those building elements and systems that may be affected by the proposed work, and involves only the specialists needed to address the types of investigation and work planned. For example, research and documentation of existing interior finishes may be required before undertaking localized structural stabilization that will require removal of interior materials.

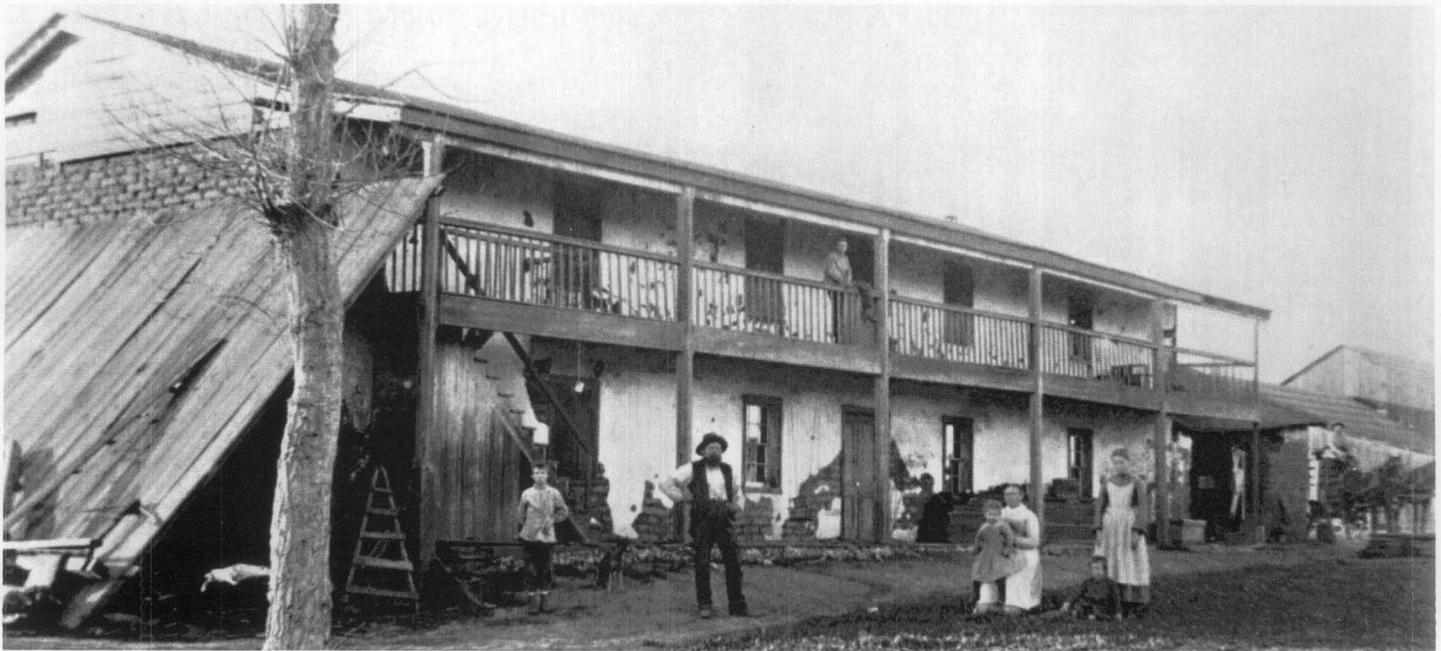
Figure 6. Historical photographs are an invaluable aid and time saver in establishing a building's original construction and evolution; in guiding the replication of missing features; and even in understanding existing material deterioration. The availability of information, such as archival photographs, surviving original architectural drawings, or HABS documentation, has a direct bearing on the cost of preparing a historic structure report. In this circa 1890 photo of the Rancho San Andrés Castro Adobe, the "lumbering up" on the south end is a character-defining feature of adobe construction, rarely seen today. Photo: Historic photograph from the Historic Structure Report for Rancho San Andrés Adobe by Edna Kimbro, State Historian, California State Parks, Monterey District.

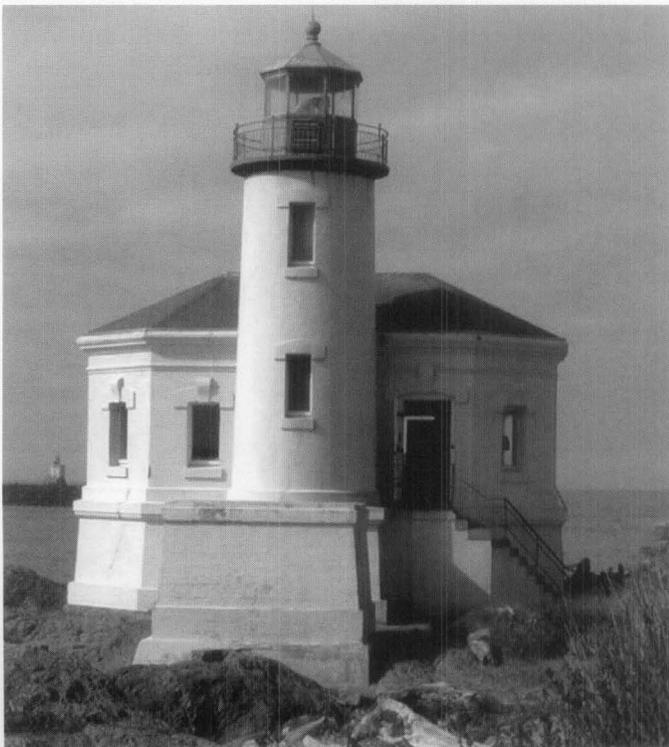
Figure 7. Numerous factors influence the cost of preparing a historic structure report including the level of significance, size, and complexity of the property; required treatment and use; existing condition; and the location and access to the structure. Historic structure reports were prepared for several small lighthouses along the Oregon coast, including the Coquille River Lighthouse, shown here. Photo: Wiss, Janney, Elstner Associates, Inc.

4. The *location of and access to a historic building* is a cost factor for some studies. A property in a remote mountain location can involve high travel costs relative to properties in or near an urban area. A structure requiring special techniques for exterior physical inspection would involve higher access costs than a small residential structure (Fig. 7).

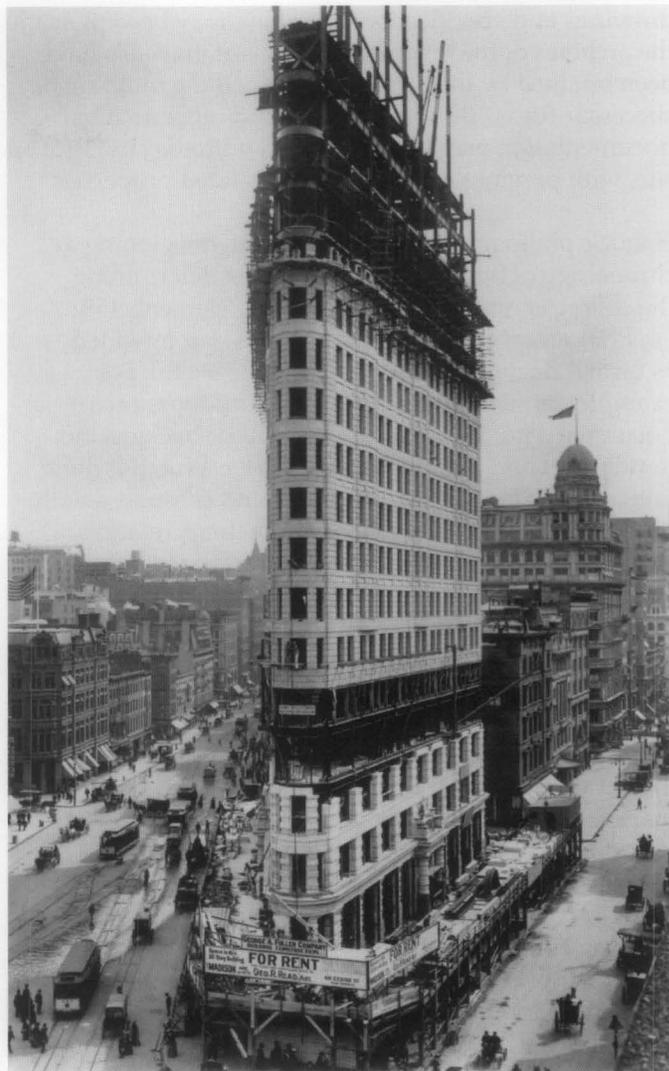
Figure 8. Historical research is directed toward gathering information on a structure’s history, original construction and later modifications, occupancies, and uses over time. Research may range from national repositories such as the Library of Congress to local collections or private family records. Old newspapers, architectural journals, and even manufacturing trade catalogs can be surprising sources of historical accounts and illustrations. This circa 1902 photograph of New York’s Flatiron Building is of the construction in progress; such photographs are useful in understanding building chronology as well as concealed conditions of as-built construction such as building framing. Photo: Library of Congress, LC-D401-14278. The interior photograph of the former Bemir Drug Store in Rochester, New York, showcases a rubber tile floor as illustrated in a 1925 publication by the United States Rubber Company.

Historical research. Archival research should be directed toward gathering information on the building’s history, original construction and later modifications, occupancies, and uses over time (Fig. 8). Research for the report is not intended to produce a large compendium of historical and genealogical material, but rather selected information necessary to understand the evolution of the structure, its significance, and justification for the treatment selected. For significant sites where other types of studies such as archeological investigations or a cultural landscape report have been completed or are underway, coordination is required to ensure that research information is shared and that the research effort is not duplicated.

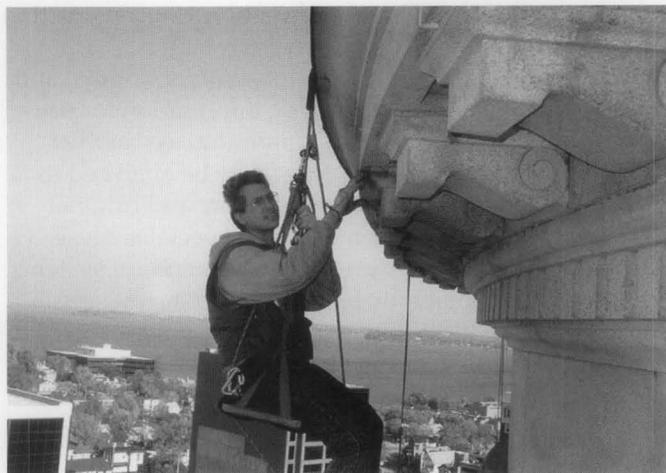
Figure 11. The use of special access methods may be necessary for close-up investigation of building elements. At the Wisconsin State Capitol, project architects and engineers used rappelling techniques. Photo: Wiss, Janney, Elstner Associates, Inc.

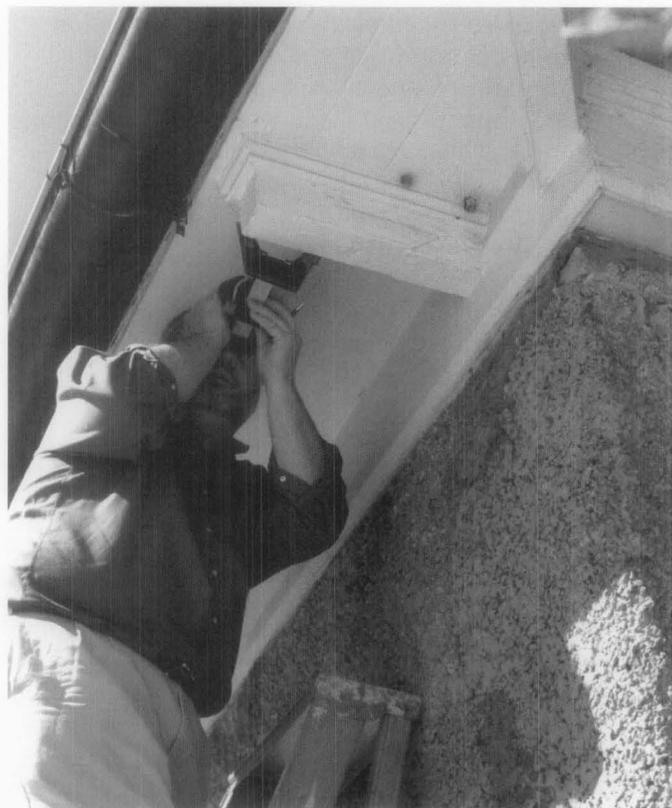
Figure 13. Paint studies may not only help establish the chronology of paints and paint colors used on a building but also may aid in the dating of existing architectural features. Examination of the paint layers on these modillions utilizing a hand-held microscope enabled an investigating team to confirm in the field which modillions were original and which were later replacements. Photo: Charles Fisher, National Park Service.

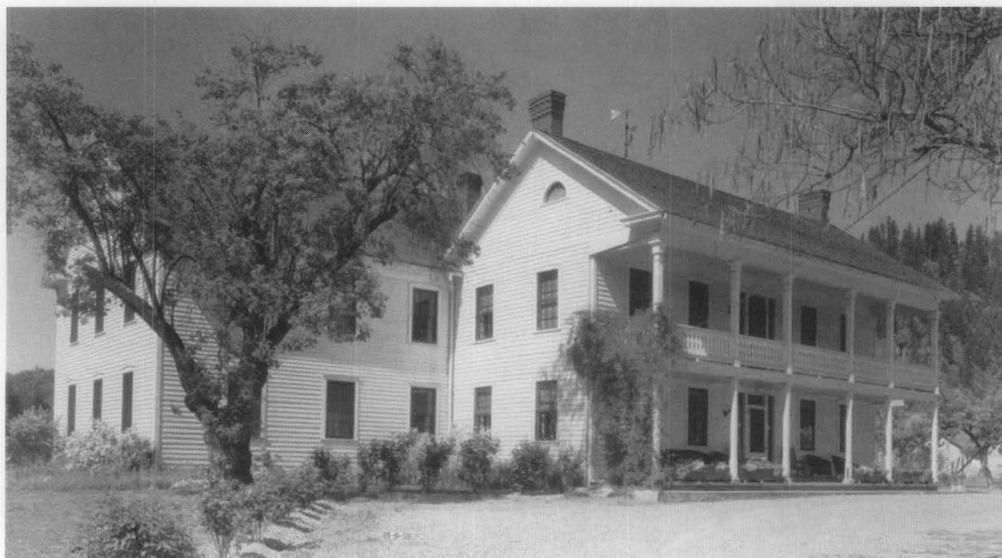
Figure 14. The treatment approach selected for a building usually is determined by the intended use of a property, funding prospects, and the findings of an investigation. The Wolf Creek Inn, operated by the Oregon Parks and Recreation Department, is among the most intact and oldest active travelers' inns in Oregon. The historic structure report outlined a rehabilitation treatment which included such work recommendations as repairs to specific historic fabric, landscape restoration and site improvements, and upgrading of the building's mechanical and electrical systems. Photo: Historic American Building Survey, 1934.

Selection of a treatment approach. Once the building's history, significance, and physical condition have been researched and investigated, an appropriate treatment is usually selected (Fig. 14). Depending upon the intended use of a property, funding prospects, and the findings of the investigation, it may be necessary in some cases to identify and discuss an alternate treatment as well. For example, a building currently occupied by caretakers that is a candidate for restoration and use as a museum may require such ambitious funding support that, for the foreseeable future, a more practical treatment could be to preserve the building and retain the caretakers. In this case, the treatment recommendation would be to restore the property and project work relevant to the

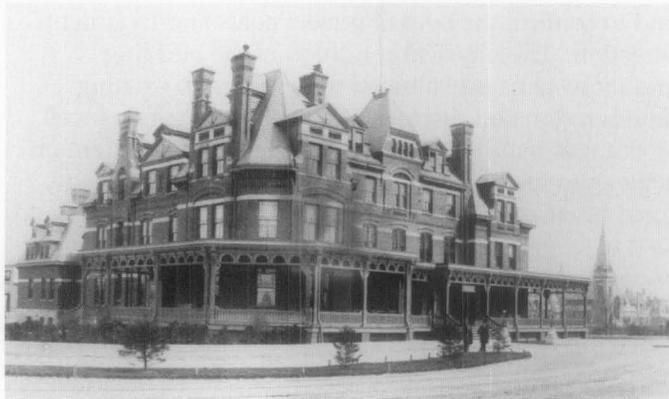
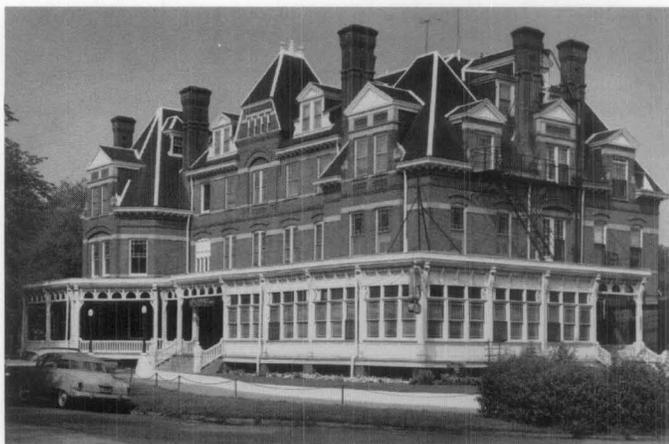
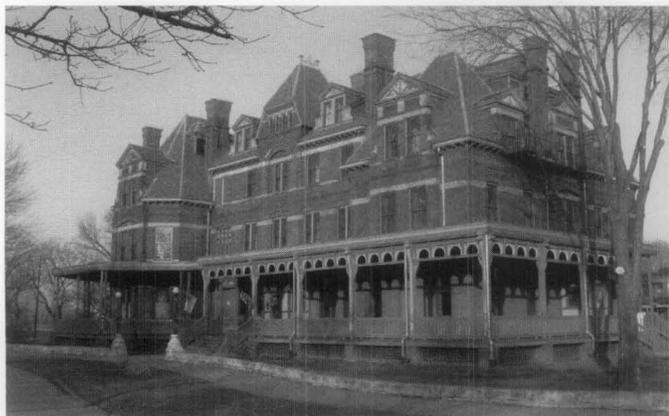
Figure 15. The historic structure report for the Hotel Florence, shown here in 1886 (upper), 1963 (center), and 2004 (lower) views, provided a basis for stabilization and repair work which has been completed. Initial phases of work addressed preservation of the building envelope, structural repairs, and limited mechanical and electrical improvements. The report also provided recommendations for future rehabilitation work that will be implemented in phases as funding becomes available. Photos: upper and center, Historic American Building Survey; lower, Wiss, Janney, Elstner Associates, Inc.

Of course, the available project budget is also a factor in determining the extent of recommended work and whether it must be accomplished in several phases or projects. Whether or not available budget is the primary factor in determining the extent of work that can be performed, it is often useful to prioritize recommended work items. The recommended tasks can be examined in terms of relative importance and the time required for implementation. Prioritizing repairs can be critical where immediate or short-term work is needed to stabilize a building or structure, eliminate safety hazards, make the building weather tight, and protect it against further deterioration (Fig. 15).

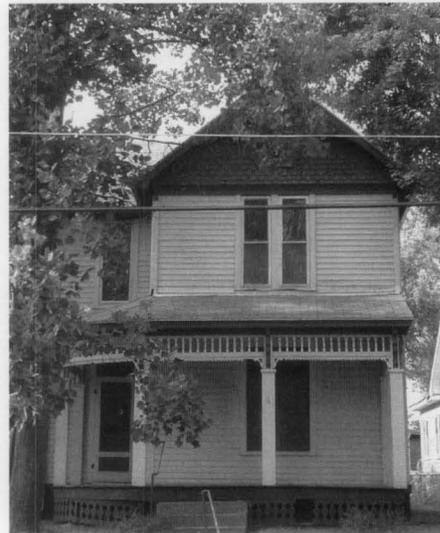
Figure 16. The historic structure report for the Noland House in Independence, Missouri, a vernacular house that is significant as part of the context of Harry S Truman's life and family in Independence, Missouri, includes photographs and measured drawings to record existing features and conditions of the building. The measured drawings will also provide a basis for construction documents for future preservation work. This photograph and drawing illustrate the front elevation of the house. Photo and drawing: Bahr Vermeer Haecker Architects.

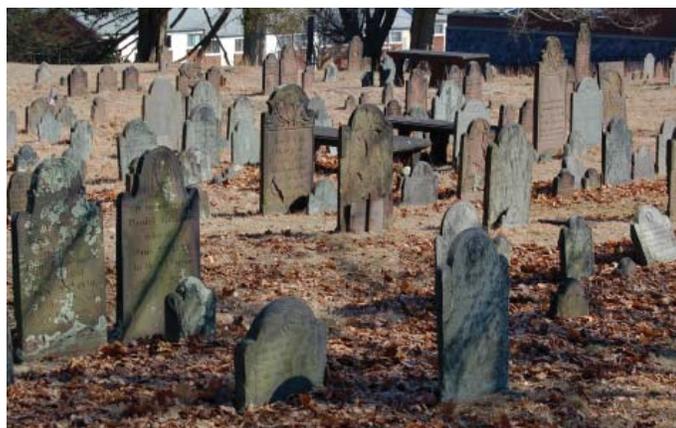
Figure 1. Sandstone and slate grave markers in the Ancient Burying Ground in New London, CT, display a variety of weathering conditions. Markers in the cemetery date from the mid-17th to the early 19th centuries. Photo: Jason Church.

While cemeteries are often considered to be perpetual, their most prominent feature—the grave markers—are not. They weather, naturally decay, often are poorly maintained and repaired and, on occasion, are vandalized (Fig. 1). Grave markers are usually noteworthy not only for their inscriptions but also for their craftsmanship. Exceptional markers are considered works of art.

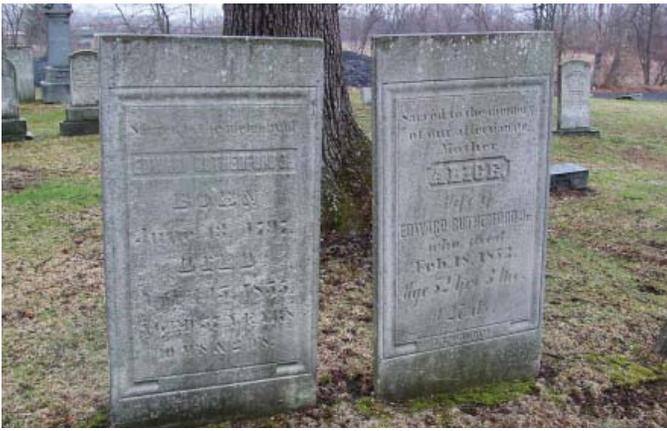
Figure 2. These mid-19th century, single-element stone grave markers in the Grove Cemetery in Bath, NY, are set in a vertical position. Photo: Jason Church.

The great variety in the types of grave markers is a fascinating aspect of the study and appreciation of historic cemeteries. Three broad categories can be used to describe grave markers—(1) single-element, (2) multiple-element, and (3) structures. Single-element grave markers are stone, cast iron, or wood elements that are set in a vertical position or placed as a horizontal slab on the ground (Fig. 2). Early examples of this simplest type of grave markers are field stone and basic wooden or wrought iron crosses, with the name of the deceased person scratched into or engraved on the marker. Often, these rudimentary grave markers are overlooked, significantly deteriorated, or lost. Vertical stone slabs and large stone ledgers laid horizontally over the gravesite are more sophisticated examples of this type.

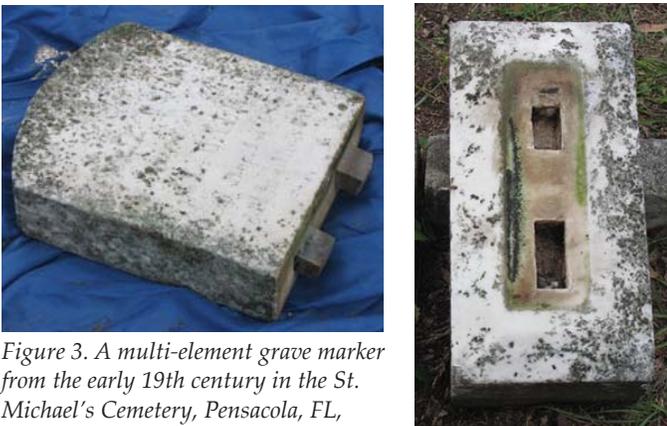
Figure 3. A multi-element grave marker from the early 19th century in the St. Michael's Cemetery, Pensacola, FL, consists of a vertical element with tabs (left image) into a slotted base (right image). Photo: Fran Gale.

Multiple-element grave markers are found in a number of different forms (Fig. 3). In the most typical form, a grave marker would consist of two stones—an upper headstone placed on top of a base stone. The upper headstone may be secured in a number of different ways to the base. In the simplest of forms, the upper stone was placed on the base, set in a bed of mortar on top of the base, or joined with pins and mortar. With a “tab-and-

slot" grave marker, the tabbed upper stone was set in a slotted base. More common today, the upper headstone is secured with a technique that uses small spacers set on the base and a setting compound. This technique or one that uses an epoxy adhesive may be found on older markers where the stones have been reset.

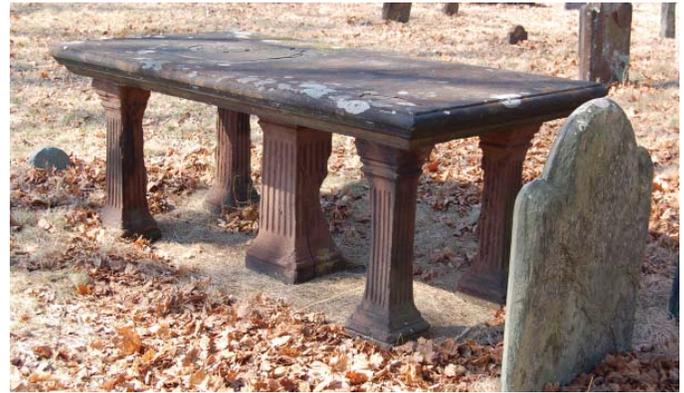
Figure 4. This sandstone table tomb, located in Cedar Grove Cemetery, New London, CT, is an engineered grave marker structure consisting of a horizontal stone tablet supported by four vertical table "legs" with and a central column,. Photo: Jason Church.

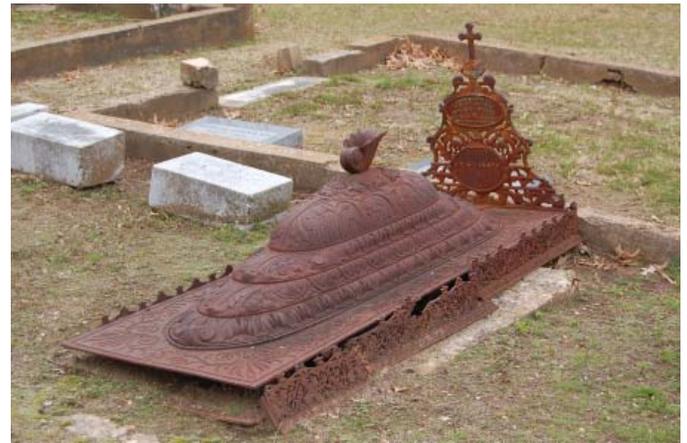
Figure 6. Decorative cast-iron grave markers like this late-19th century one in Oakland Cemetery in Shreveport, LA, are produced by heating the iron alloy and casting the liquid metal into a mold. Photo: Jason Church.

Metals are solid materials that are typically hard, malleable, fusible, ductile, and often shiny when new (Fig. 6). A metal alloy is a mixture or solid solution of two or more metals. Metals are easily worked and can be melted or fused, hammered into thin sheets, or drawn into wires. Different metals have varying physical

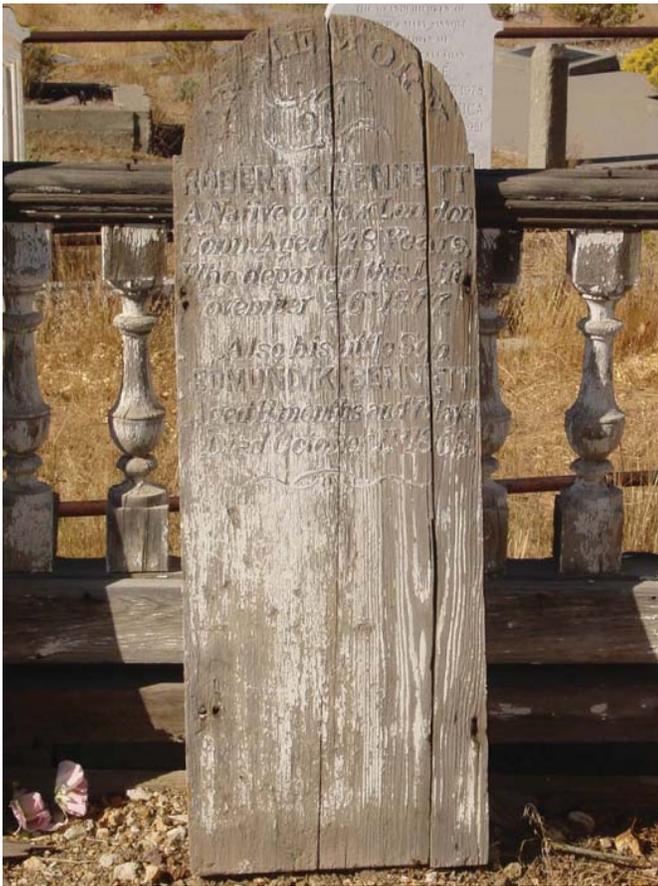
Figure 7. As shown by this 1877 marker in Silver Terrace Cemetery, Virginia City, NV, exposure to sunlight can damage wood grave markers, making the wood more susceptible to water damage and cracking. Photo: Jason Church.

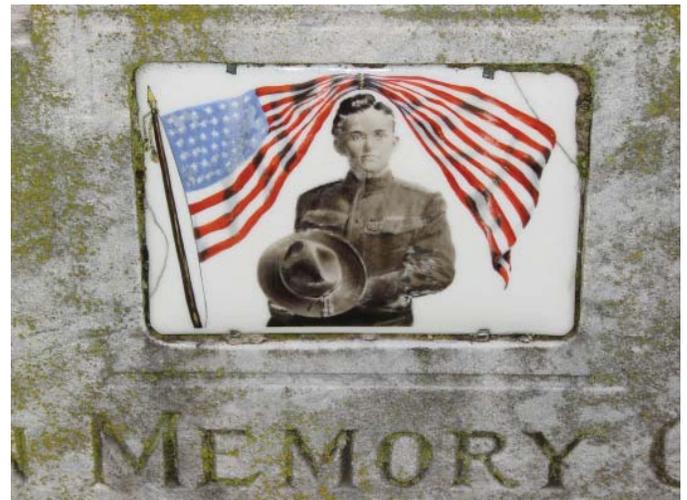
Figure 8. A fired ceramic, this cameo is set in a marble grave marker, located in Elmwood Cemetery, Memphis, TN. Different materials may require different conservation approaches. Photo: Mary Striegel.

Old cemeteries often include a wide variety of other materials not normally associated with contemporary grave markers, such as ceramics, stained glass, shells, and plastics (Fig. 8). As with masonry, metals, and wood, each has its own chemical and physical properties which affect durability and weathering. These materials

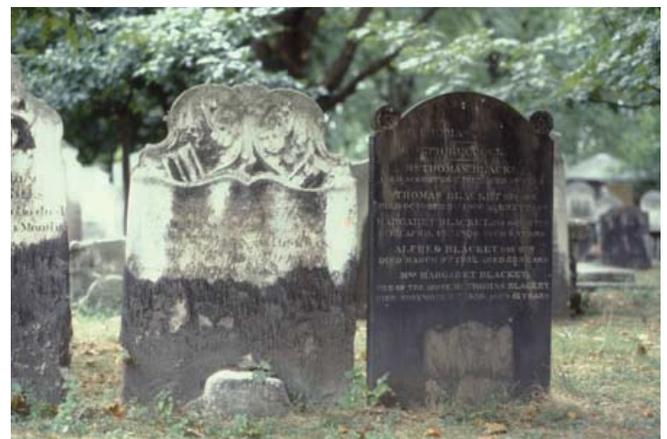
Figure 9. The limestone and sandstone grave markers in this historic cemetery have different weathering processes. On the left, the limestone shows surface loss in areas exposed to rainwater and gypsum crust formation below. The sandstone marker on the right displays uniform soiling, but surface hardening may be occurring. Photo: Fran Gale.

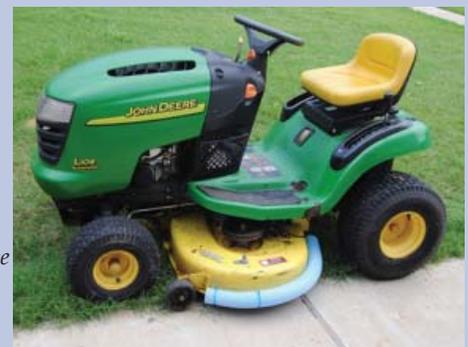
Figure B. A pool ‘noodle’ can be fitted to the deck of a lawnmower to prevent damage to grave markers. Photo: Debbie Dietrich Smith.

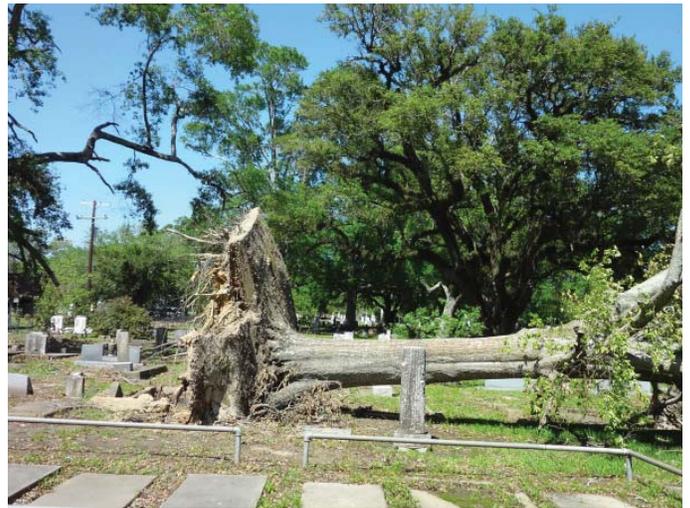
Figure 11. Woody vegetation can damage grave markers and pose a risk to visitors unless well managed and maintained. Photo: Jason Church.

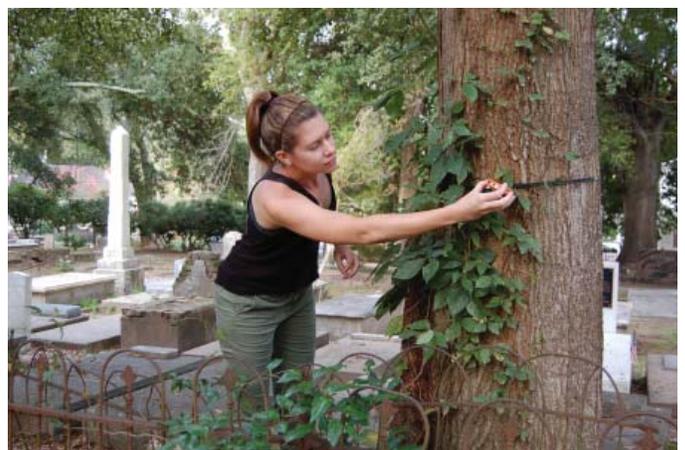
Figure 12. A cemetery professional undertakes a tree inventory in American Cemetery, Natchitoches, LA, to determine the health of trees in the cemetery. Management decisions for trimming or removal are based on the inventory. Photo: Debbie Dietrich Smith.

Woody vegetation can damage grave markers in a variety of ways (Fig. 11). Trees, bushes, and vines can shade grave markers, extending the time that the markers are exposed to moisture. Tendrils and roots may burrow into mortar joints and openings, causing mechanical damage and large plants may lift up or shift markers. Even leaves and twigs, when allowed to collect on the ground near grave markers, can affect water drainage and evaporation (Fig. 12).

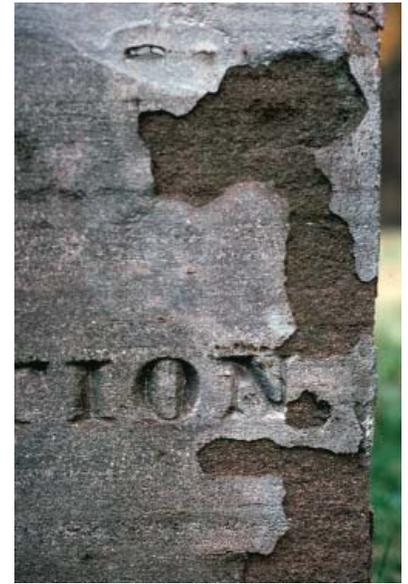
Figure 13. The impervious coating used to "protect" this sandstone grave marker trapped moisture within the stone, eventually resulting in deterioration and surface loss. Photo: Fran Gale.

Repointing masonry grave markers using Portland cement mortars that are harder than historic mortars often results in accelerated deterioration of the masonry material. Mortar should be softer than the adjacent masonry, enabling trapped moisture to migrate out, and serve as the sacrificial material when cracking occurs to relieve excessive stress. Problems also result when using impervious "protective" coatings that can trap moisture within the masonry, resulting in damage during wet/dry and freeze/thaw cycles (Fig. 13).

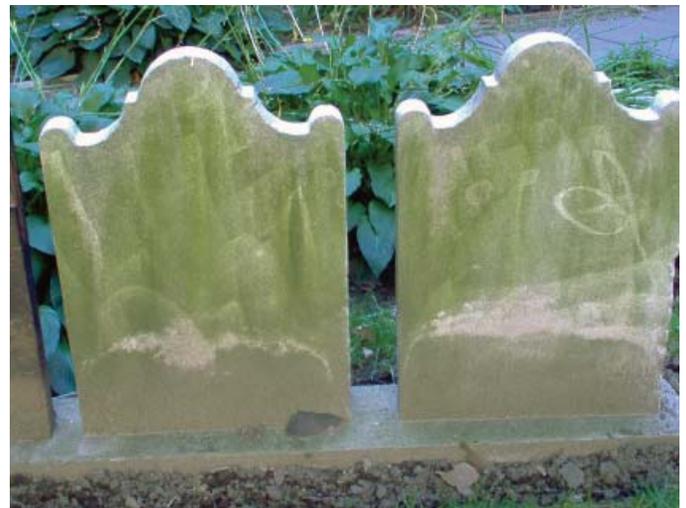
Figure 14. High-pressure water washing can damage grave markers. The photograph shows "wand marks" on the headstones produced by inappropriate pressure washing. Photo: Jason Church.

Harsh cleaning products and techniques can have a detrimental effect on grave markers. Acidic cleaners such as muriatic acid can dissolve minerals in many masonry materials and can attack metals. Alkaline cleaners, such as bleach, are notorious for leaving residual salts that are deposited on the surface (a process called efflorescence). Both acidic and alkaline cleaning can result in staining, especially if rinsing is inadequate. Using high-pressure water, above 500 to 1,000 psi, can needlessly damage masonry materials as well, increasing their vulnerability to weathering (Fig. 14). If the marker is fragile, even low pressure water can be damaging. Techniques to avoid include aggregate blasting with sand or other harsh media and the use of power tools with abrasive wire or Nylox™ brushes.

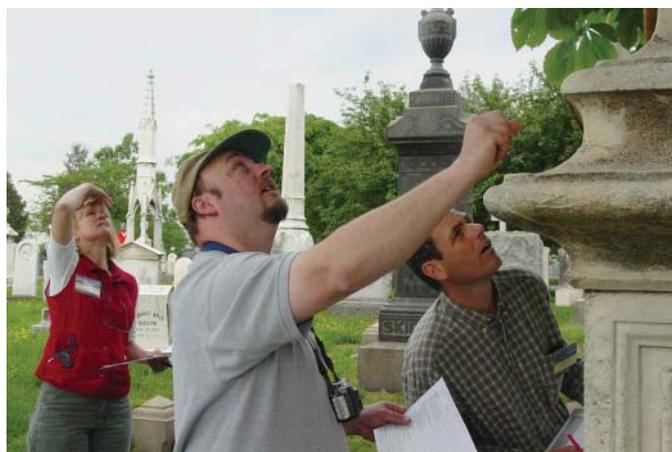
Figure 15a. Condition surveys are undertaken to document current conditions, determine safety issues, and plan both emergency stabilization and future treatment plans. There are a variety of survey forms available that can be tailored to the specific cemetery. Photo: Mary Striegel.

Depending upon the size of the cemetery and funding available, the initial assessment may be carried out by a team consisting of cemetery staff, a materials conservator, and, where necessary, an architect or structural engineer for cases involving large monuments and mausoleums (Figs. 15a and 15b). For smaller cemeteries without large monuments and mausoleums, and where funding is problematic, volunteers can be trained to prepare a condition assessment under the guidance of an experienced individual.
