Cleaning, Repair and Protection

Repair

Repairs to Glass

Repairs to Structural Support Systems

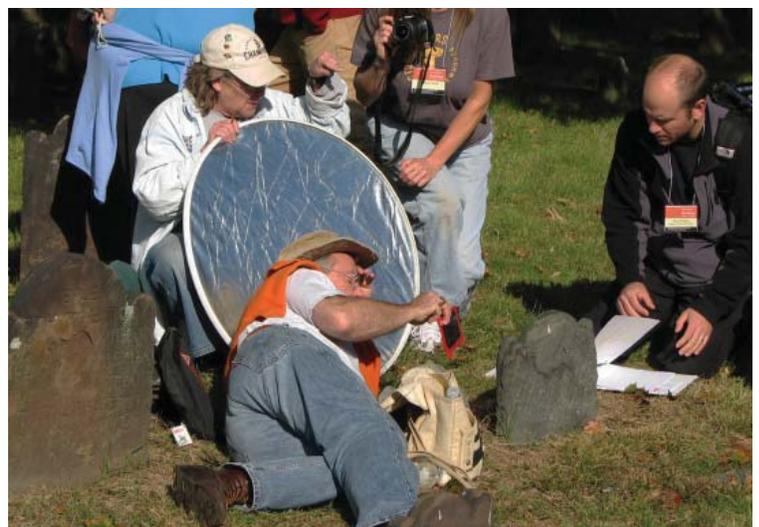
Figure 15b. Photographs are used to document the condition of the grave marker as part of a condition assessment. Photo: Fran Gale.

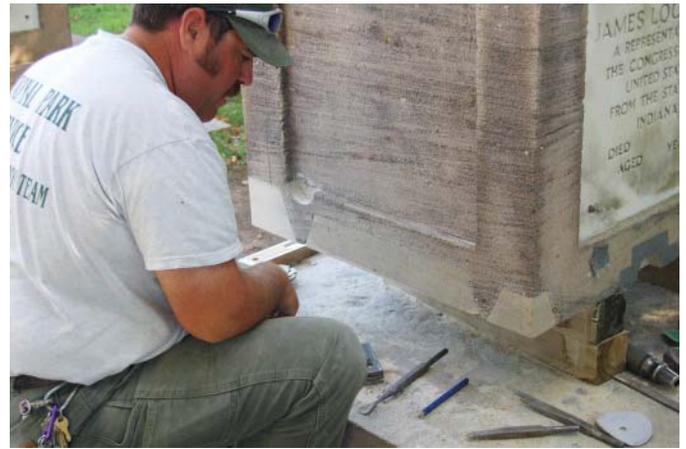
Figure 16. A professional mason works to insert a new piece of stone. Often referred to as a “dutchman”, this repair technique requires replacing the deteriorated stone section with a new finished piece of the same size and material. Photo: Jason Church.

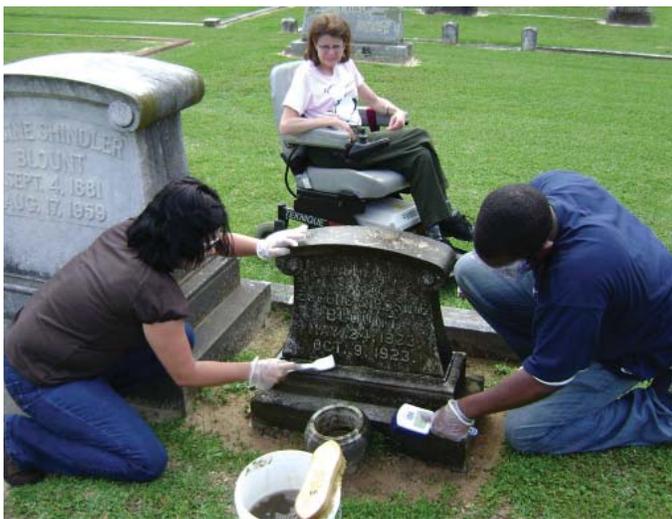
Figure 17. Volunteers can undertake cleaning of grave markers once they have received initial training. Cleaning methods may include wetting the stone, using a mild chemical cleaner, gently agitating the surface with a soft bristle brush, and thoroughly rinsing the marker with clean water. Photo: Jason Church.

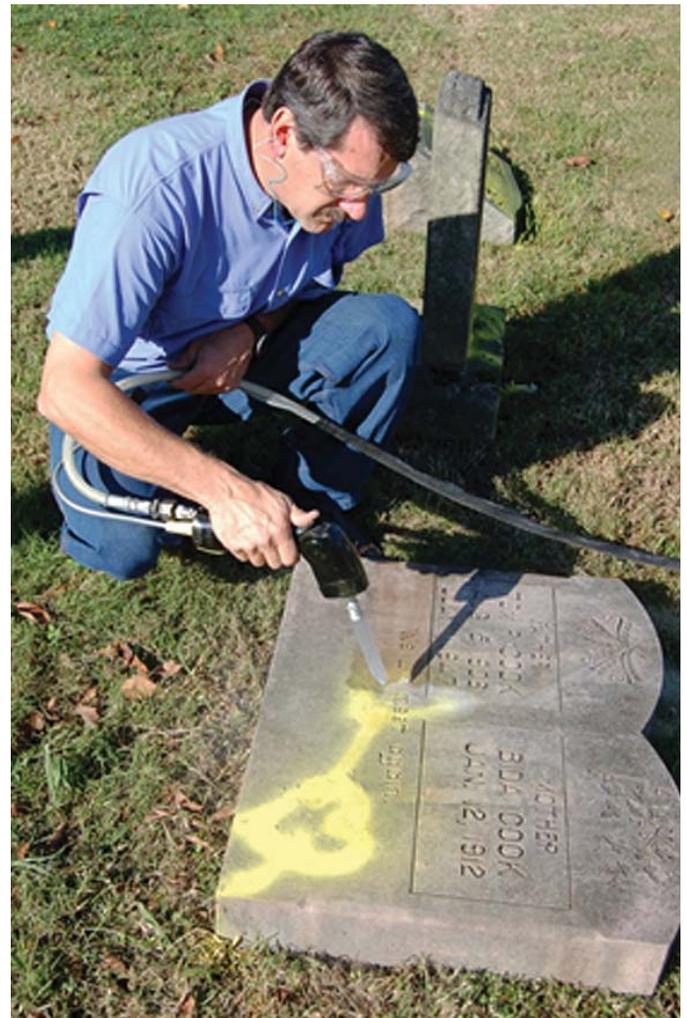
Figure 18. Graffiti is carefully removed using a low-pressure dry-ice misting instrument. Photo: Jason Church.

Markers with graffiti tend to be targets for further vandalism (Fig. 18). Timely removal helps deter future vandalism and improves the marker’s appearance.

If the graffiti is water soluble, it can be removed using water and a soft cloth or towel. Rinsing the cloth frequently helps to avoid smearing graffiti on unaffected areas. If the graffiti is not water soluble, organic solvents or commercial graffiti removal products suitable for the grave marker material are recommended. Products should be tested prior to use. General cleaning of the entire marker is a good follow-up for a more even appearance. For deep-seated graffiti, poultice cleaning (previously described) may be required to extract staining materials.

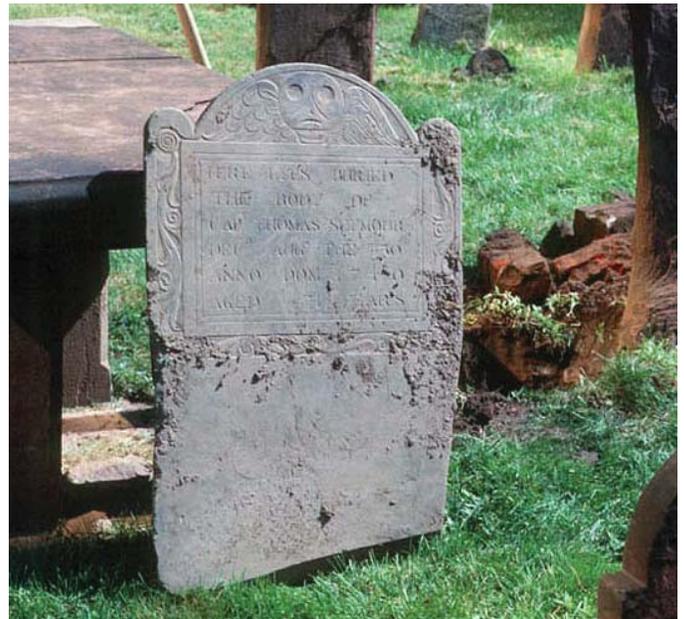
Figure 20a. This slate grave marker in the Ancient Burying Ground in Hartford, CT, is a ground-support stone. Resetting requires digging a hole that will hold the base of the stone and then compacting the soil at the bottom of the hole by hand. Photo: Fran Gale.

Resetting is recommended for grave markers when their foundations are unstable or out of plumb (Figs. 20a through 20c). This often complex activity involves lifting the grave marker, leveling its foundation, and returning the marker to its original upright position. Workers can be injured and the grave marker damaged if resetting is not carried out properly and safely.

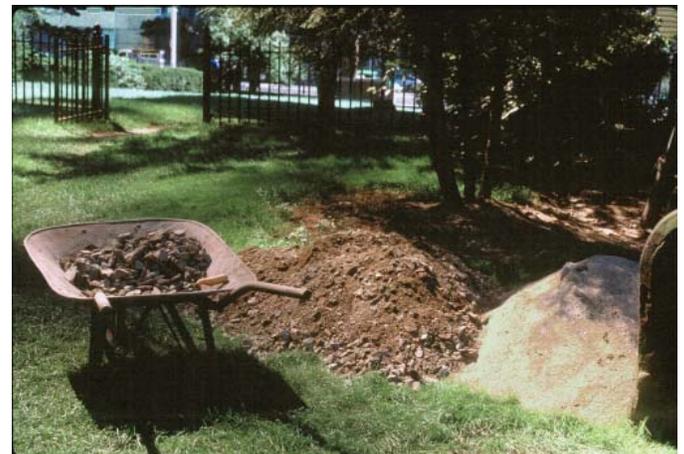
Figure 20b. To facilitate drainage, crushed stone, gravel, and sharp sand line the hole and are hand-tamped around the stone after placement. Photo: Fran Gale.

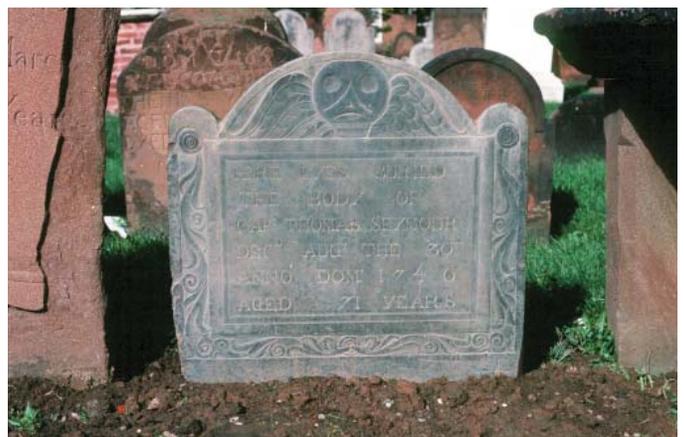
Figure 20c. The reset ground-supported grave marker should be level and plumb. Photo: Fran Gale.

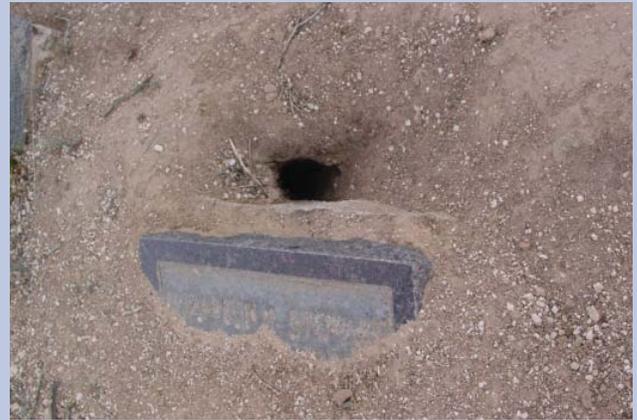
Figure C. Gophers and other burrowing animals produce uneven ground and holes that are trip and falling hazards to visitors and staff of historic cemeteries. Photo: Jason Church.

Trip and falling hazards include uneven ground, holes, open graves, toppled grave markers, fallen tree limbs, and other debris (Fig. C). Sitting, climbing, or standing on a grave marker should be avoided since the additional weight may cause

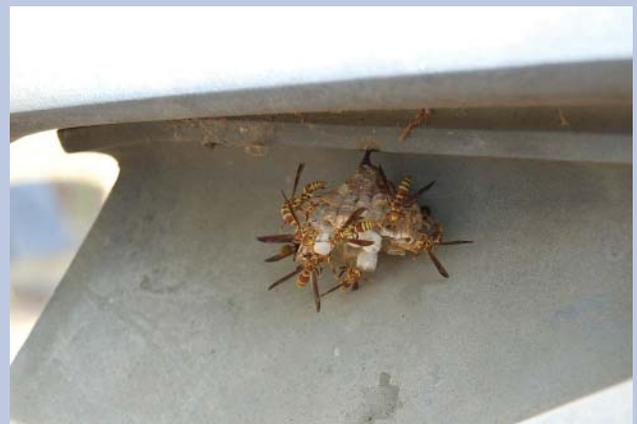
Figure D. Yellow jackets that are nesting below the projecting molding of this grave marker pose a hazard to visitors and staff because, if disturbed, they will vigorously defend their nest. Yellow jacket, paper wasp and hornet nests should be removed from grave markers by trained staff or specialists. Photo: Jason Church.

Snakes, wasps, and burrowing animals inhabit historic cemeteries (Fig. D). Snakes sun on warm stones and hide in holes and ledges, so it is important to be able to identify local venomous snakes. An appropriate venomous snake management plan should be in place, and

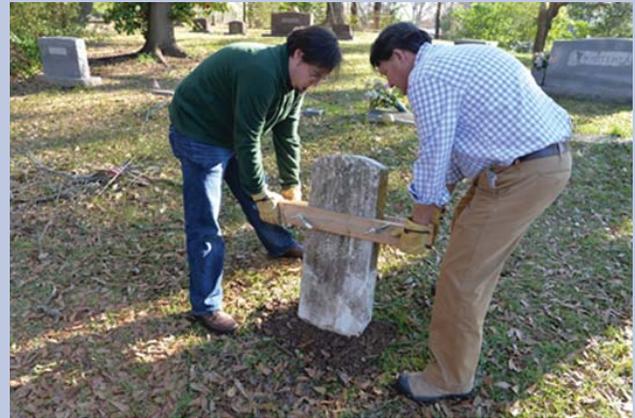
Figure E1. The simple wooden clamp system allows two people to safely lift a marble grave marker. Photo: Sarah Jackson.

lifting techniques. Lift equipment and ergonomically correct tools should be routinely used to lift heavy markers (for most people this includes markers that weight more than 50 pounds). For smaller grave markers, a simple wooden clamp system can be constructed for a two-person lift (Figs. E1 and E2).

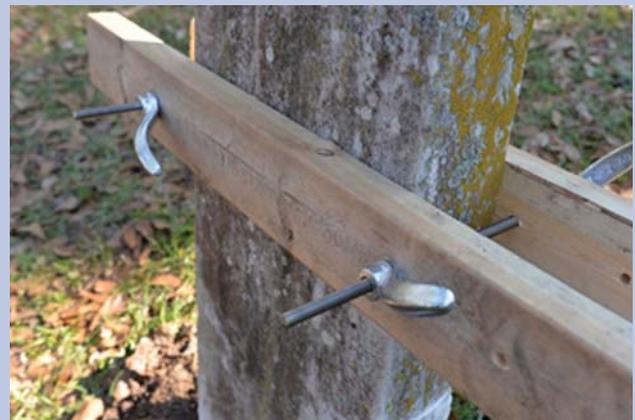
Figure E2. The clamp system is constructed from off-the-shelf wooden boards. Photo: Sarah Jackson.

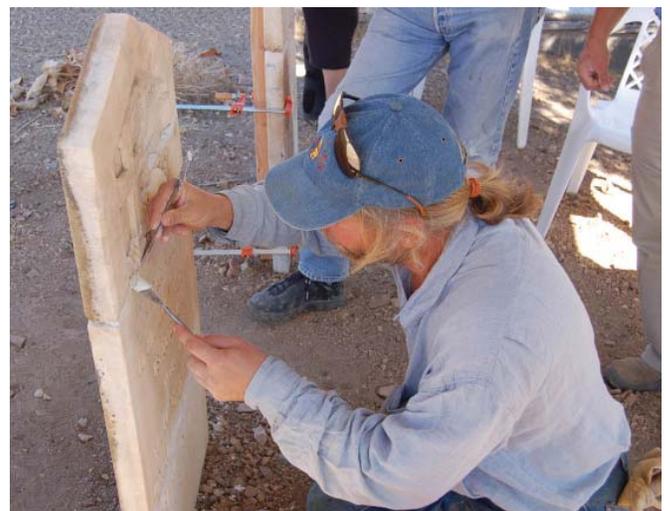
Figure 21. Cracks in a stone marker should be filled to keep water and debris out and prevent the crack from becoming larger. A patching mortar is designed to be used, in this case, with historic marble. Photo: Mary Striegel.

Hairline masonry cracks may be the result of natural weathering and require no immediate treatment except to be photographed and recorded. However, larger cracks often merit further attention. Repairing masonry cracks involves several steps and typically a skilled hand (Fig. 21). The repair begins with the removal of loose material and cleaning. Materials that are used for crack repair include grouts for small cracks and epoxy for large cracks affecting the structural integrity of the monument. Gravity or pressure injection is used to apply grout or epoxy. Crack repair can be messy, so careful planning and experience are helpful. If the crack is active, a change in size of the crack will be noted over time. Active cracks require further investigation to ascertain the cause of the changes, such as differential settlement, and to correct, if possible, the cause prior to repairing the crack.

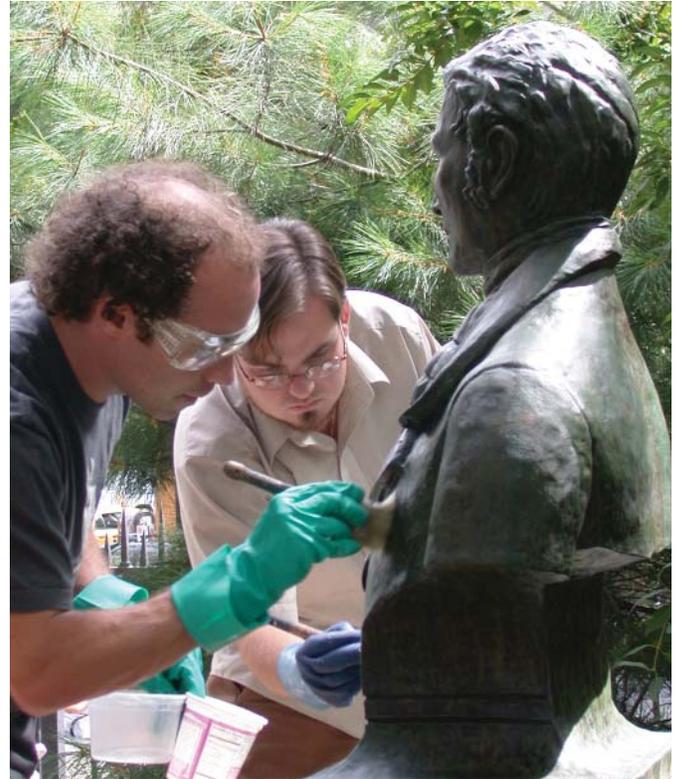
Figure 22. A protective coating must be maintained on metal elements. Wax or lacquer coatings help preserve the bronze patina and slow corrosion. Conservators apply a microcrystalline wax to this bust at St. Mark's Church in-the-Bowery, New York, NY. Photo: John Scott.

Wax coatings are often used for bronze markers (Fig. 22). Wax provides a protective barrier against moisture, soiling, and graffiti. There are several steps in the wax application process. Where there is little corrosion, gentle cleaning of the marker is undertaken prior to applying the wax coating. Apply a thin layer of wax to the marker using a stencil brush or chip brush. Mineral spirits can be added to the wax to facilitate

brush application. A soft, clean cloth is used to remove excess wax and buff the surface. A second coat of wax is sometimes needed.

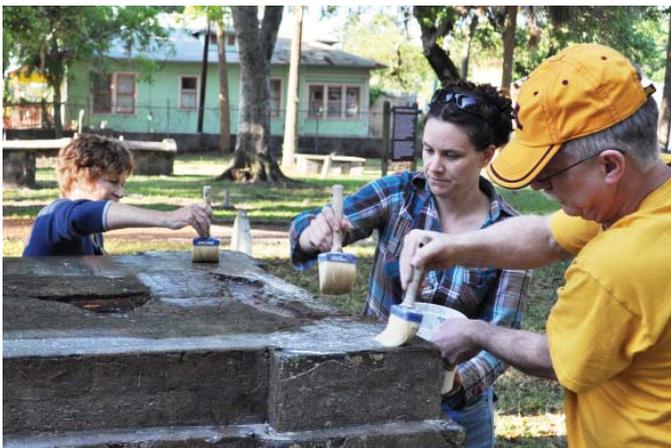
Figure 23. Limewash is a breathable coating sometimes used to protect the surface of the grave marker and provide a decorative finish. Limewash is applied by brush in five to eight thin coats (with each coat about the consistency of skim milk). The surface is allowed to slowly dry between coats. Sometimes the surface is covered by damp burlap to slow the drying process. Photo: Sarah Jackson.

Limewash is a traditional coating that brightens stucco-covered grave markers (Fig. 23). Like paint coatings, it needs to be periodically applied. Limewash is prepared with lime putty or hydrated lime and water. Curing begins following application. The lime putty or hydrated lime reacts with carbon dioxide in the air in a process called carbonation. This reaction eventually forms calcium carbonate, a stable hard coating. Limewash is a “green” coating with no volatile organic compound content and is “breathable,” i.e., it allows for water vapor transmission. Although commonly white, limewash can be colored or tinted with alkali-stable pigments such as iron oxide.

Before applying the limewash, the masonry surfaces should be inspected for coating residues that need to be removed and any required repair work undertaken. Stucco-covered surfaces should be repaired and allowed to fully cure before applying limewash. If the original color has been determined, the renewal coating can be formulated to match. In preparing the wash, enough water is added to lime putty or hydrated lime to produce slurry with the consistency of skim milk. A mixture of four parts water and one part lime usually works well. A Zahn or Ford cup can be found at a hardware store and used to measure the thickness of the limewash and ensure consistency with each batch. Although many traditional recipes include additives, a simple mixture of lime and water performs best. Using a power drill with a paddle attachment to stir the limewash will help ensure that the lime particles are fully suspended in the

Proper curing of limewash is critical to its durability. To prevent premature drying, the treated surface may need to be covered with damp burlap. Limewash must not be applied when frost or freeze conditions are predicted or in temperatures above 90° F. Ideally, limewash should be applied during spring or fall when temperatures are around 70° F, avoiding direct sunlight where possible.

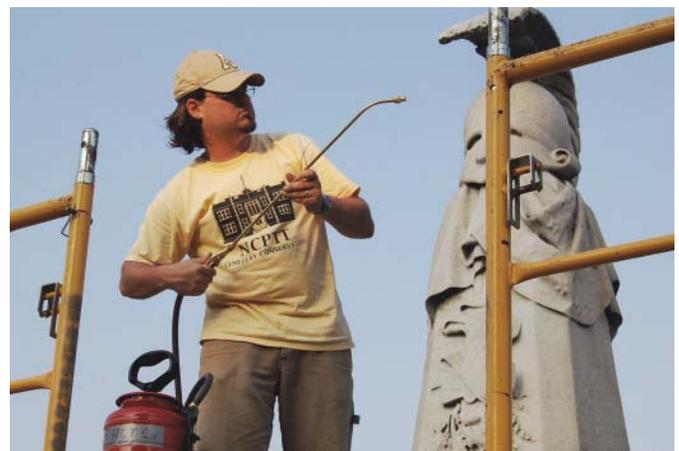
Figure 24. A severely deteriorating monument or grave marker can be treated with a stone consolidant. The treatment is usually applied using a spray system. The consolidant soaks into the stone and replaces mineral binders that hold the stone together. On-site and laboratory testing and evaluation are performed prior to using this non-reversible type of treatment. Photo: Lucas Flickinger.

When erosion is severe, consolidation treatments (e.g., ethyl silicate) have been used to replace mineral binders lost to weathering (Fig. 24). Because these treatments are not reversible, laboratory and on-site testing are essential. Application by a conservator or other experienced preservation professional is advised.
