17 PRESERVATION BRIEFS

The Maintenance and Repair of Architectural Cast Iron

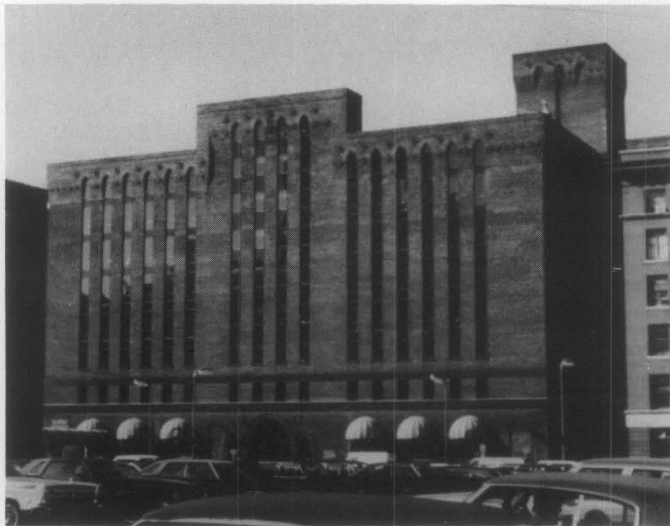
Overall Visual Character: Shape

The shape of a building can be an important aspect of its overall visual character. The building illustrated here, for example, has a distinctive horizontal box-like shape with the middle portion of the box projecting up an extra story. This building has other visual aspects that help define its overall character, including the pattern of vertical bands of windows, the decorative horizontal bands which separate the base of the building from the upper floors, the dark brown color of the brick, the large arched entranceway, and the castle-like tower behind the building.

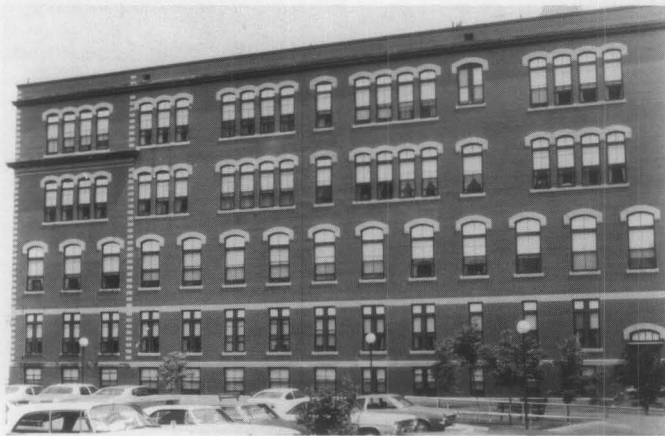
Overall Visual Character: Openings

Window and door openings can be important to the overall visual character of historic buildings. This view shows only part of a much larger building, but the windows clearly help define its character, partly because of their shape and rhythm: the upper floor windows are grouped in a 4,3,4,1,4 rhythm, and the lower floor windows are arranged in a regular 1,1,1,... rhythm. The individual windows are tall, narrow and arched, and they are accented by the different colored arched heads, which are connected where there are multiple windows so that the color contrast is a part of its character. If additional windows were inserted in the gap of the upper floors, the character would be much changed, as it would if the window heads were painted to match the color of the brick walls. Photo by Susan I. Dynes

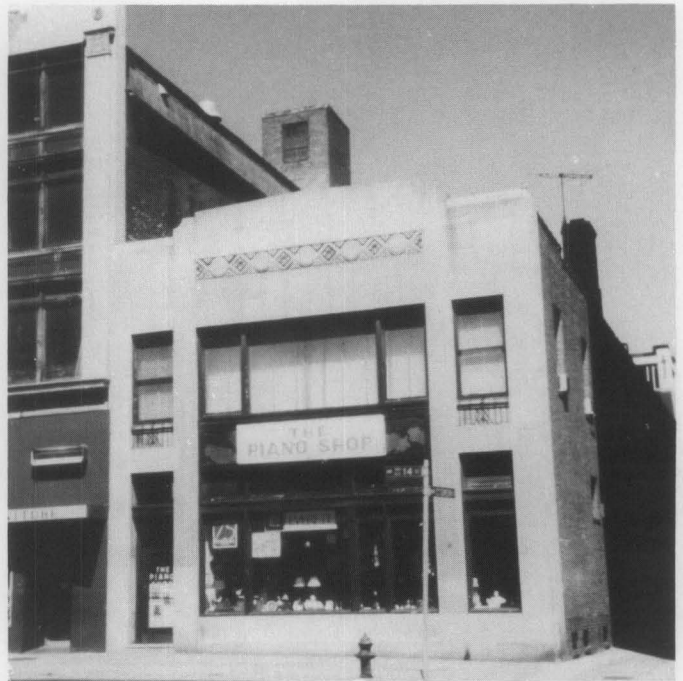
Overall Visual Character: Shape

It should not be assumed that only large or unusual buildings have a shape that is distinctive or identifiable. The front wall of this modest commercial building has a simple three-part shape that is the controlling aspect of its overall visual character. It consists of a large center bay with a two story opening that combines the storefront and the windows above. The upward projecting parapet and the decorative stonework also relate to and emphasize its shape. The flanking narrow bays enframe the side windows and the small iron balconies, and the main entrance doorway into the store. Any changes to the center portion of this three-part shape, could drastically affect the visual character of this building. Photo by Emogene A. Bevirt

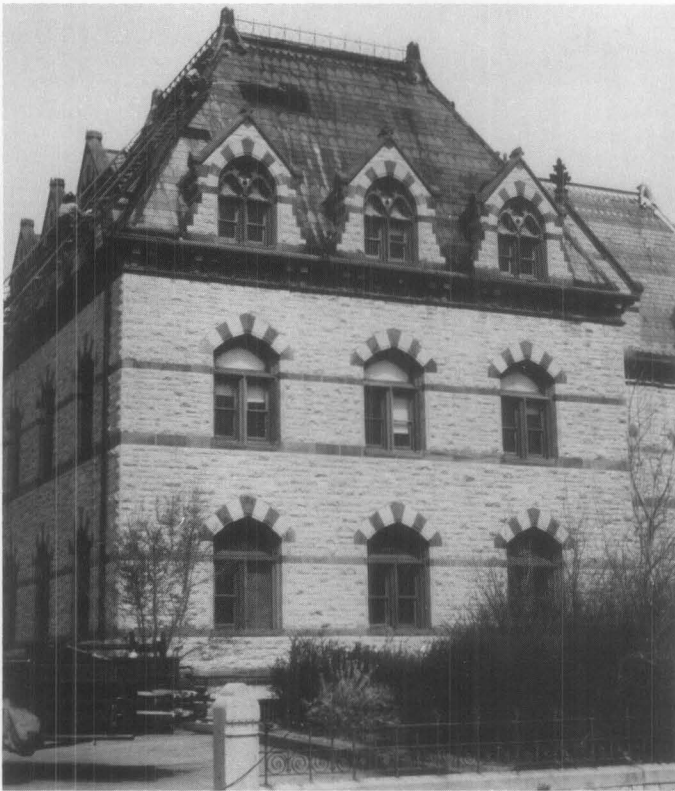
The opening illustrated here dominates the visual character of this building because of its size, shape, location, materials, and craftsmanship. Because of its relation to the generous staircase, this opening places a strong emphasis on the principal entry to the building. Enclosing this arcade-like entry with glass, for example, would materially and visually change the character of the building. Photo by Lee H. Nelson.

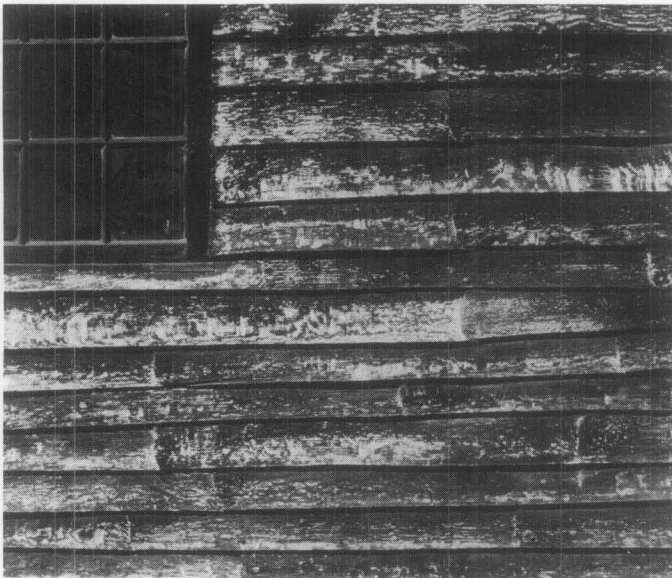
Arm's Length Visual Character: Craft Details

On some buildings, there are subtle aspects of visual character that cannot be perceived from a distance. This is especially true of certain craft details that can be seen only at close range. On this building, it is easily understood that the narrow, unpainted, and weathered clapboards are an important aspect of its overall visual character; but at close range there are a number of subtle but very important craft details that contribute to the handmade quality of this building, and which clearly differentiate it from a building with machine sawn clapboards. The clapboards seen here were split by hand and the bottom edges were not dressed, so that the boards vary in width and thickness, and thus they give a very uneven shadow pattern. Because they were split from oak that is unpainted, there are occasional wavy rays in the wood that stand against the grain. Also noticeable is the fact that the boards are of relatively short lengths, and that they have feather-edged ends that overlap each other, a detail that is very different from butted joints. The occasional large nail heads and the differential silver-gray weathering add to the random quality of the clapboards. All of these qualities contribute to the arm's length visual character. Photo by Lee H. Nelson

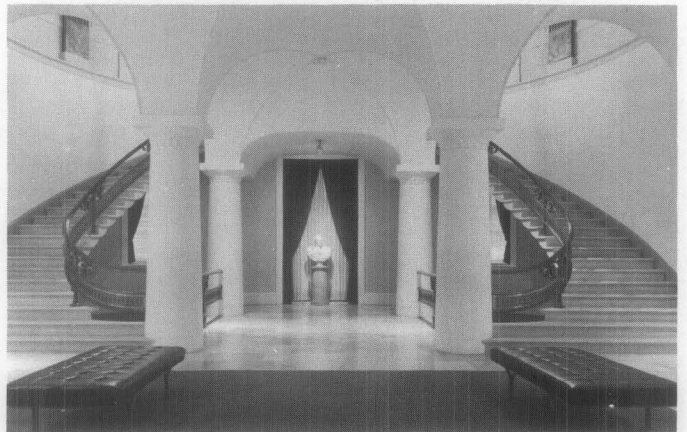
Interior Visual Character: Individually Important Spaces

The character of the individually important space which is illustrated here is a combination of its size, the twin curving staircases, the massive columns and curving vaulted ceilings, in addition to the quality of the materials in the floor and in the stairs. If the ceiling were to be lowered to provide space for heating ducts, or if the stairways were to be enclosed for code reasons, the shape and character of this space would be damaged, even if there was no permanent physical damage. Such changes can easily destroy the visual character of an individually important interior space. Thus, it is important that the visual aspects of a building's interior character be recognized before planning any changes or alterations. Photo by National Portrait Gallery

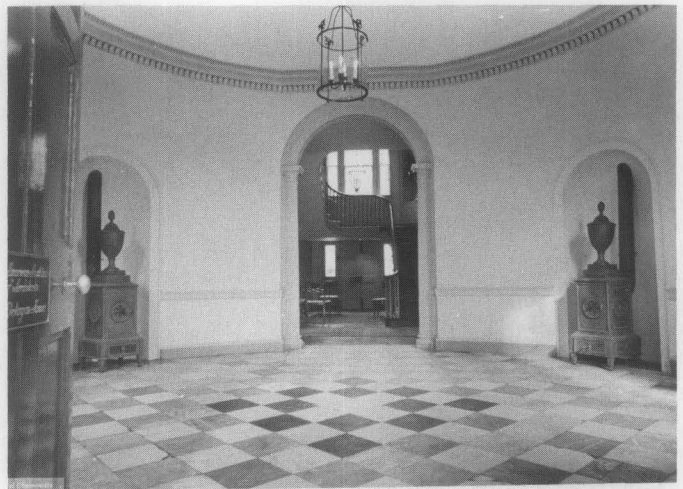
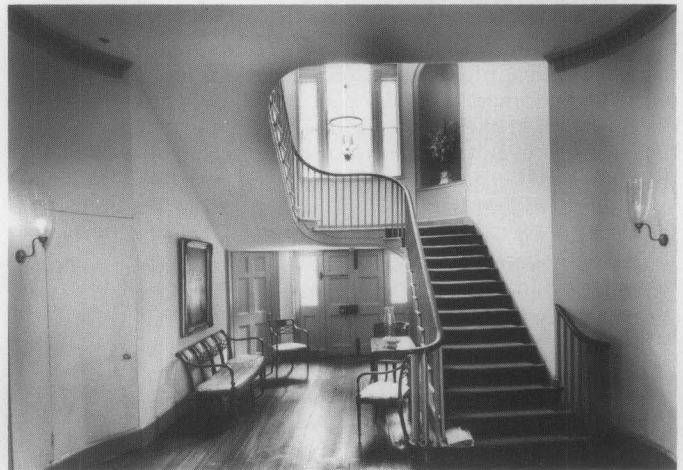
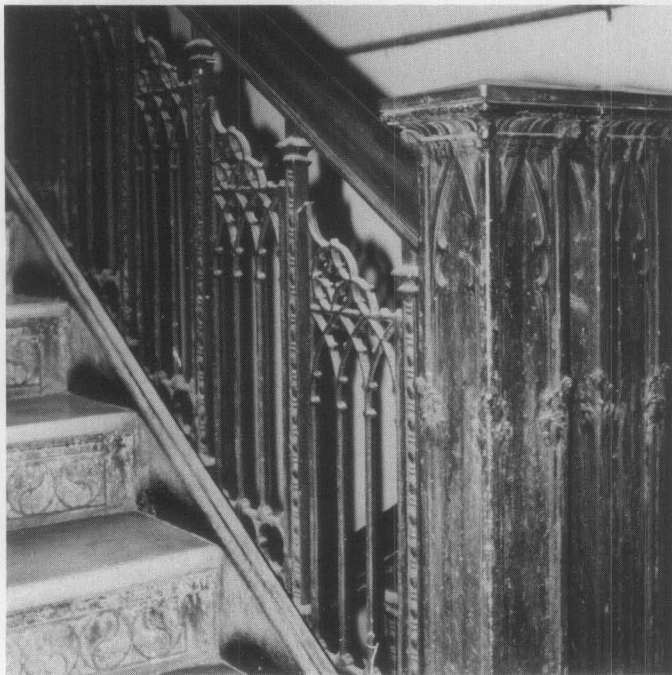
These related spaces are very important in defining the interior character of this building. Almost any change to these spaces, such as installing doors between the vestibule and the hallway, or enclosing the stair would seriously impact their character and the way that character is perceived. Top photo by Mel Chamowitz, others by John Tennant

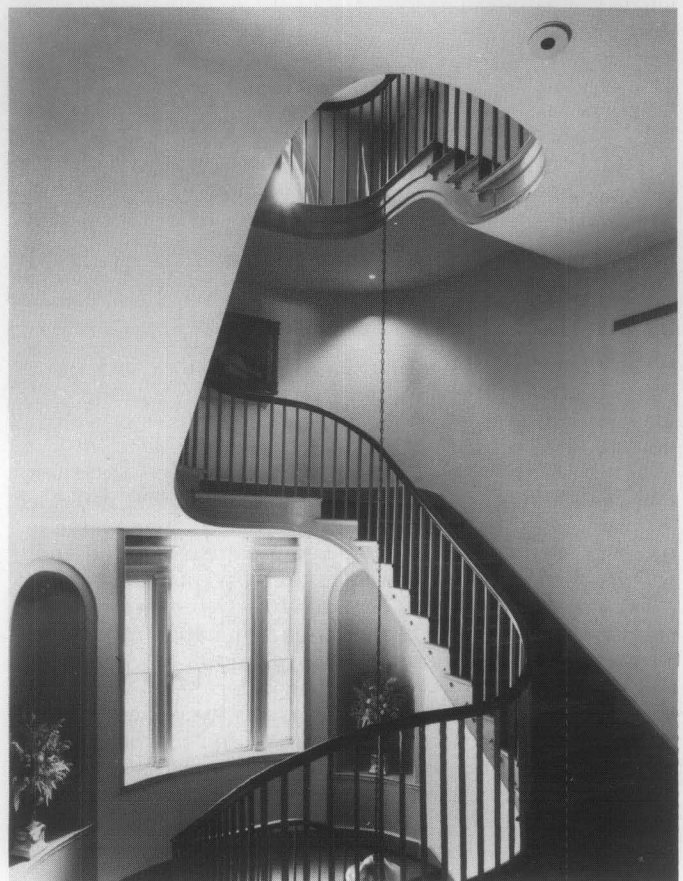
Interior Visual Character: Interior Features

Interior features are three-dimensional building elements or architectural details that are an integral part of the building as opposed to furniture. Interior features are often important in defining the character of an individual room or space. In some instances, an interior feature, like a large and ornamental open stairway may dominate the visual character of an entire building. In other instances, a modest iron stairway (like the one illustrated here) may be an important interior feature, and its preservation would be crucial to preserving the interior character of the building. Such features can also include the obvious things like fireplace mantles, plaster ceiling medallions, or panelling, but they also extend to features like hardware, lighting fixtures, bank tellers cages, decorative elevator doors, etc. Photo by David W. Look

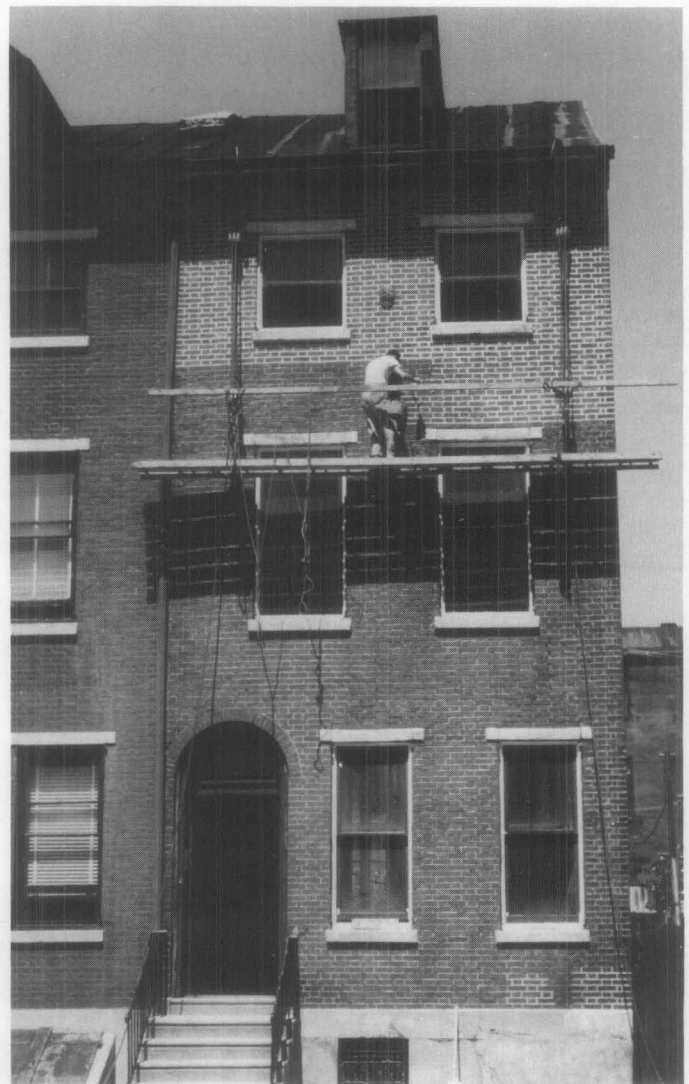
Fragility of A Building's Visual Character

Some aspects of a building's visual character are fragile and are easily lost. This is true of brickwork, for example, which can be irreversibly damaged with inappropriate cleaning techniques or by insensitive repointing practices. At least two factors are important contributors to the visual character of brickwork, namely the brick itself and the craftsmanship. Between these, there are many more aspects worth noting, such as color range of bricks, size and shape variations, texture, bonding patterns, together with the many variable qualities of the mortar joints, such as color, width of joint and tooling. These qualities could be easily damaged by painting the brick, by raking out the joint with power tools, or repointing with a joint that is too wide. As seen here during the process of repointing, the visual character of this front wall is being dramatically changed from a wall where the bricks predominate, to a wall that is visually dominated by the mortar joints. Photo by Lee H. Nelson

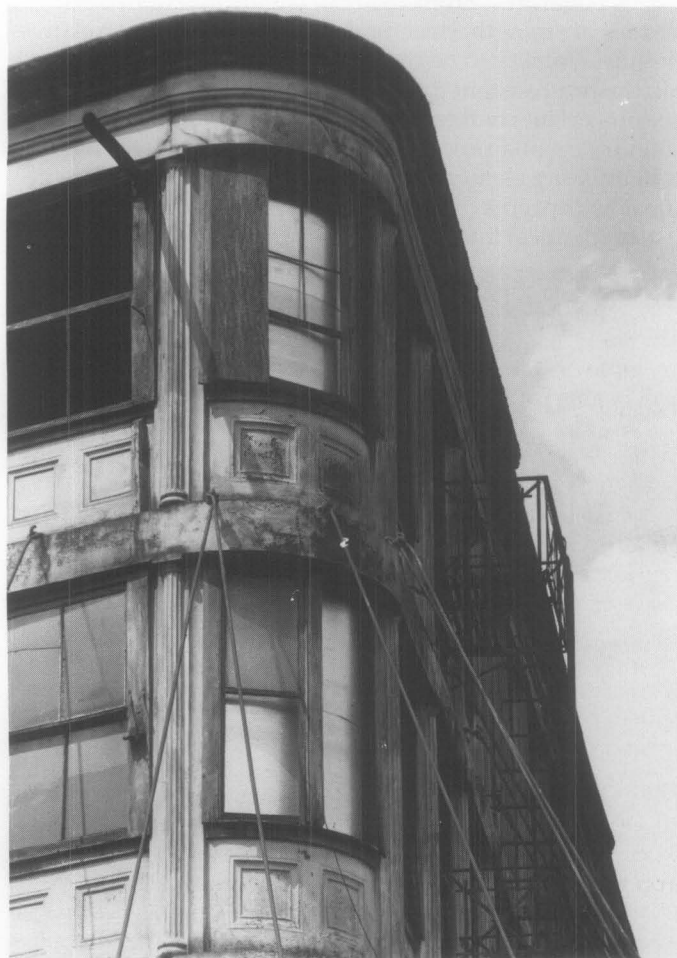
Fig. 2. The Edgar Laing Stores Block in New York City was designed by James Bogardus. It was the first building constructed with facades of self-supporting cast iron. This corner view shows the Doric-style engaged columns, panels, and spandrel beams; the loss of most of the original ornamental castings give it an austere look. As part of an urban renewal project, the facades were carefully disassembled in 1971 for later re-erection in another location—only to have its iron parts stolen for scrap. Photo: Jack E. Boucher, HABS Collection.

In 1849 Bogardus created something uniquely American when he erected the first structure with self-supporting, multi-storied exterior walls of iron. Known as the Edgar Laing Stores, this corner row of small four-story warehouses that looked like one building was constructed in lower Manhattan in only two months. Its rear, side, and interior bearing walls were of brick; the floor framing consisted of timber joists and girders. One of the cast-iron walls was load-bearing, supporting the wood floor joists. The innovation was its two street facades of self-supporting cast iron, consisting of multiples of only a few pieces—Doric-style engaged columns, panels, sills, and plates, along with some applied ornaments (cover photo and Fig. 2). Each component of the facades had been cast individually in a sand mold in a foundry, machined smooth, tested for fit, and finally trundled on horse-drawn drays to the building site. There they were hoisted into position, then bolted together and fastened to the conventional structure of timber and brick with iron spikes and straps (Fig. 3).

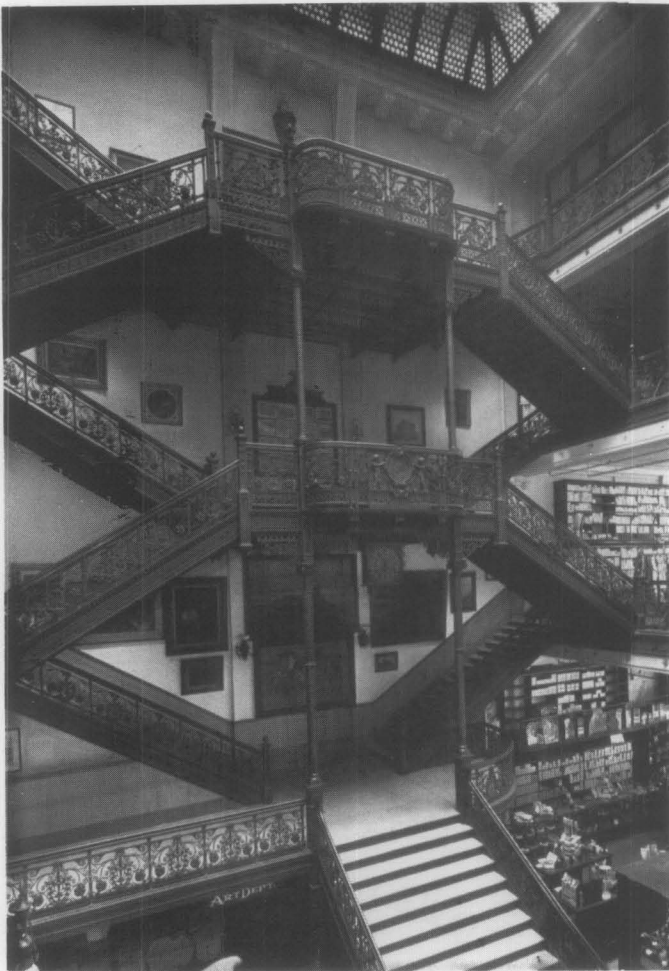
Fig. 4. The 1904 grand stairway of the former Frear's department store in Troy, N.Y. was constructed of cast iron, as was the frame of the skylight above. Some ornamental wrought iron was also employed. This use of iron was typical in major commercial buildings constructed throughout the United States. Courtesy: Rensselaer County Historical Society.

In addition to these exterior uses, many public buildings display magnificent exposed interior ironwork, at once ornamental and structural (Fig. 4). Remarkable examples have survived across the country, including the Peabody Library in Baltimore; the Old Executive Office Building in Washington, D.C.; the Bradbury Building in Los Angeles; the former Louisiana State Capitol; the former City Hall in Richmond; Tweed Courthouse in New York; and the state capitols of California, Georgia, Michigan, Tennessee, and Texas. And it is iron, of course, that forms the great dome of the United States Capitol, completed during the Civil War. Ornamental cast iron was a popular material in the landscape as well, appearing as fences, fountains with statuary, lampposts, furniture, urns, gazebos, gates, and enclosures for cemetery plots (Fig. 5). With such widespread demand, many American foundries that had been casting machine parts, bank safes, iron pipe, or cookstoves added architectural iron departments (Fig. 6). These called for patternmakers with sophisticated design capabilities, as well as knowledge of metal shrinkage and other technical aspects of casting. Major companies included the Hayward Bartlett Co. in Baltimore; James L. Jackson, Cornell Brothers, J. L. Mott, and Daniel D. Badger's Architectural Iron Works in Manhattan; Hecla Ironworks in Brooklyn; Wood & Perot of Philadelphia; Leeds & Co., the

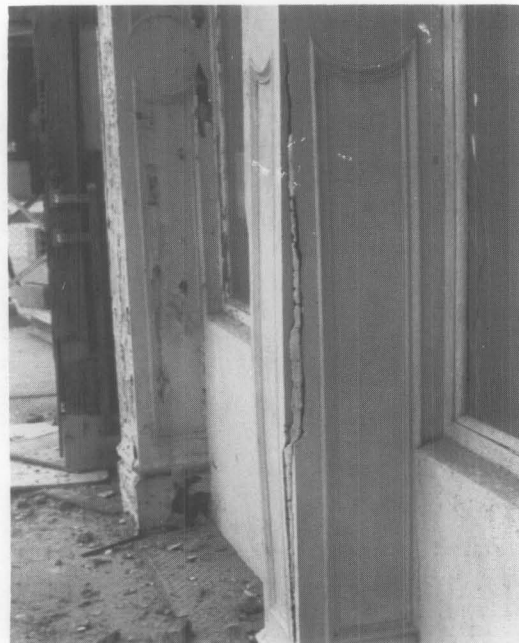
Fig. 11. Major cracks in the piers of this cast-iron storefront in Galveston, Texas resulted from the transfer of load onto the iron from internal brick piers eroded by rising damp. This crack was inappropriately filled with concrete, which trapped moisture and accelerated internal corrosion, pushing the iron further apart. Photo: Ford, Powell & Carson.

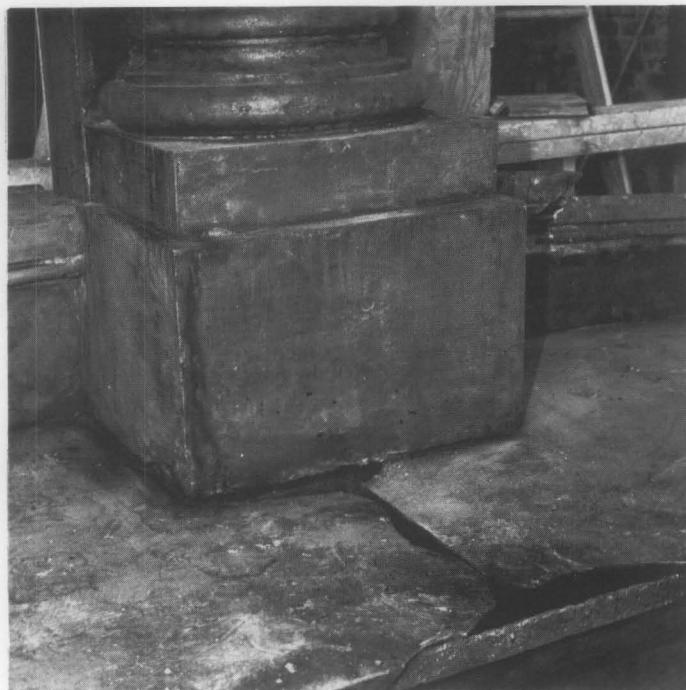
Fig. 12. Paint stripping exposed a large defect under a faulty patch at a joint of this wide cast-iron watertable. The damage can be repaired mechanically by splicing in a cast-iron replacement piece. Photo: Peter Jensen, Kapell and Kostow Architects.

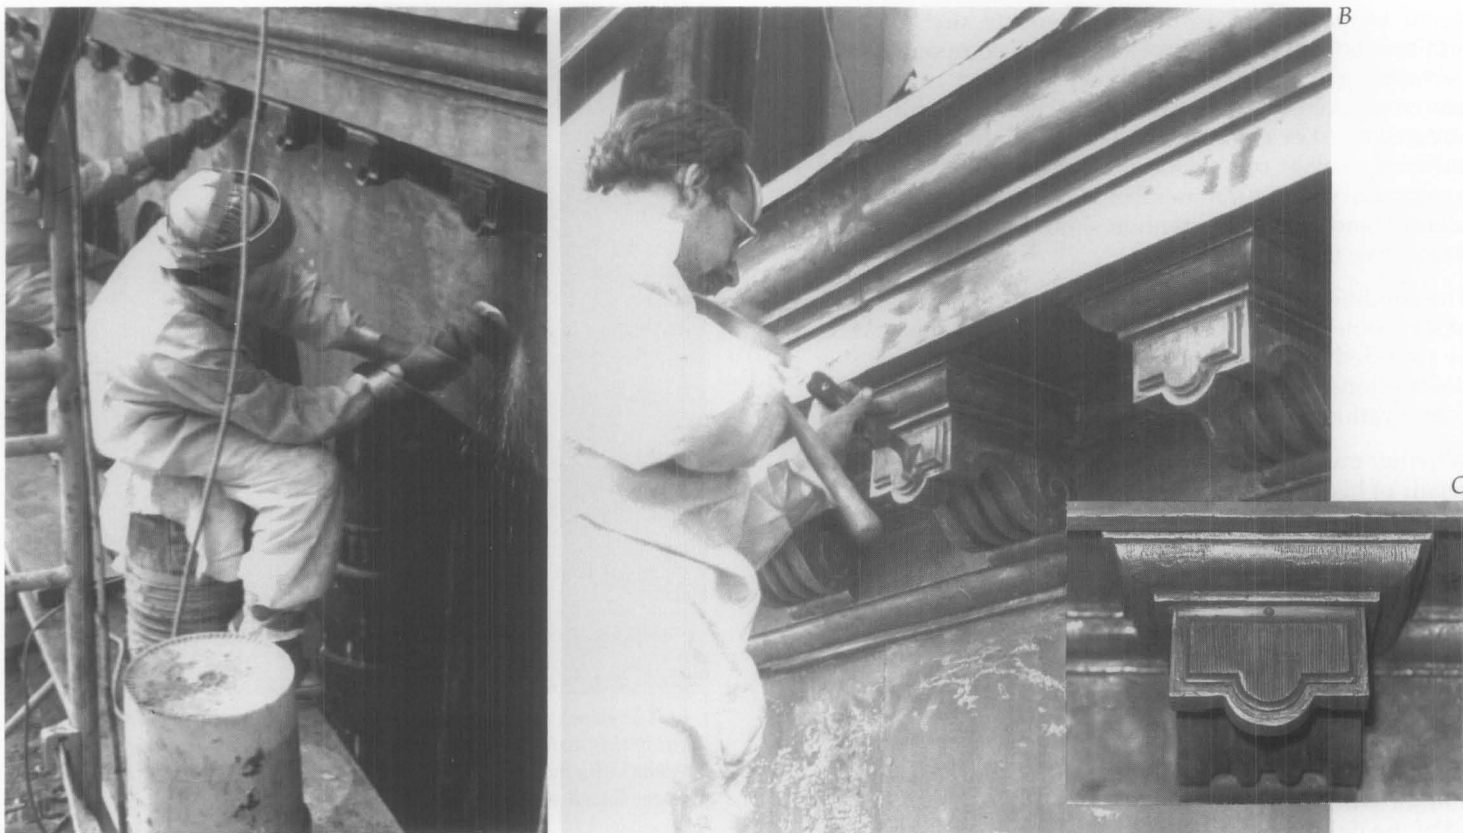
Fig. 13. Surface preparation may involve several different techniques. Where chemical paint stripping is involved, careful planning of the sequence of work and inspection by an architect or conservator to ensure strict compliance with the contract documents is important to minimize the risk of problems. After the chemical paste and paint was scraped off, the remaining paint and chemical residue were removed with a wire brush (a) and scrapers selected or cut to fit the shape of the iron surfaces (b). The surface was then wiped with solvent to create a completely clean surface prior to repainting (c). Photos: Raymond M. Pepi, Building Conservation Associates.

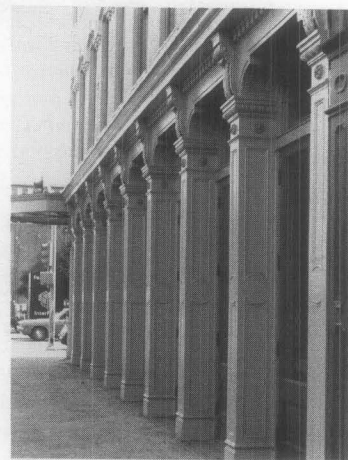
Fig. 16. Architectural cast iron is made of many small components bolted and screwed together. (a) This exploded view of a storefront illustrates the variety of elements, including brackets, fasteners, and holes for bolts. (b) The storefront was replicated in cast iron because of the extensive damage and structural failure, a detail of which is shown in Fig. 11. Drawing and photo: Historical Arts & Casting, Inc.

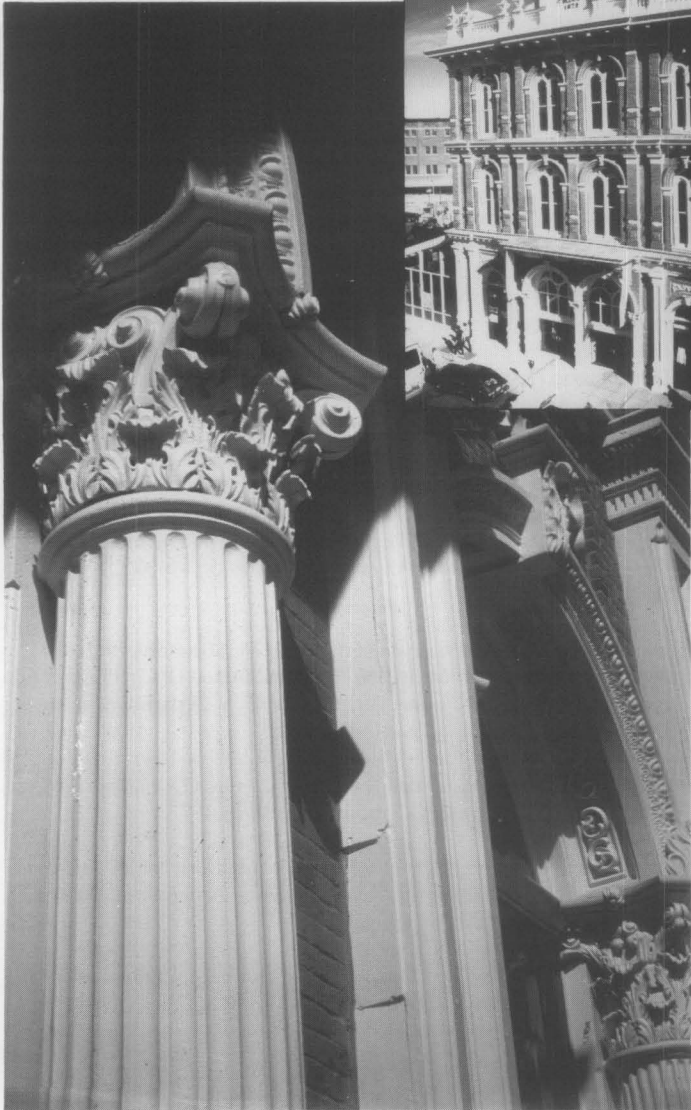
Fig. 19. (a) Fiberglass columns and aluminum capitals were installed to replicate the ornamental features on the east facade of the New Market Theater in Portland, Oregon, that had been destroyed by previous occupants. Like cast iron, crisp ornamental details can be achieved with cast aluminum. Although aluminum may be in contact with fiberglass, galvanic corrosion may result when aluminum is in direct contact with cast iron. Photo: William J. Hawkins, III. (b) The west facade of the theatre retains its original cast iron features. Photo: George McMath.

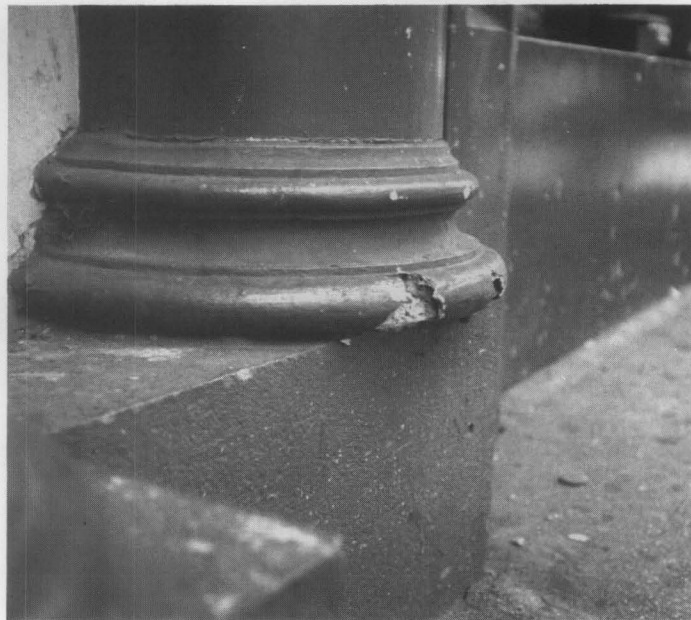
Fig. 20. The location of the feature must be taken into account if a substitute replacement material is being considered. This lightweight fiberglass column at street level sustained damage from impact within a few years of installation. The great strength of cast iron makes it ideal for storefronts and elements that must withstand heavy use. Photo: Building Conservation Associates.

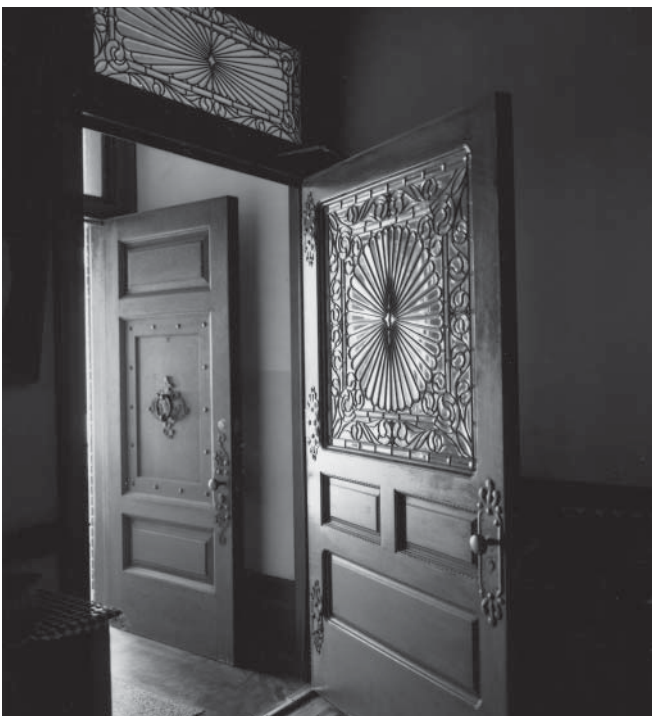
Figure 1. This door and transom suggest the richness of 19th century leaded glass. Photo: Jack E. Boucher, HABS.

Stained and leaded glass can be found throughout America in a dazzling variety of colors, patterns, and textures (Fig. 1). It appears in windows, doors, ceilings, fanlights, sidelights, light fixtures, and other glazed features found in historic buildings (Fig. 2). It appears in all building types and architectural styles—embellishing the light in a great cathedral, or adding a touch of decoration to the smallest rowhouse or bungalow. A number of notable churches, large mansions, civic buildings, and other prominent buildings boast windows or ceilings by LaFarge, Tiffany, Connick, or one of many other, lesser-known, American masters, but stained or leaded glass also appears as a prominent feature in great numbers of modest houses built between the Civil War and the Great Depression.

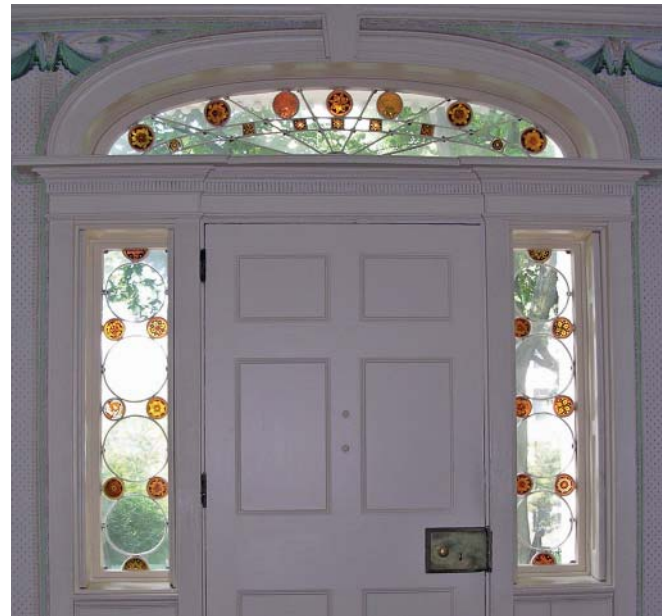
Figure 3. The entrance to the Morris-Jumel Mansion, New York City, is one of the earliest surviving installations of stained glass in the country. It features a fanlight and sidelights of large clear roundels and small bulls-eyes of red and orange glass tinted with silver stains from ca. 1810. Photo: Ken Moss.

from these periods is very significant (Fig. 3). Every effort should be made to document and preserve it.

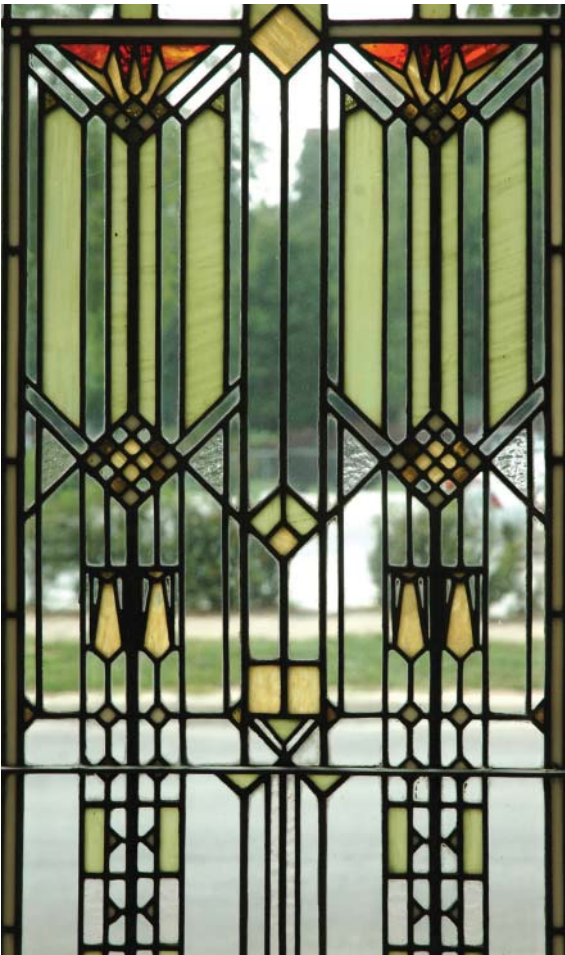
Figure 8. This 1902 window by Henry Webster Tomlinson reflects the Prairie School philosophy of providing ornamentation while retaining a view through the window.

Advocates of the Prairie Style, of whom Frank Lloyd Wright is the best known, rejected Tiffany's naturalistic scenes and Connick's Gothic imitations. (Fig. 8). Wright's rectilinear organic abstractions developed simultaneously with the similar aesthetic of the various European Secessionists. The creation of this style was aided by the development of zinc and copper comes in 1893. These comes—much stiffer than lead—made it possible to carry out the linear designs of Prairie School windows with fewer support bars. At first, these windows had only an elitist following, but they were soon widely accepted and proliferated during the early 20th century.

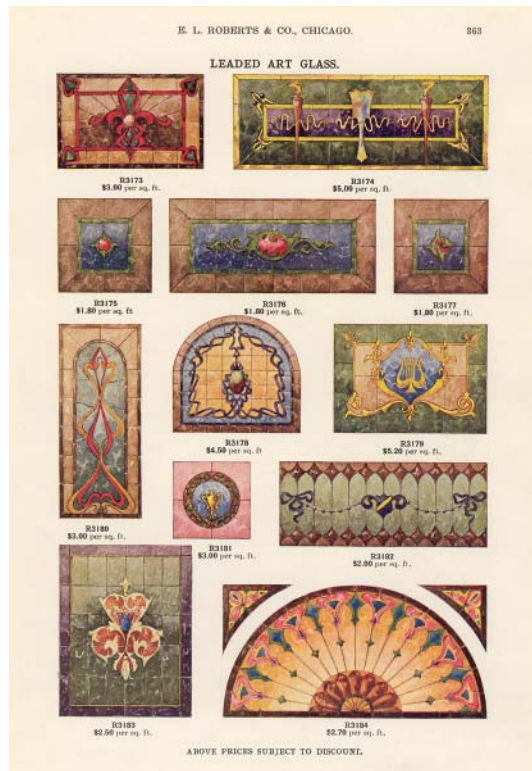
Figure 9. A typical mail-order catalog page of art glass windows available in 1903 from the E. L. Roberts Company, Chicago.

some offering over 100 low-cost, mass produced designs (although the same catalogs assured buyers that their leaded glass was “made to order”) (Fig. 9).

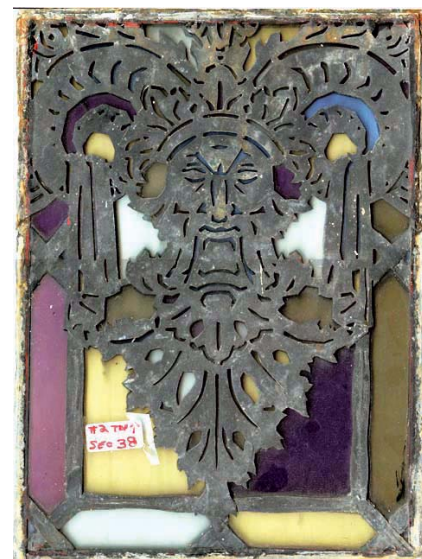
Figure 10. This lead-silhouette stained glass face graces a 1928 coach house in Buffalo, and is attributed to D'Ascenzo Studios of Philadelphia.

Some creative efforts expanded leaded glass media in new directions. Lead-overlay or “silhouette” glass was one novelty that climaxed in the late 1920s and early 1930s. Some designers sandwiched glass between layers of hand-cut sheet lead, while others sandwiched the perforated sheet lead between layers of glass. These windows present a playful reversal from traditional stained glass; in “silhouette” glass the lead metalwork, rather than the glass, becomes the primary art form (Fig. 10). However, such novelties failed to catch on during the Depression. World War II delivered the final blow and ornamental glass is seldom found in residential, commercial, and secular architecture after circa 1940. The great age of American stained glass was over. Fortunately, leaded glass panels survived in uncounted numbers throughout the country, and are now once again appreciated as virtually irreplaceable features of historic buildings.

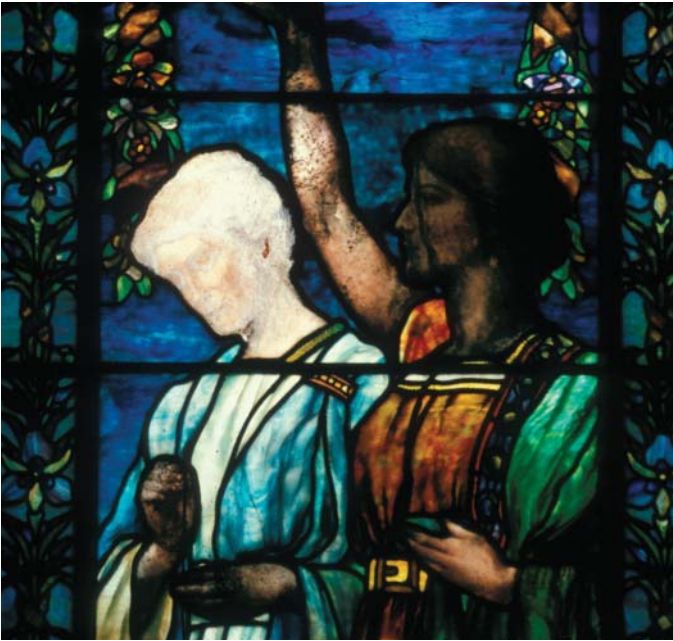
Figure 11. The face paint has failed substantially in the figure at the left. Ghost images of the feature are barely visible. Window (1903) by Edwin P. Sperry, glass by Tiffany Studios; “Old Main,” (1891-1893) Illinois Institute of Technology, Chicago. Photo: Rolf Achilles.

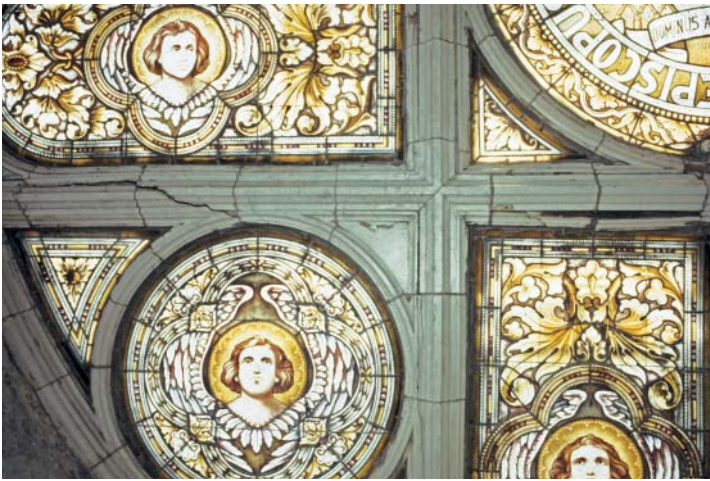
Figure 12. Stained glass frames are typically wood, steel or stone; however, other materials, and their inherent problems, can also be found as seen in this photograph of cracked terra cotta frames from 1926.

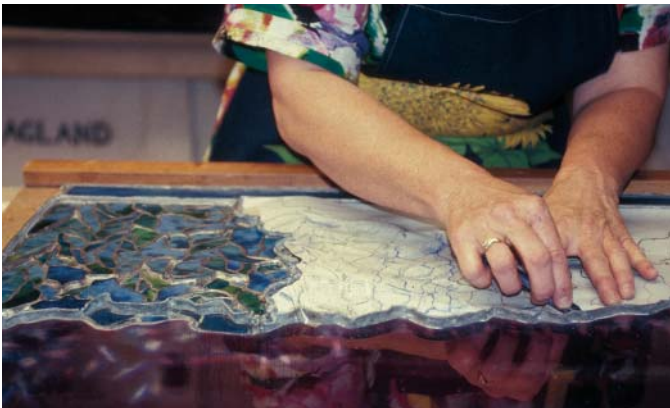
Figure 14. The external glass plate has been removed to clean the interlayer of this plated Tiffany Studios window.

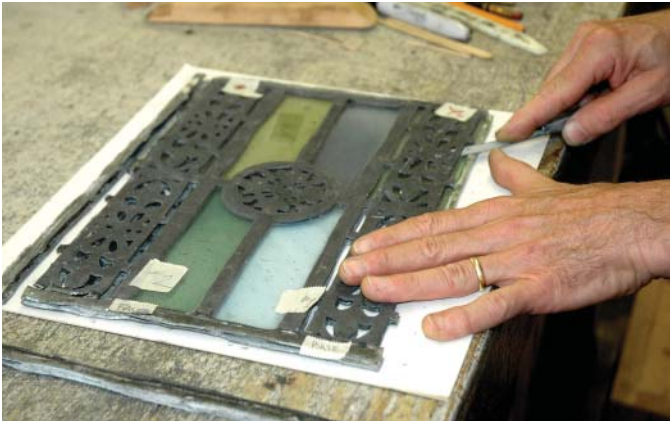
Figure 15. To permit repair of the cracked glass, the original lead overlay is first salvaged from this historic leaded panel of silhouette glass to retain as much of the original work as possible.

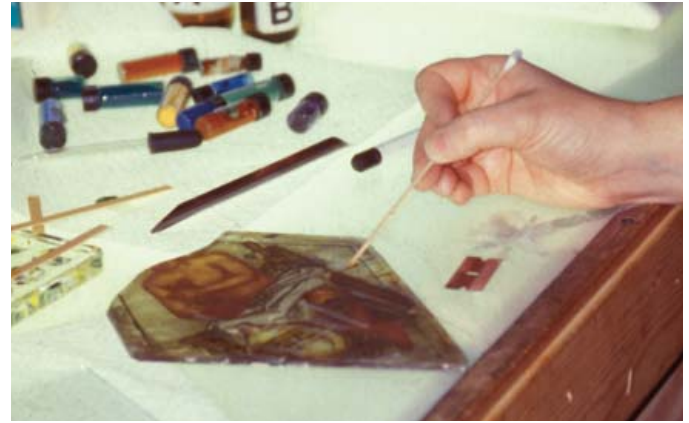
Figure 16. A valuable historic piece of original hand-painted glass is carefully edge-glued with epoxy.

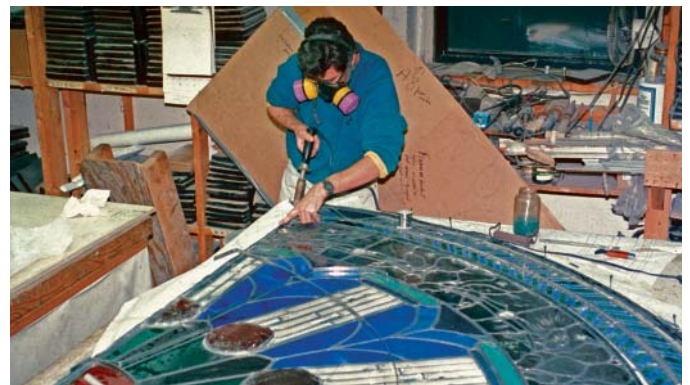
Figure 17. Total releading is very time consuming and costly and should only be undertaken when the original lead is exhausted beyond repair.

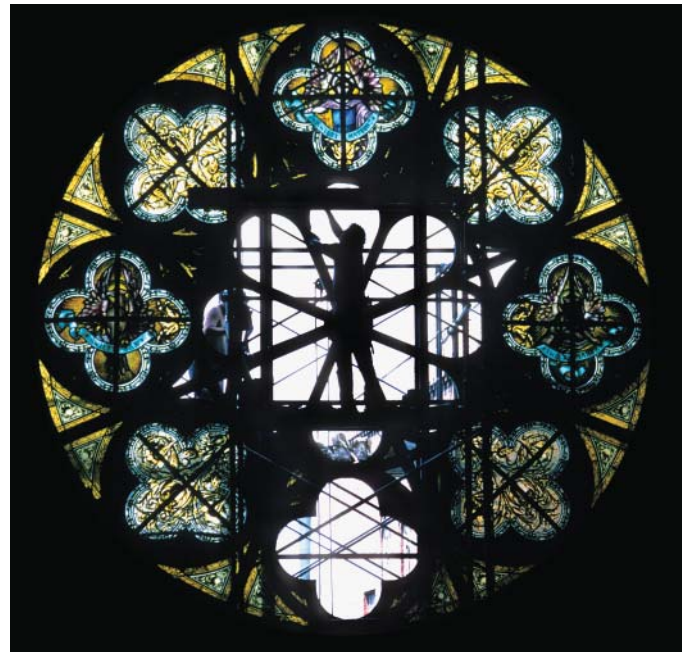
Wooden frame of the rose window undergoing repair (exterior view).

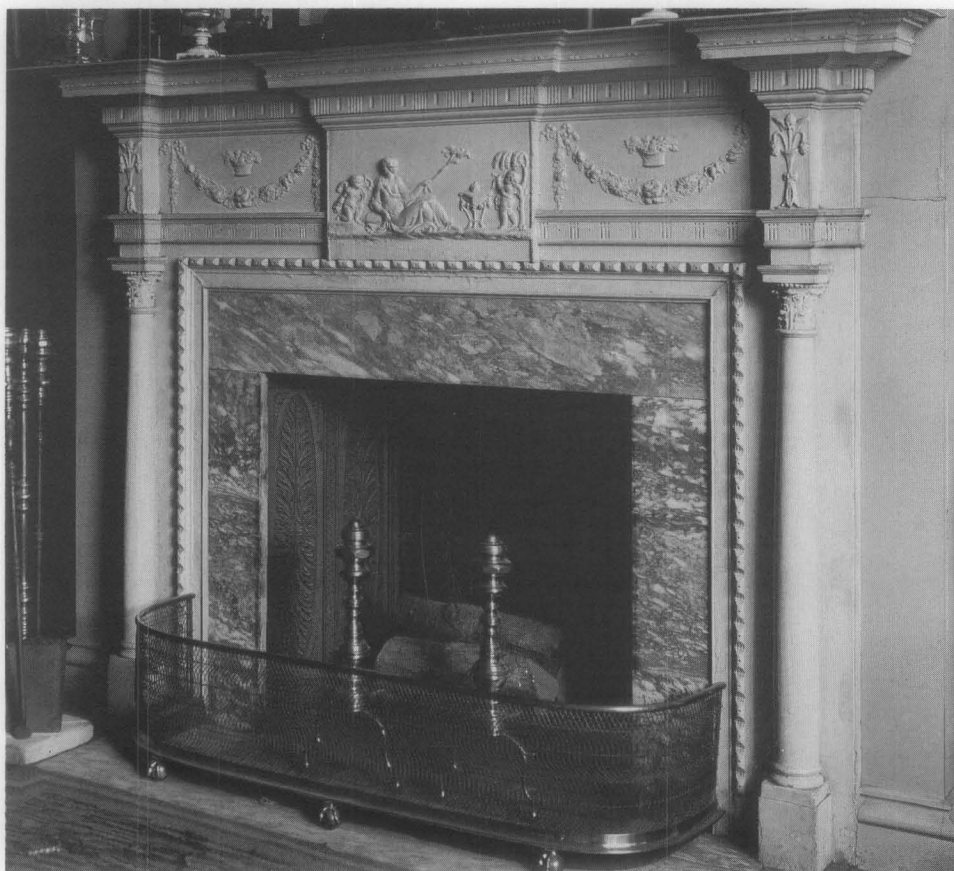
Figure 1. An American mantelpiece in the Adam style dating from the early 19th century illustrates composition ornament's reputation as a first-rate imitator of wood. Only the allegorical design, flower baskets, floral swags or festoons, flanking fleur-de-lis ornamentation and pilaster capitals are compo; the panels and simple moldings are carved wood. Photo: Courtesy, Philadelphia Museum of Art: Given by Mrs. Thurston Mason in memory of her sister, Miss Anna P. Stevenson.

the eye of the viewer (see Fig. 1). The confusion has been heightened over time by makers who claimed to be the sole possessors of secret recipes and by the variety of names and misnomers associated with the material, including *plaster*, *French stucco*, and *Swedish putty*, to name a few.

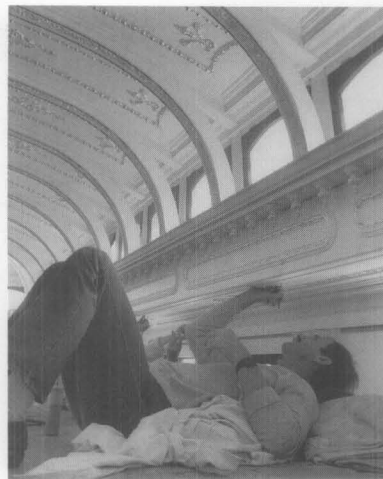
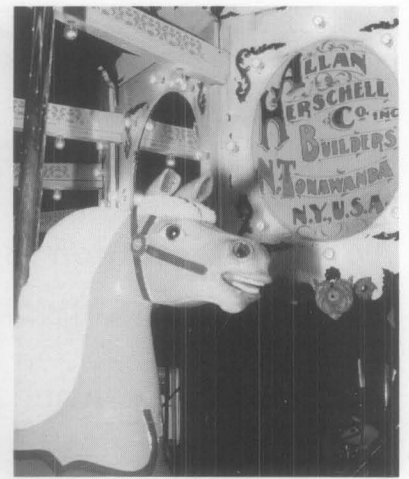
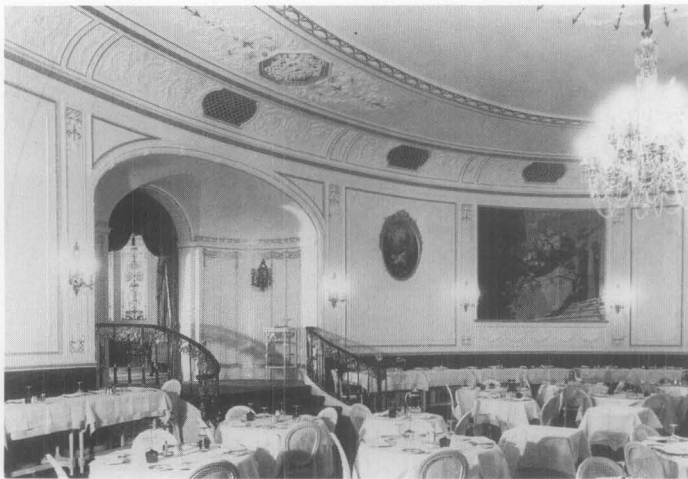
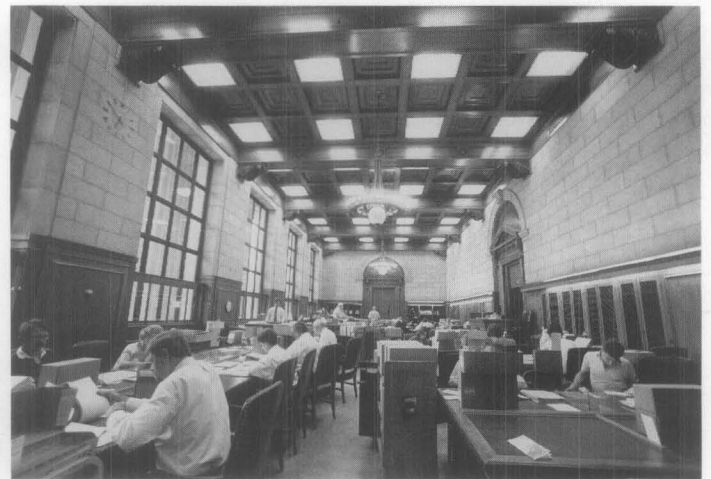
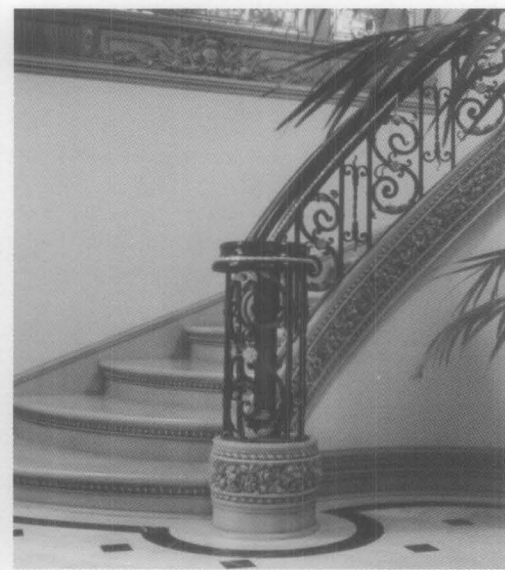
Figure 2. Composition ornament has been used in America for over two hundred years in a variety of applications: (a) a floral festoon and basket in the Adam style for an 1803 mantelpiece; (b) the social saloon of an 1866 steamship, S.S. China; (c) scenery panels on a 1916 Allan Herschell carousel; (d) ceiling decoration in a 1920s hotel; (e) the coffered ceiling of the National Archives library, 1938; (f) a modern reproduction of a Stanford White-designed frame; and (g) 1990s compo ornamentation for a re-modeled residence. (a) Courtesy, Gold Leaf Studios, Inc.; (b) Philip L. Molten; (c) Elizabeth Brick; (d) Courtesy, J.P. Weaver Co.; (e) Courtesy, National Archives; (f) 06.218: Self Portrait of Thomas Wilmer Dewing (1851-1938). American, 1906. Oil on wood panel: 50.8 x 36.8 cm. Courtesy, Freer Gallery of Art, Smithsonian Institution, Washington, D.C.; (g) Courtesy, J.P. Weaver Co.

Generally adhered to wood, historic composition ornament is most often found decorating flat surfaces such as interior cornice and chair rail moldings, door and window surrounds, mantelpieces, wainscot paneling, and staircases—indeed, anywhere that building designers and owners wanted to delight and impress the visitor, but stay within a budget. While composition was cheaper than carved ornament, it was still meticulously hand made and applied; thus, it was more often used in “high style” interiors. But the types of structures historically decorated with composition ornament were more democratic, encompassing residential, commercial, and institutional buildings, and even including specialty applications such as the social saloon of a steamship (see Fig. 2).

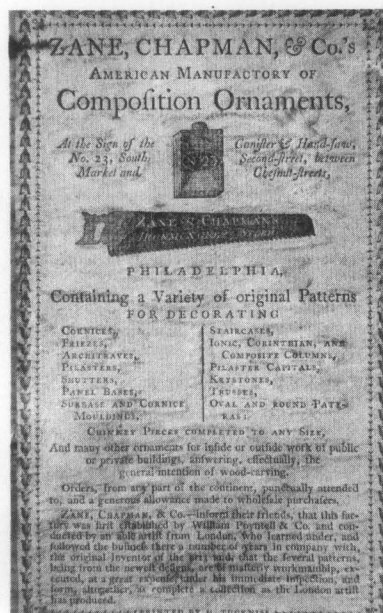
Figure 4. Compo ornament could be applied to simple and complex surfaces, including cornices, friezes, architraves, pilasters, and chimney pieces and to looking glass and picture frames. Manufacturers' ads such as these were commonplace in 19th century America, particularly in eastern cities. Left: Zane, Chapman, & Co. Right: Horton & Waller. Photo left: Courtesy, Jonathan Thornton. Photo right: Courtesy, Gold Leaf Studios, Inc.

Compo mixes have been the subject of a good deal of variation and there has never been a set recipe, but the ornament manufacturers of the later 18th and early 19th centuries understood in general terms what their material was and what it could do (see Fig. 4). The advantages of the material were described by a prominent American maker, Robert Wellford, in his advertising broadside of 1801:

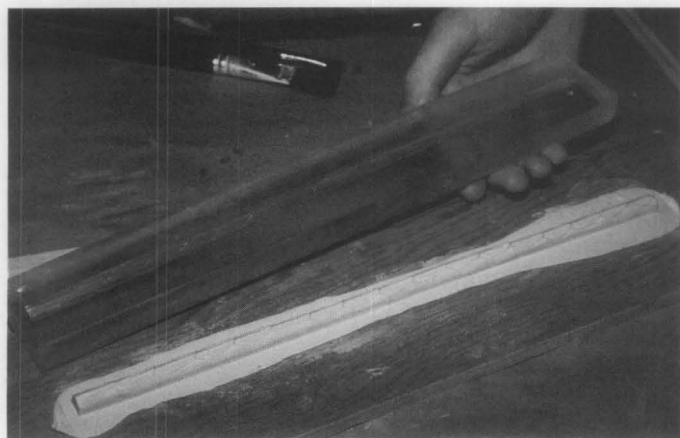
Figure 6. This finished length of compo molding is stuck to its pressing board. The newly made piece will be sliced off the board, then applied. Photo: Jonathan Thornton.
