17 PRESERVATION BRIEFS

The Maintenance and Repair of Architectural Cast Iron

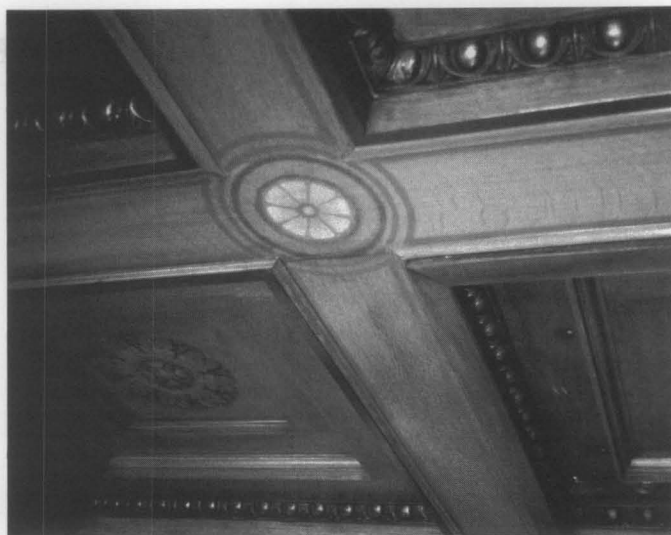
Figure 7. The coffered ceiling of the 1938 National Archives library in Washington, D.C. features egg-and-dart composition molding finished with a dark brown stain. While compo design is more often light and delicate, here, it has a bold, massive quality. Photo: Bryan Blundell.

Finally, when completely hard, it could be given a polished marble shine with nothing but a damp cloth. It could be stained, coated with any sort of paint, varnish, or oil gilded without any further preparation (see Fig. 7).

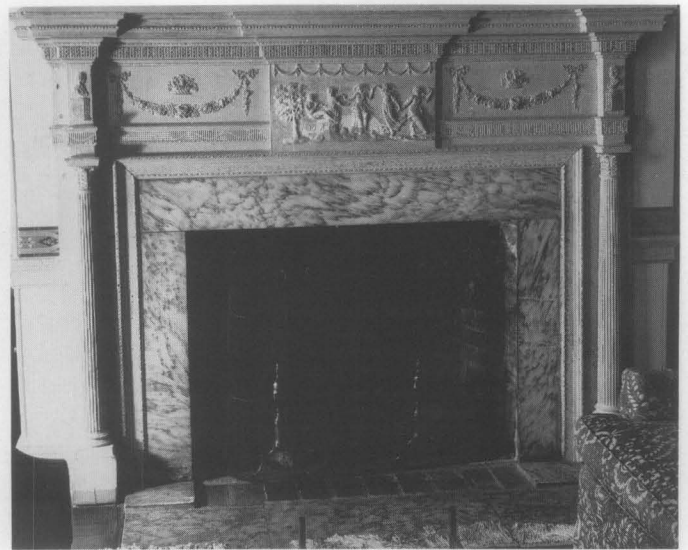
Figure 13. Top: Since rooms with fireplaces were centers of social activity in early American houses, mantelpieces often received special decorative attention. This early 19th century mantelpiece in a Philadelphia residence features a panel depicting A Country Dance flanked by floral swags and sculptural busts of Milton and Shakespeare. Bottom: Several American and English makers produced versions of a frieze entitled, *The Triumph of Mars*. This one, ca. 1800-1810, is in a modest "single" house on John Street in Charleston, South Carolina. Note how several layers of paint are obscuring the detail. Photo top: Gold Leaf Studios, Inc. Photo bottom: Jonathan Thornton.

The 19th Century. During the early decades of the nineteenth century, Neoclassical—encompassed in America by the terms Federal, Empire, and Greek Revival—was in the ascendancy. Composition makers continued to increase and also to find new uses for their material. Composition picture and mirror frames became common and some makers advertised the suitability of composition ornaments for casting iron firebacks and stoves. Composition ornament was explicitly advertised for exterior use as well, although very little has survived. The interiors of houses and public buildings in every prosperous American city were decorated with composition (see Fig. 13).
