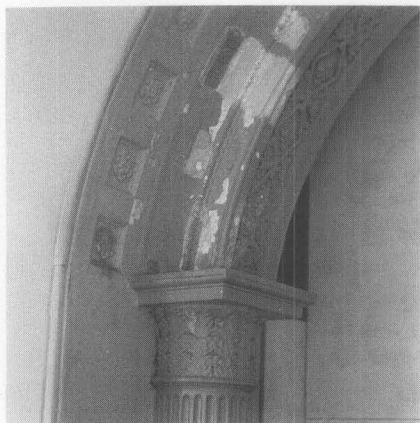
Figure 20. The Octagon House, in Washington, D.C., was constructed between 1801-1802. During recent project work, it was discovered that early repairs to the composition ornament in this doorway had been made with plaster. The plaster repairs were removed during restoration of the doorway to its original appearance. Photo: Lonnie J. Hovey, AIA.

After having identified the presence of composition ornament, its overall condition can be evaluated. Layers of paint may obscure fine detailing as well as deterioration problems. Degrees of damage and deterioration should be recorded. These are typical questions that need to be answered. Is the surface merely "crazed", requiring no action or limited repair, or are the cracks severe enough to require replacement? Are pieces missing? Are the attachment brads rusted or missing? The condition of the substrate is also important. Is the wood surface intact, or is it in need of repair? After answering key questions, the conservator will make random tests to differentiate original compo from later repairs, some of which may well have been done with plaster, rather than compo (see Fig. 20).

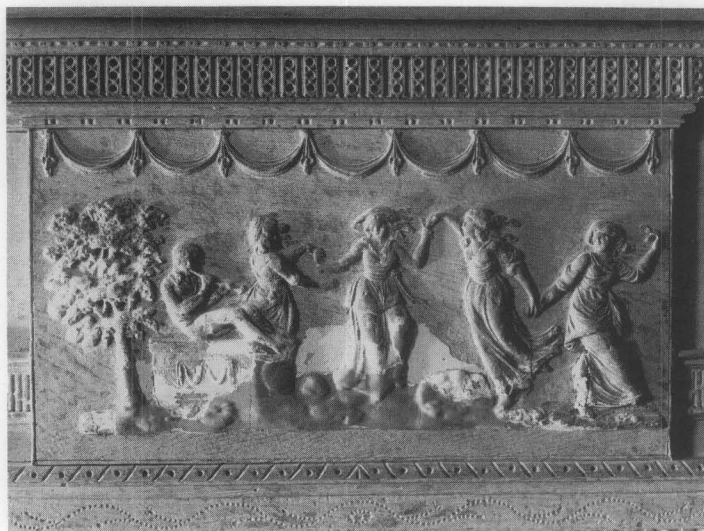
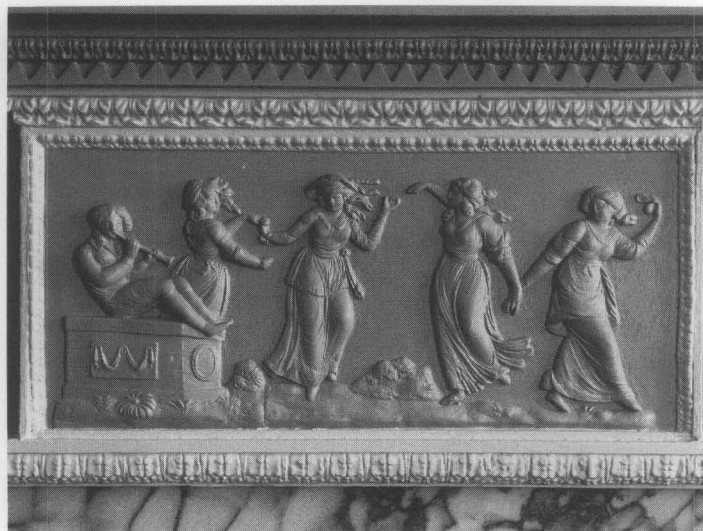
Figure 21. The same theme on two early mantelpieces, *A Country Dance*, dramatically illustrates the visual difference between cleaned and uncleared composition ornament. When old paint layers are removed, the exquisite detailing is revealed. Left: George Read II House, 1801-1803, New Castle, Delaware; Right: First Harrison Gray Otis House, 1796, Boston, Massachusetts. Photo left: Gold Leaf Studios, Inc. Photo right: David Bohl. Courtesy, Society for the Preservation of New England Antiquities.

For purposes of this Brief and the guidance paragraphs that follow, it is assumed that all layers of paint are being removed in order to reveal the fine detailing of the composition ornament (see Fig. 21).

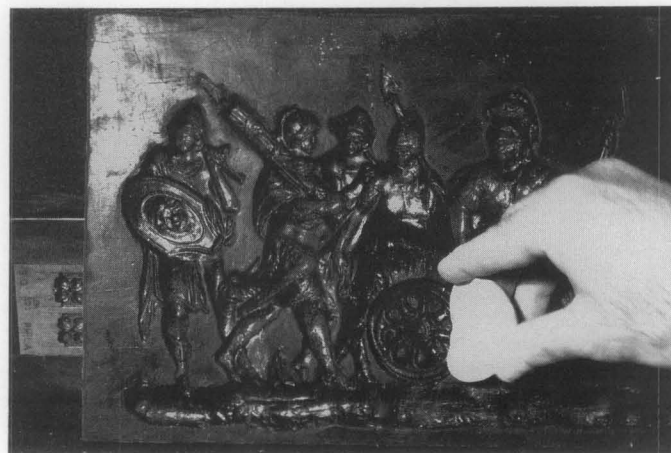
Figure 27. When a compo frieze depicting *The Triumph of Mars* was found to be damaged, improperly restored, and its intricate design clogged with paint, the first step was to replace a missing wheel on the chariot. Because molds depicting classical themes are part of many professional studio collections, it was possible to fabricate a new wheel from the rubber mold shown here. Photo: William Adair.

Repairs to broken or damaged compo. When some original compo has been lost, additional work is required to make a repair. One particularly easy and inexpensive method of repairing broken ornamentation is to use non-hardening clay ("plastilina") or polymer-based modeling materials as an impression material to make a mold. After a mold is made from existing ornament, missing or deteriorated portions of the historic design can be duplicated with a durable gypsum plaster (see Fig. 26). Especially in cases where economic considerations dictate procedure, use of this substitute material may be helpful because it is cheaper. Alternatively, an existing studio mold may sometimes be used to make small replacement pieces in a repair project (see Fig. 27).

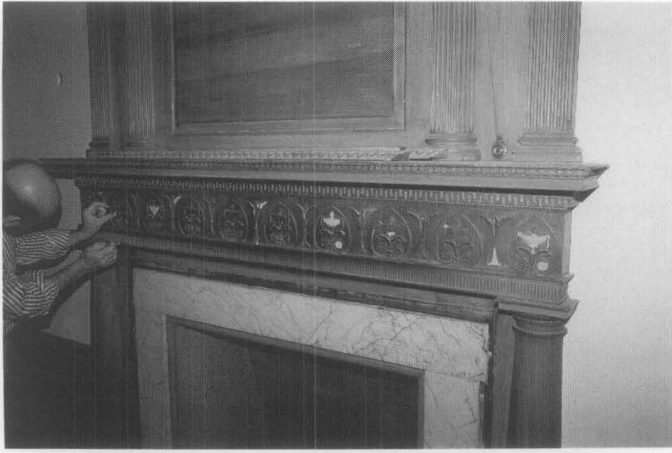
Figure 28. A conservator is replacing broken pieces of compo ornamentation on a mantel during restoration of the Nightingale-Brown House in Providence, Rhode Island. Photo: Courtesy, Irving Haynes and Associates.

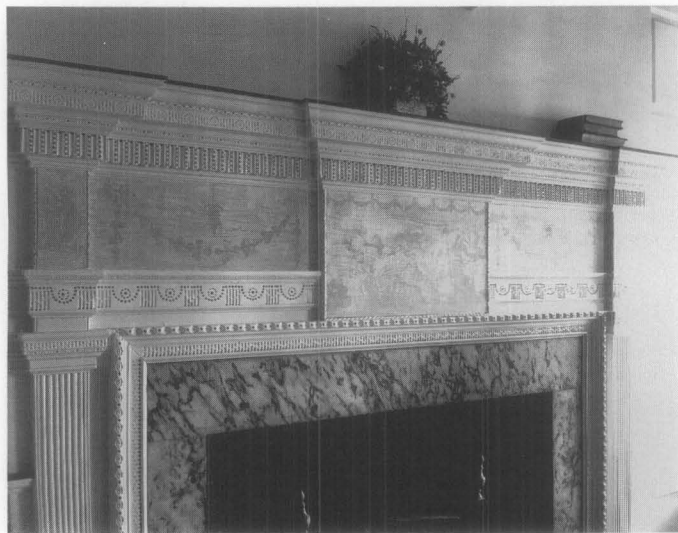
Figure 29. The ghost marks of compo past—floral swags or festoons—are in clear evidence on a mantelpiece in the back bedroom of the George Read II House, New Castle, Delaware. This physical evidence will be used to assure their accurate re-creation in a restoration project. Photo: Courtesy, Gold Leaf Studios, Inc.

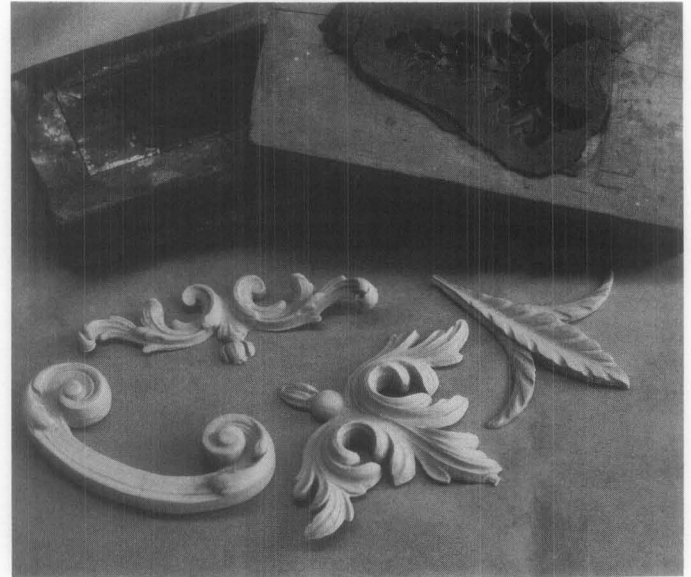
a.

Figure 30. Based on documentary and physical evidence, missing composition ornament was accurately re-created for the Miles-Brewton House, Charleston, South Carolina. First (a) the conservator used molds to fabricate ornament in small pieces and lengths; and (b) the new ornament was attached to thin birch plywood backing with glue and brads to create larger sections. These sections were then fastened to the original paneling with stainless steel screws. Photos: Jonathan Thornton

In summary, detailed physical evidence, as well as written and pictorial documentation, can provide a valid framework for replacement at a particular site. With careful detective work, missing historic ornamentation may be successfully identified and replaced with matching ornament (see Fig. 30; see also Fig. 19).

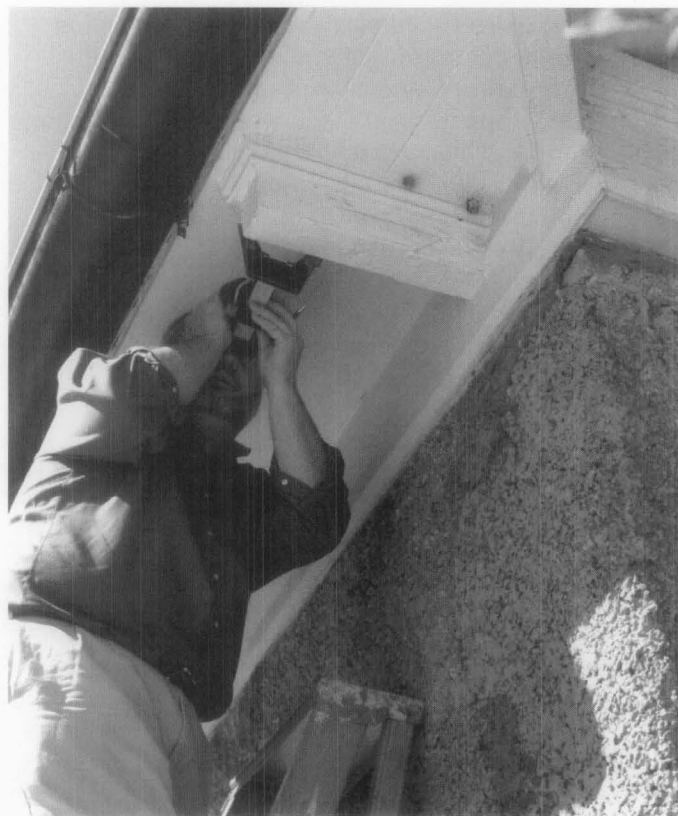
Figure 13. Paint studies may not only help establish the chronology of paints and paint colors used on a building but also may aid in the dating of existing architectural features. Examination of the paint layers on these modillions utilizing a hand-held microscope enabled an investigating team to confirm in the field which modillions were original and which were later replacements. Photo: Charles Fisher, National Park Service.

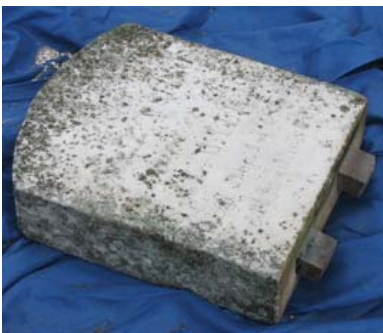
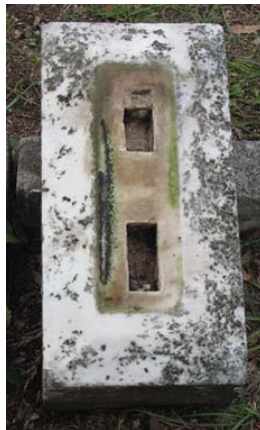
Figure 3. A multi-element grave marker from the early 19th century in the St. Michael's Cemetery, Pensacola, FL, consists of a vertical element with tabs (left image) into a slotted base (right image). Photo: Fran Gale.

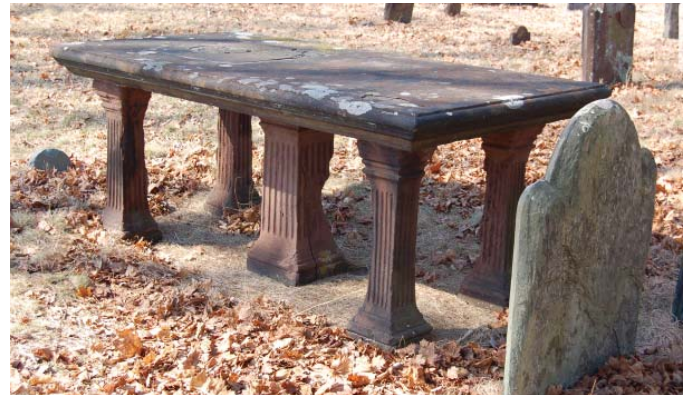
Figure 4. This sandstone table tomb, located in Cedar Grove Cemetery, New London, CT, is an engineered grave marker structure consisting of a horizontal stone tablet supported by four vertical table "legs" with and a central column,. Photo: Jason Church.

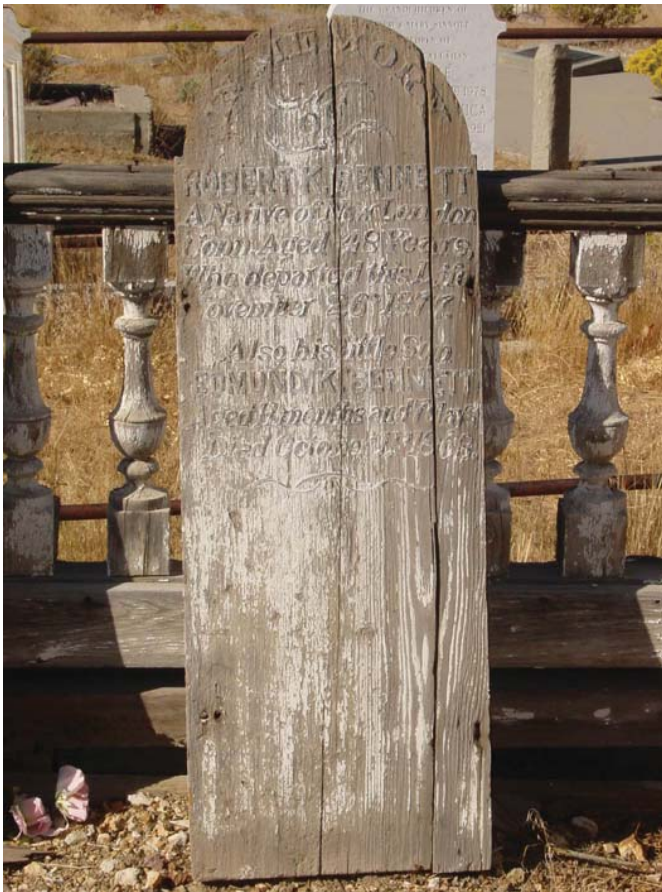
Figure 7. As shown by this 1877 marker in Silver Terrace Cemetery, Virginia City, NV, exposure to sunlight can damage wood grave markers, making the wood more susceptible to water damage and cracking. Photo: Jason Church.

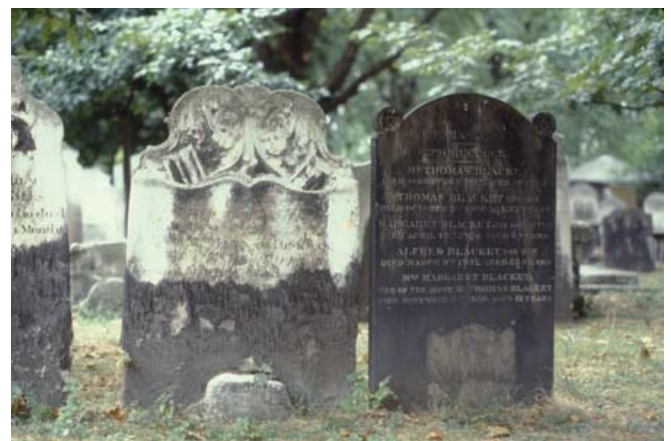
Figure 9. The limestone and sandstone grave markers in this historic cemetery have different weathering processes. On the left, the limestone shows surface loss in areas exposed to rainwater and gypsum crust formation below. The sandstone marker on the right displays uniform soiling, but surface hardening may be occurring. Photo: Fran Gale.

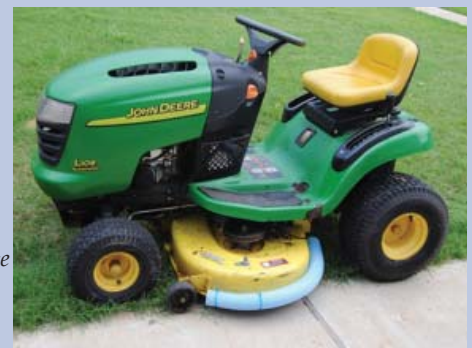
Figure B. A pool ‘noodle’ can be fitted to the deck of a lawnmower to prevent damage to grave markers. Photo: Debbie Dietrich Smith.

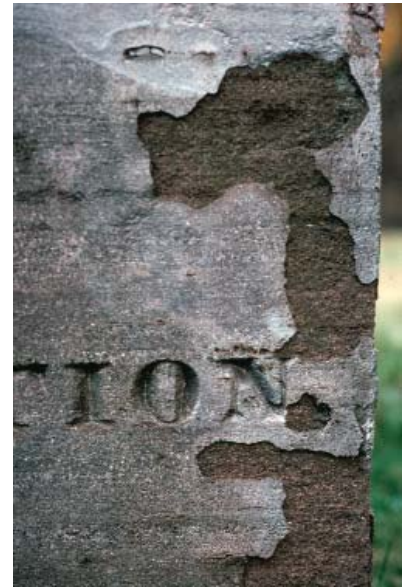
Figure 14. High-pressure water washing can damage grave markers. The photograph shows "wand marks" on the headstones produced by inappropriate pressure washing. Photo: Jason Church.

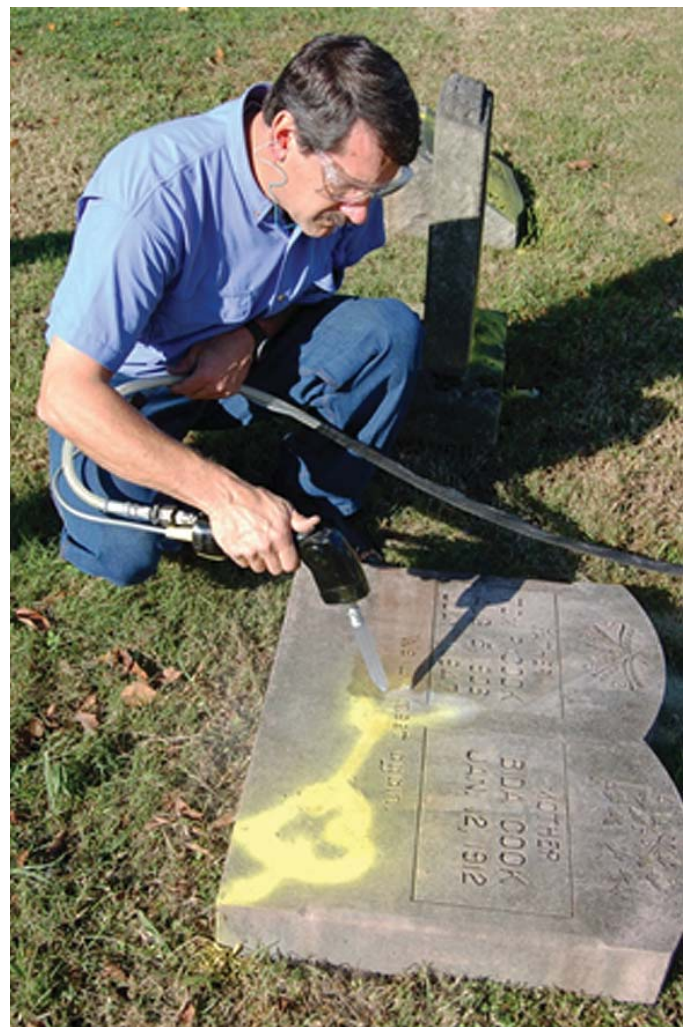
Figure 18. Graffiti is carefully removed using a low-pressure dry-ice misting instrument. Photo: Jason Church.

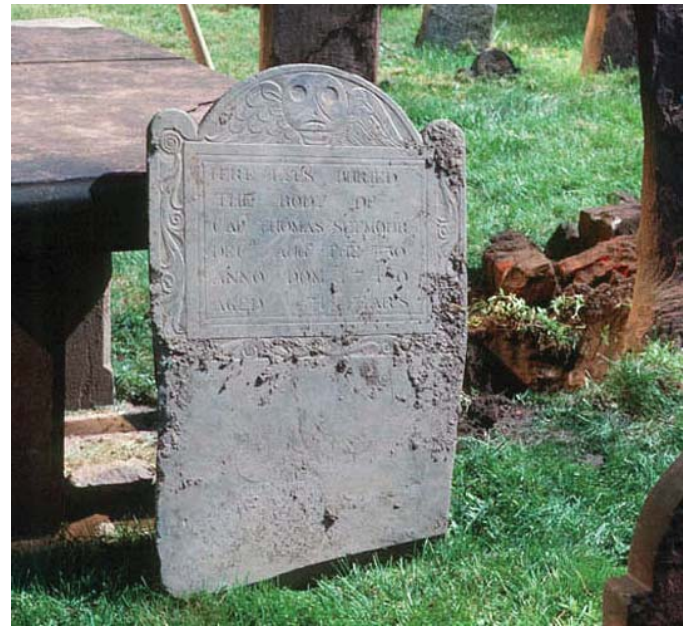
Figure 20a. This slate grave marker in the Ancient Burying Ground in Hartford, CT, is a ground-support stone. Resetting requires digging a hole that will hold the base of the stone and then compacting the soil at the bottom of the hole by hand. Photo: Fran Gale.

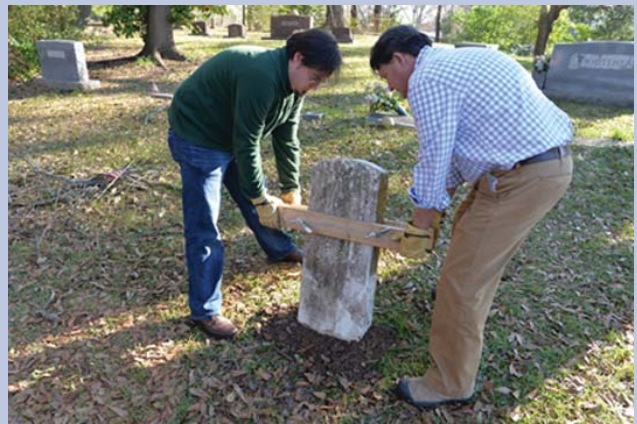
Figure E1. The simple wooden clamp system allows two people to safely lift a marble grave marker. Photo: Sarah Jackson.
