WETLAND DETERMINATION DATA FORM – Eastern Mountains and Piedmont Region

USACE FILE NO./Project Name:	Mountain Valley Pipeline Project			COORDINATES:	Lat.	39.290258	Lon.	-80.518898
STREAM/SITE ID AND SITE DESCRIPTION: (% stream slope, watershed size {acreage}, unaltered or impairments)				Wetland UU1 (W-UU1), 1.28ac watershed, HUC 12 watershed Salem Fork, riverine, RPWWD, forested wetland adjacent to gravel road and equipment staging area				
FORM OF MITIGATION:		Mitigation Bank						
DATE:	23-Sep-16	WEATHER CONDITIONS:				PRECIPITATION PAST 48 HRS:		
PART I - Wetland Indicators								
Impact Wetland ID:	Impact Wetland Classification	Impacts (acreage)	Mitigation Wetland Classification					
W-UU1	Forested	0.0045	Emergent					
Total Impact		0.0045						
PART II - Unit Scores								
Wetland Classification			Replacement Unit(s)					
Total Emergent			0.0045					
Total Scrub-Shrub			0					
Total Forested			0					
Total Open Water			0

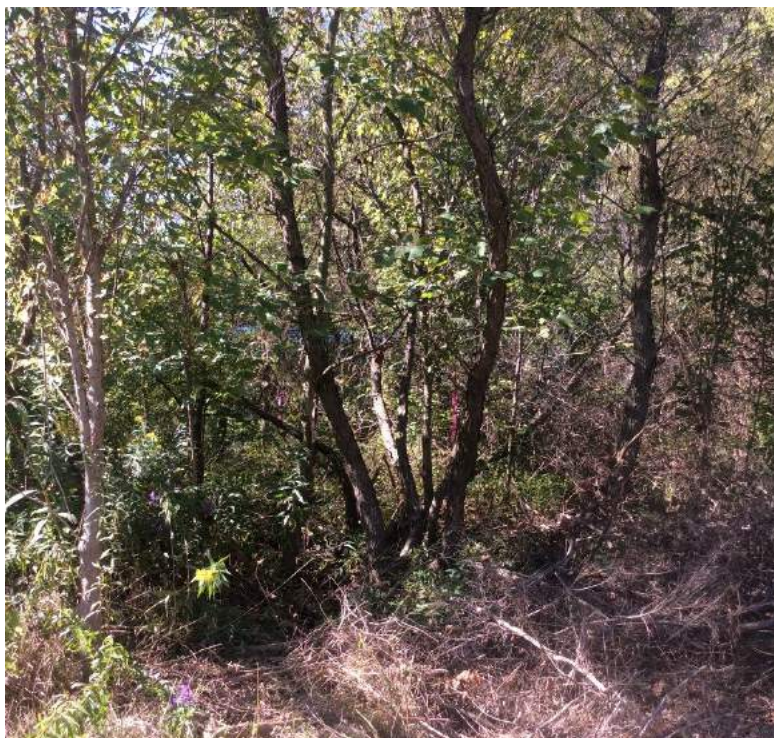
Photograph Number: 1

Feature Name: W-UU1

Cowardin Class: PFO

Direction: NNE

Most of wetland is forested with salix, acer negundo.

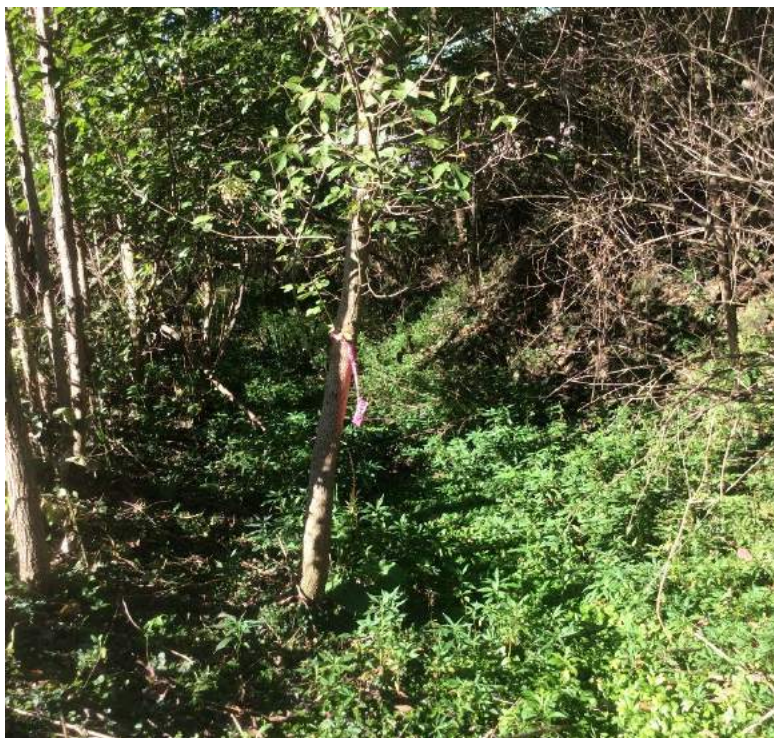
Photograph Number:	1	Feature Name:	W-UU3	Cowardin Class:	PFO
Direction:	NE	Date:	9/24/2015

Cowardin Code: PFO

HGM: Riverine

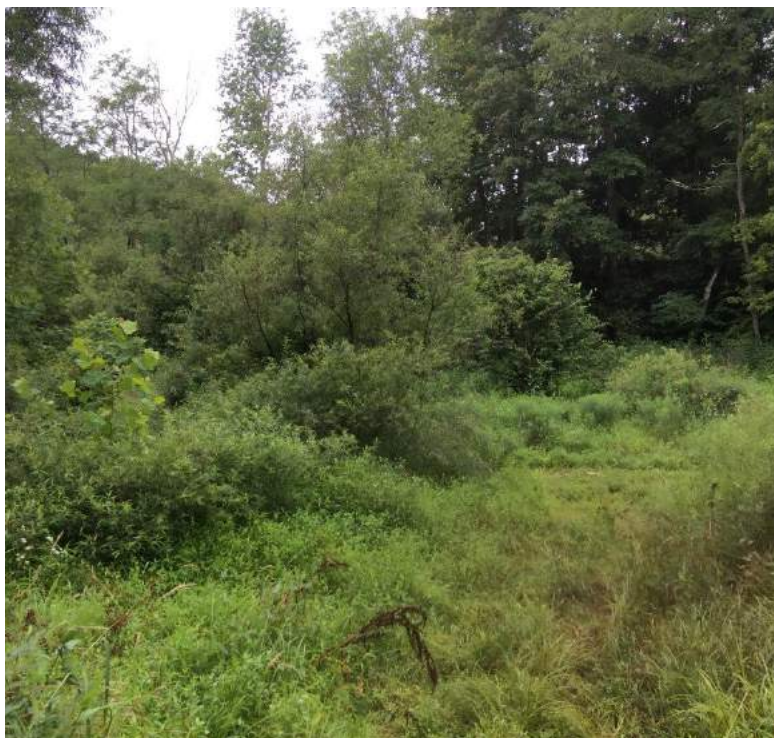
Photograph Number: 1

Feature Name: W-ST12

Cowardin Class: PSS

Direction: S

Remarks: Cowardin Code: PSS HGM: Riverine Water Type: RPWWD
Open

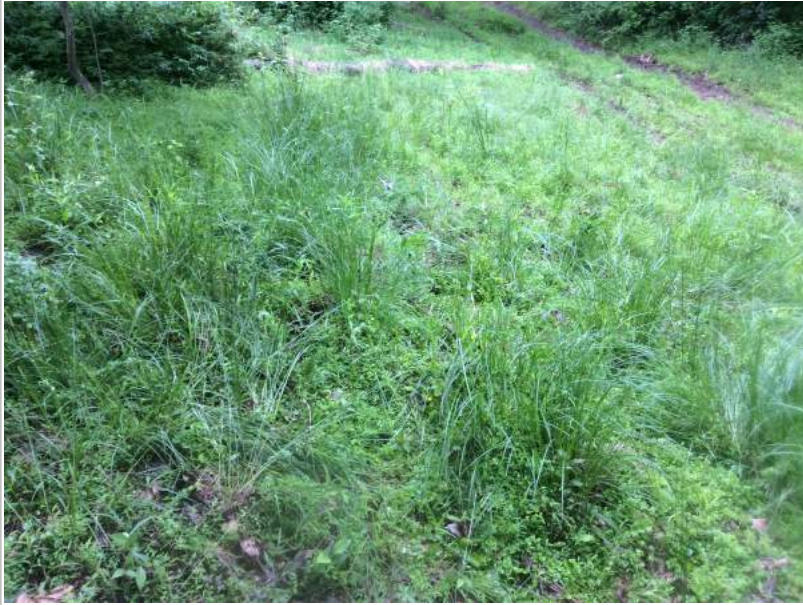
Wetland ID W-K52

Photograph Direction West

Comments: 2015 wetland delineation.

2015 comments: Wetland plot paired with W-K52UP. Slope wetland occurs on slope where groundwater is discharging. Water is pooling in tire ruts of roadbed. Small drainage feature also contributes flows.

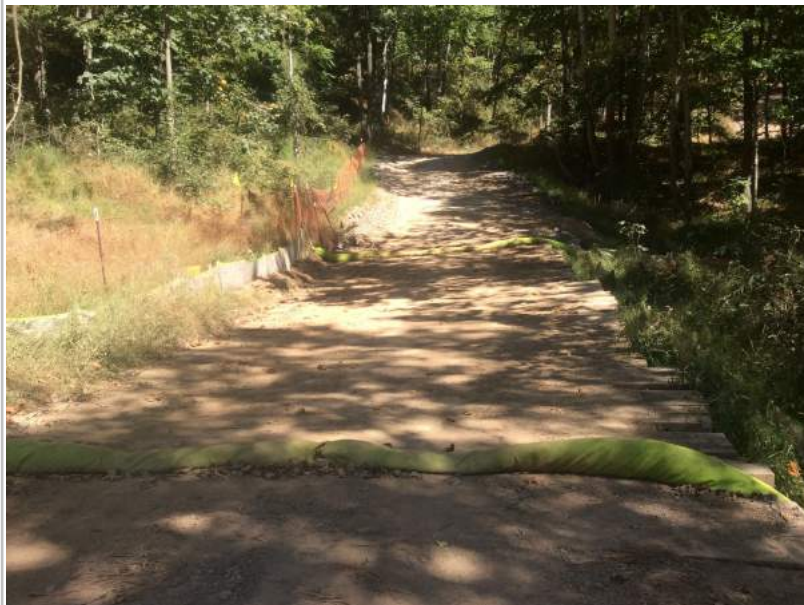
Photograph Direction East

Comments: 2019 wetland delineation confirmation.

Information listed on this form represents the data collected in 2015. The wetland was revisited on 09/18/2019. The presence of wetland hydrology, hydrophytic vegetation, and hydric soils was unable to be confirmed because the wetland was obstructed by timber matting.
