## Baseline Assessment – Stream Attributes

### Reach S-A69(1) (Pipeline ROW) Intermittent Spread D Nicholas County, West Virginia

## Spread D Stream S-A69 (1) (Pipeline ROW) Nicholas County

Profile PROFILE AND CROSS-SECTIONS  
BASELINE SURVEY  
CROSSING S-A69 (1) - UNNAMED TRIB.  
TO BIG BEAVER CREEK (MP 115.47)  
NICHOLAS COUNTY, WV

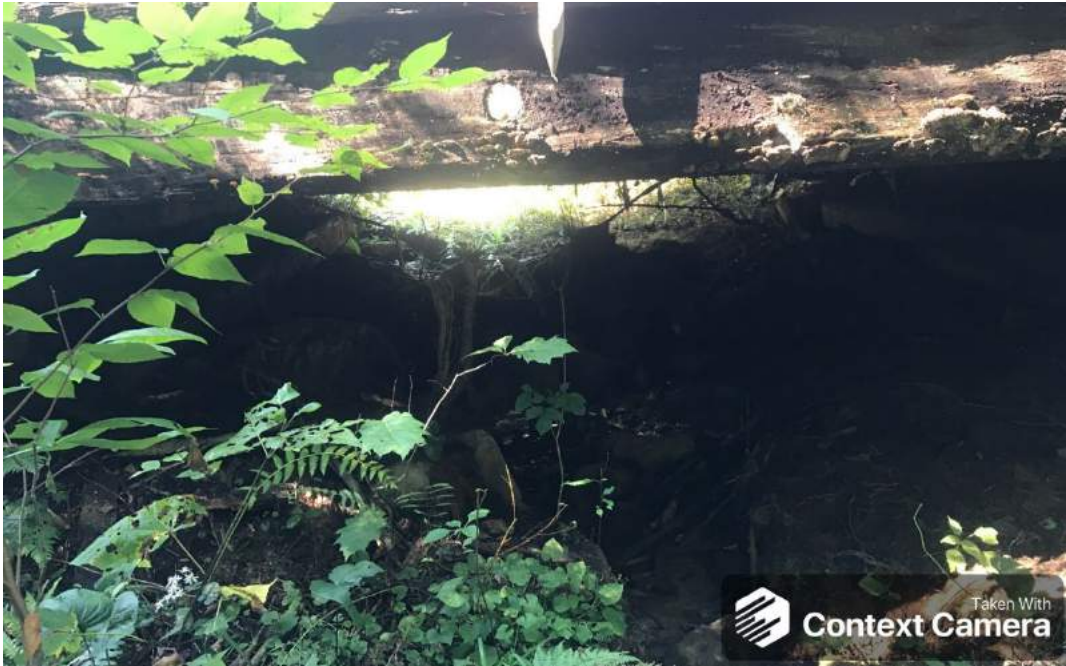
Photo Type: DS, US View  
Location, Orientation, Photographer Initials: Downstream Edge of ROW, Upstream View, JM  
Lat: 38.317217 Long: -80.671495 (9/7/2021)

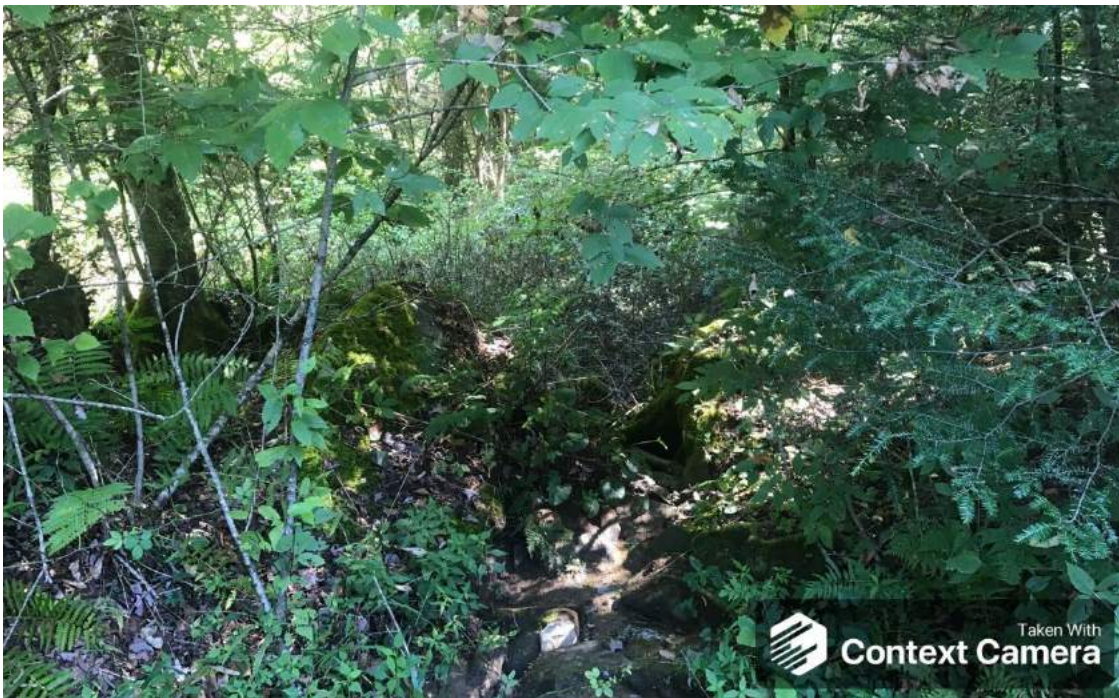
Photo Type: DS, DS View  
Location, Orientation, Photographer Initials: Downstream Edge of ROW, Downstream View, JM  
Lat: 38.317217 Long: -80.671495 (9/7/2021)

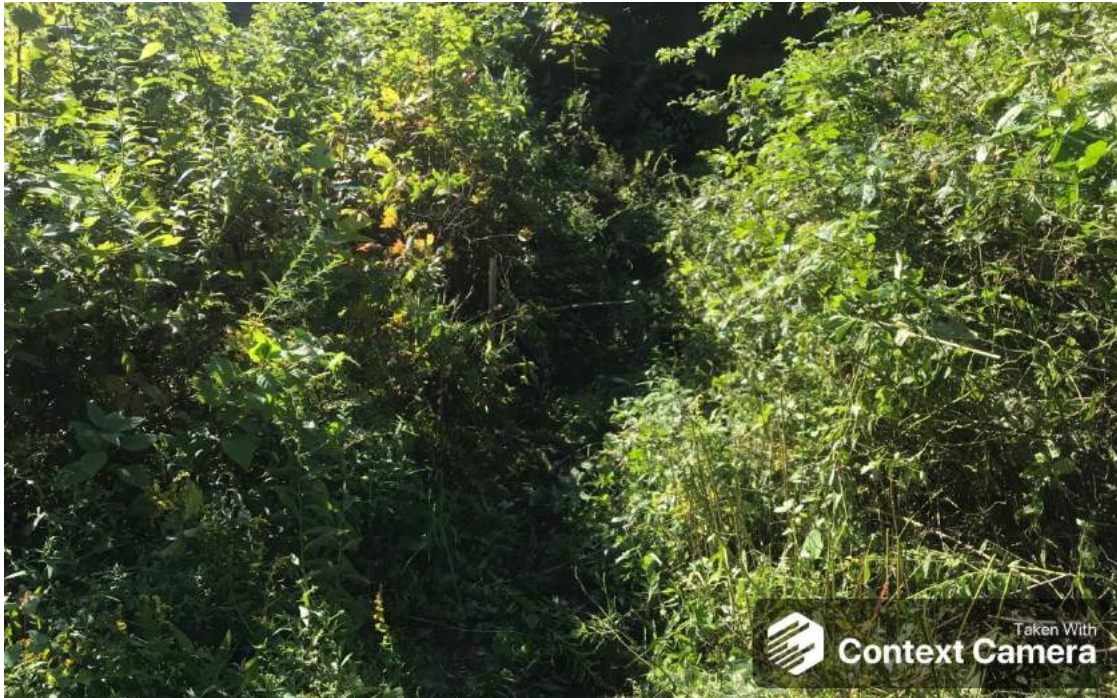
Photo Type: US View at Center  
Location, Orientation, Photographer Initials: Center ROW, Upstream View, JM  
Lat: 38.317217 Long: -80.671495 (9/7/2021)

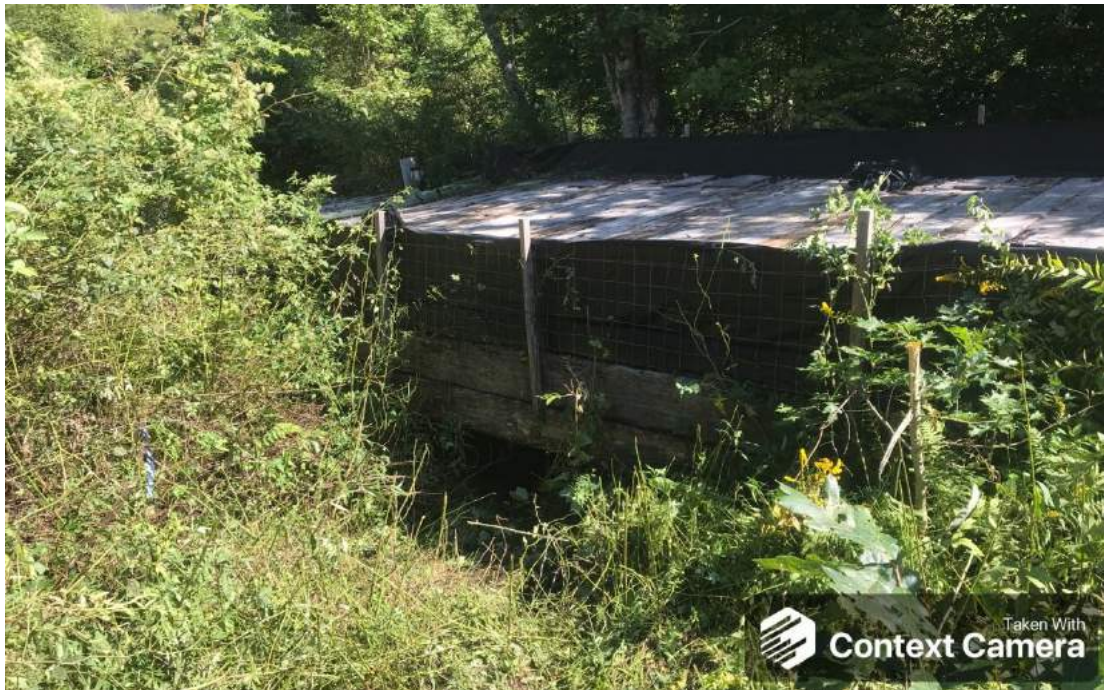
Photo Type: DS View at Center  
Location, Orientation, Photographer Initials: ROW Center, Downstream View, JM  
Lat: 38.317217 Long: -80.671495 (9/7/2021)

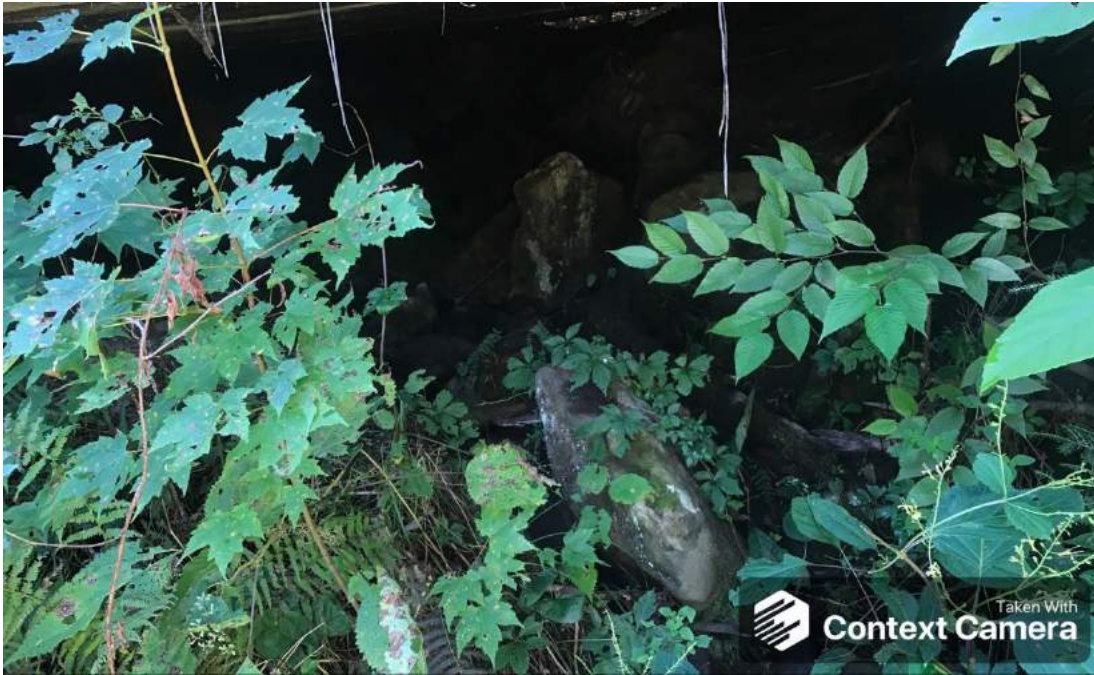
Photo Type: US, US View

Location, Orientation, Photographer Initials: Upstream Edge of ROW, Upstream View, JM  
Lat: 38.317217 Long: -80.671495 (9/7/2021)

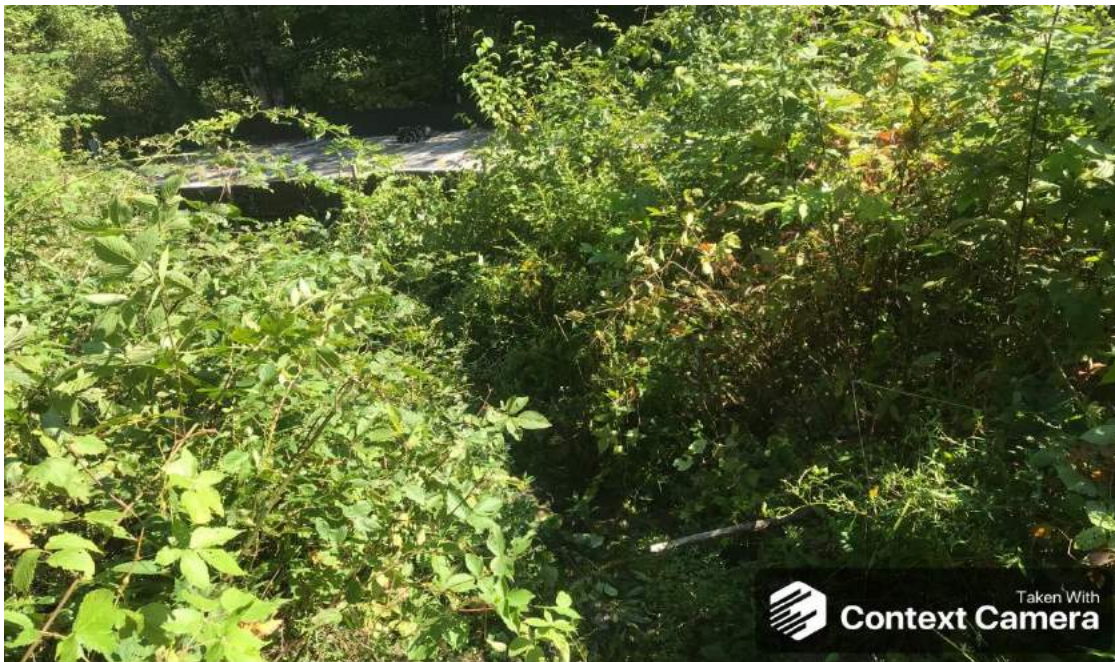
Photo Type: US, DS View

Location, Orientation, Photographer Initials: Upstream Edge of ROW, Downstream View, JM  
Lat: 38.317217 Long: -80.671495 (9/7/2021)

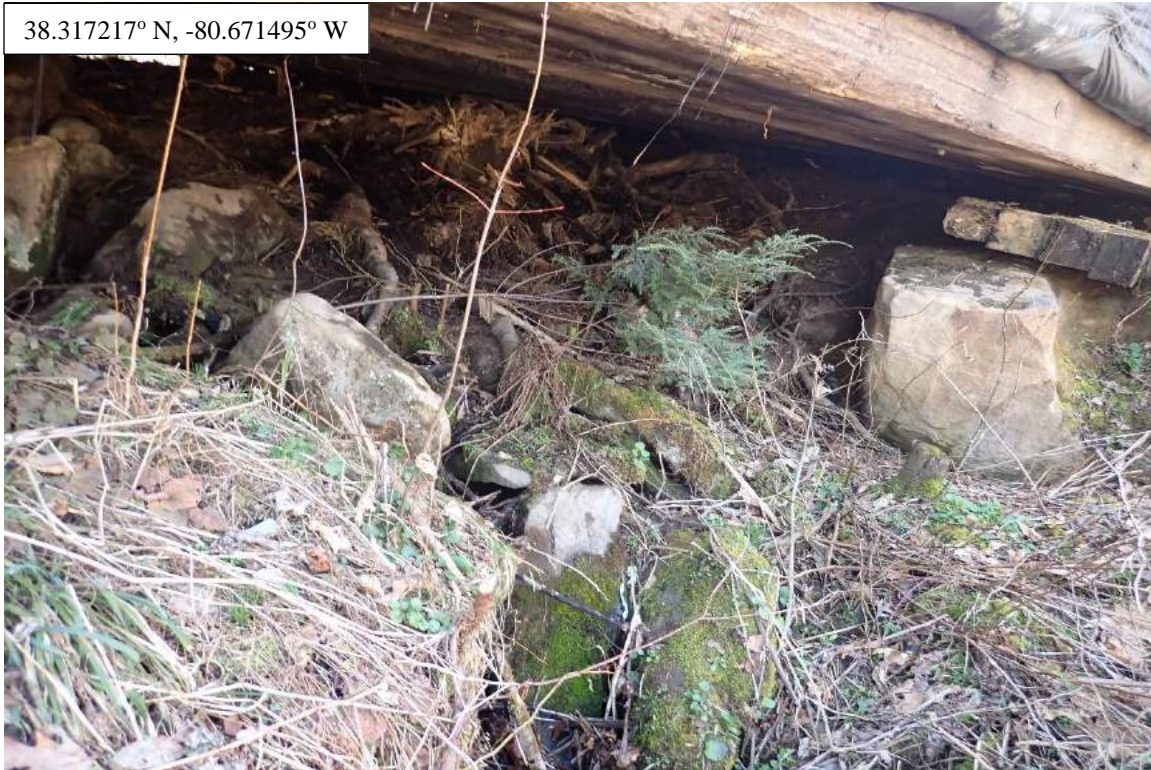
Photo Type: US Edge of ROW, US View  
Location, Orientation, Photographer Initials: Upstream Edge of Right of Way, Upstream View, BB/ABK  
(3/24/2022)

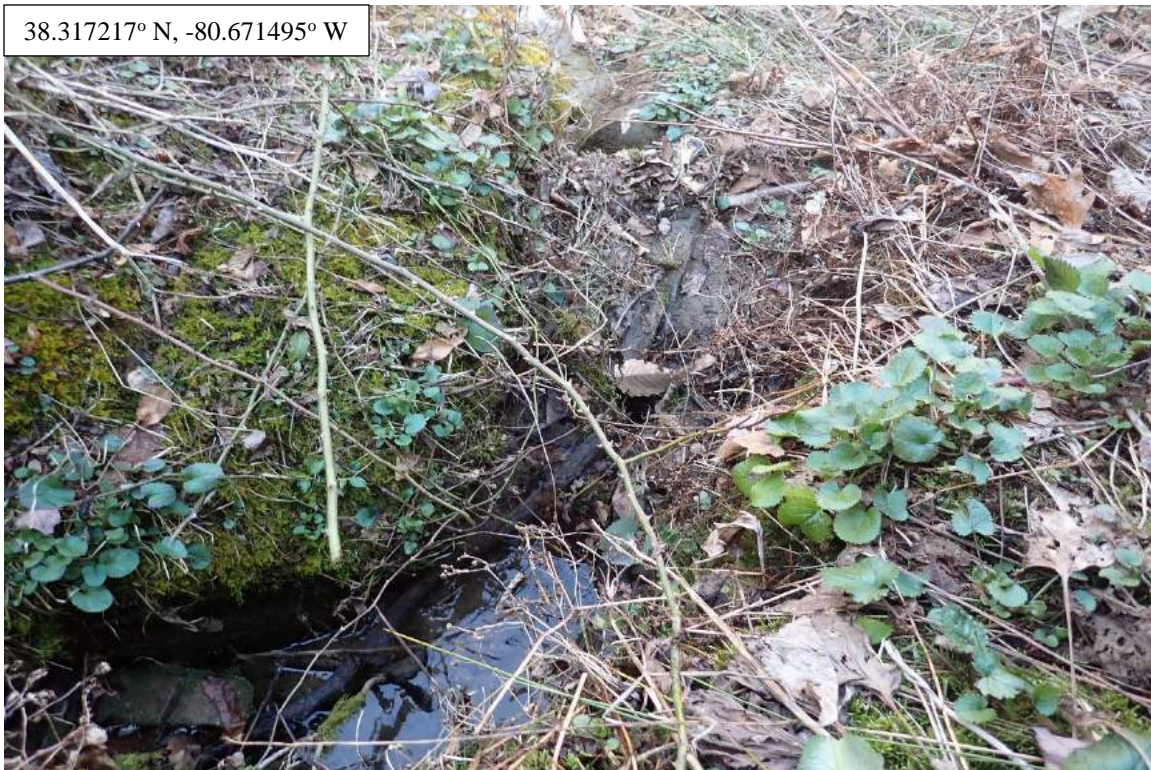
Photo Type: US Edge, DS View  
Location, Orientation, Photographer Initials: Upstream Edge of Right of Way, Downstream View, BB/ABK  
(3/24/2022)

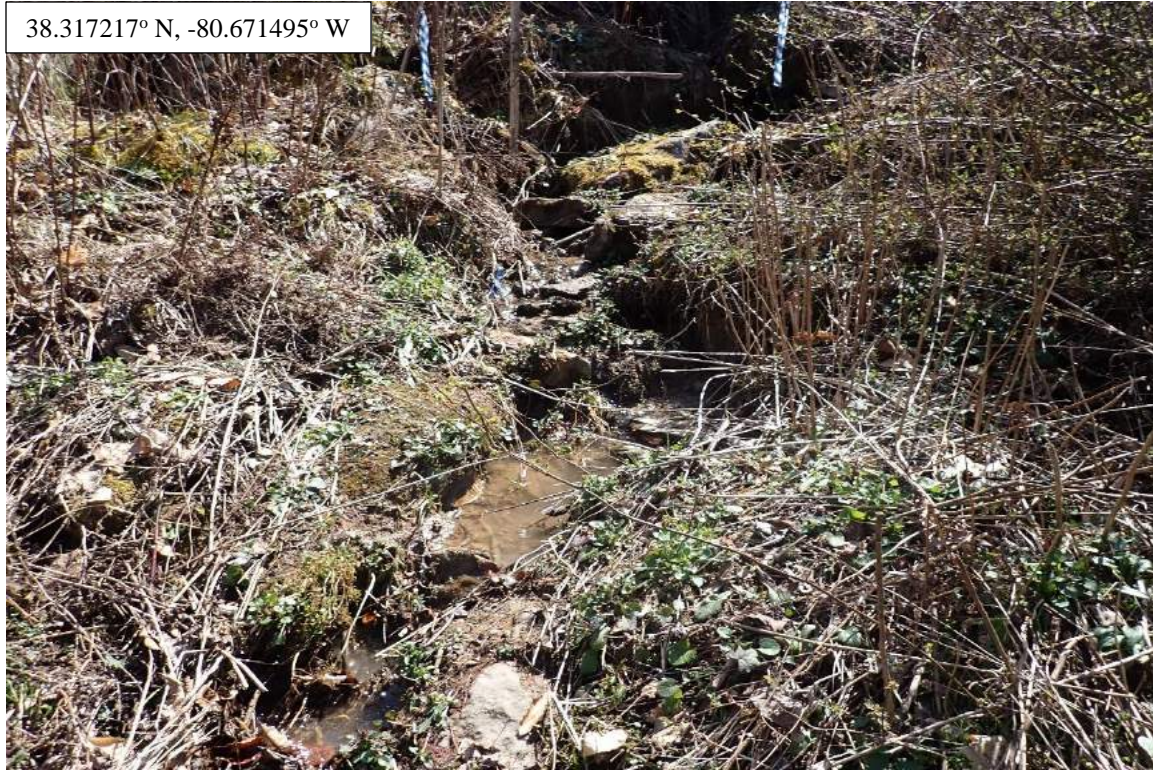
Photo Type: C ROW, US View

Location, Orientation, Photographer Initials: Center of Right of Way, Upstream View, BB/ABK (3/24/2022)

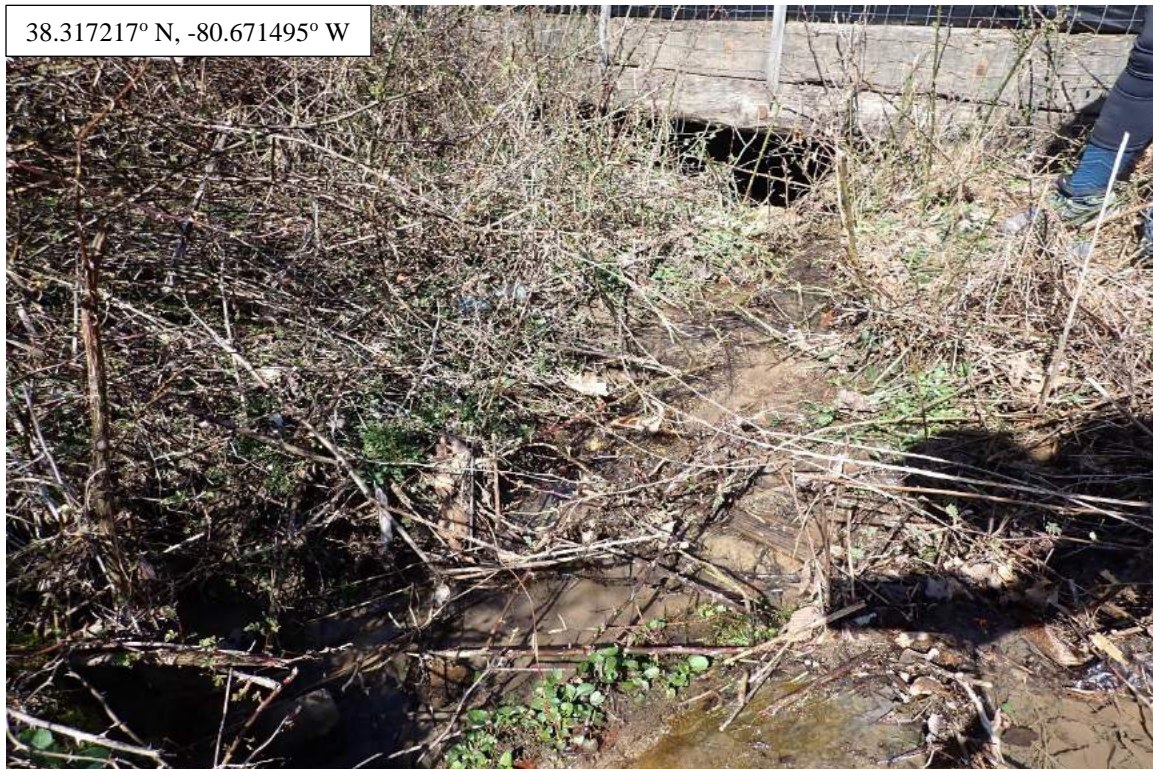
Photo Type: C ROW, DS View

Location, Orientation, Photographer Initials: Center of Right of Way, Downstream View, BB/ABK (3/24/2022)

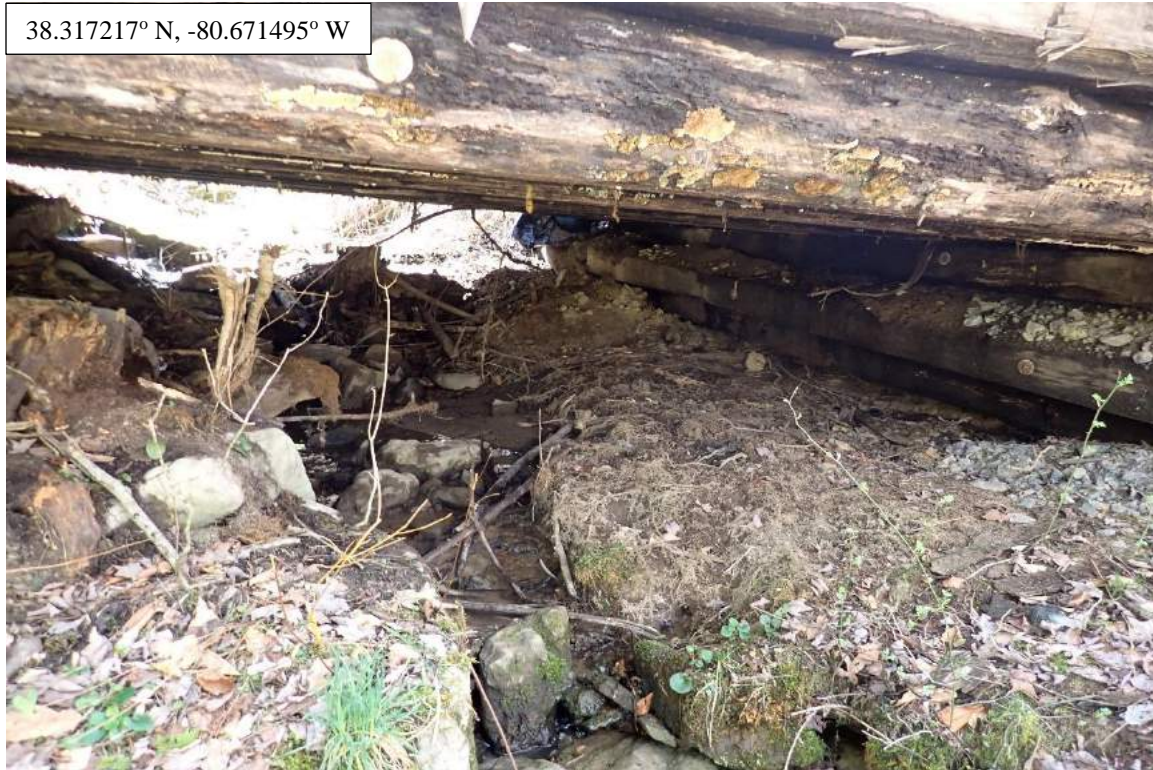
Photo Type: DS Edge, US View

Location, Orientation, Photographer Initials: Downstream Edge of Right of Way, Upstream View, BB/ABK  
(3/24/2022)

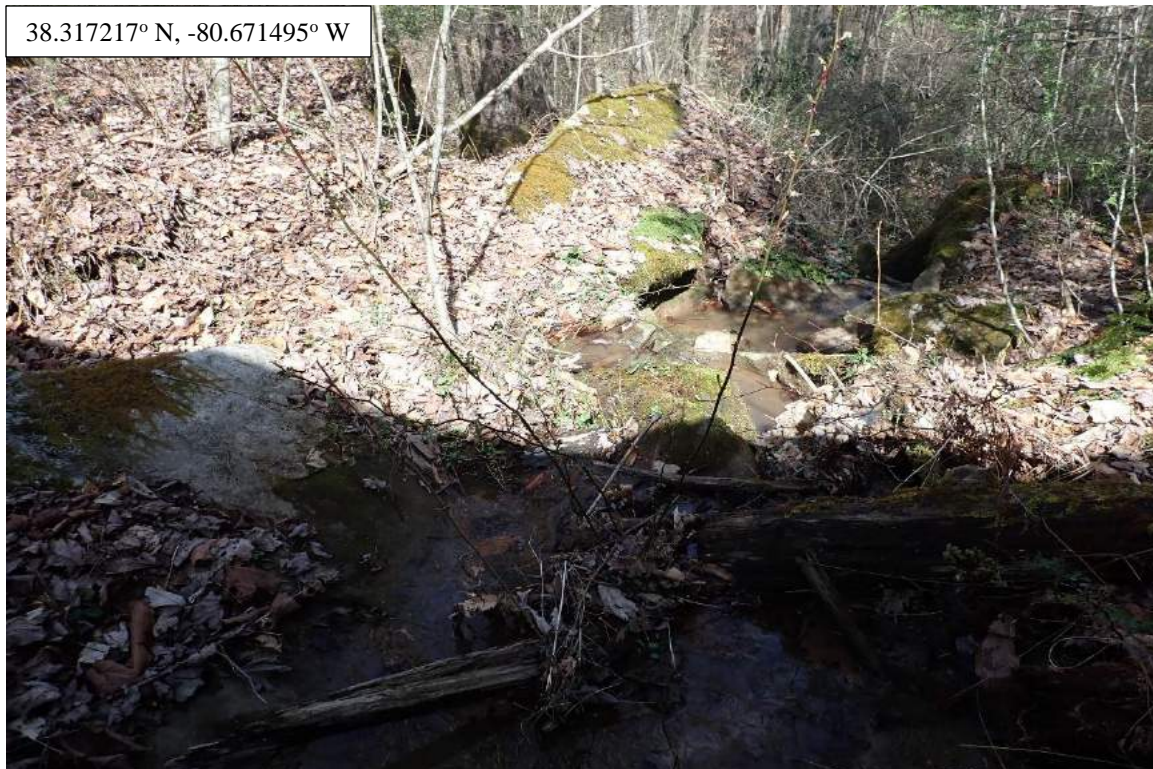
Photo Type: DS Edge, DS View

Location, Orientation, Photographer Initials: Downstream Edge of Right of Way, Downstream View, BB/ABK  
(3/24/2022)

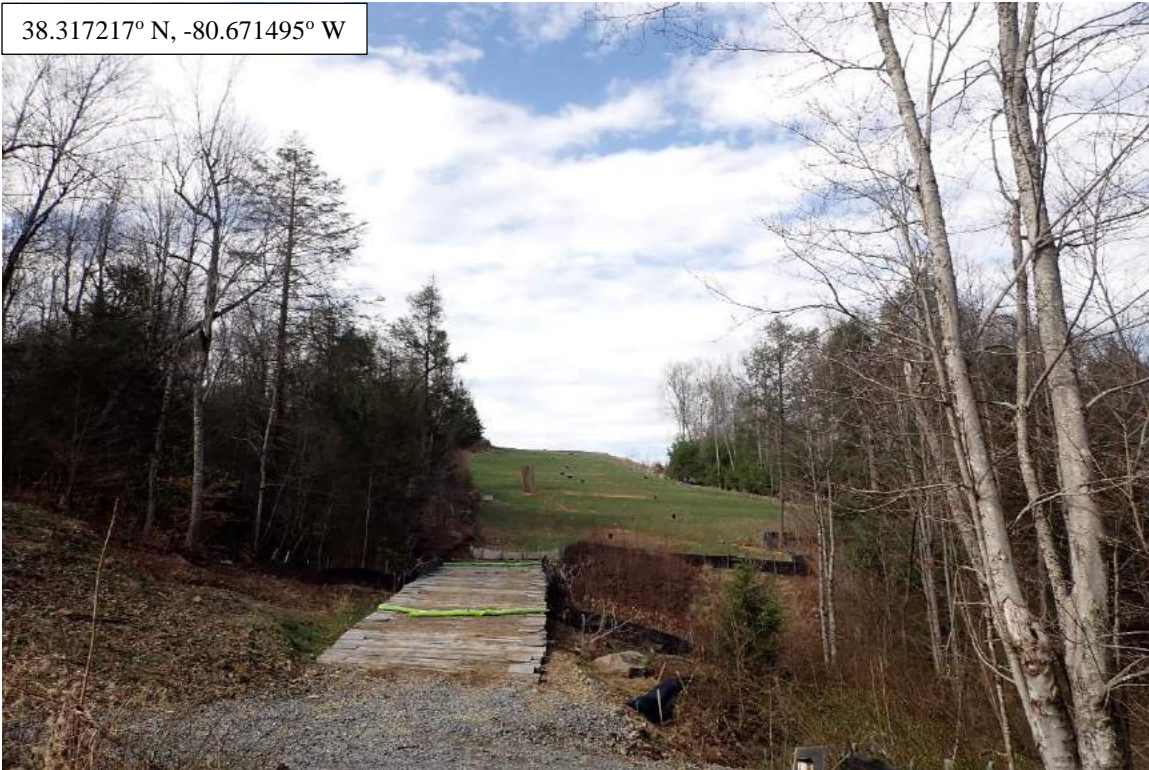
Photo Type: ROW, N

Location, Orientation, Photographer Initials: Right of Way, North View, BB/ABK (3/24/2022)

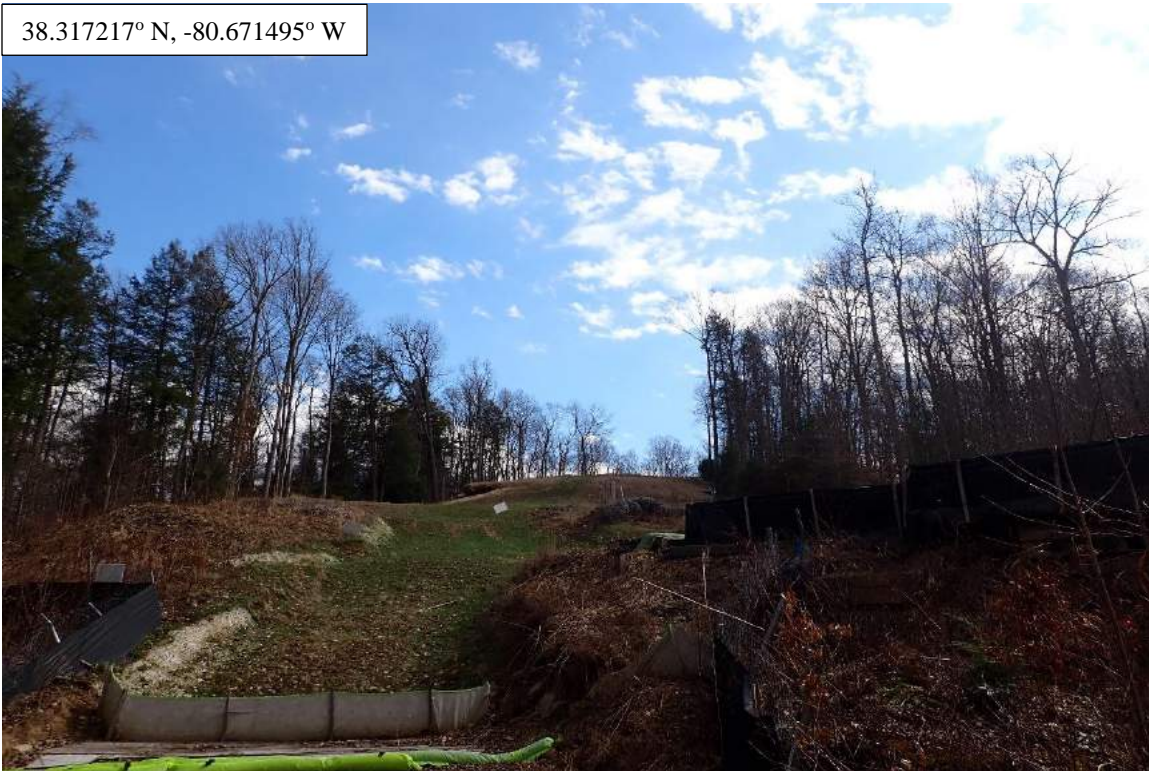
Photo Type: ROW, S

Location, Orientation, Photographer Initials: Right of Way, South View, BB/ABK (3/24/2022)

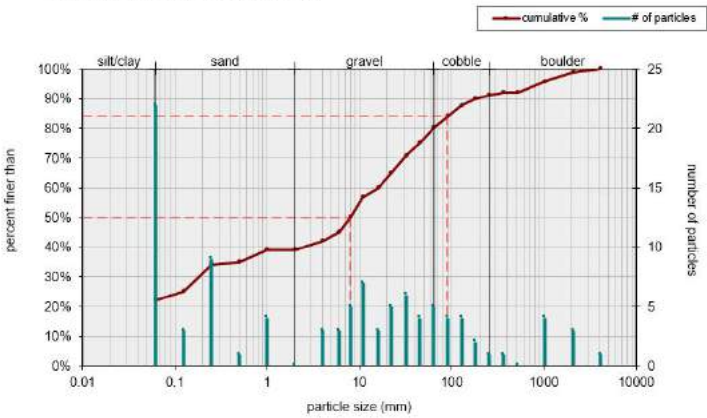
Bankfull Channel Pebble Count, S-A69 (1)

Size (mm)		Size Distribution		Type	
D16	0.062	mean	2.4	silt/clay	22%
D35	0.5	dispersion	70.1	sand	17%
D50	8	skewness	-0.30	gravel	41%
D65	22			cobble	11%
D84	90			boulder	9%
D95	860

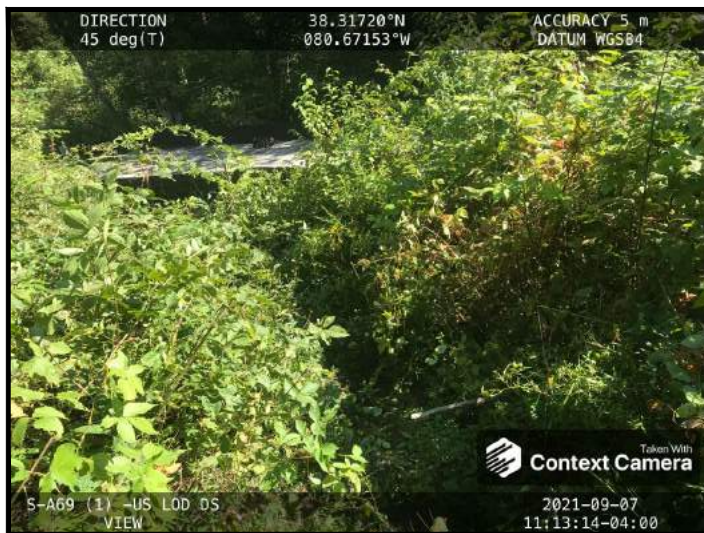
PHOTO TAKEN LOOKING DOWNSTREAM  
FROM UPSTREAM IMPACT LIMITS

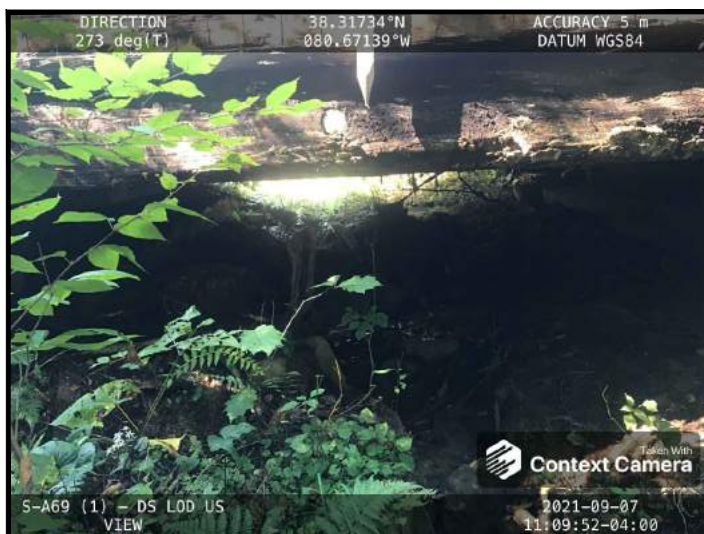
PHOTO TAKEN LOOKING UPSTREAM FROM  
DOWNSTREAM IMPACT LIMITS

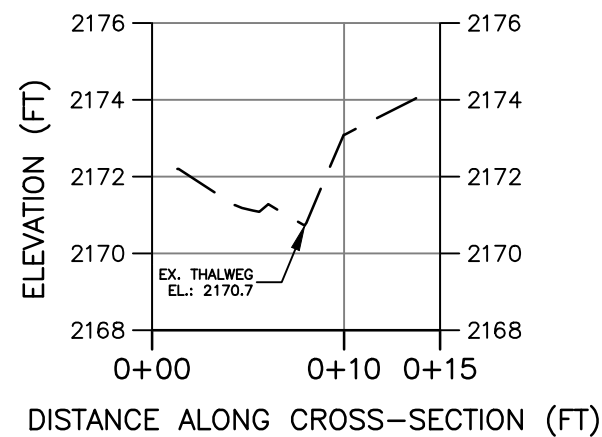
**CROSS SECTION**  
SCALE: H: 1"=10'  
V: 1"=5'

— — — EXISTING GRADE

AS-BUILT TABLE: S-A69 (1) CROSS SECTION A					
PRE-CROSSING				AS-BUILT	
PT. LOC.	NORTHING	EASTING	ELEV	VERT. DIFF.	HORZ. DIFF.
TS-L	13914249.47	1734655.67	2172.20		
BS-L	13914246.78	1734656.81	2171.25		
THW	13914245.18	1734657.49	2171.28		
BS-R	13914243.40	1734658.25	2170.76		
TS-R	13914241.52	1734659.59	2173.06
