## Baseline Assessment – Stream Attributes

### Reach S-CV27 (Pipeline ROW) Intermittent Spread F Monroe County, West Virginia

Title  
PROFILE AND CROSS-SECTIONS  
BASELINE SURVEY  
CROSSING S-CV27 - UNNAMED TRIB. OF  
HANS CREEK (MP 190.9)  
MONROE COUNTY, WV

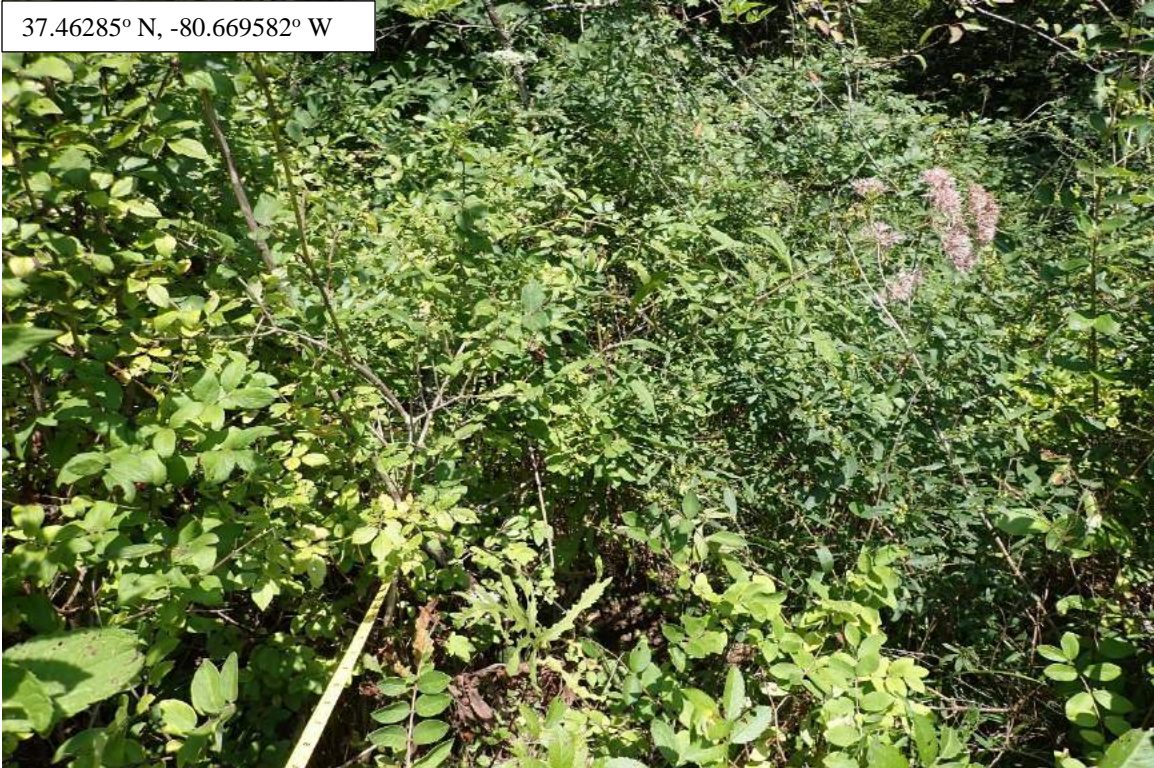
Photo Type: US, US View

Location, Orientation, Photographer Initials: Upstream Edge of Right of Way, Upstream View, AK/WP/RA/EW

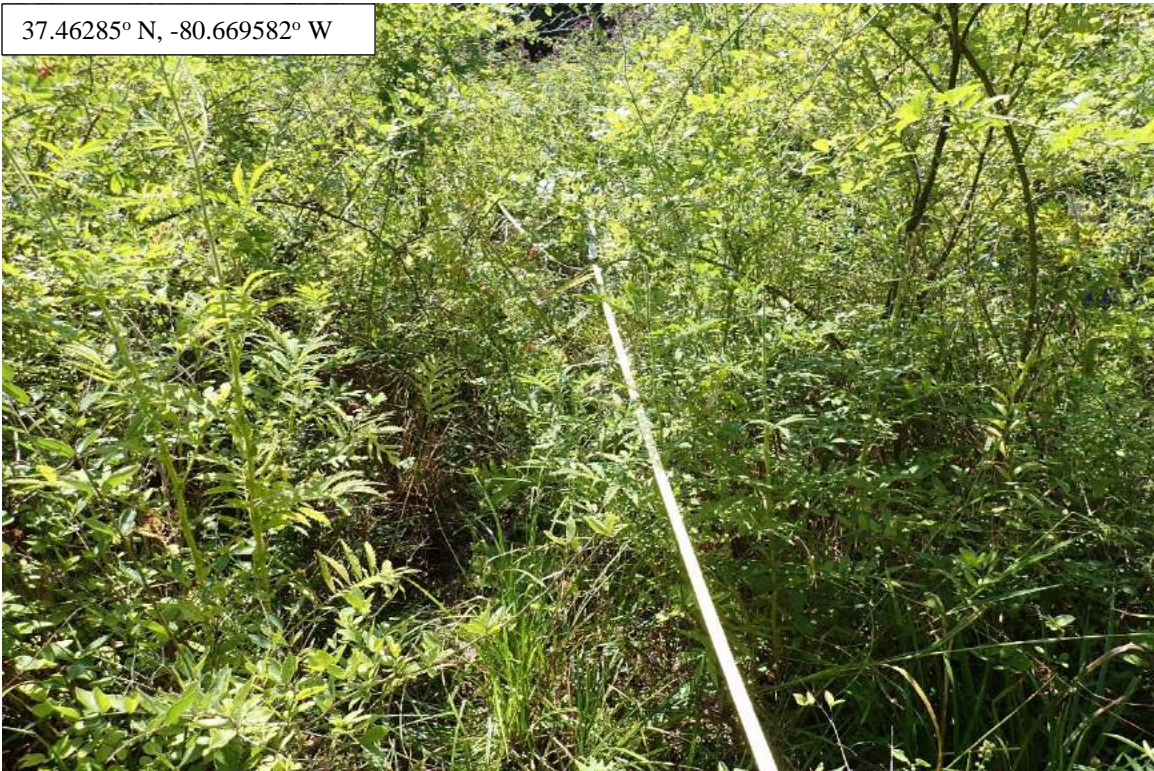
Photo Type: US, DS View

Location, Orientation, Photographer Initials: Upstream Edge of Right of Way, Downstream View, AK/WP/RA/EW

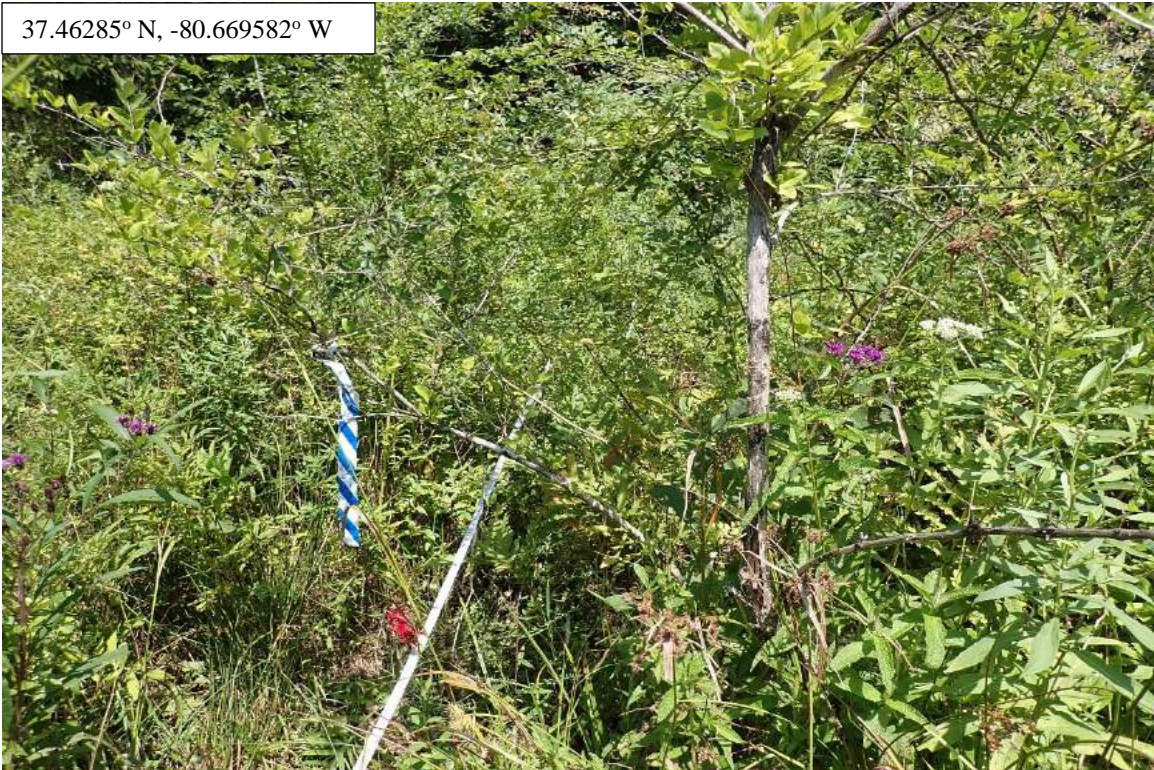
Photo Type: CP, US View

Location, Orientation, Photographer Initials: Center Point, Upstream View, AK/WP/RA/EW

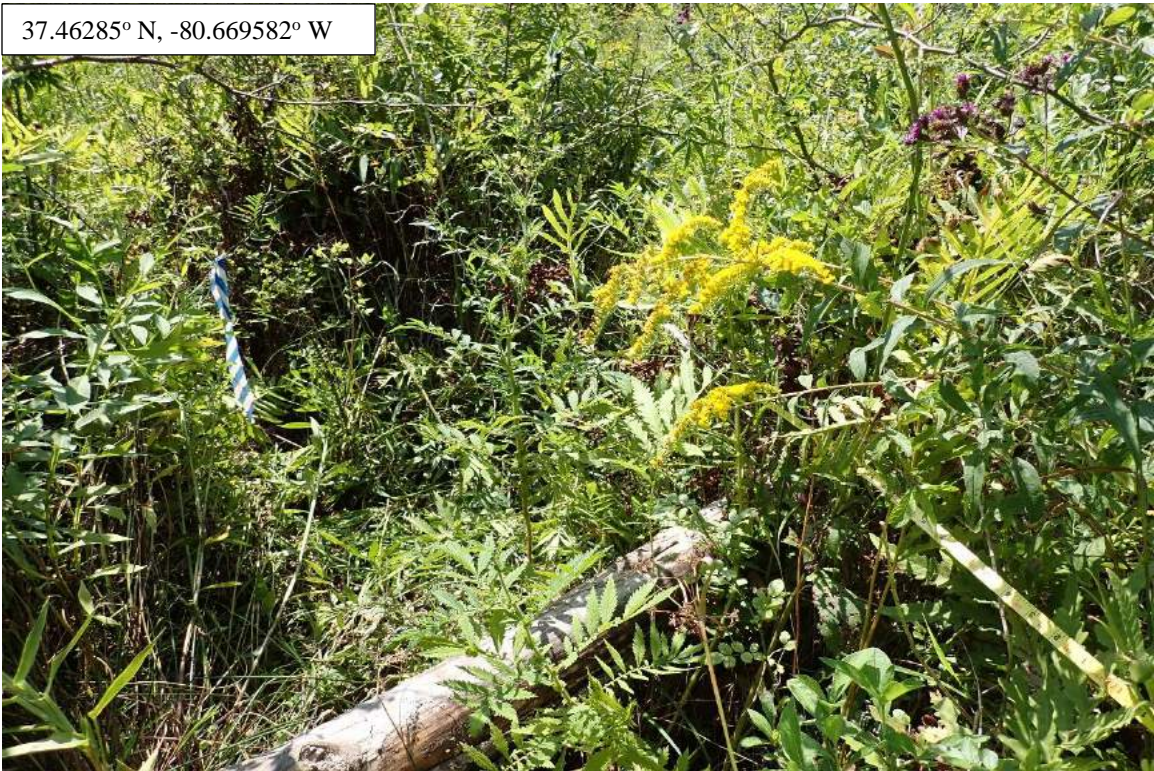
Photo Type: CP, DS View

Location, Orientation, Photographer Initials: Center Point, Downstream View, AK/WP/RA/EW

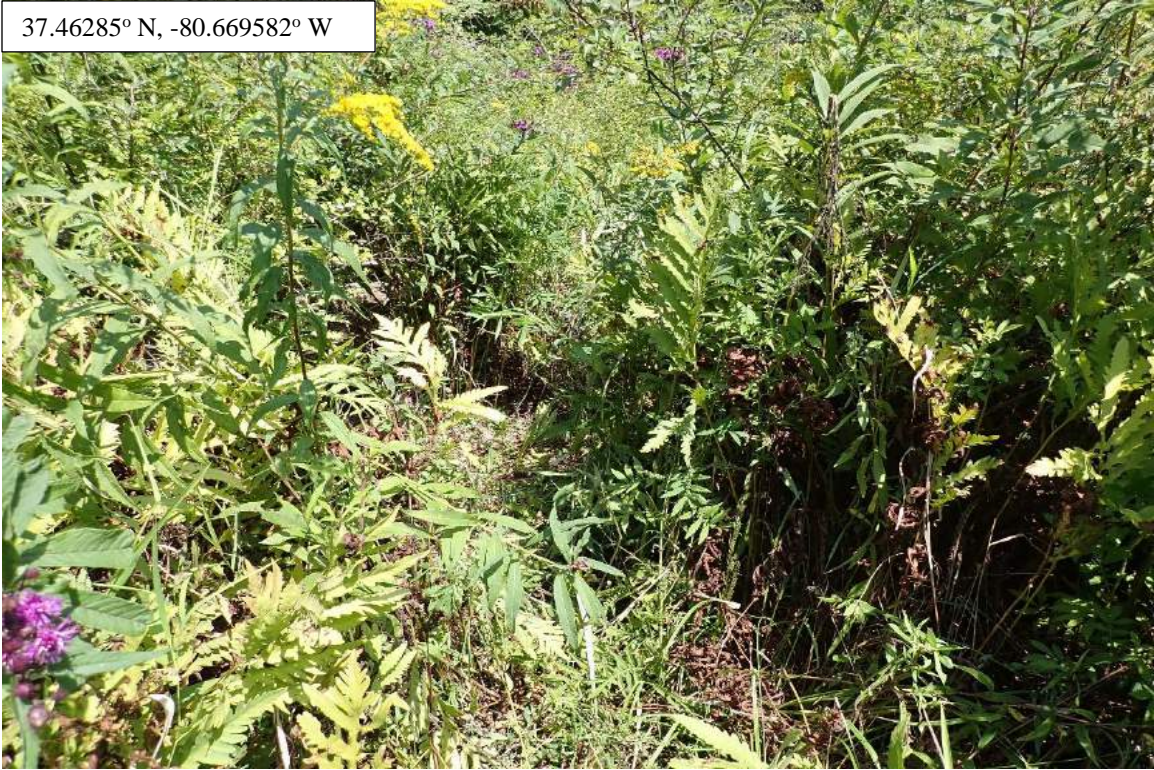
Photo Type: DS, US View

Location, Orientation, Photographer Initials: Downstream Edge of Right of Way, Upstream View, AK/WP/RA/EW

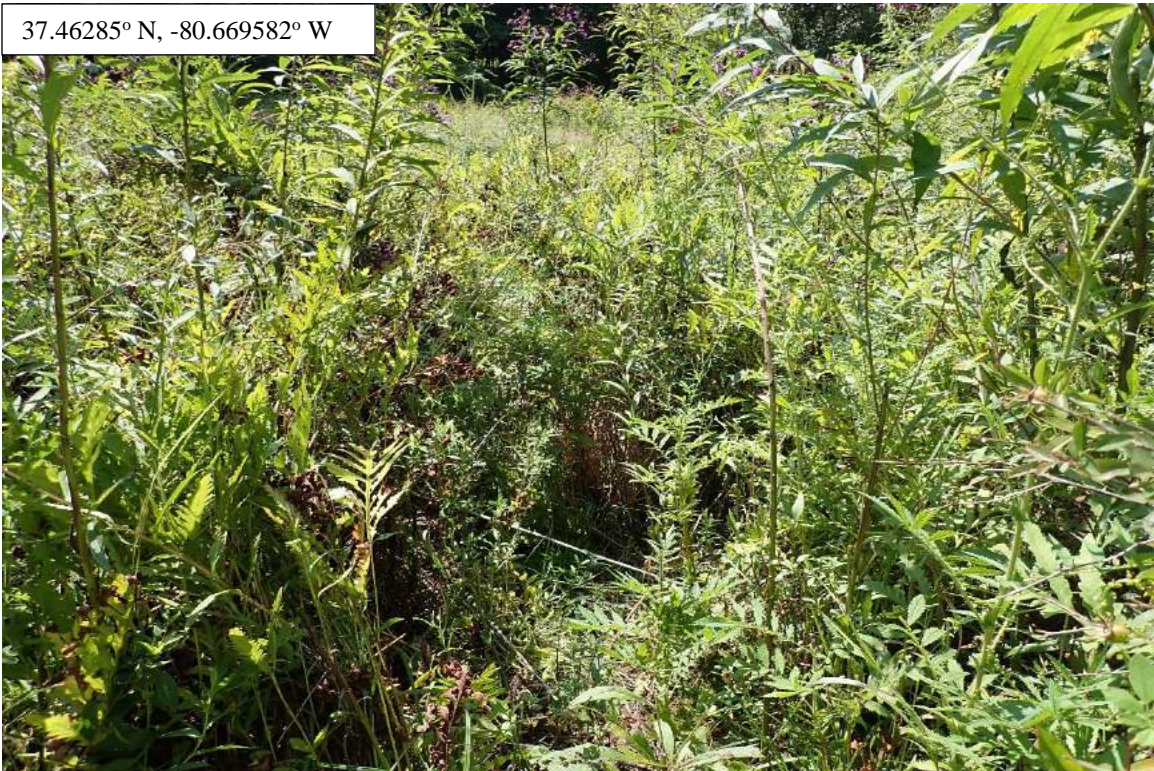
Photo Type: DS, DS View

Location, Orientation, Photographer Initials: Downstream Edge of Right of Way, Downstream View, AK/WP/RA/EW

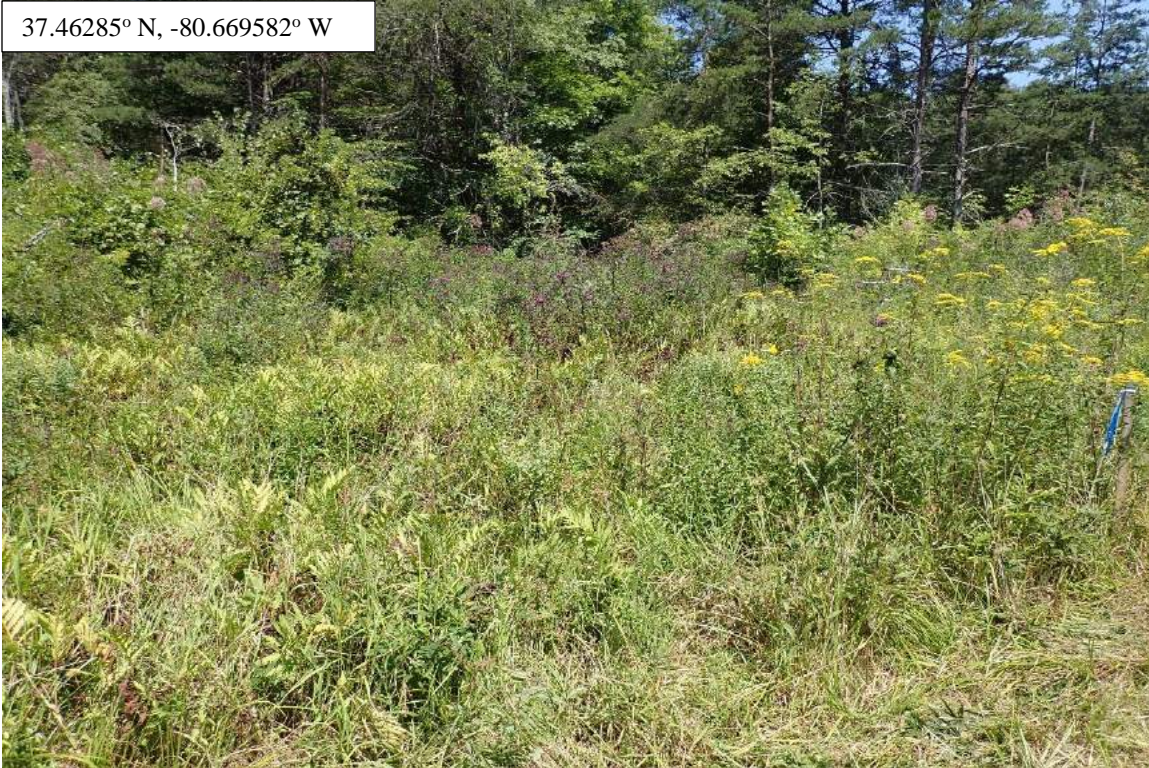
Photo Type: Wetland View

Location, Orientation, Photographer Initials: View of Wetland, AK/WP/RA/EW

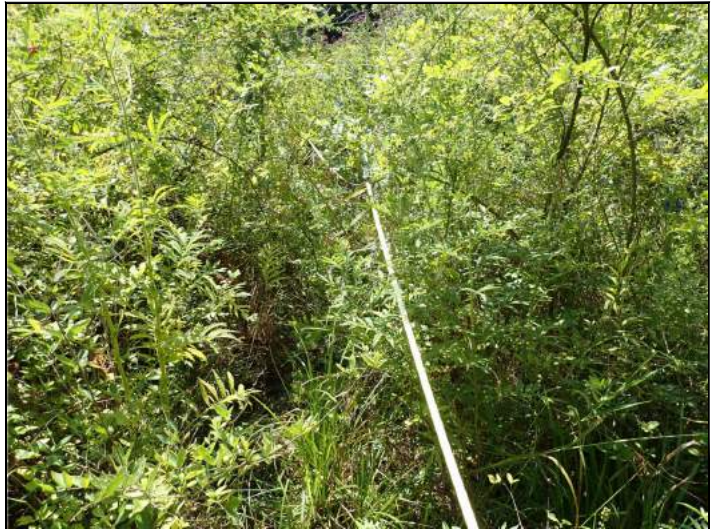
PHOTO TAKEN LOOKING DOWNSTREAM FROM UPSTREAM IMPACT LIMITS

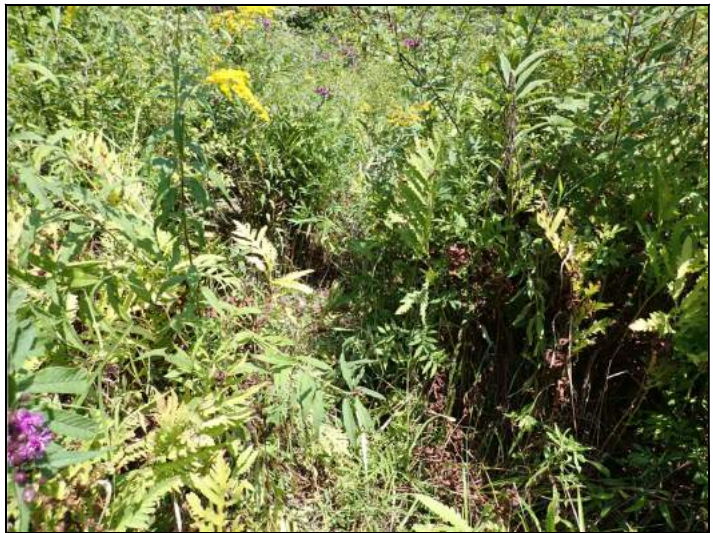
PHOTO TAKEN LOOKING UPSTREAM FROM DOWNSTREAM IMPACT LIMITS
