Baseline Assessment – Stream Attributes

Reach S-F18 TM (Timber Mat Crossing) Perennial Spread F Monroe County, West Virginia

Title
PROFILE AND CROSS-SECTIONS
BASELINE SURVEY
CROSSING S-F18 TM - UNNAMED TRIB.
HANS CREEK (MP 184.25)
MONROE COUNTY, WV

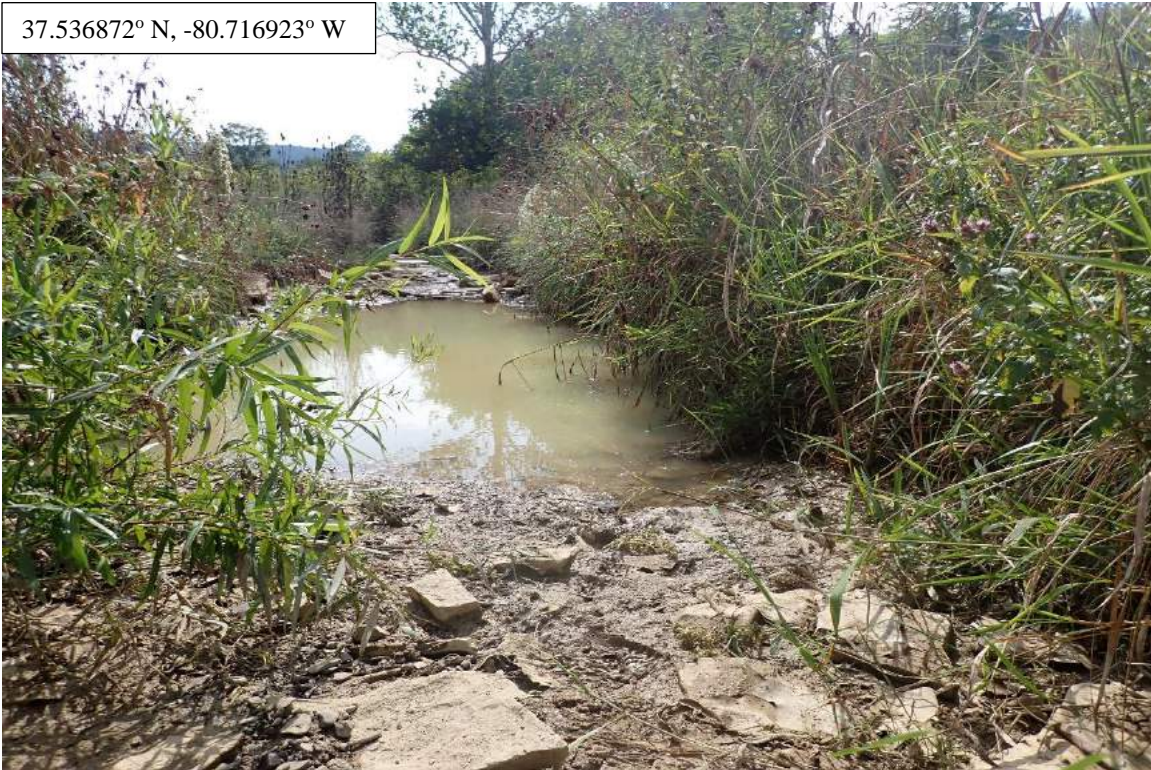
Photo Type: US, US View

Location, Orientation, Photographer Initials: Upstream Edge of Right of Way, Upstream View, ABK/EW/WP

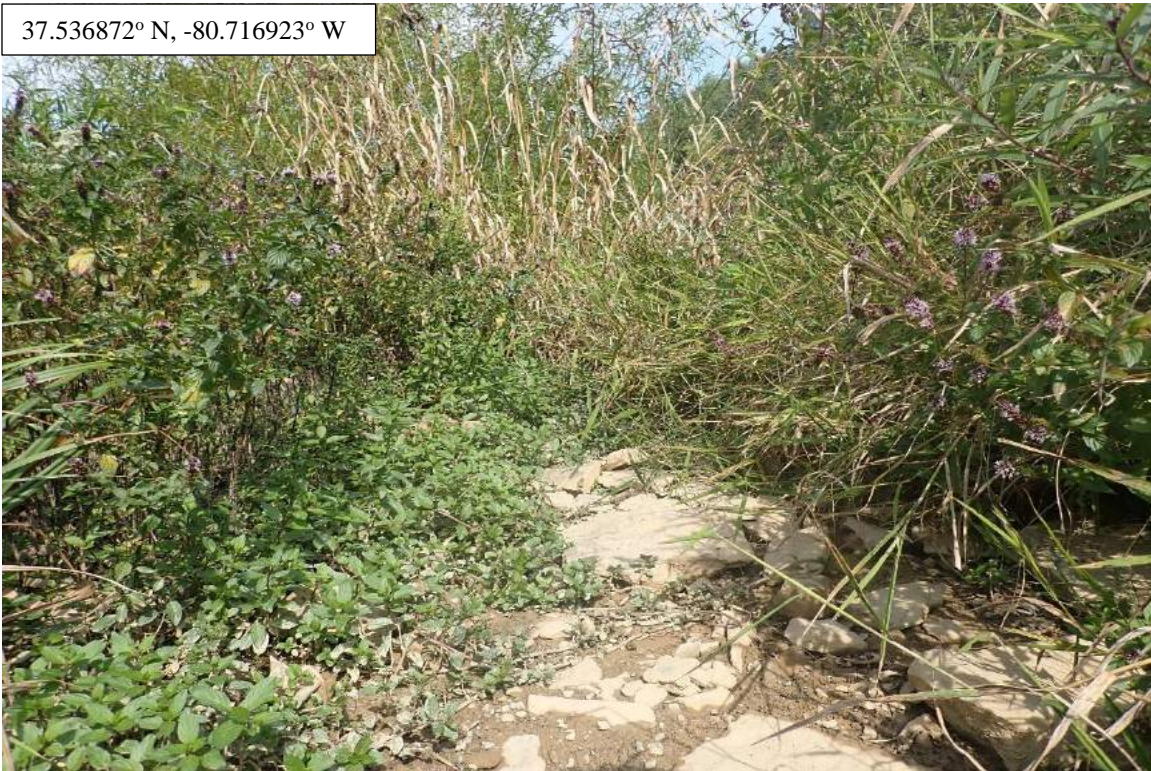
Photo Type: US, DS View

Location, Orientation, Photographer Initials: Upstream Edge of Right of Way, Downstream View, ABK/EW/WP

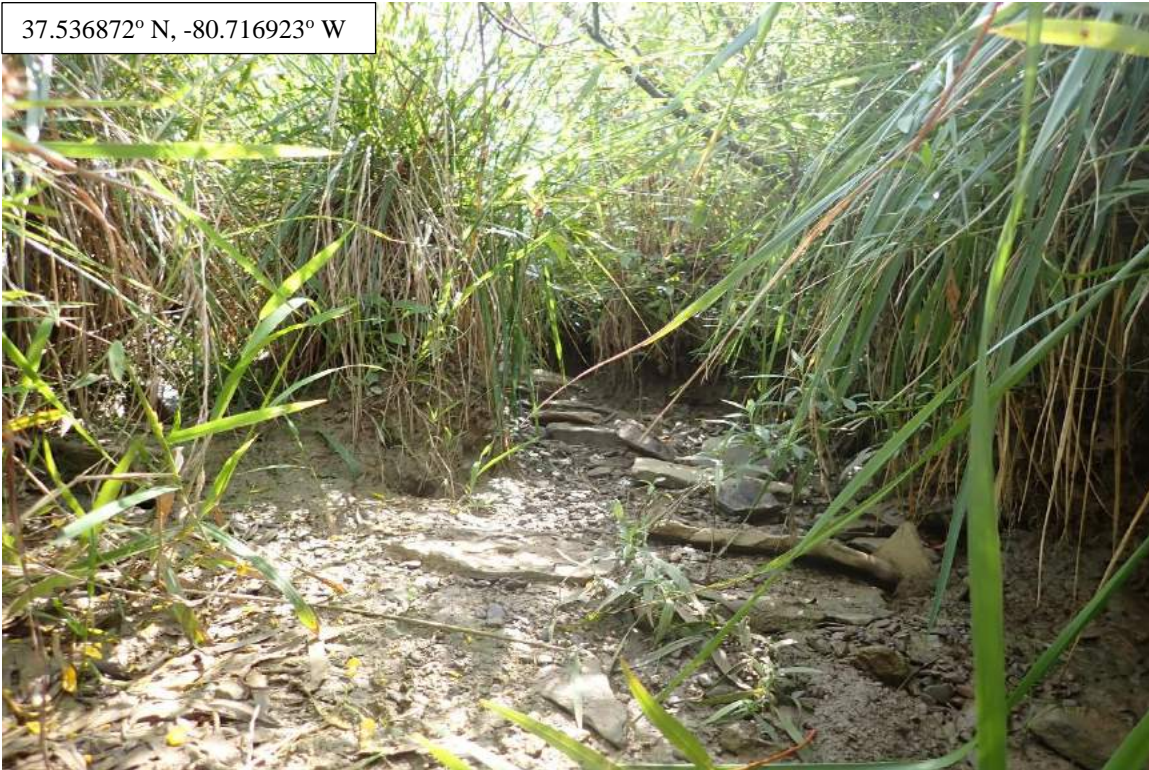
Photo Type: CP, US View

Location, Orientation, Photographer Initials: Center of Right of Way, Upstream View, ABK/EW/WP

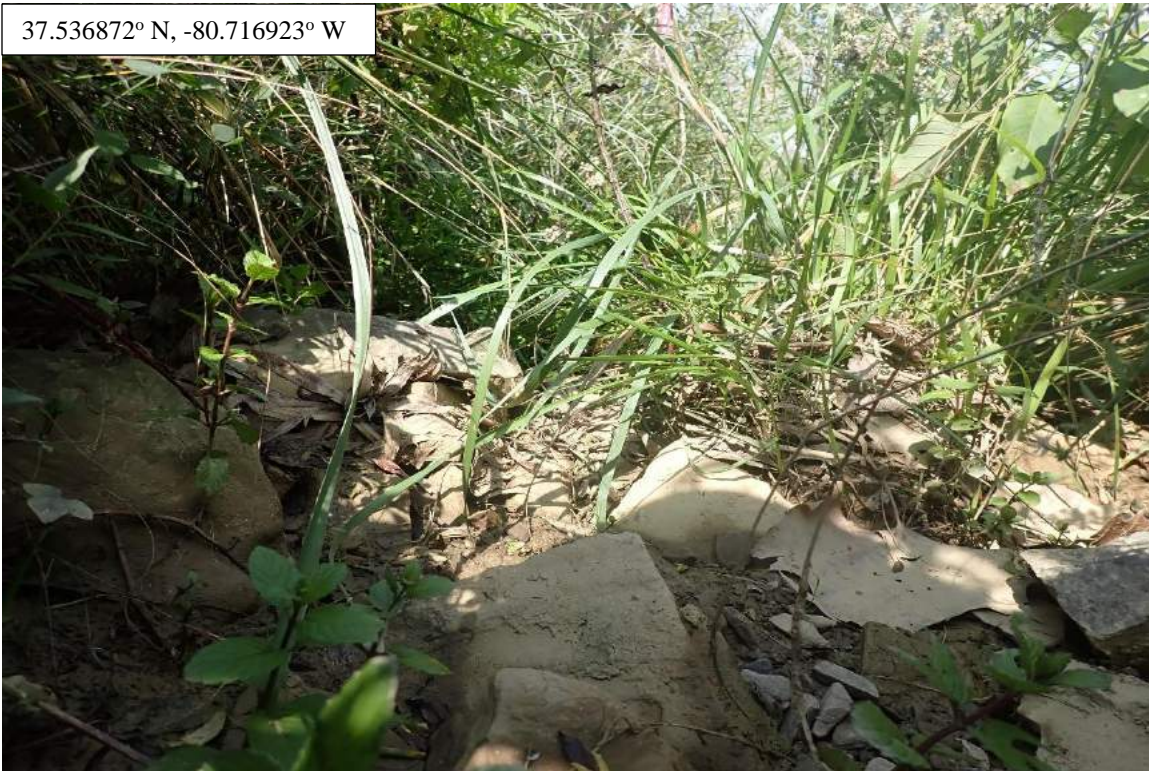
Photo Type: CP, DS View

Location, Orientation, Photographer Initials: Center of Right of Way, Downstream View, ABK/EW/WP

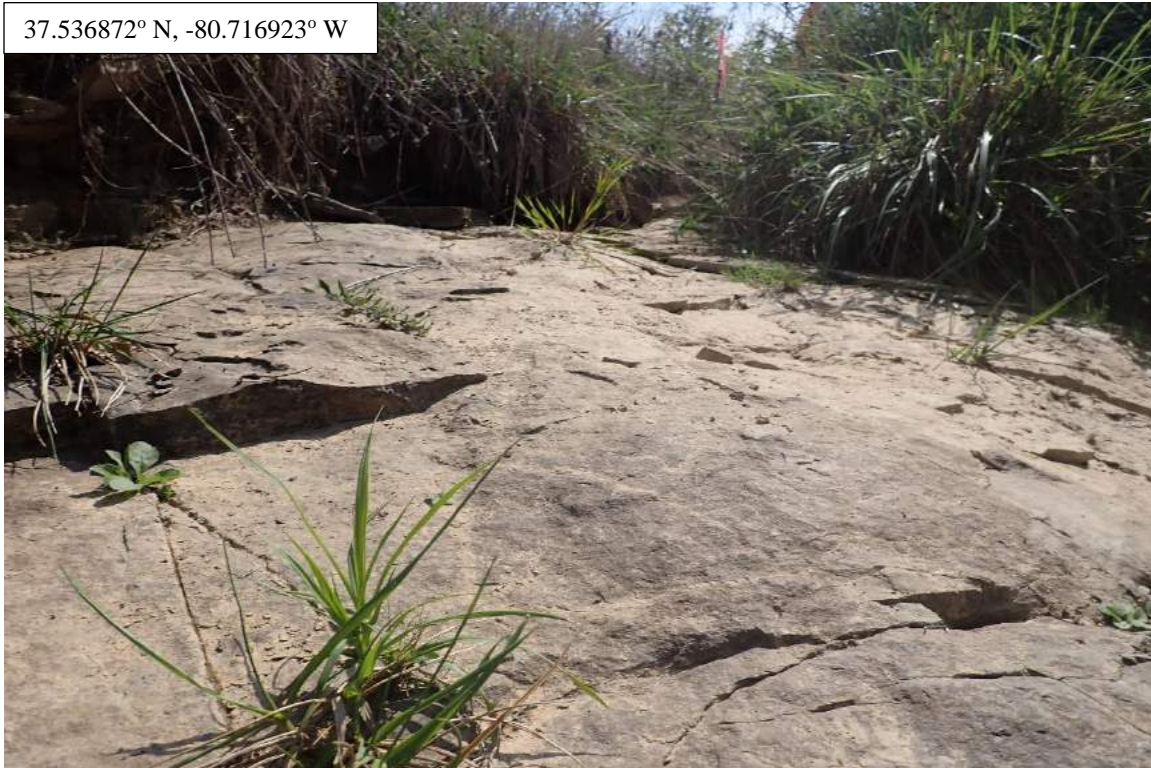
Photo Type: DS, US View

Location, Orientation, Photographer Initials: Downstream Edge of Right of Way, Upstream View, ABK/EW/WP

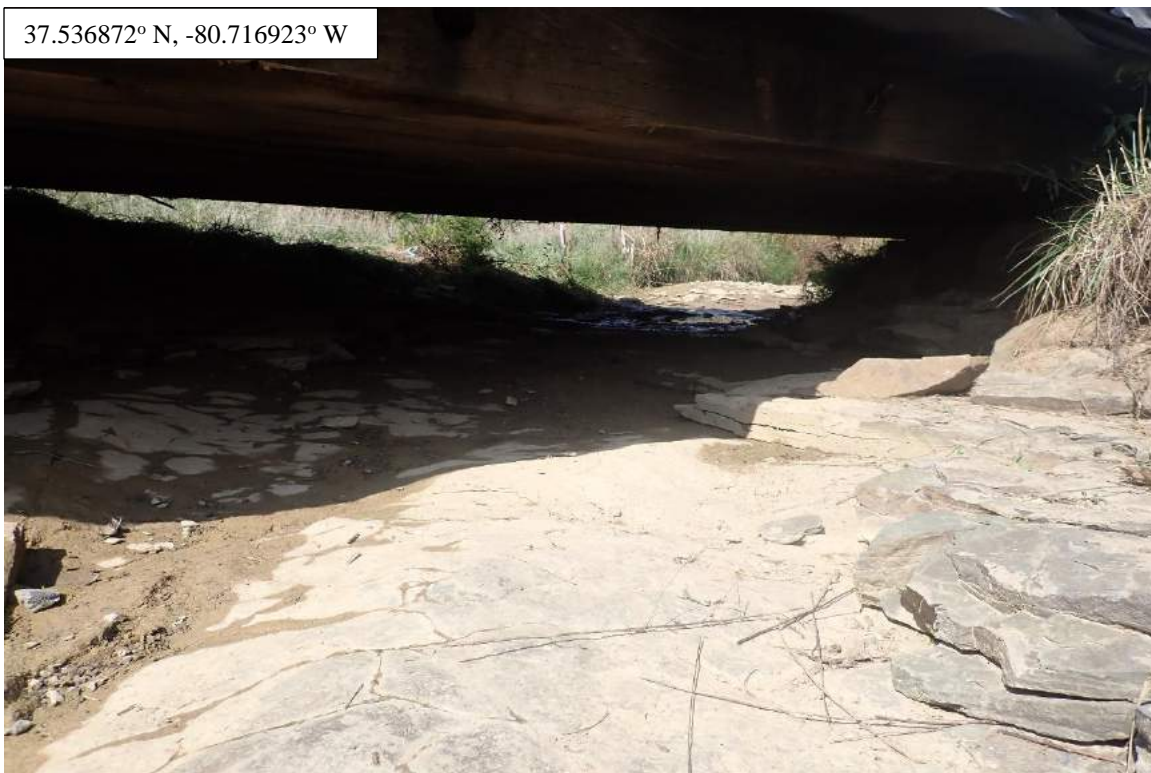
Photo Type: DS, DS View

Location, Orientation, Photographer Initials: Downstream Edge of Right of Way, Downstream View, ABK/EW/WP

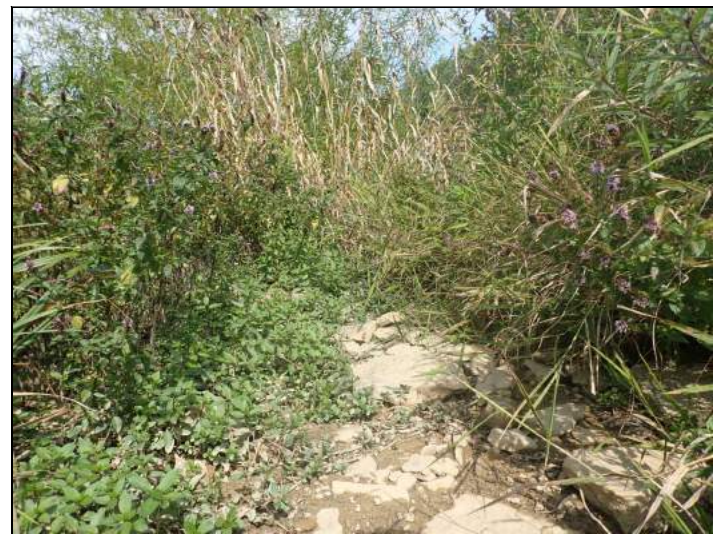
PHOTO TAKEN LOOKING DOWNSTREAM FROM UPSTREAM IMPACT LIMITS

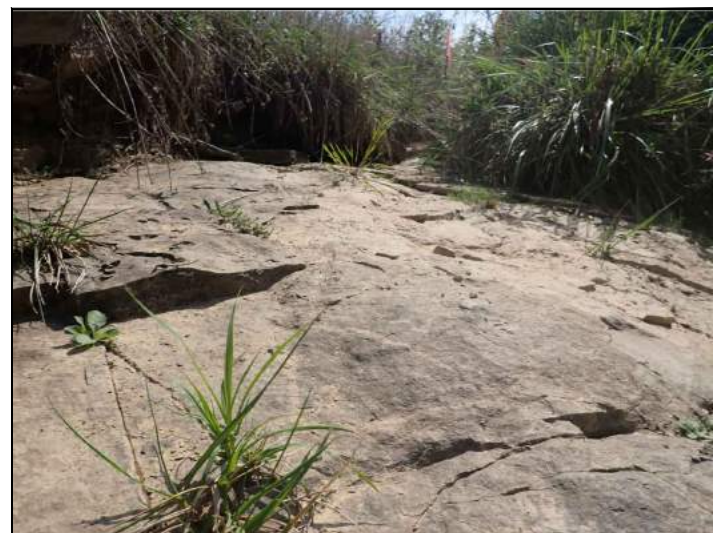
PHOTO TAKEN LOOKING UPSTREAM FROM DOWNSTREAM IMPACT LIMITS
