Baseline Assessment – Stream Attributes

Reach S-F40 (Timber Mat Crossing)

Webster County, West Virginia

Client	<p>PROFILE AND CROSS-SECTIONS BASELINE SURVEY CROSSING S-F40 – OLDLICK CREEK (MP 82.28) WEBSTER COUNTY, WV</p>
MC	222

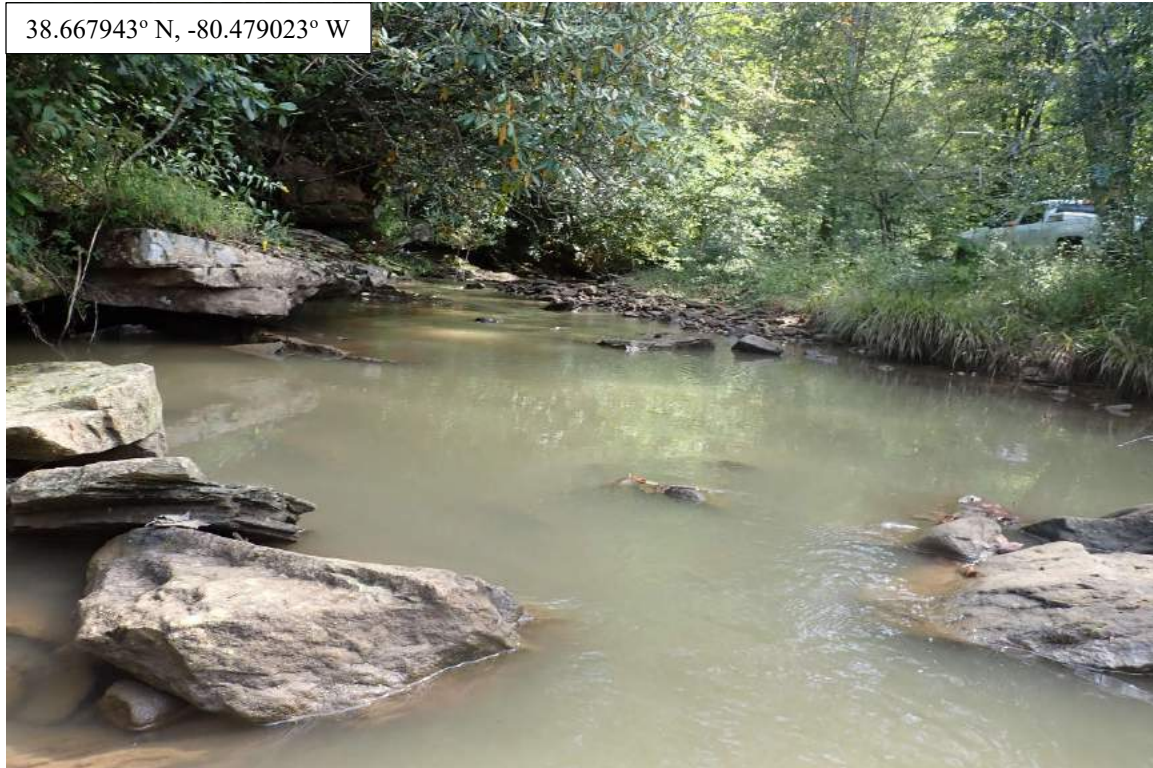
Photo Type: US, US View

Location, Orientation, Photographer Initials: Upstream Edge of Right of Way, Upstream View, ABK/EW/WP

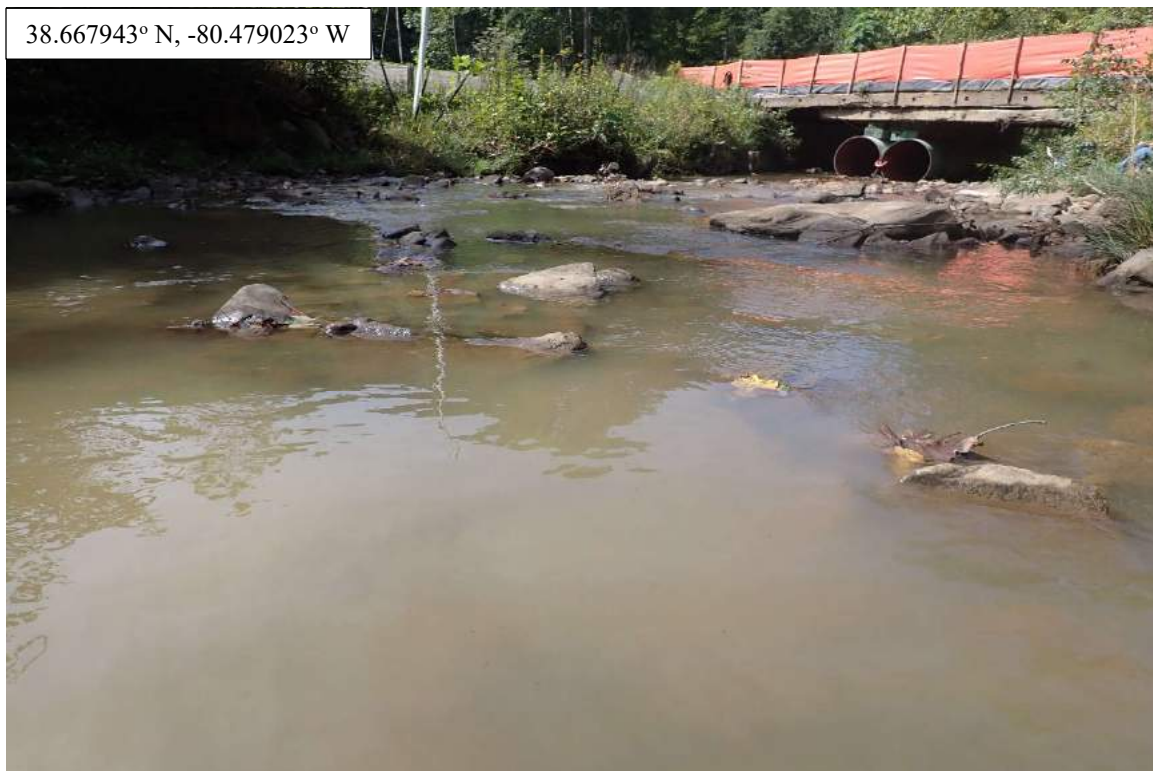
Photo Type: US, DS View

Location, Orientation, Photographer Initials: Upstream Edge of Right of Way, Downstream View, ABK/EW/WP

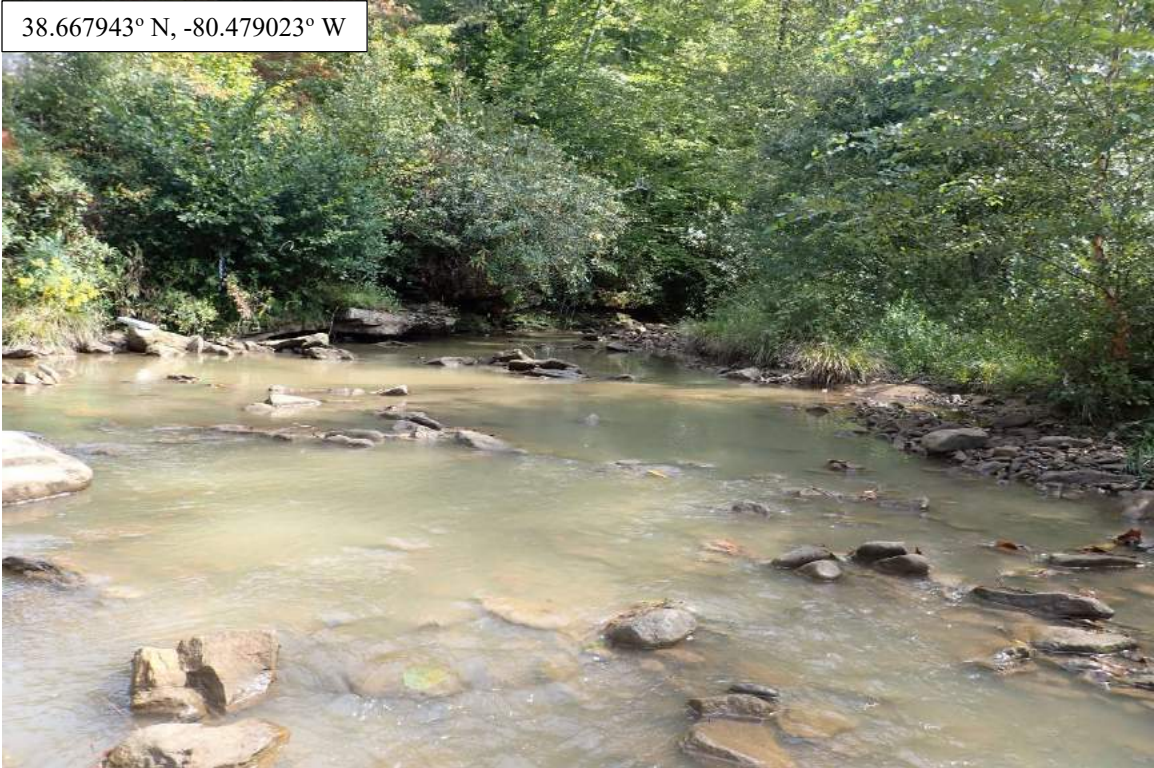
Photo Type: CP, US View

Location, Orientation, Photographer Initials: Center Point of Right of Way, Upstream View, ABK/EW/WP

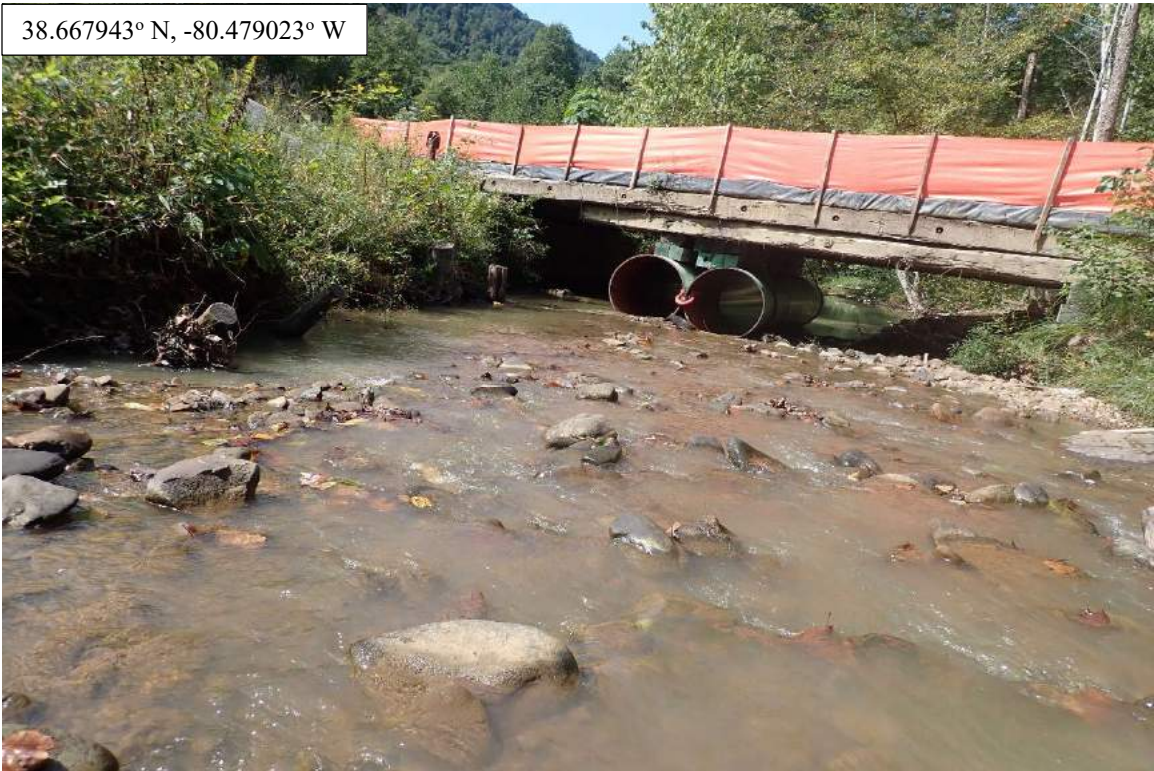
Photo Type: CP, DS View

Location, Orientation, Photographer Initials: Center Point, Downstream View, ABK/EW/WP

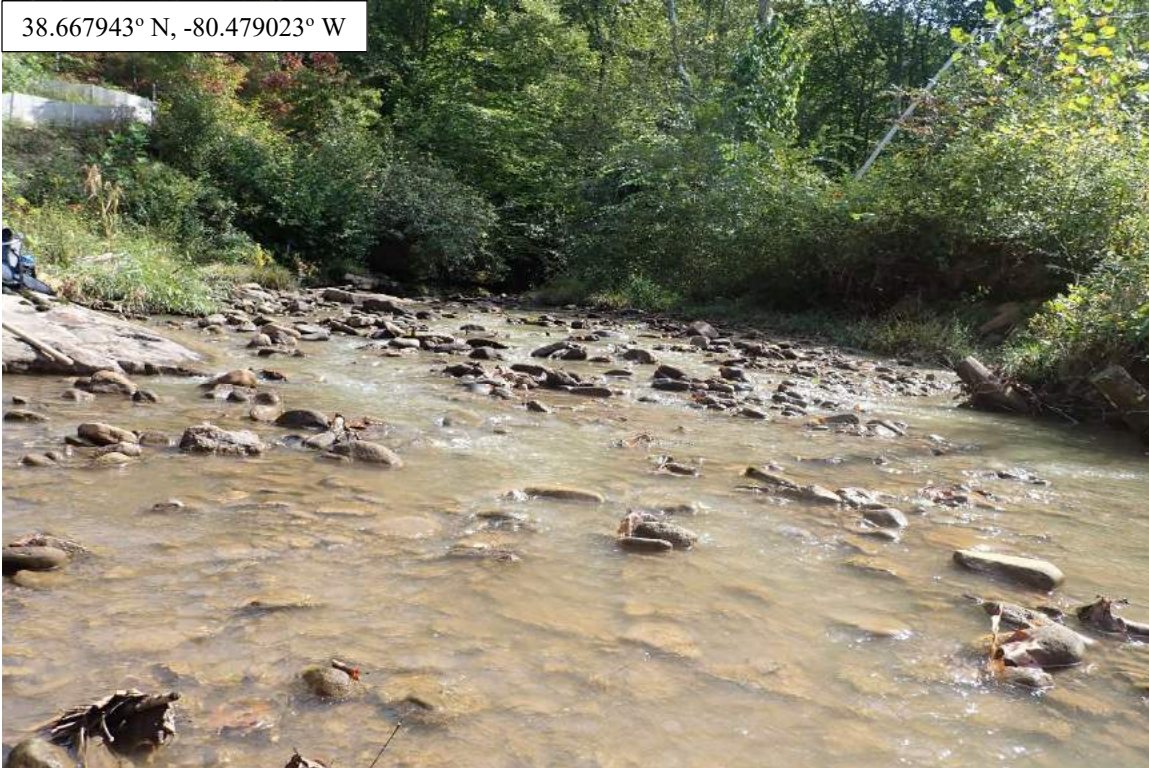
Photo Type: DS, US View, US Edge of TMB

Location, Orientation, Photographer Initials: Downstream of Upstream Edge of Timber Mat Bridge, Upstream View, ABK/EW/WP

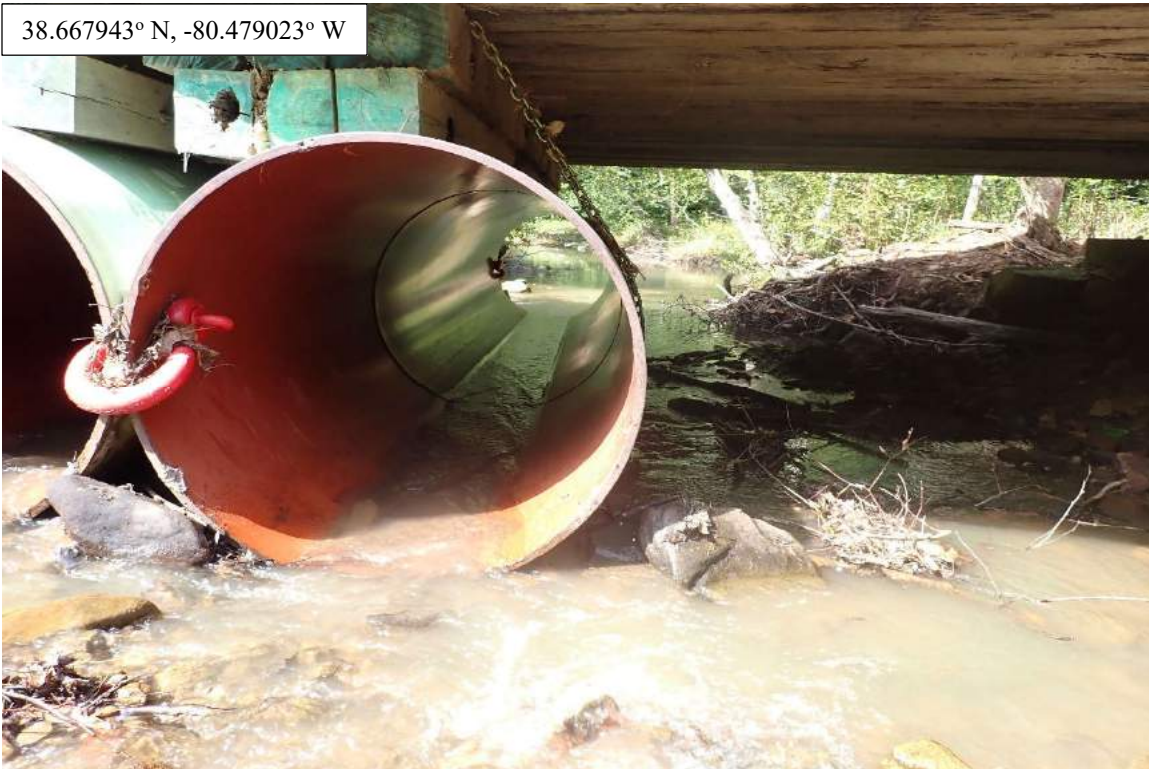
Photo Type: DS, DS View, US Edge of TMB

Location, Orientation, Photographer Initials: Downstream of Upstream Edge of Timber Mat Bridge, Downstream View, ABK/EW/WP

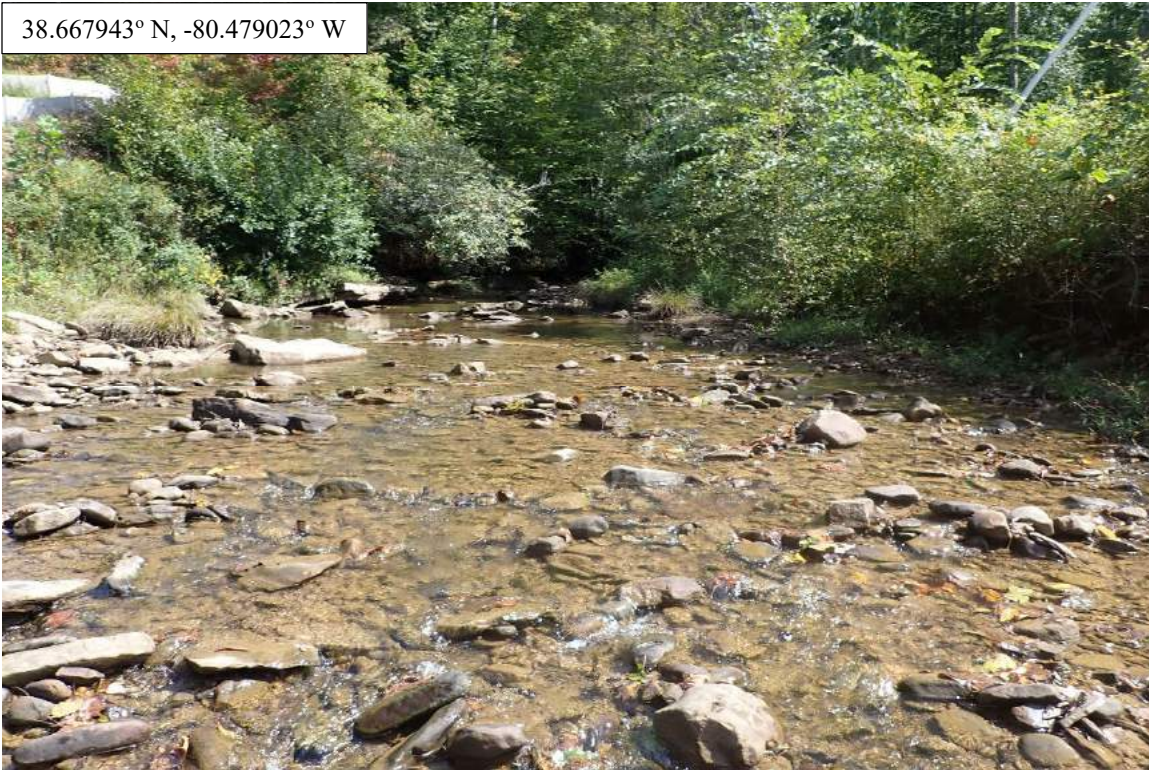
Photo Type: X Section, US Riffle

Location, Orientation, Photographer Initials: Cross Section, Upstream Riffle, ABK/EW/WP

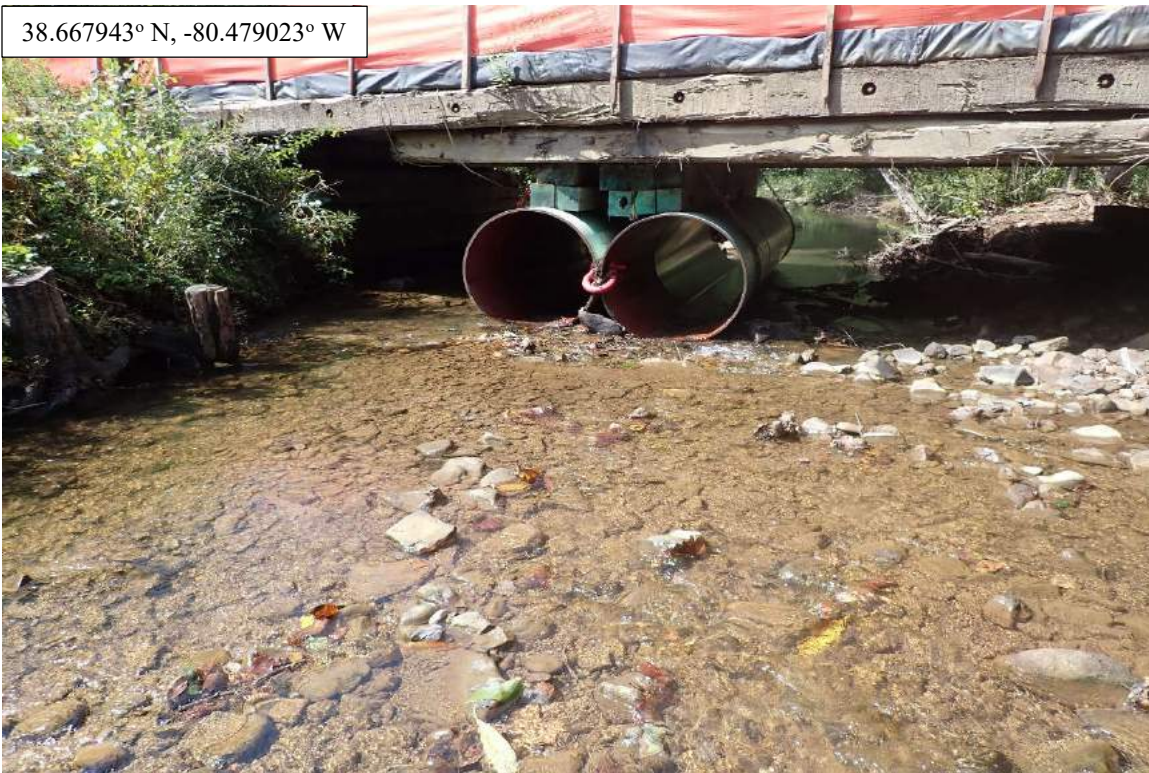
Photo Type: X Section, DS Riffle

Location, Orientation, Photographer Initials: Cross Section, Downstream Riffle, ABK/EW/WP

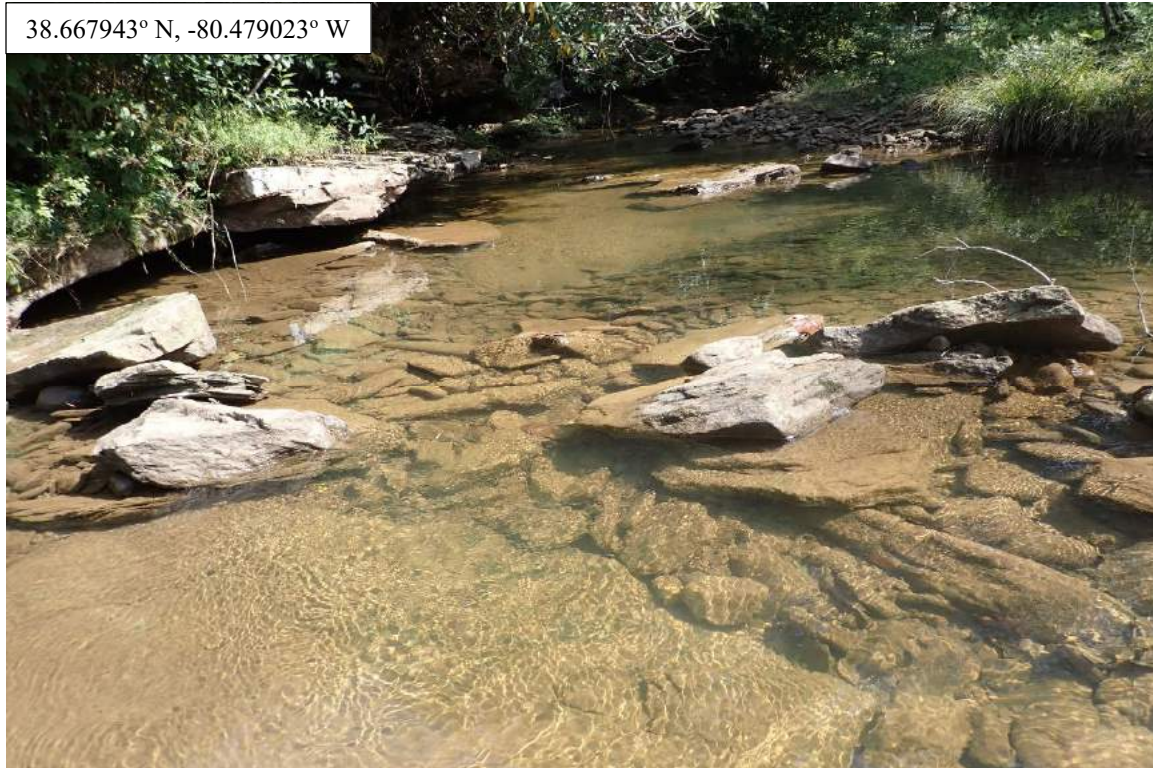
Photo Type: X Section, US Pool
Location, Orientation, Photographer Initials: Cross Section, Upstream Pool, ABK/EW/WP

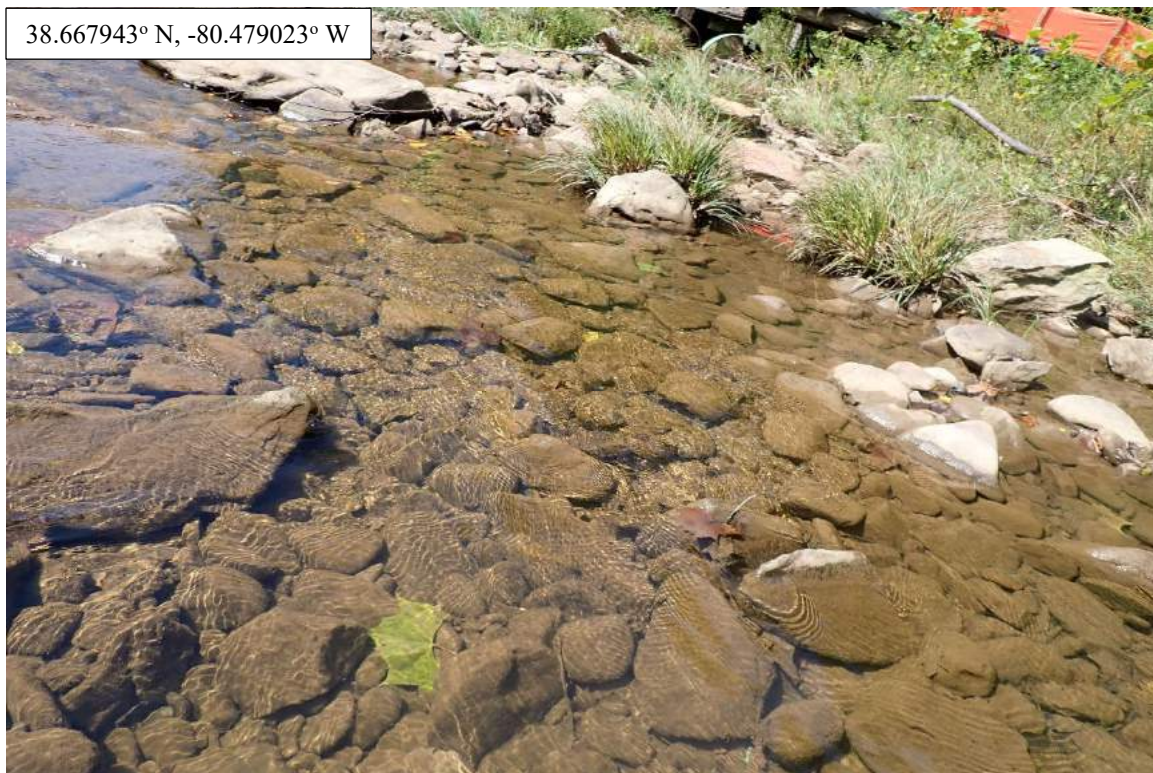
Photo Type: X Section, DS Pool
Location, Orientation, Photographer Initials: Cross Section, Downstream Pool, ABK/EW/WP

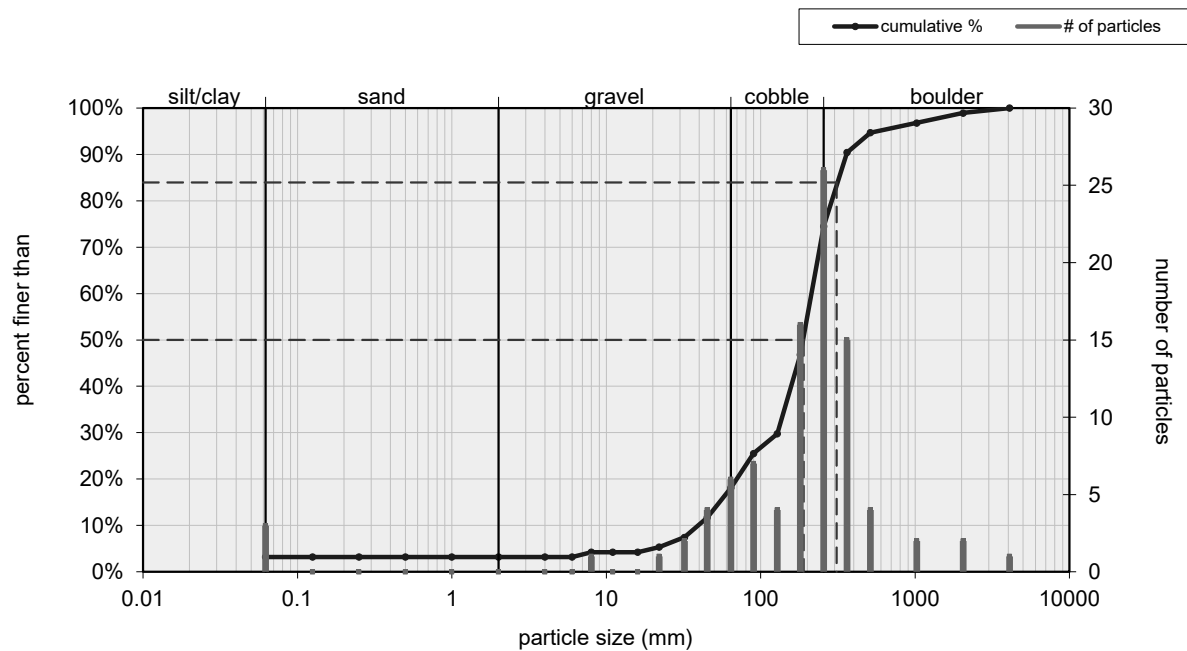
Bankfull Channel Pebble Count, Oldlick Creek (S-F40)

Size (mm)		Size Distribution		Type	
D16	57	mean	132.9	silt/clay	3%
D35	140	dispersion	2.5	sand	0%
D50	190	skewness	-0.18	gravel	14%
D65	230			cobble	53%
D84	310			boulder	24%
D95	570				
				bedrock	6%

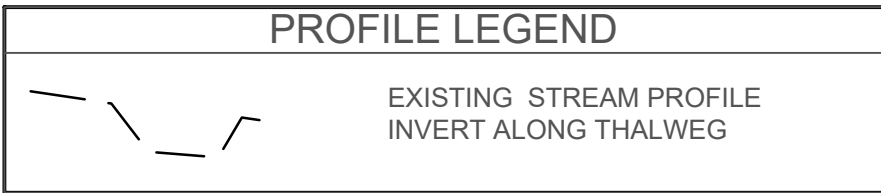
TYPICAL 5-POINT CROSS-SECTION
(FACING DOWNSTREAM)

TS-L TS-R

BS-L THW BS-R

TS: TOP OF SLOPE
BS: BOTTOM OF SLOPE
THW: THALWEG (INVERT)

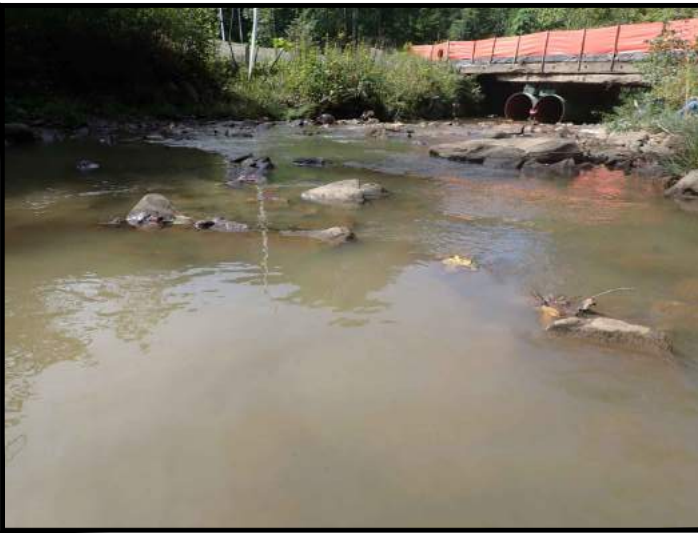
PHOTO TAKEN LOOKING DOWNSTREAM
FROM UPSTREAM IMPACT LIMITS

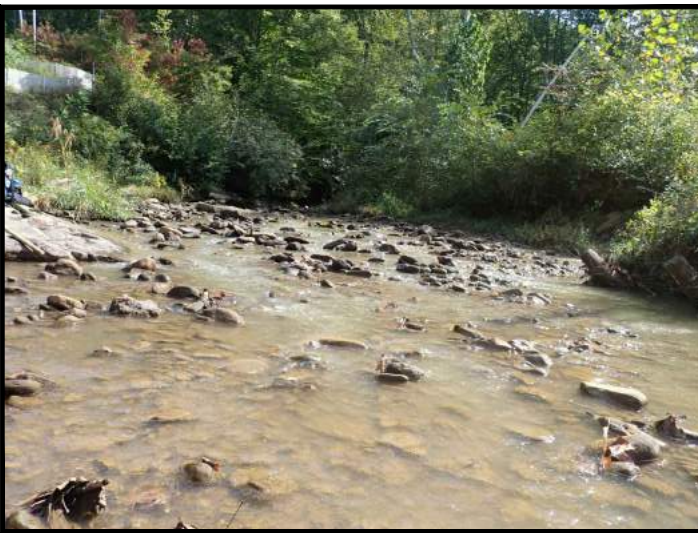
PHOTO TAKEN LOOKING UPSTREAM FROM
DOWNSTREAM IMPACT LIMITS
