Baseline Assessment – Stream Attributes

Reach S-F43 (Pipeline ROW)
Perennial
Spread C
Webster County, West Virginia

Title
PROFILE AND CROSS-SECTIONS
BASELINE SURVEY
CROSSING S-F43 - UNNAMED TRB. OF
OLDLICK CREEK (MP 82.6)
WEBSTER COUNTY, WV

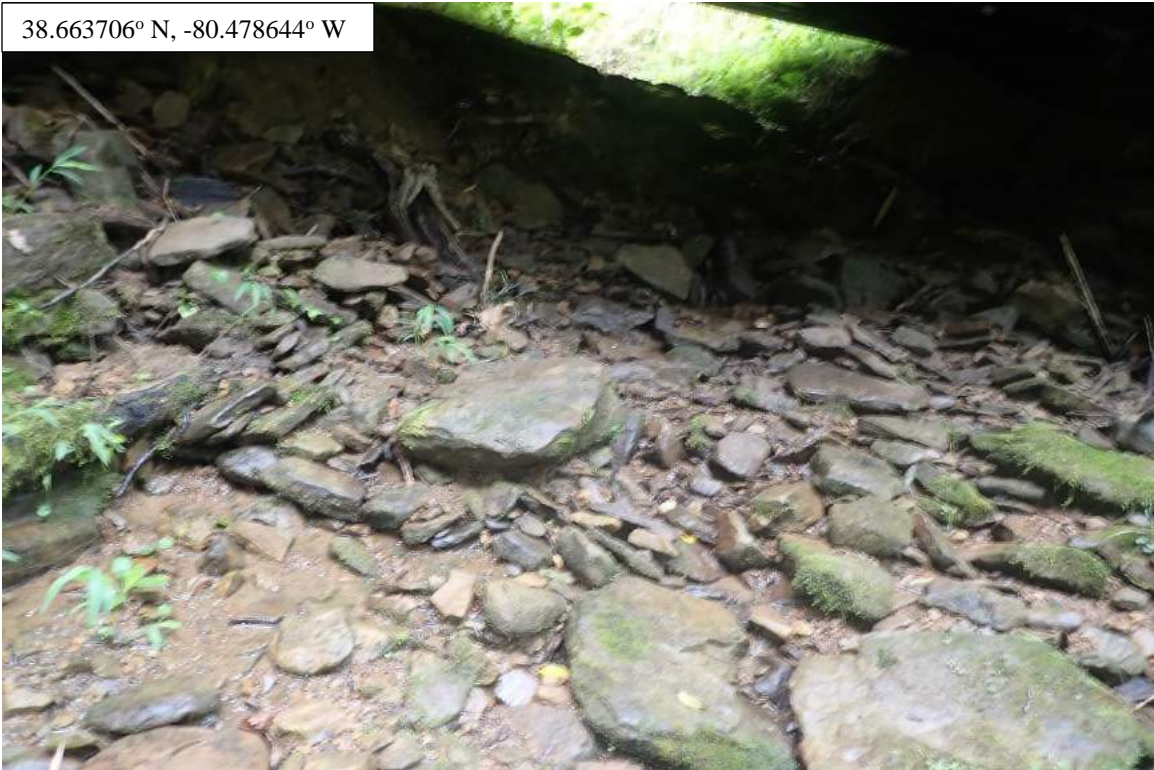
Photo Type: DS Edge of Reach, US View

Location, Orientation, Photographer Initials: Downstream Edge of Reach, Upstream View, ABK/AAK/TA

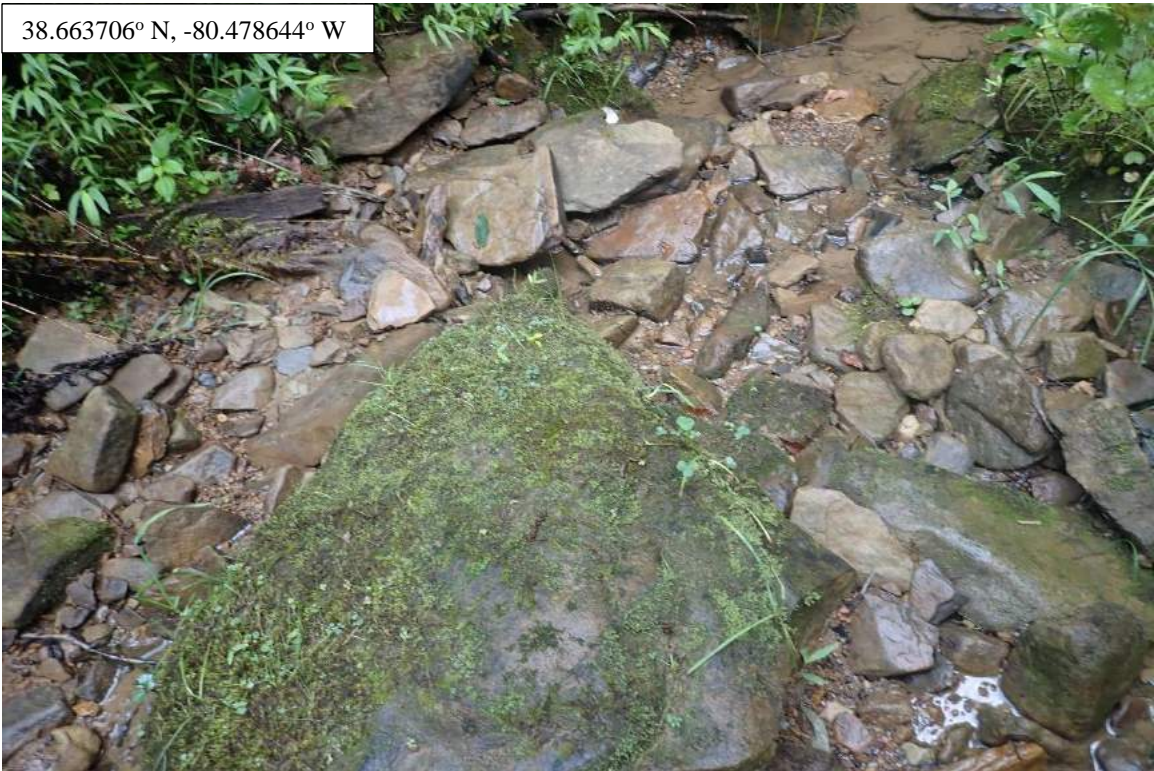
Photo Type: DS Edge of Reach, DS View

Location, Orientation, Photographer Initials: Downstream Edge of Reach, Downstream View, ABK/AAK/TA

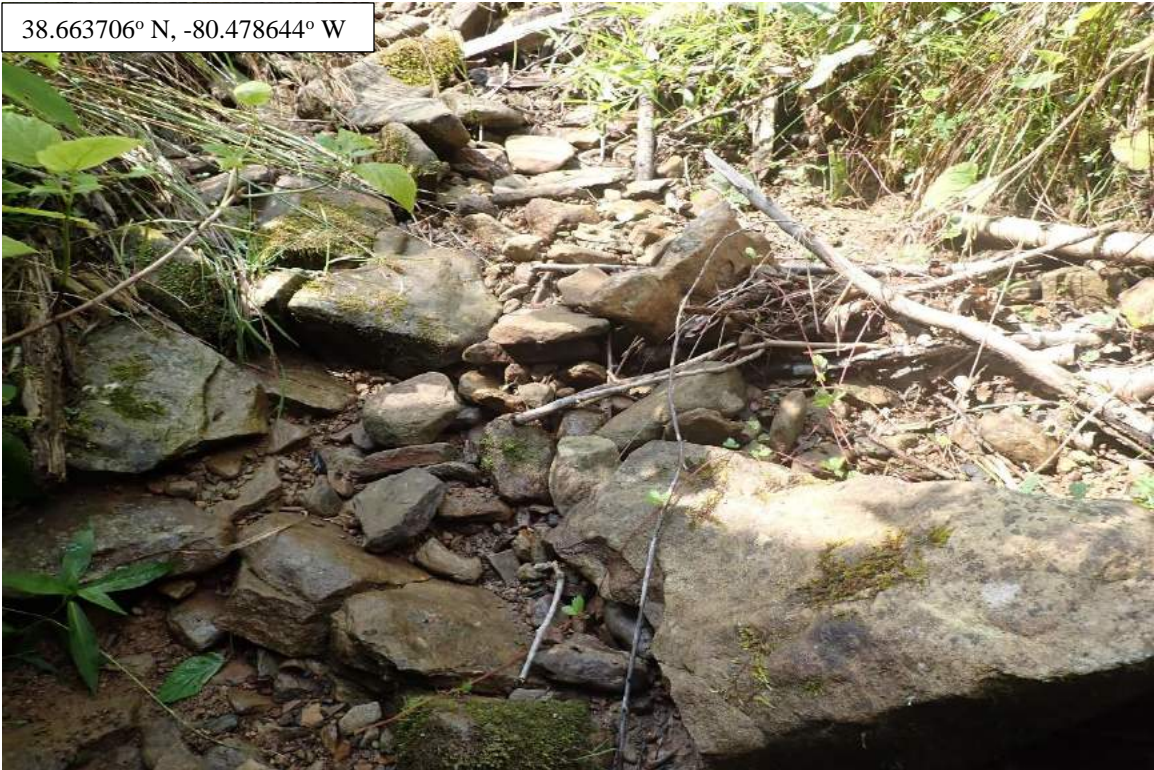
Photo Type: US Edge of TMB, US View

Location, Orientation, Photographer Initials: Upstream Edge of Timber Mat Bridge, Upstream View, ABK/AK/TA

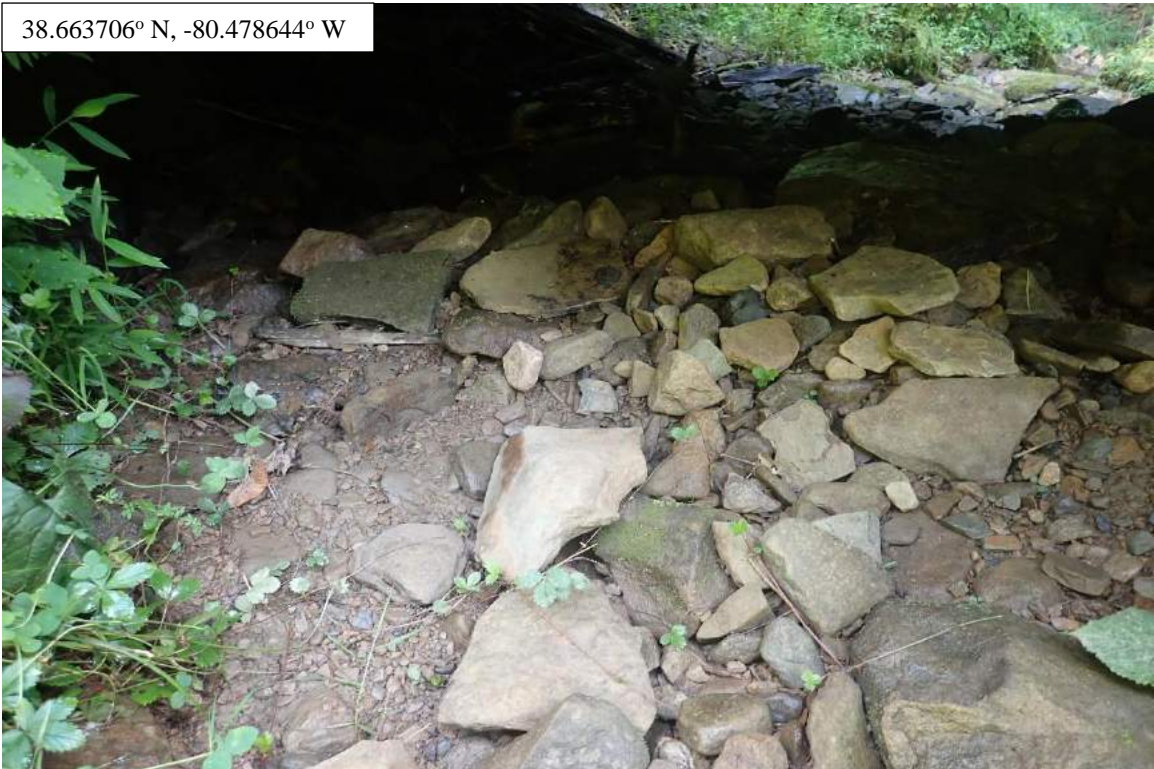
Photo Type: US Edge of TMB, DS View

Location, Orientation, Photographer Initials: Upstream Edge of Timber Mat Bridge, Downstream View, ABK/AK/TA

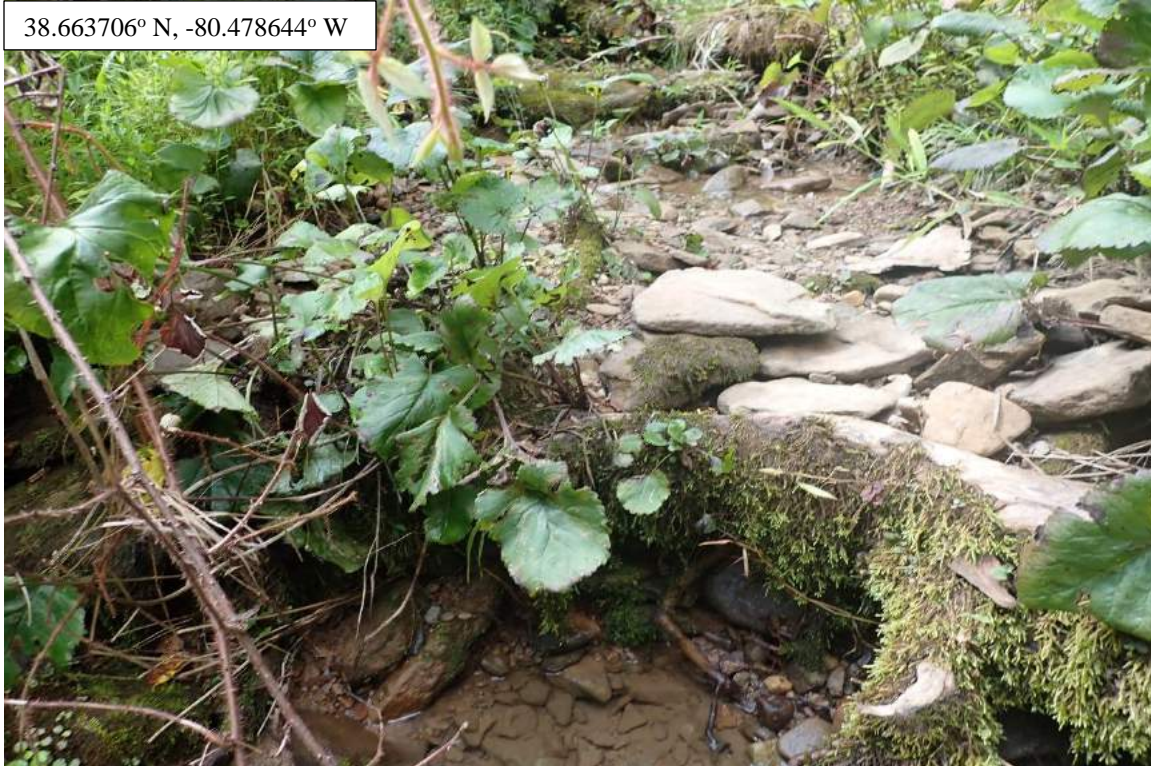
Photo Type: CP, US View and Cross Section, Center of Channel

Location, Orientation, Photographer Initials: Center ROW, Upstream View and Cross Section, Center of Channel, ABK/AAK/TA

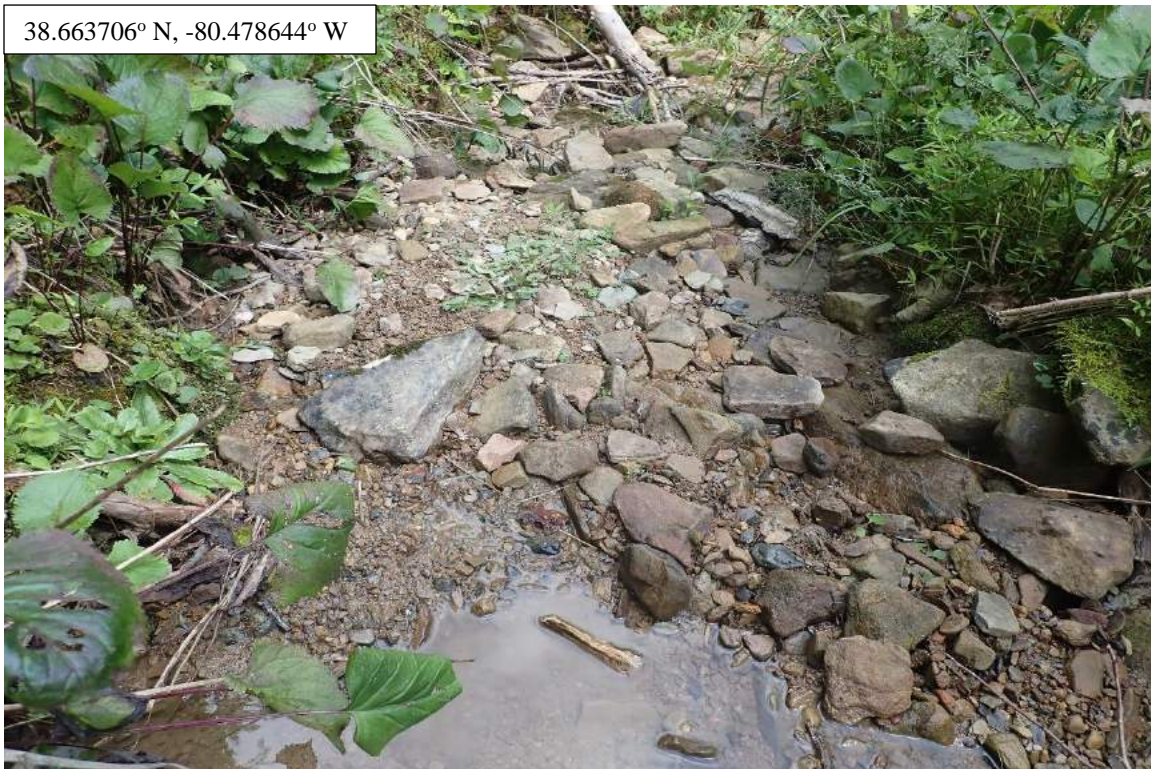
Photo Type: CP, DS View and Cross Section, Center of Channel

Location, Orientation, Photographer Initials: Center ROW, Downstream View and Cross Section, Center of Channel, ABK/AAK/TA

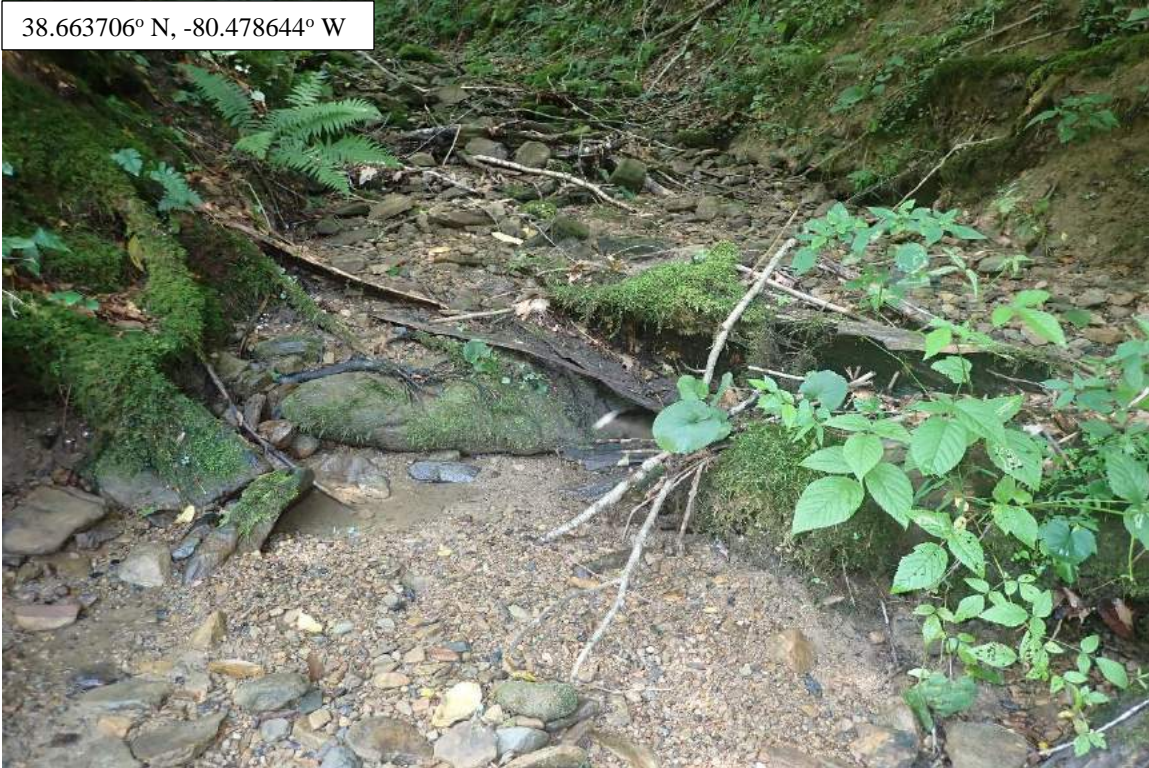
Photo Type: US, US View

Location, Orientation, Photographer Initials: Upstream Edge of ROW, Upstream View, ABK/AK/TA

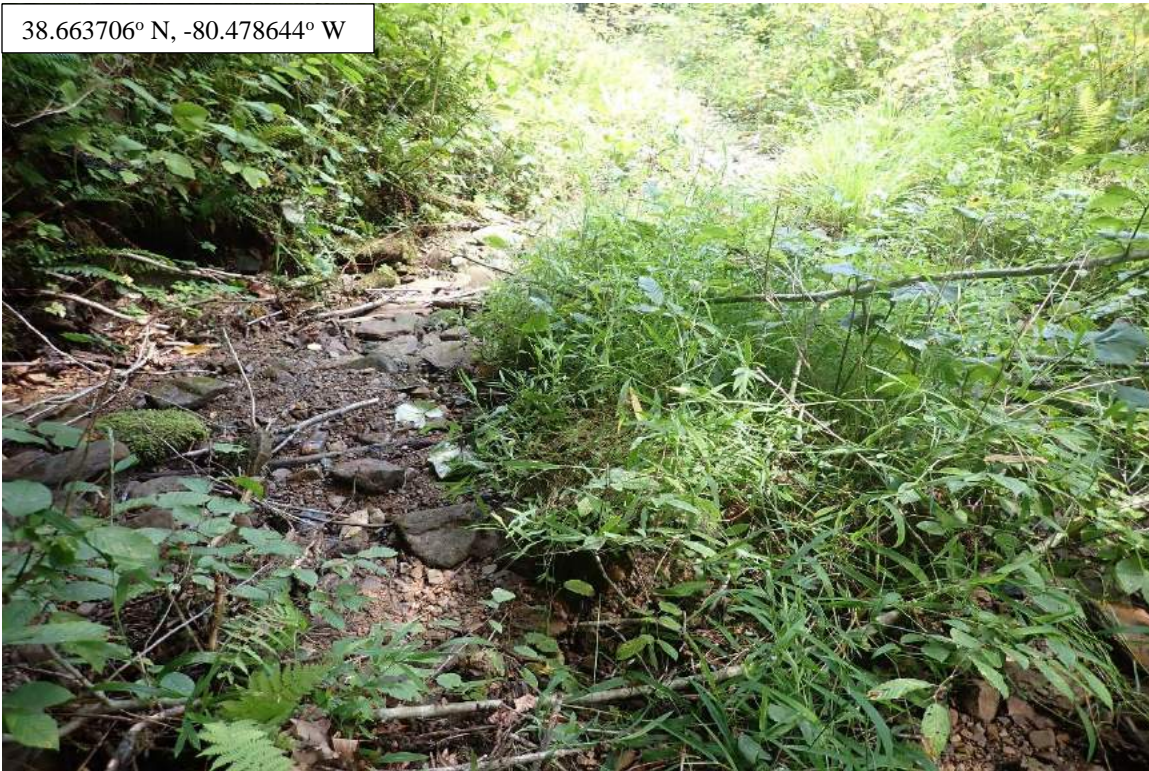
Photo Type: US, DS View

Location, Orientation, Photographer Initials: Upstream Edge of ROW, Downstream View, ABK/AK/TA

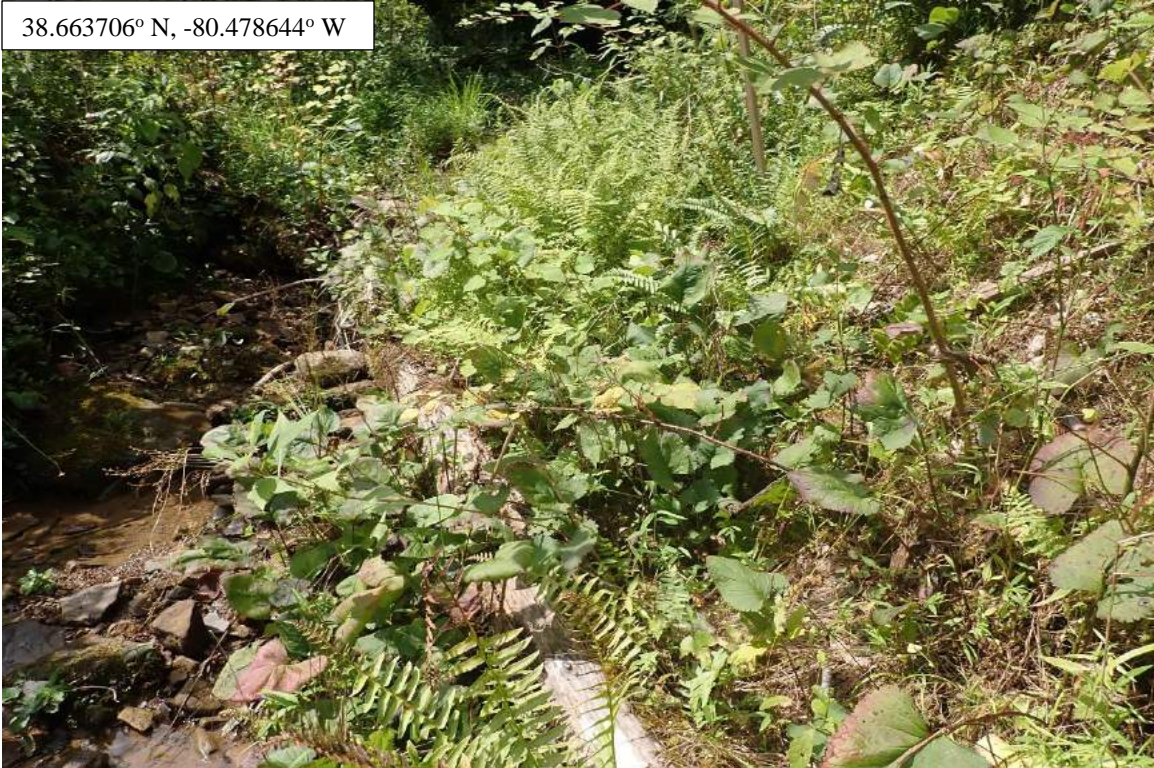
Photo Type: Cross Section, LDB, US

Location, Orientation, Photographer Initials: Cross Section, Left Descending Bank, Upstream View, ABK/AAK/TA

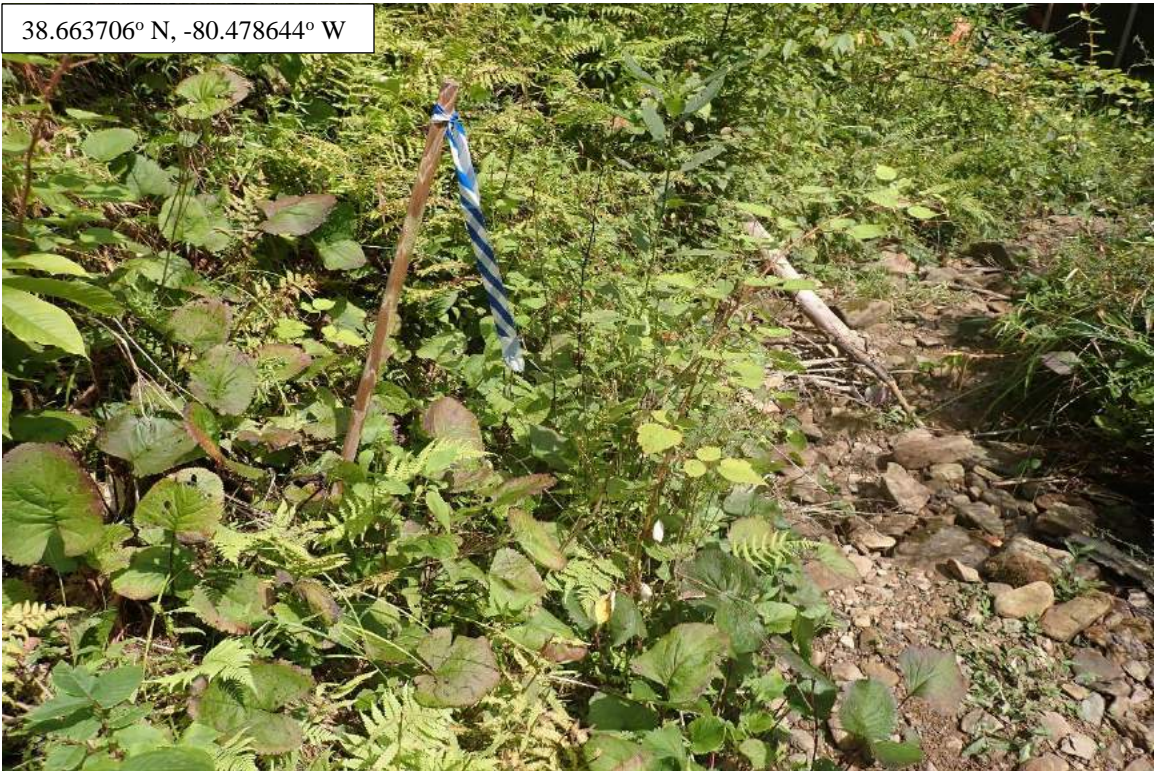
Photo Type: Cross Section, LDB, DS

Location, Orientation, Photographer Initials: Cross Section, Left Descending Bank, Downstream View, ABK/AAK/TA

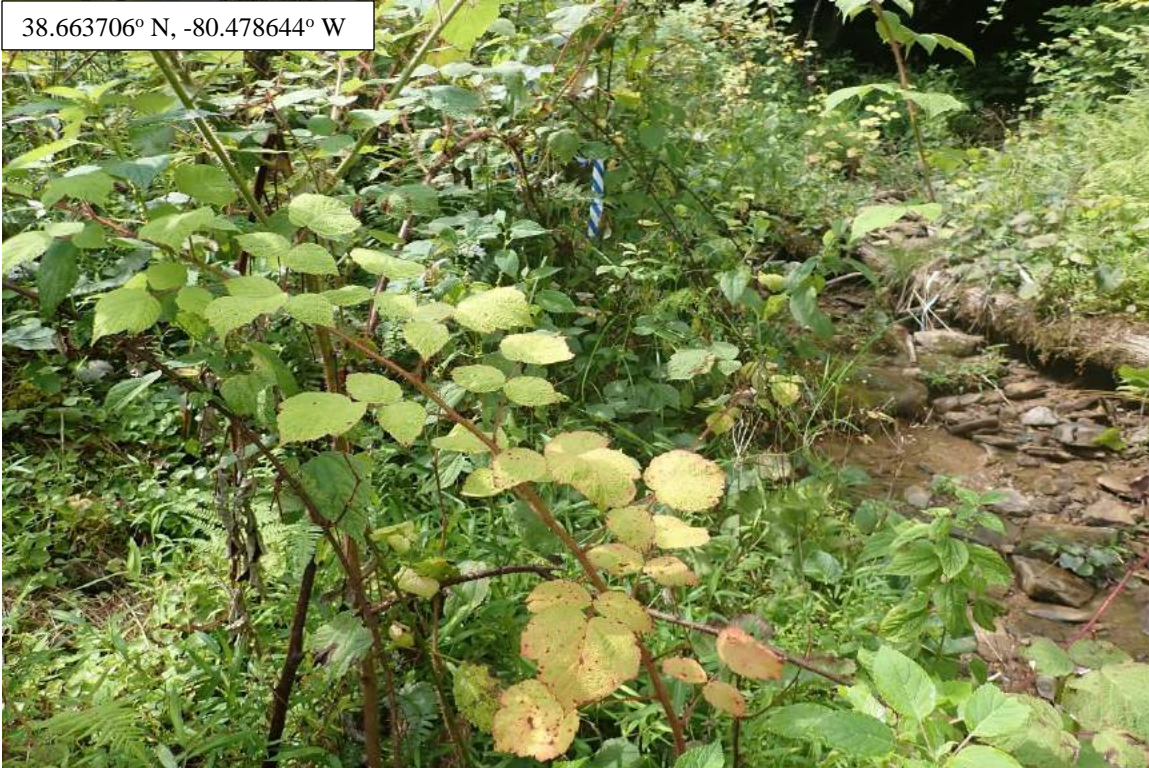
Photo Type: Cross Section, RDB, US

Location, Orientation, Photographer Initials: Cross Section, Right Descending Bank, Upstream View, ABK/AAK/TA

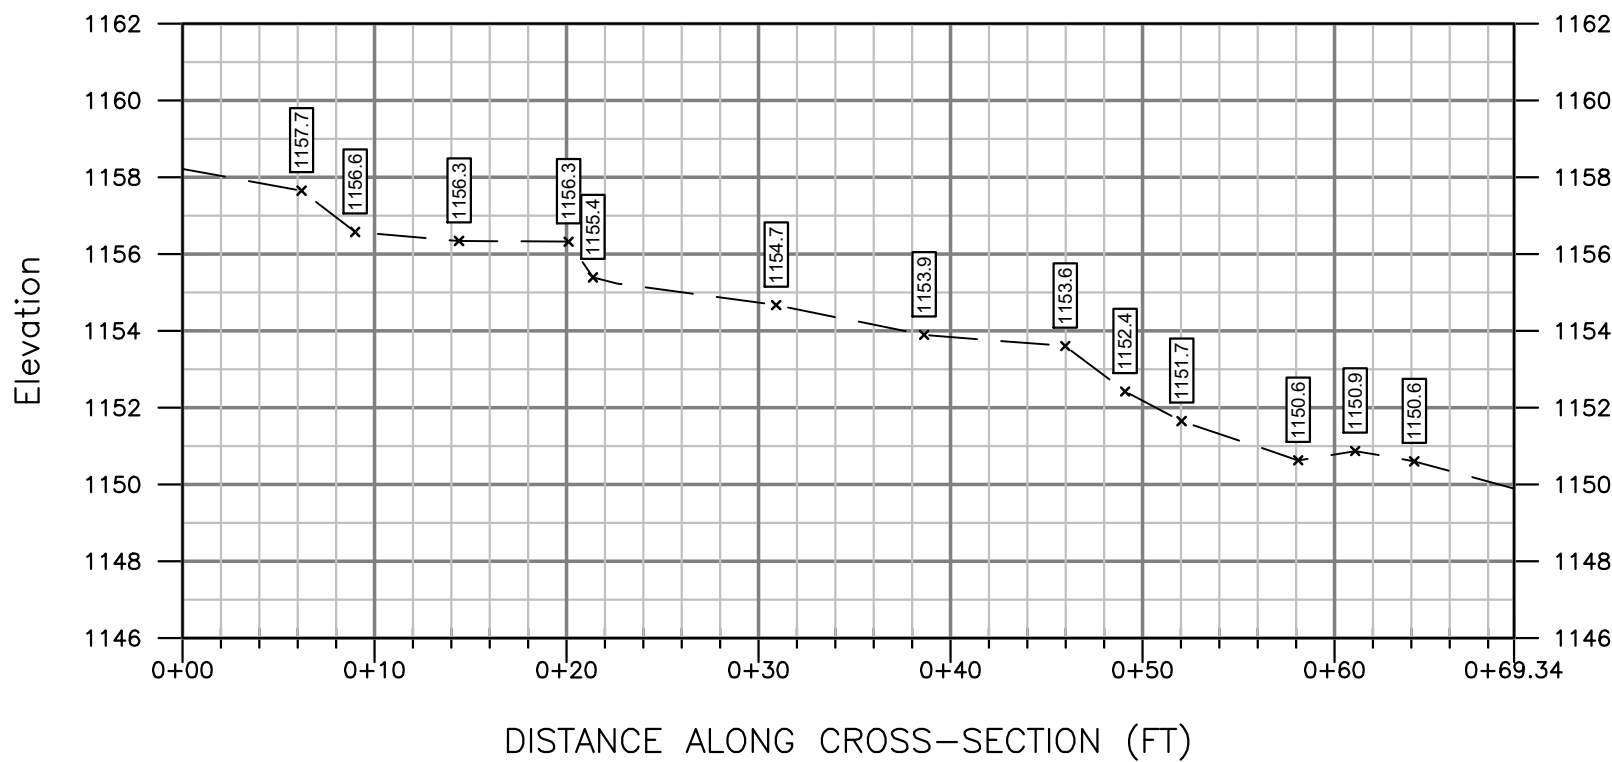
S-F43 BASELINE THALWEG

EXISTING STREAM PROFILE
INVERT ALONG THALWEG

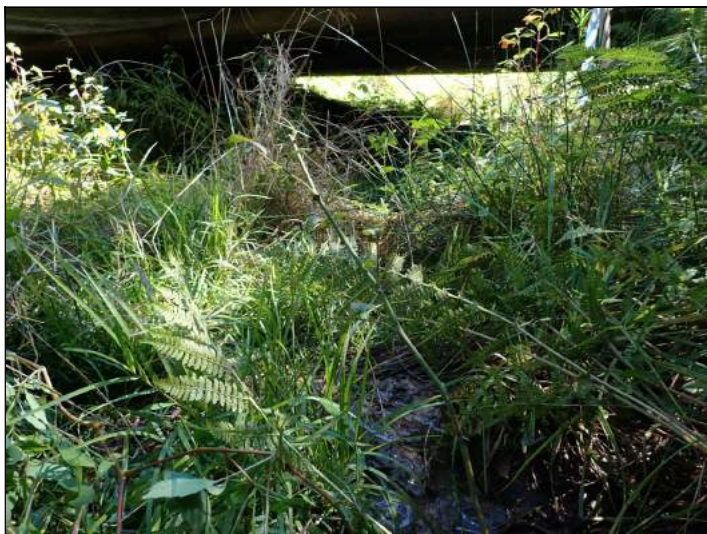
PHOTO TAKEN LOOKING DOWNSTREAM
FROM UPSTREAM IMPACT LIMITS

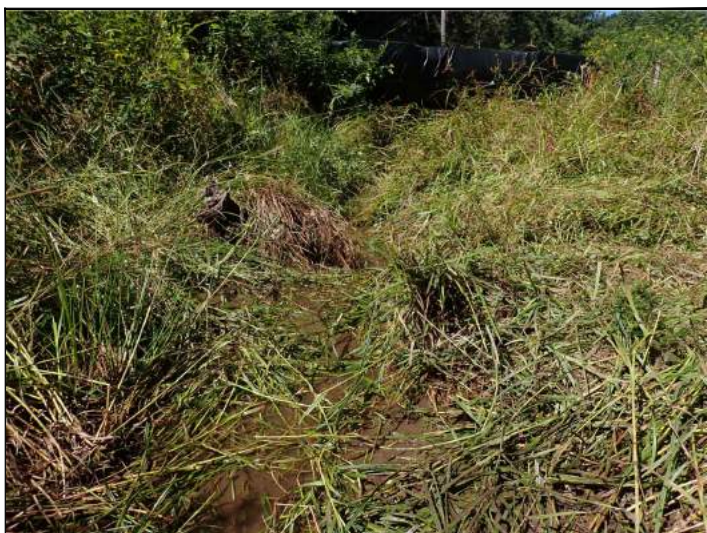
PHOTO TAKEN LOOKING UPSTREAM FROM
DOWNSTREAM IMPACT LIMITS
