## Baseline Assessment – Stream Attributes

### Reach S-I19 (Pipeline ROW) Perennial Spread F Summers County, West Virginia

### S-119 BASELINE THALWEG PROFILE

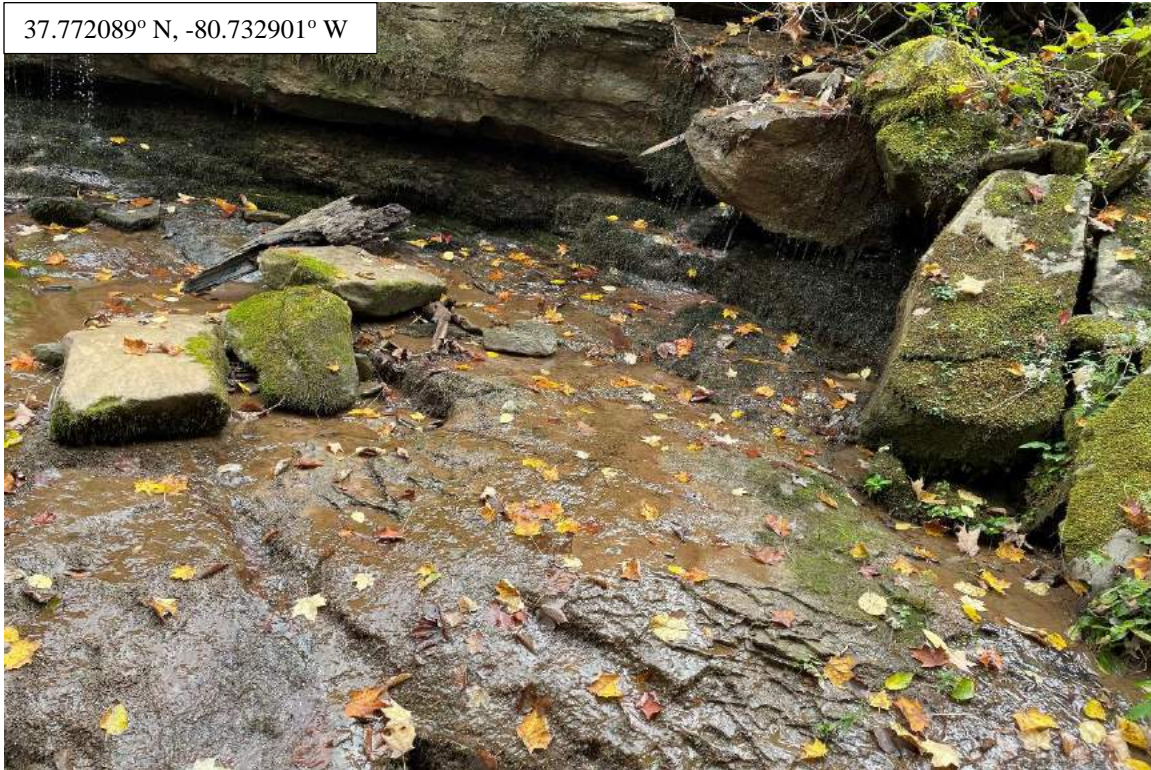
Photo Type: DS, US View

Location, Orientation, Photographer Initials: Downstream Edge of ROW, Upstream View, ABK/AG/WP/TA

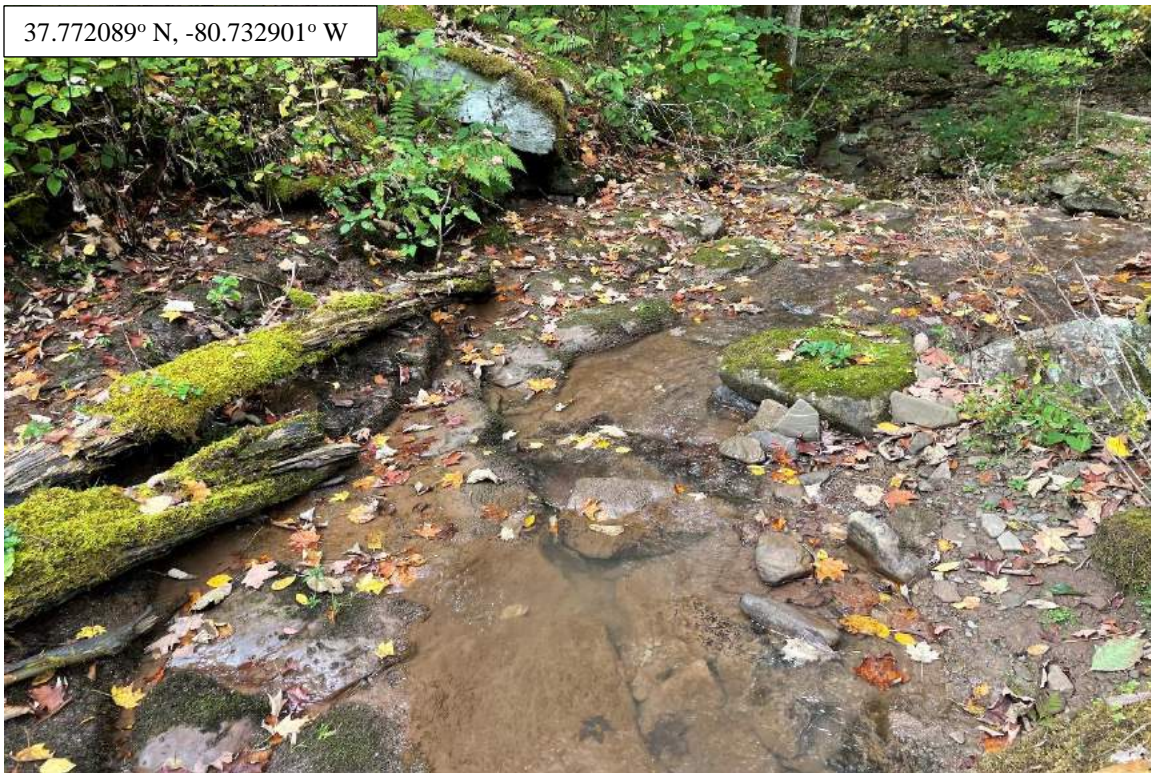
Photo Type: DS, DS VIEW

Location, Orientation, Photographer Initials: Downstream Edge of ROW, Downstream View, ABK/AG/WP/TA

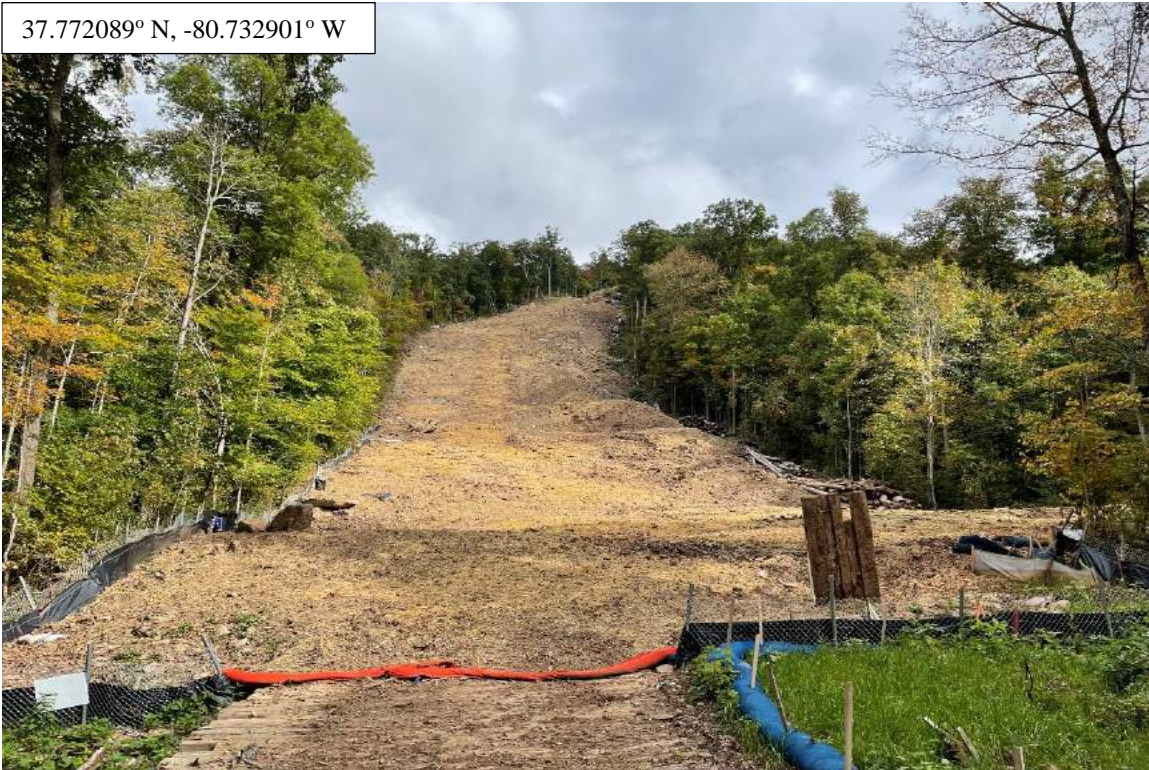
Photo Type: ROW N

Location, Orientation, Photographer Initials: Right of Way, Facing North, ABK/AG/WP/TA

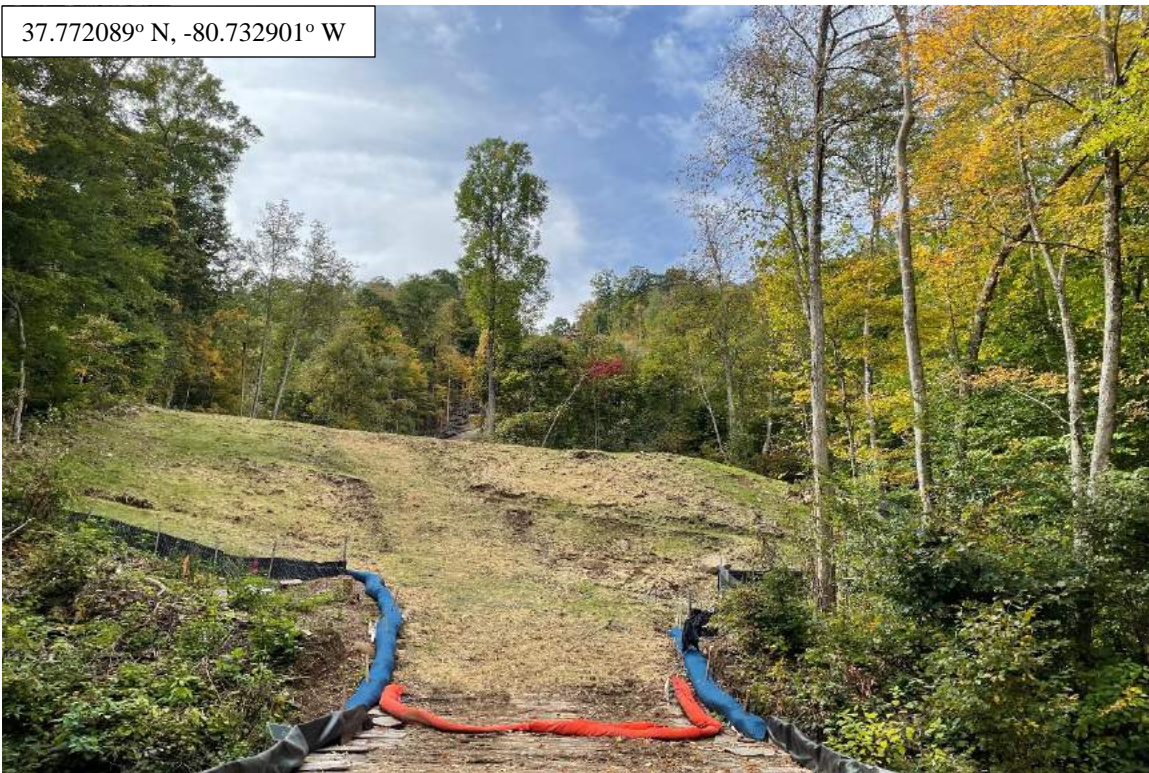
Photo Type: ROW S

Location, Orientation, Photographer Initials: Right of Way, Facing South, ABK/AG/WP/TA

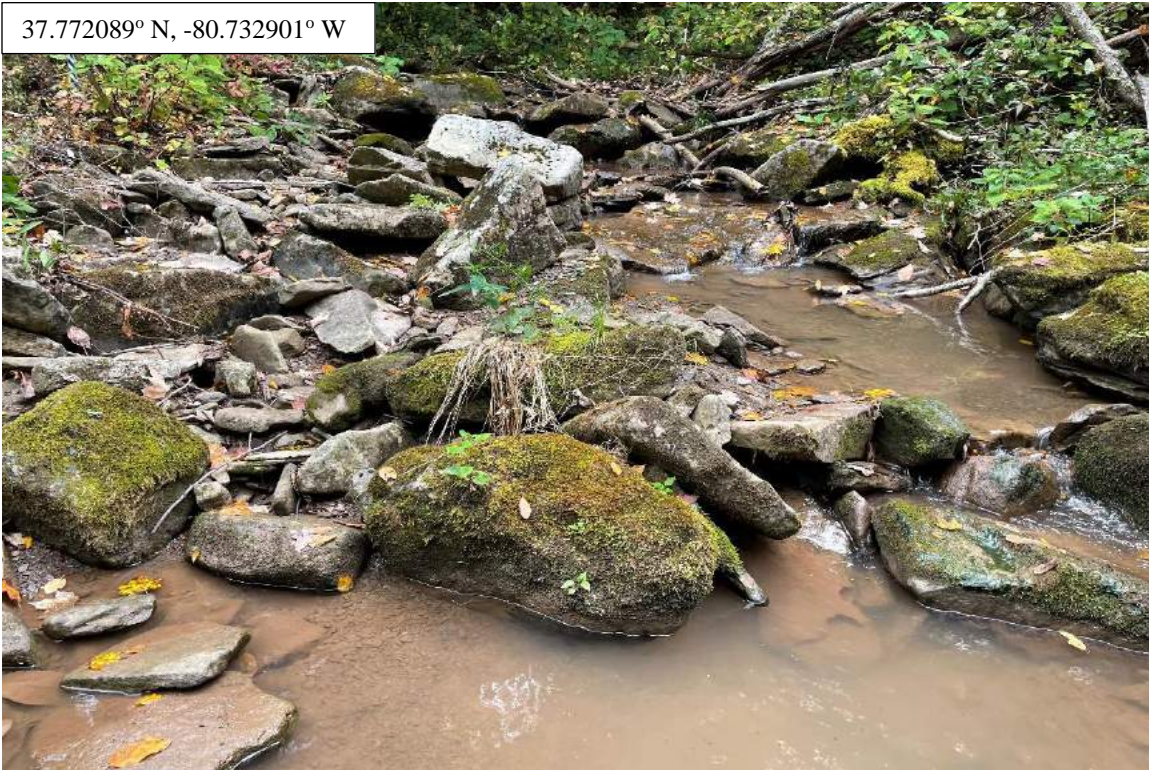
Photo Type: CP, US View

Location, Orientation, Photographer Initials: Center Point of ROW, Upstream View, ABK/AG/WP/TA

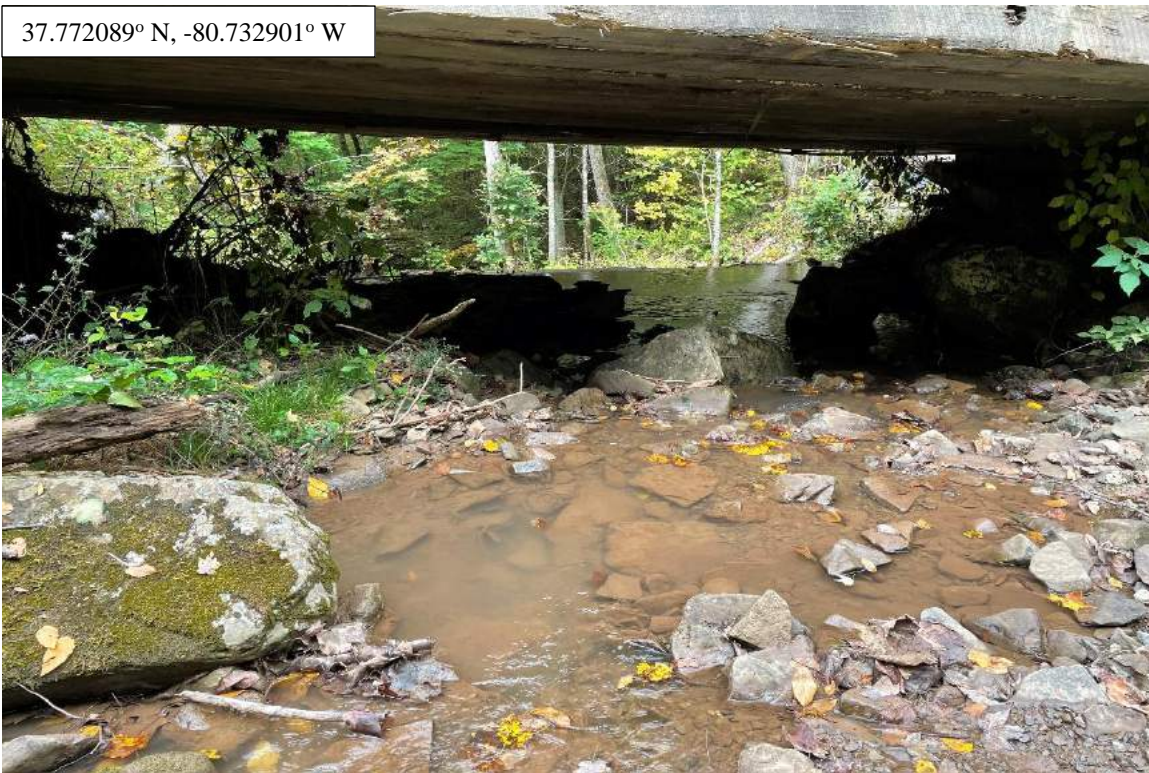
Photo Type: CP, DS View

Location, Orientation, Photographer Initials: Center Point of ROW, Downstream View, ABK/AG/WP/TA

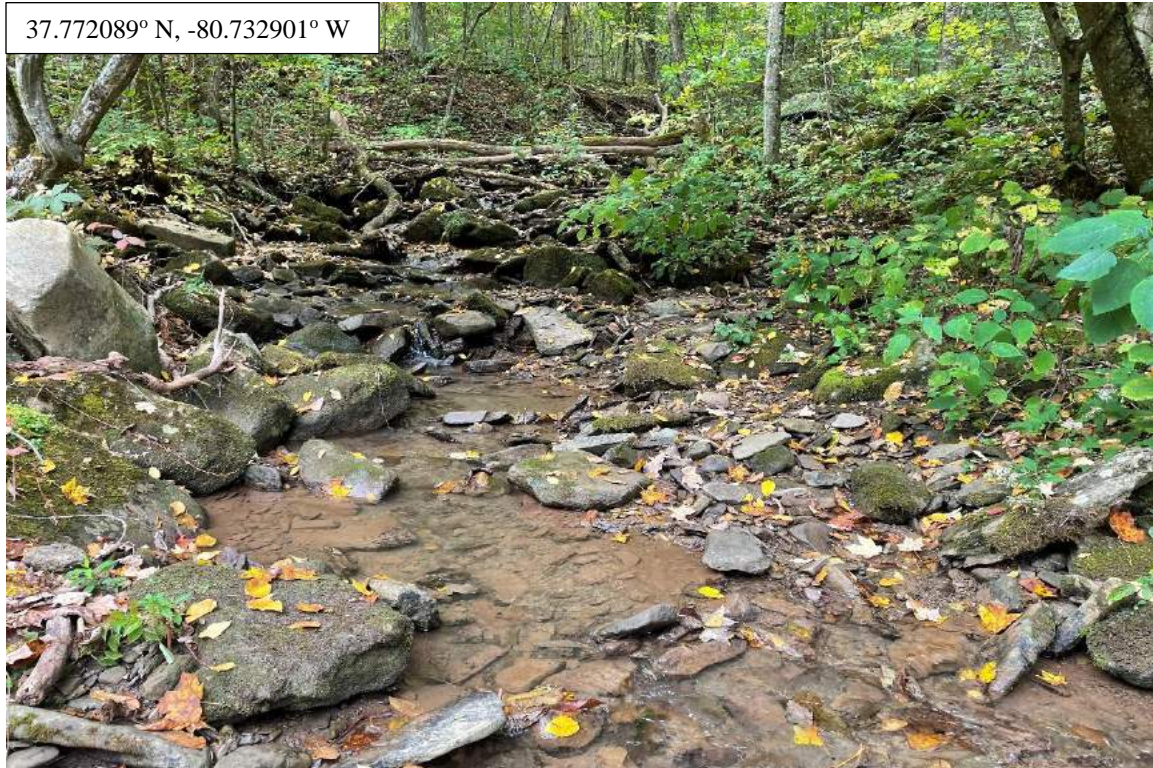
Photo Type: US, US View

Location, Orientation, Photographer Initials: Upstream Edge of Right of Way, Upstream View, ABK/AG/WP/TA

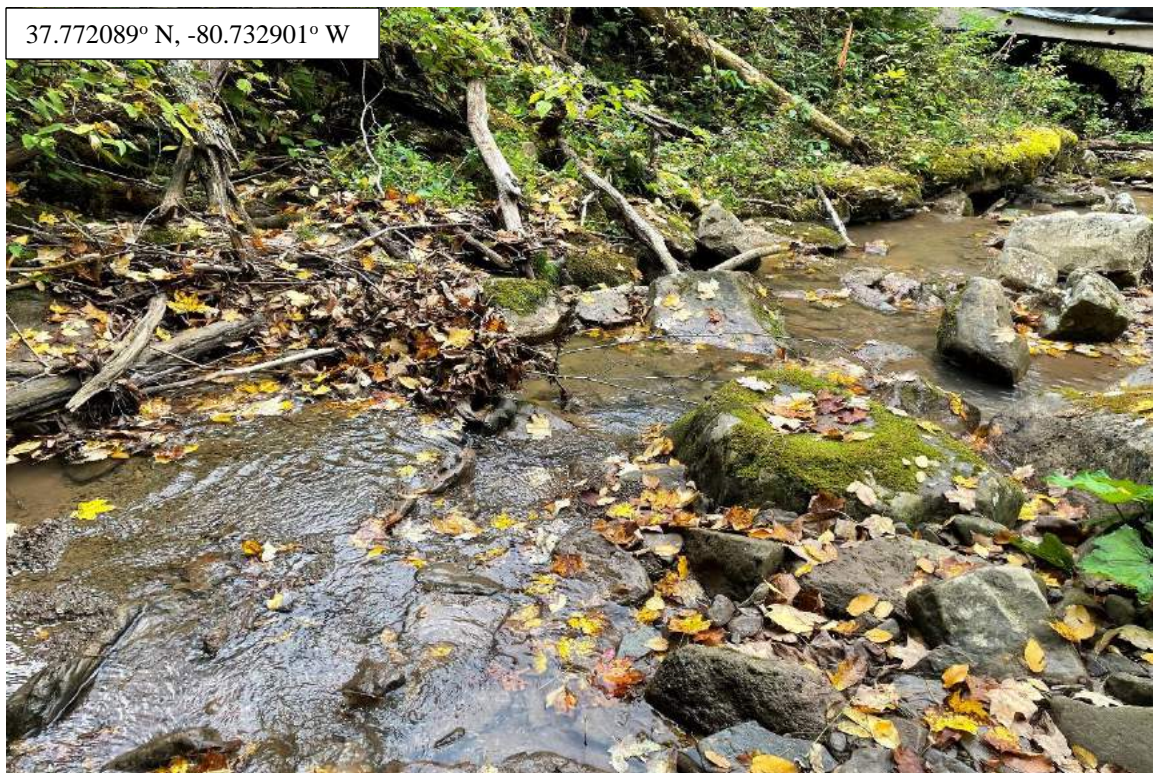
Photo Type: US, DS View

Location, Orientation, Photographer Initials: Upstream Edge of Right of Way, Downstream View, ABK/AG/WP/TA

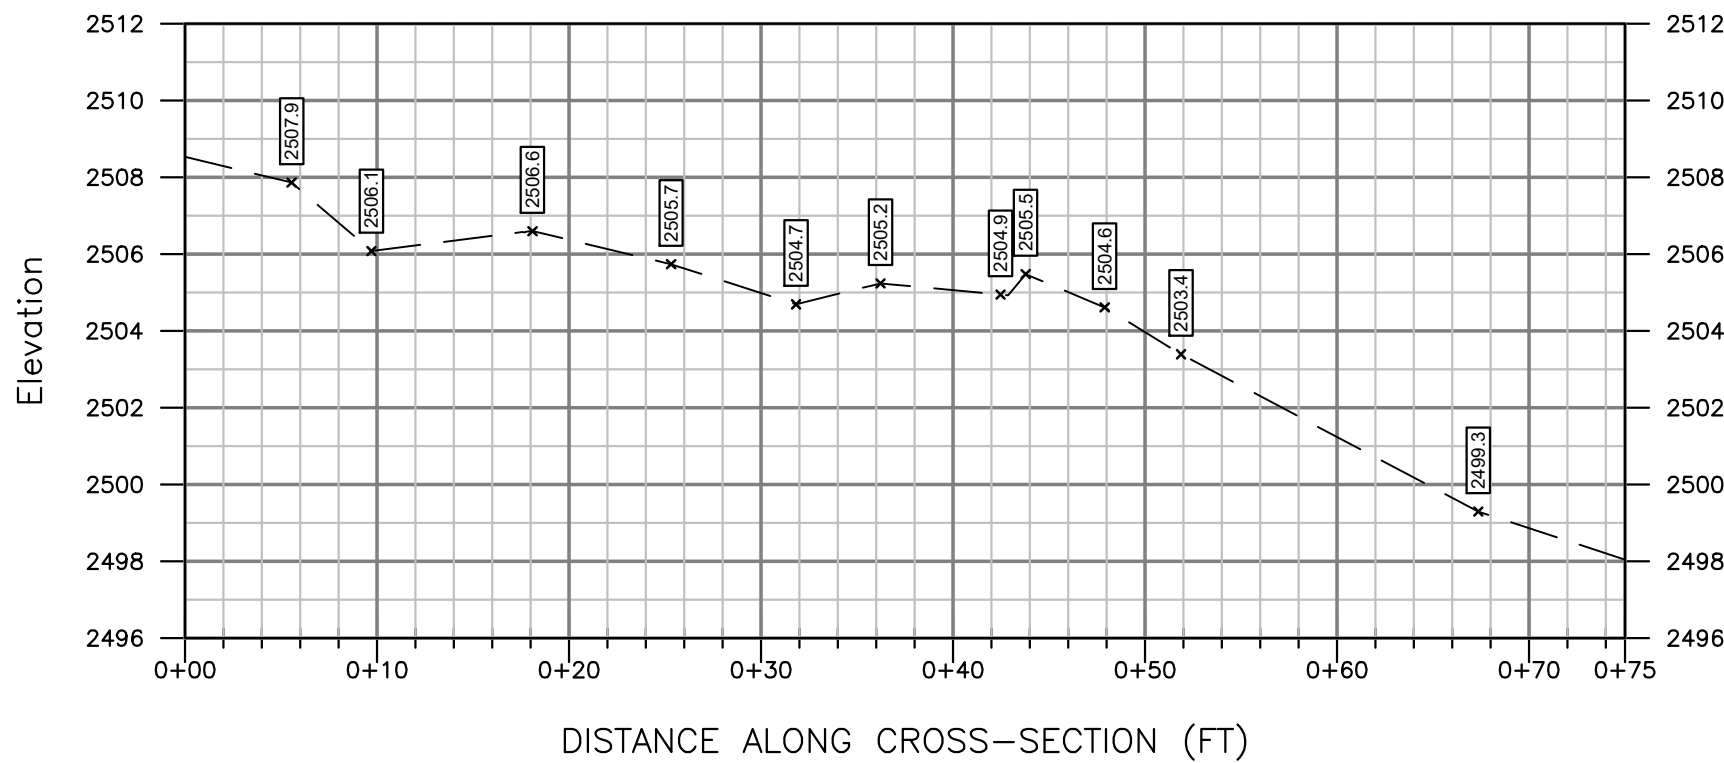
EXISTING STREAM PROFILE  
INVERT ALONG THALWEG

H: 1"=10'  
V: 1"=5'

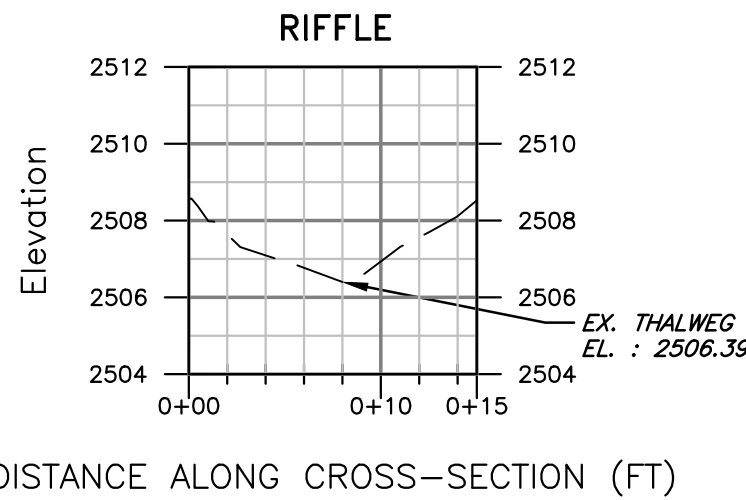
### S-119 BASELINE CROSS-SECTION A

DISTANCE ALONG CROSS-SECTION (FT)

H: 1"=10'  
V: 1"=5'

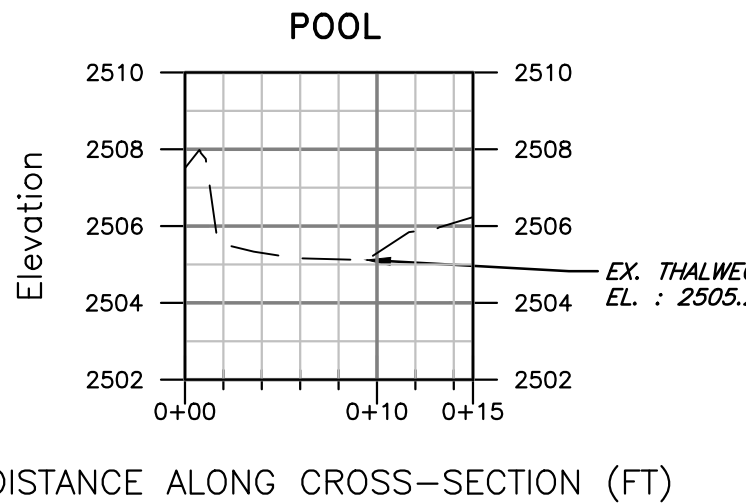
### S-119 BASELINE CROSS-SECTION B

AS-BUILT TABLE: S-119 CROSS SECTION B					
PT. LOC.	PRE-CROSSING			AS-BUILT	
	NORTHING	EASTING	ELEV.	VERT. DIFF.	HORZ. DIFF.
TS-L	13715722.07	1717592.75	2507.97		
BS-L	13715722.59	1717593.39	2505.59		
THW	13715726.07	1717595.79	2505.23		
BS-R	13715730.27	1717600.32	2505.98		
TS-R	14000678.25	1717601.13	2505.99

DISTANCE ALONG CROSS-SECTION (FT)

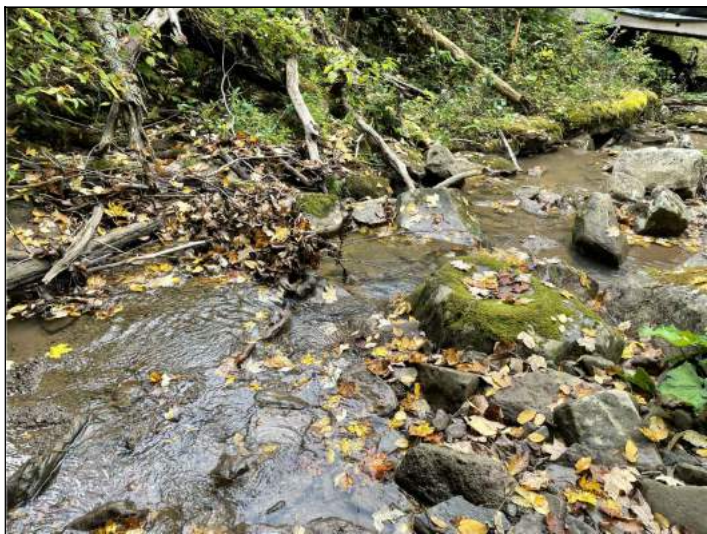
PHOTO TAKEN LOOKING DOWNSTREAM  
FROM UPSTREAM IMPACT LIMITS

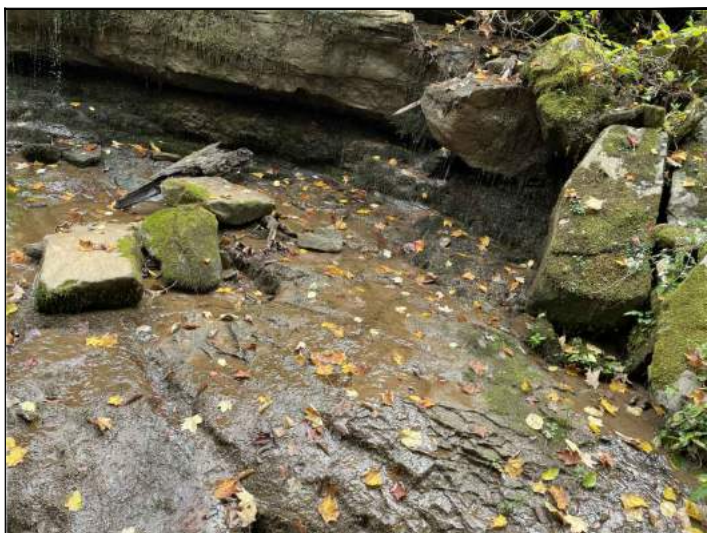
PHOTO TAKEN LOOKING UPSTREAM FROM  
DOWNSTREAM IMPACT LIMITS
