Baseline Assessment – Stream Attributes

Reach S-I40 (Pipeline ROW) Intermittent Spread D Nicholas County, West Virginia

Mountain Valley Pipeline

UNT to Hominy Creek (S-I40)

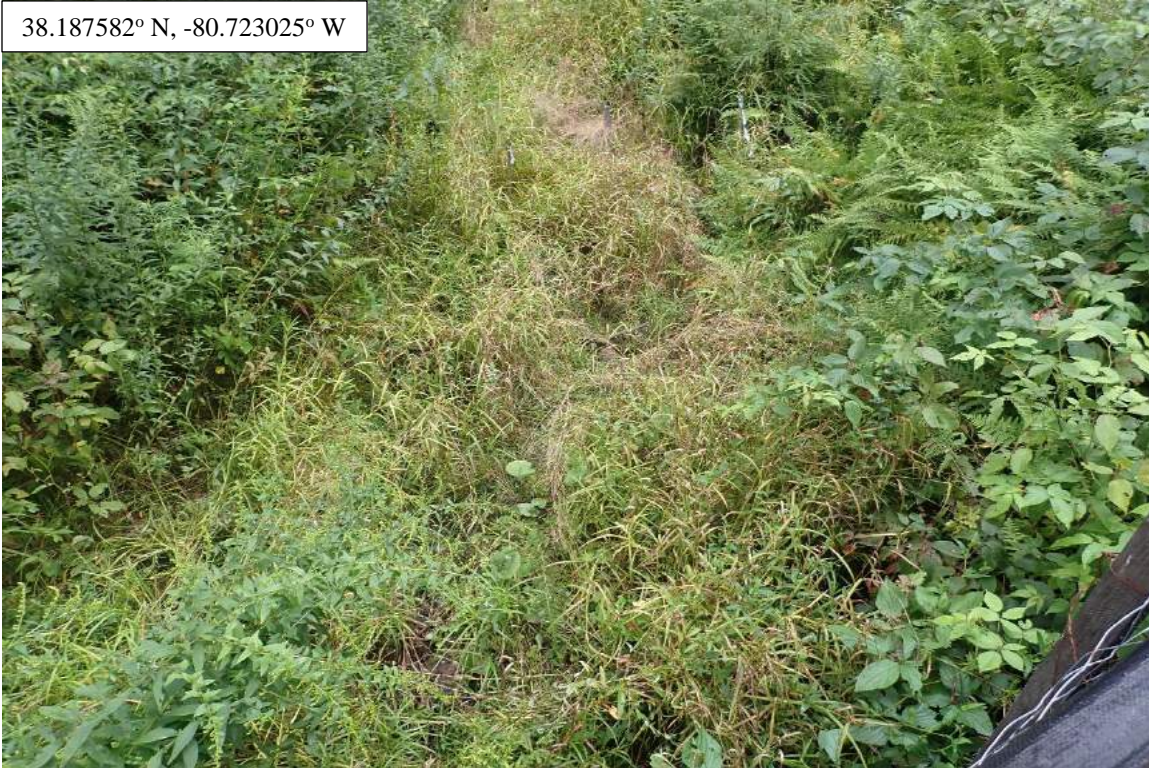
Photo Type: US View at DS Edge of LOD

Location, Orientation, Photographer Initials: Downstream Edge of Limits of Disturbance, Upstream View, TF

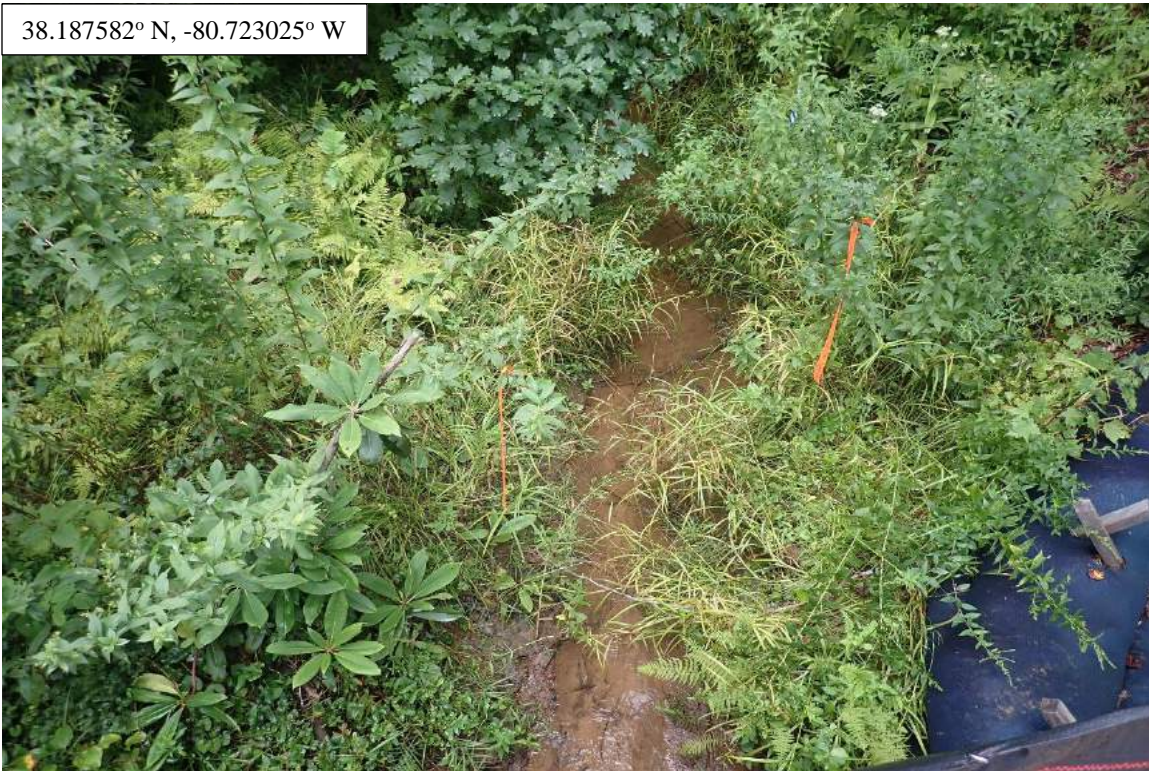
Photo Type: DS View at DS Edge of LOD

Location, Orientation, Photographer Initials: Downstream Edge of Limits of Disturbance, Downstream View, TF

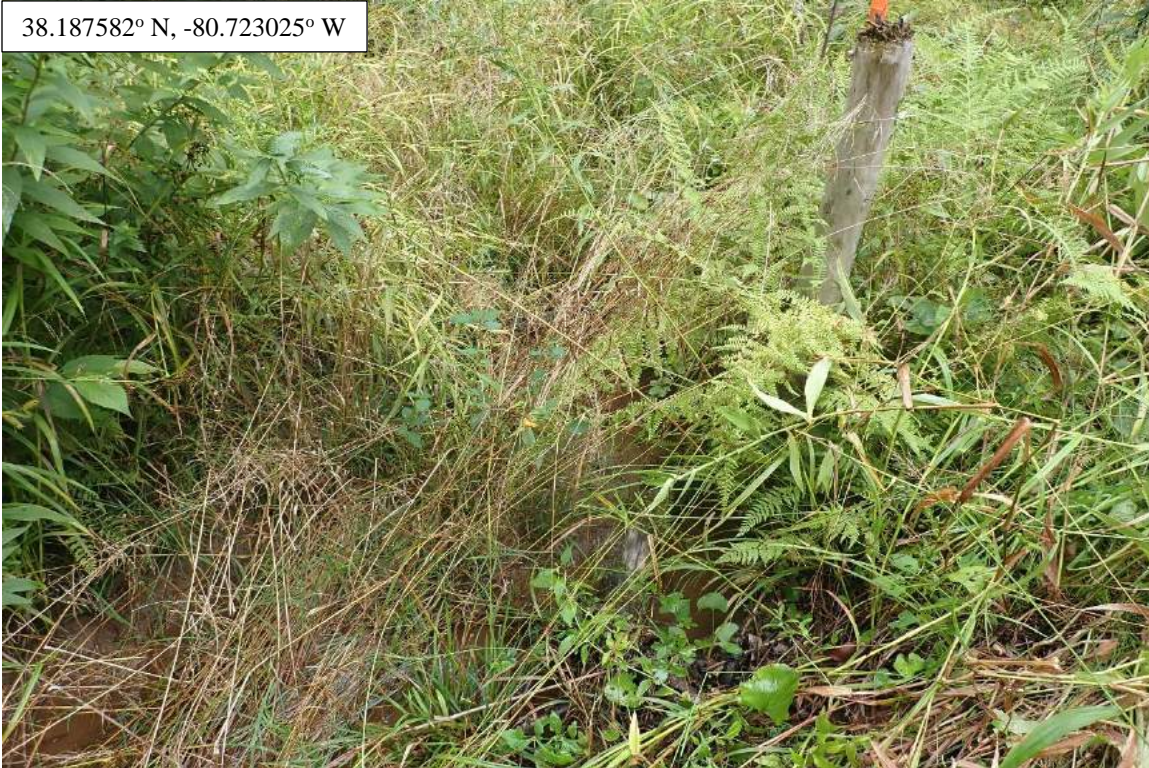
Photo Type: US View at Center LOD

Location, Orientation, Photographer Initials: Center of Limits of Disturbance, Upstream View, TF

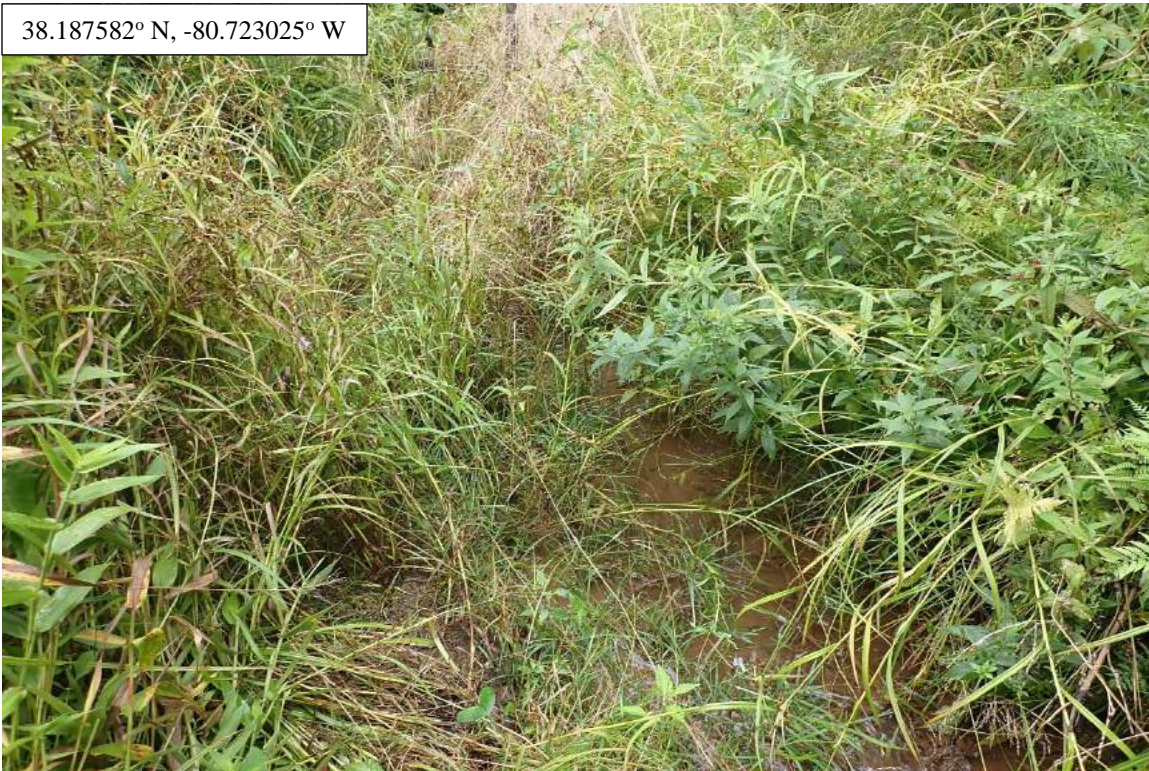
Photo Type: DS View at Center LOD

Location, Orientation, Photographer Initials: Center of Limits of Disturbance, Downstream View, TF

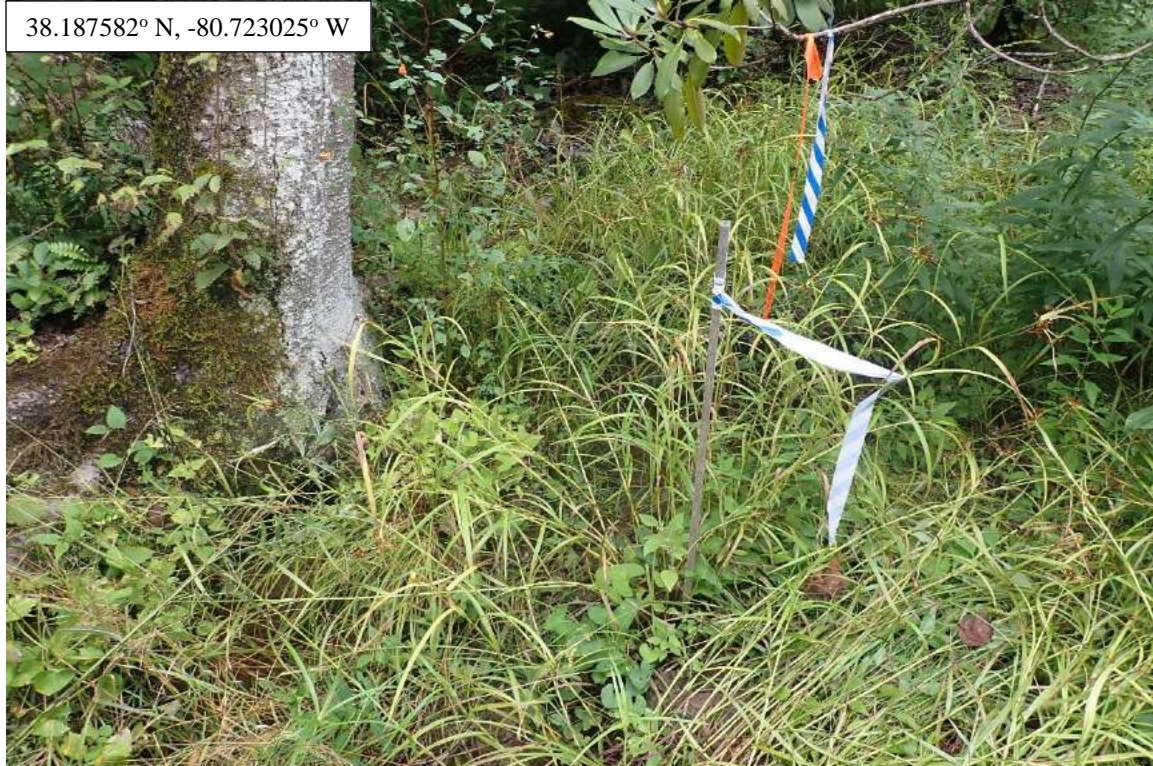
Photo Type: US View at US Edge of LOD

Location, Orientation, Photographer Initials: Upstream Edge of Limits of Disturbance, Upstream View, TF

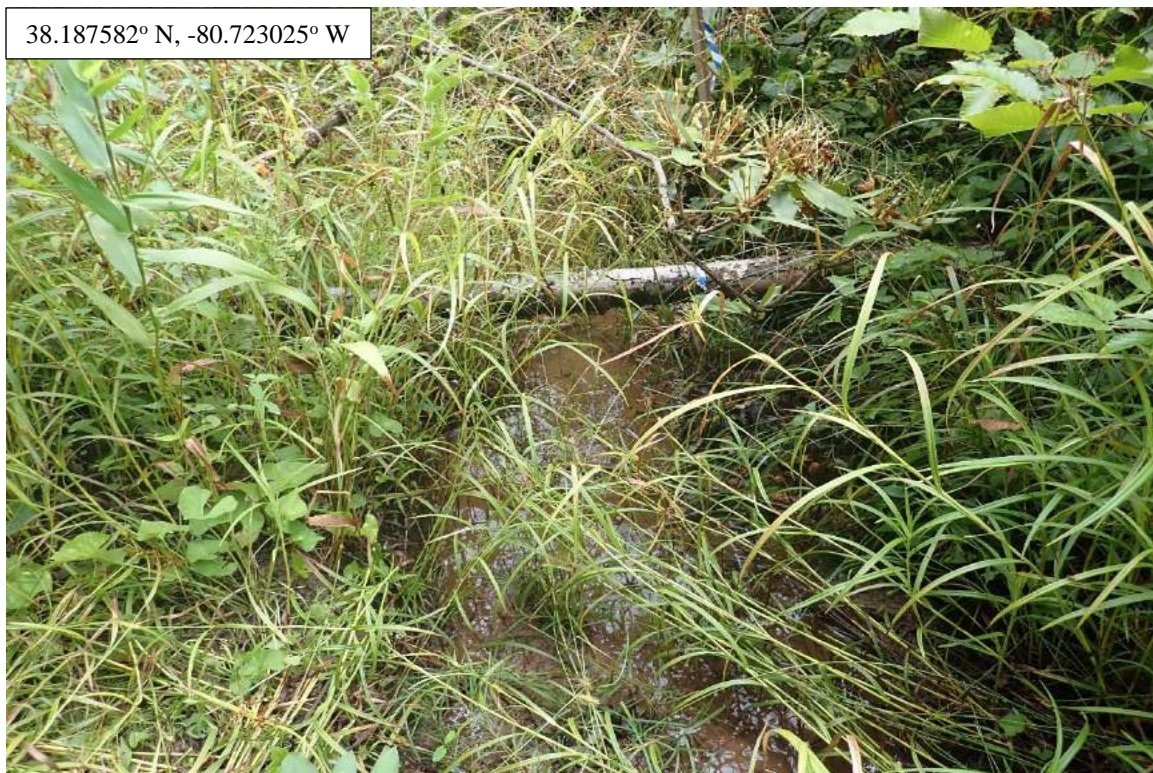
Photo Type: DS View at US Edge of LOD

Location, Orientation, Photographer Initials: Upstream Edge of Limits of Disturbance, Downstream View, TF

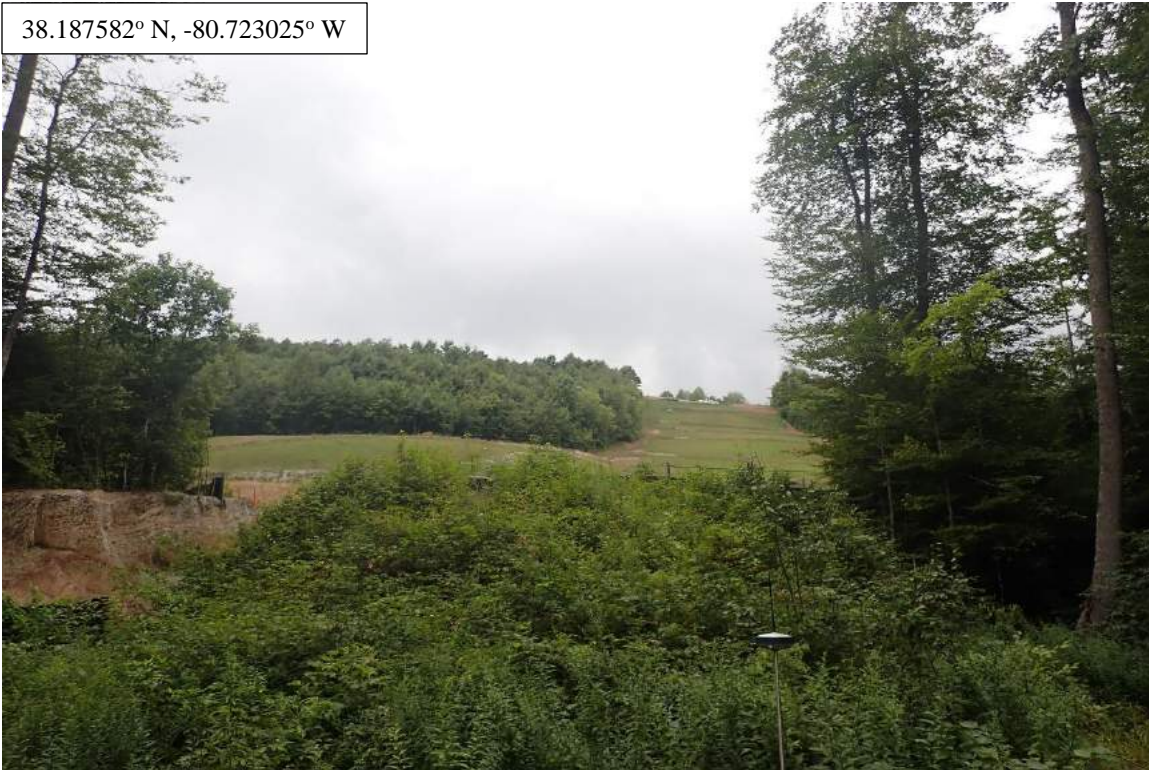
Photo Type: C LOD, N

Location, Orientation, Photographer Initials: Center of Limits of Disturbance, Facing North, TF

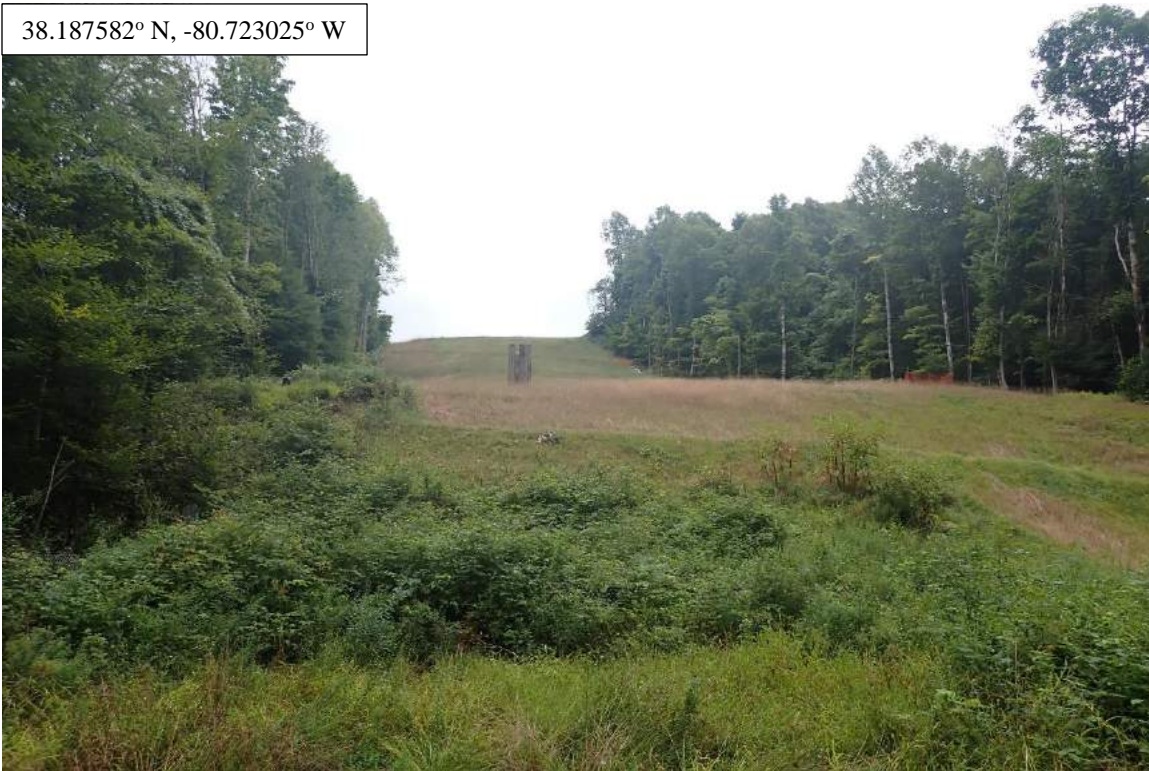
Photo Type: C LOD, S

Location, Orientation, Photographer Initials: Center of Limits of Disturbance, Facing South, TF

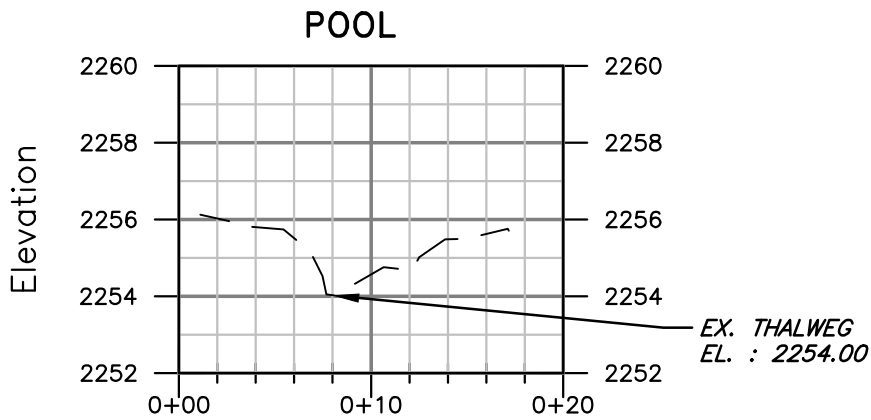
S-140 BASELINE CROSS-SECTION A

DISTANCE ALONG CROSS-SECTION (FT)

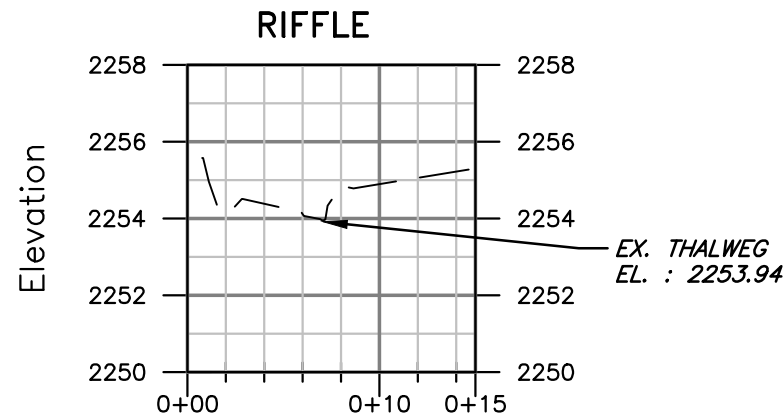
S-140 BASELINE CROSS-SECTION B

DISTANCE ALONG CROSS-SECTION (FT)

AS-BUILT TABLE: S-140 CROSS SECTION B					
PRE-CROSSING			AS-BUILT		
PT. LOC.	NORTHING	EASTING	ELEV.	VERT. DIFF.	HORZ. DIFF.
TS-L	13866966.145	1719994.75	2255.57		
BS-L	13866966.78	1719995.20	2254.27		
THW	13866971.83	1719996.24	2253.87		
BS-R	13866972.44	1719995.74	2253.97		
TS-R	13866973.25	1719996.01	2254.84

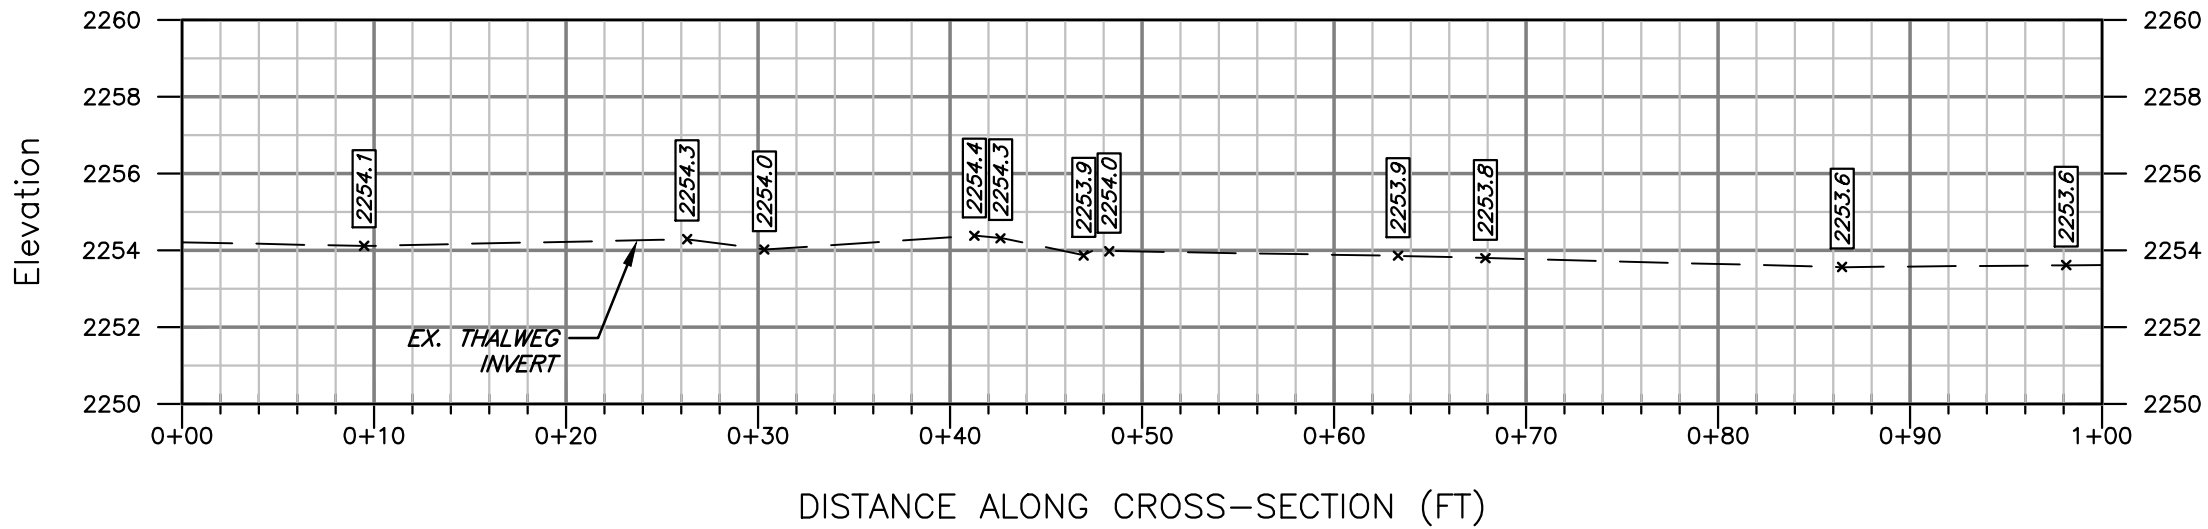
S-140 BASELINE THALWEG PROFILE

EXISTING STREAM PROFILE
INVERT ALONG THALWEG

SCALE: H: 1"=10'
V: 1"=5'

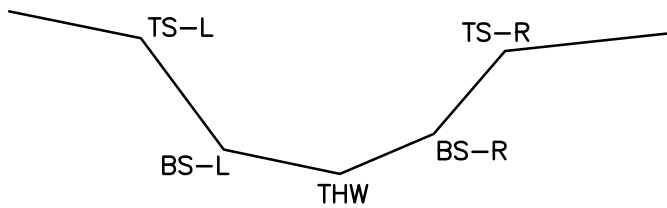
TYPICAL 5-POINT CROSS-SECTION
(FACING DOWNSTREAM)

TS: TOP OF SLOPE
BS: BOTTOM OF SLOPE
THW: THALWEG (INVERT)

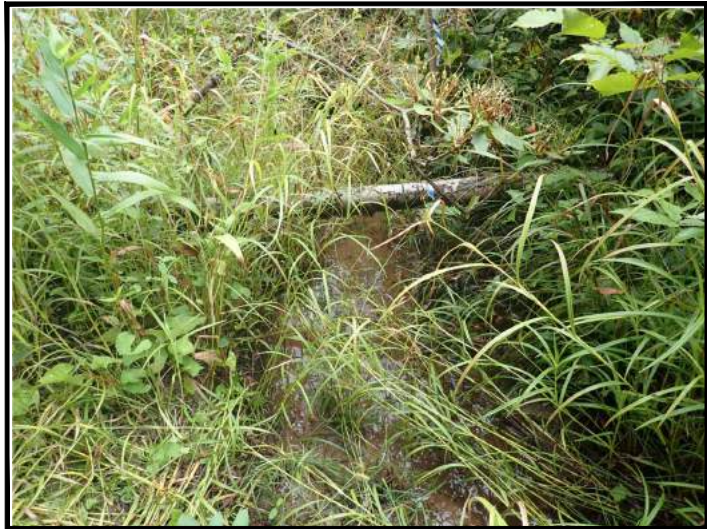
PHOTO TAKEN LOOKING DOWNSTREAM
FROM UPSTREAM IMPACT LIMITS

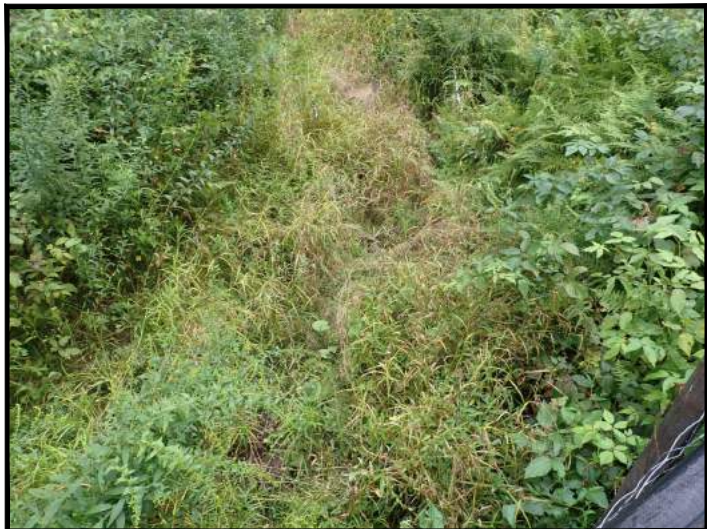
PHOTO TAKEN LOOKING UPSTREAM FROM
DOWNSTREAM IMPACT LIMITS
