Baseline Assessment – Stream Attributes

Reach S-J19 (Timber Mat Crossing) Ephemeral Spread E Greenbrier County, West Virginia

Spread E Stream S-J19 (Timber Mat Crossing) Greenbrier County

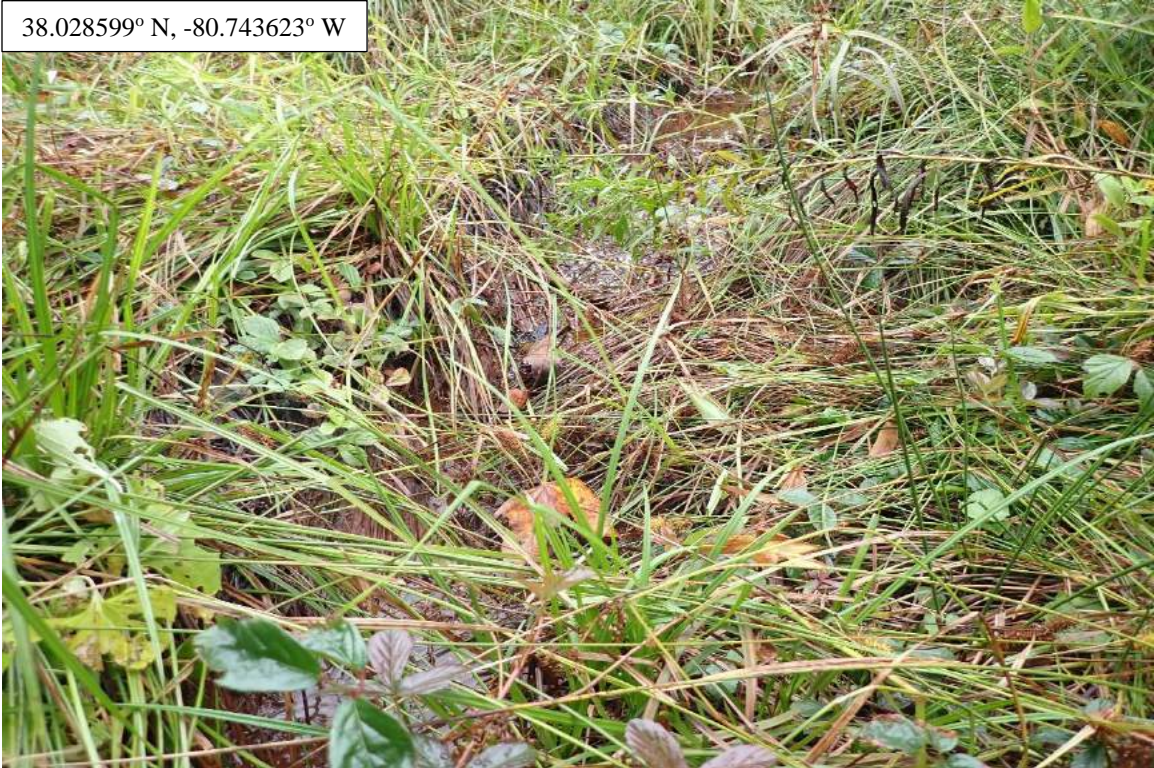
Photo Type: DS, US View

Location, Orientation, Photographer Initials: Downstream Edge of Right of Way, Upstream View, ABK/WP

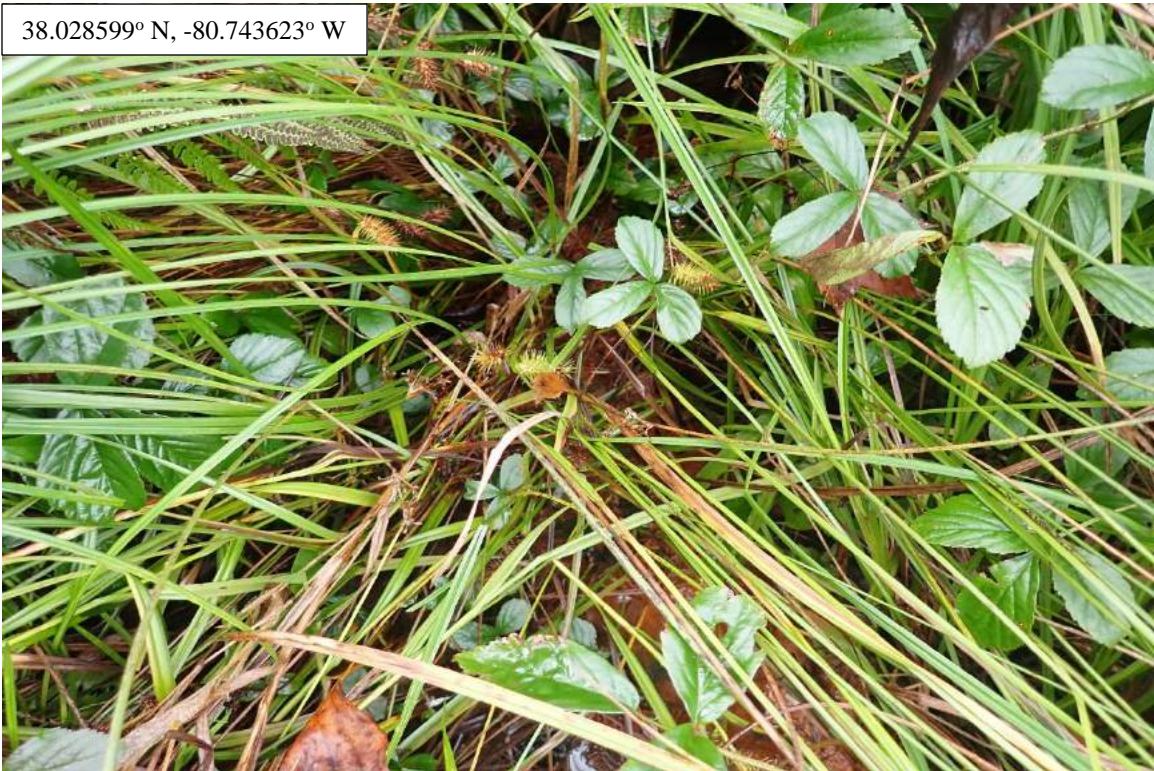
Photo Type: DS Edge ROW, DS View

Location, Orientation, Photographer Initials: Downstream Edge of ROW, Downstream View, ABK/WP

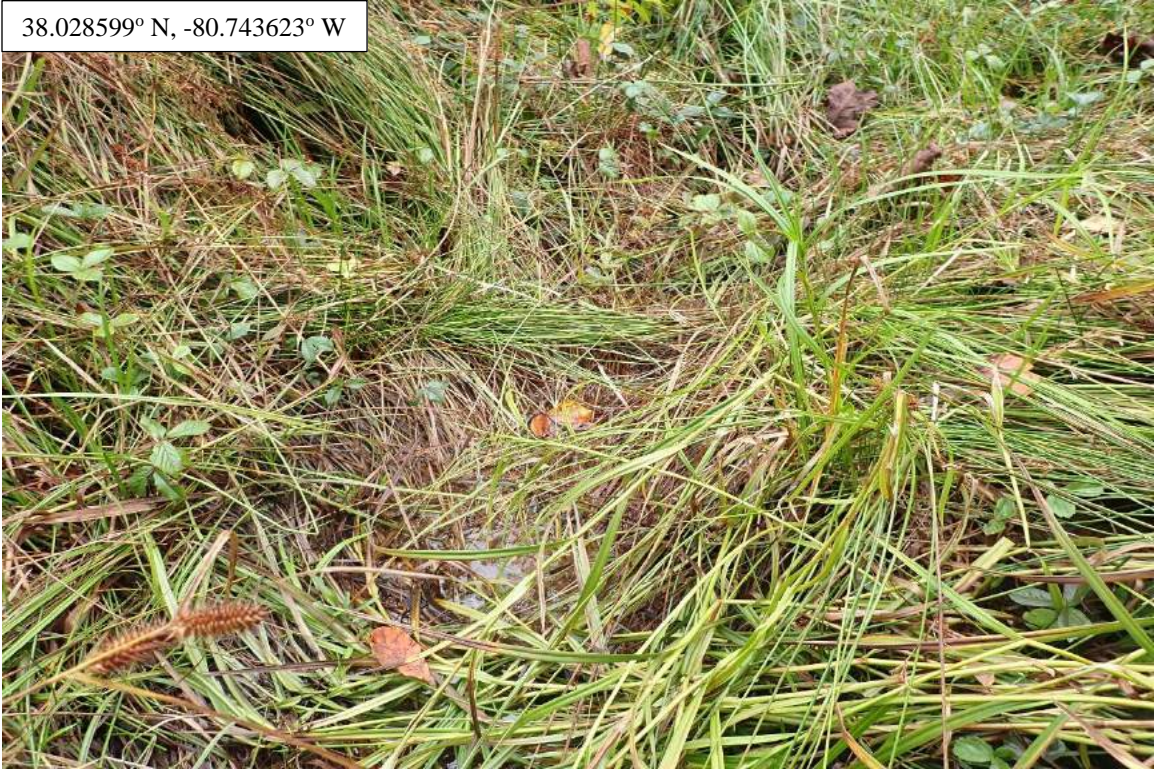
Photo Type: C ROW, US View

Location, Orientation, Photographer Initials: Center Right of Way, Upstream View, ABK/WP

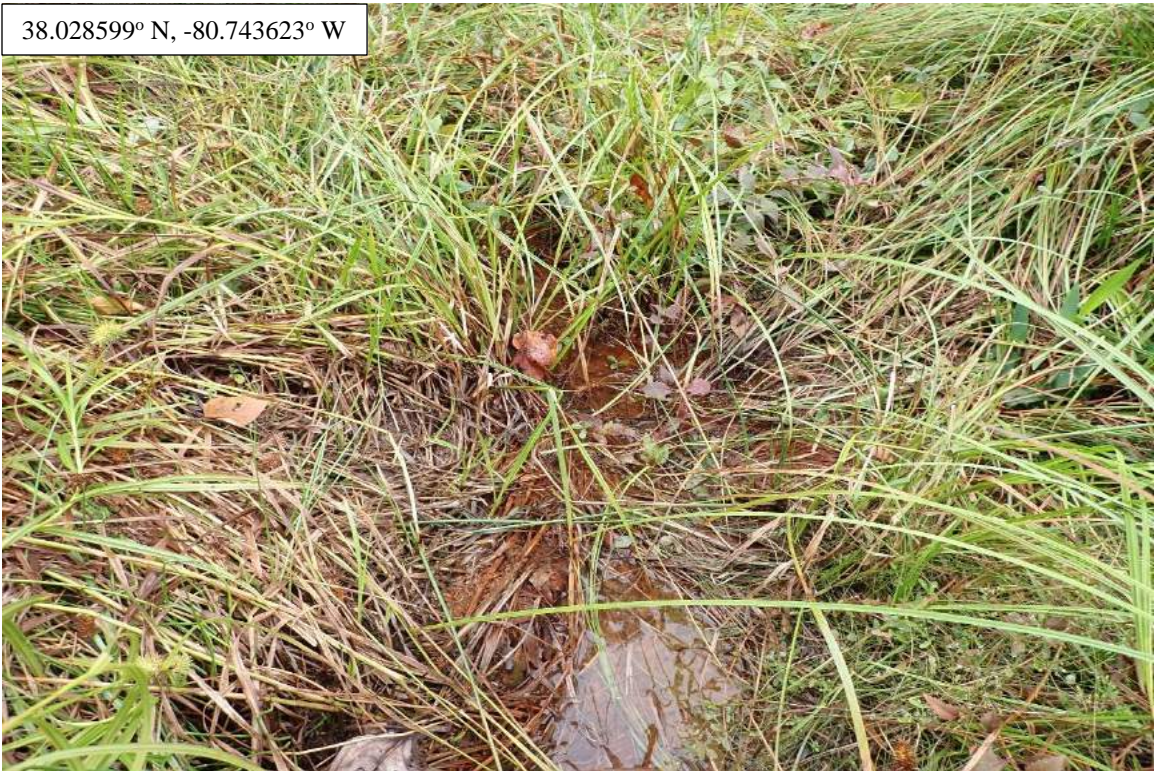
Photo Type: C ROW, DS View

Location, Orientation, Photographer Initials: Center of Right of Way, Downstream View, ABK/WP

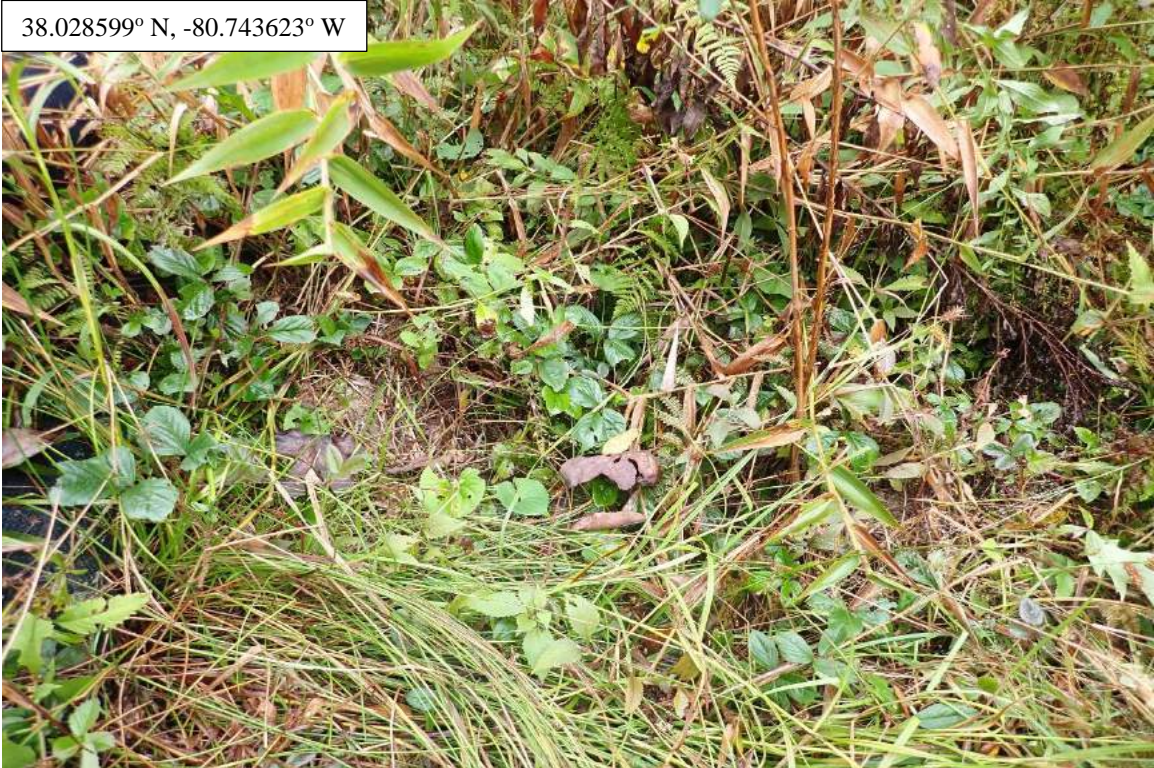
Photo Type: US, US View

Location, Orientation, Photographer Initials: Upstream Edge of Right of Way, Upstream View, ABK/WP

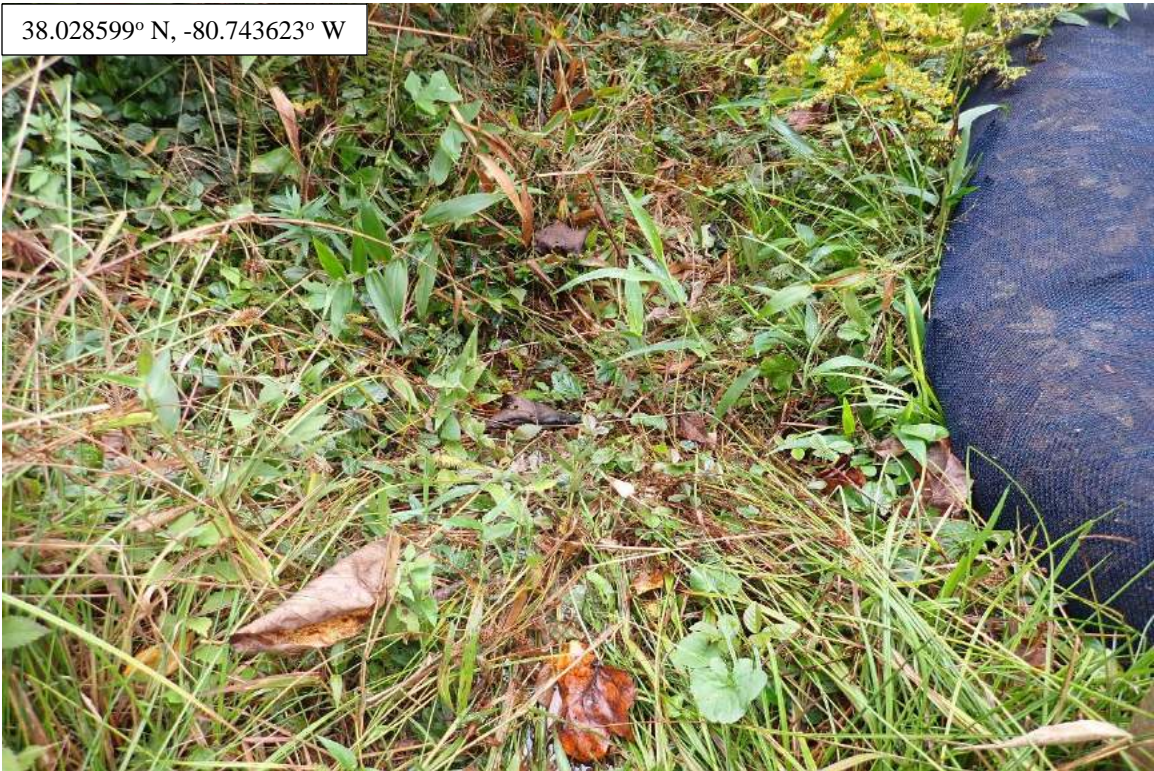
Photo Type: US, DS View

Location, Orientation, Photographer Initials: Upstream Edge of Right of Way, Downstream View, ABK/WP

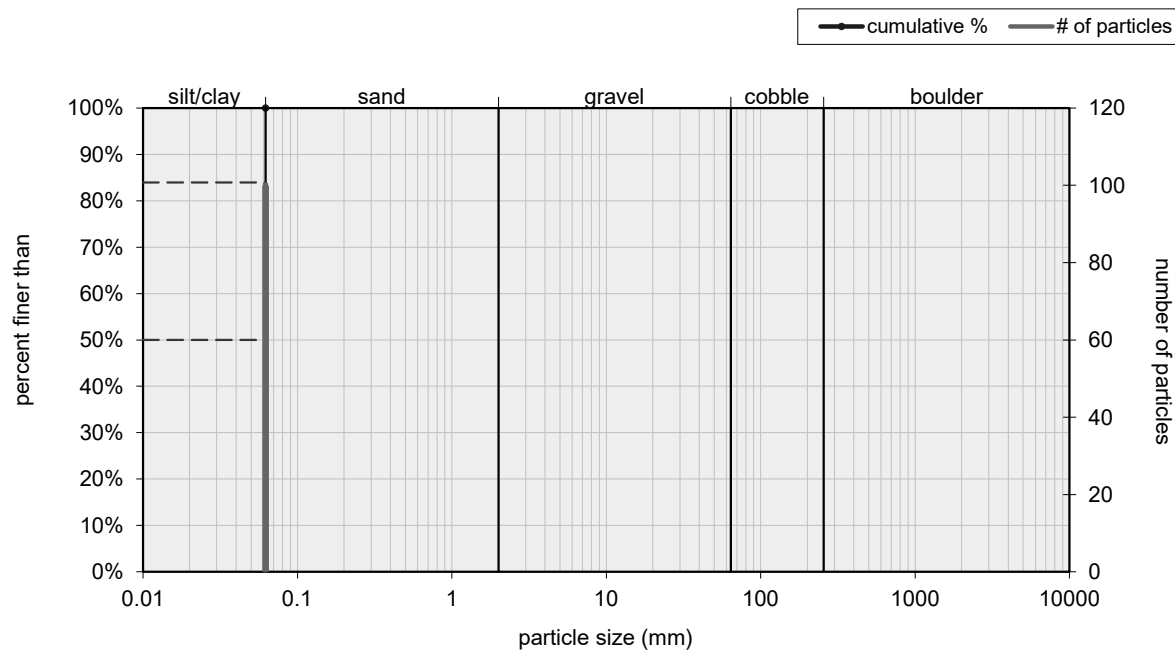
Riffle Surface Pebble Count, UNT to Meadow River (S-J19)

Size (mm)		Size Distribution		Type	
D16	0.062	mean	0.1	silt/clay	100%
D35	0.062	dispersion	1.0	sand	0%
D50	0.062	skewness	---	gravel	0%
D65	0.062			cobble	0%
D84	0.062			boulder	0%
D95	0.062

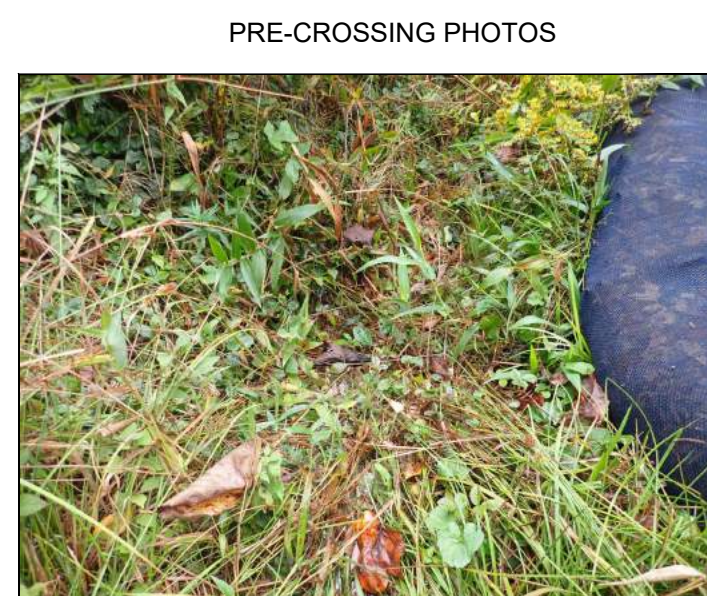
PHOTO TAKEN LOOKING DOWNSTREAM
FROM UPSTREAM IMPACT LIMITS

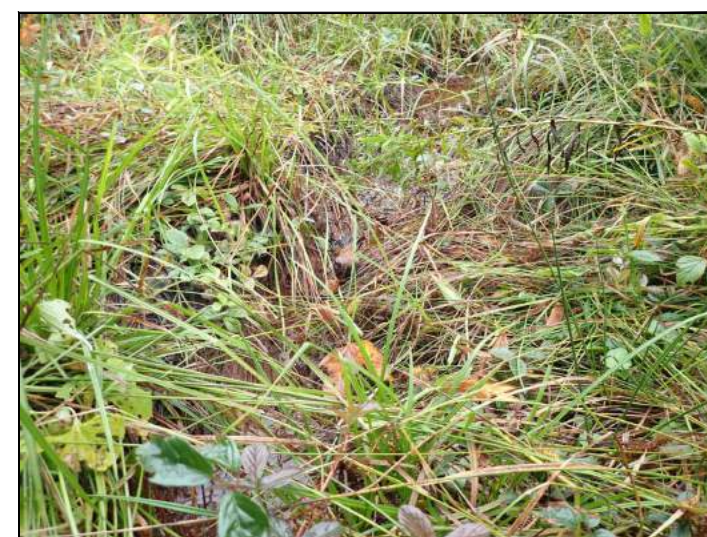
PHOTO TAKEN LOOKING UPSTREAM FROM
DOWNSTREAM IMPACT LIMITS
