Baseline Assessment – Stream Attributes

Reach S-MN2 (Pipeline ROW) Perennial Spread F Monroe County, West Virginia

Mountain Valley Pipeline

S-MN2 UNT to Hans Creek

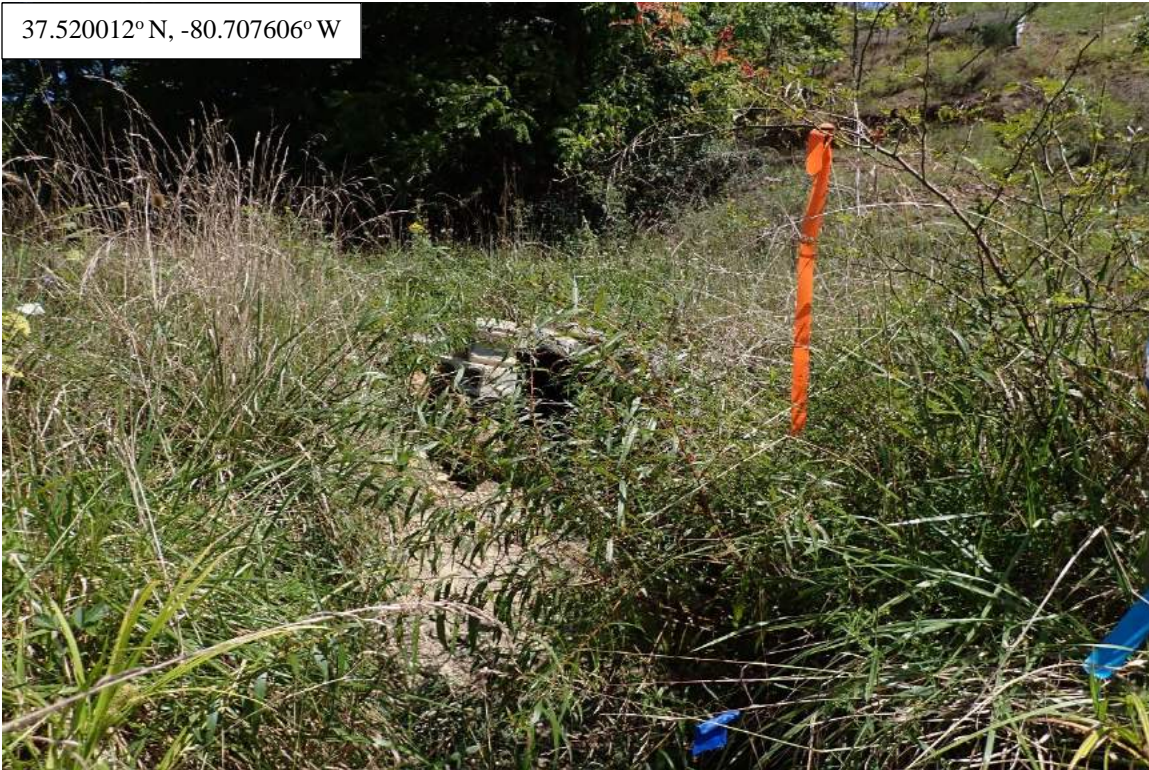
Photo Type: US Edge of ROW, US View

Location, Orientation, Photographer Initials: Upstream Edge of Right of Way, Upstream View, AK/TA/SM

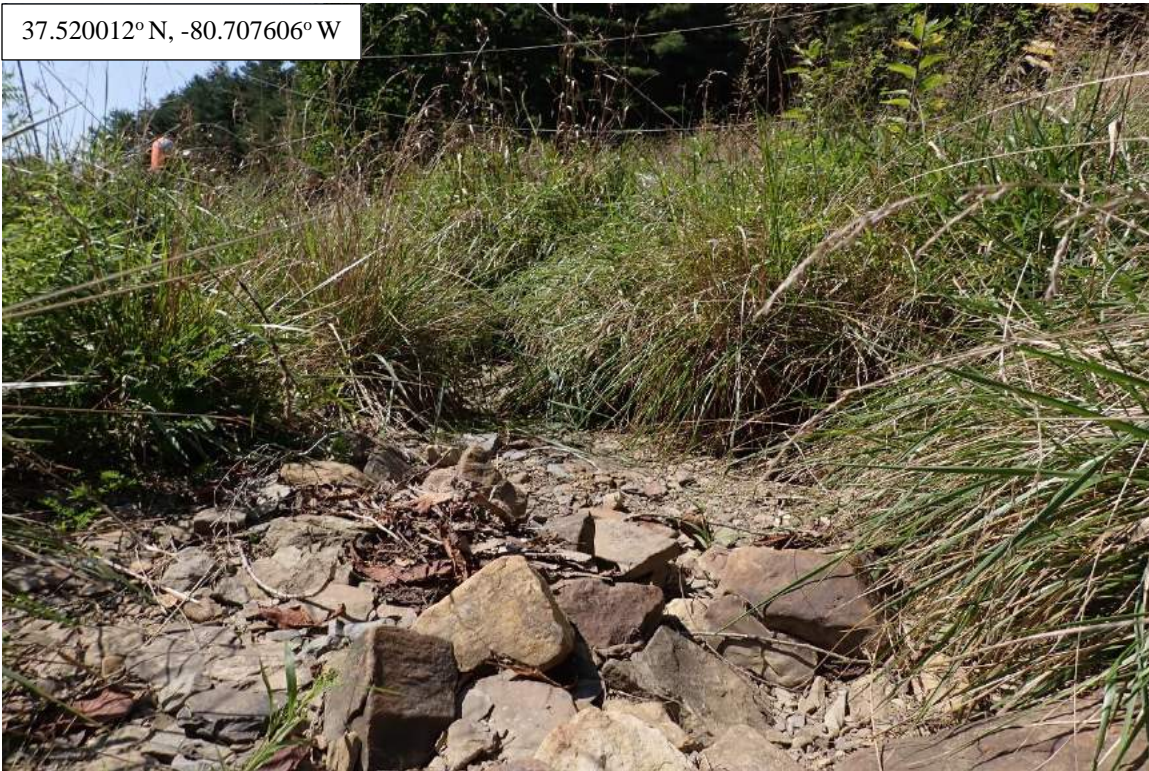
Photo Type: US Edge of ROW, DS View

Location, Orientation, Photographer Initials: Upstream Edge of Right of Way, Downstream View, AK/TA/SM

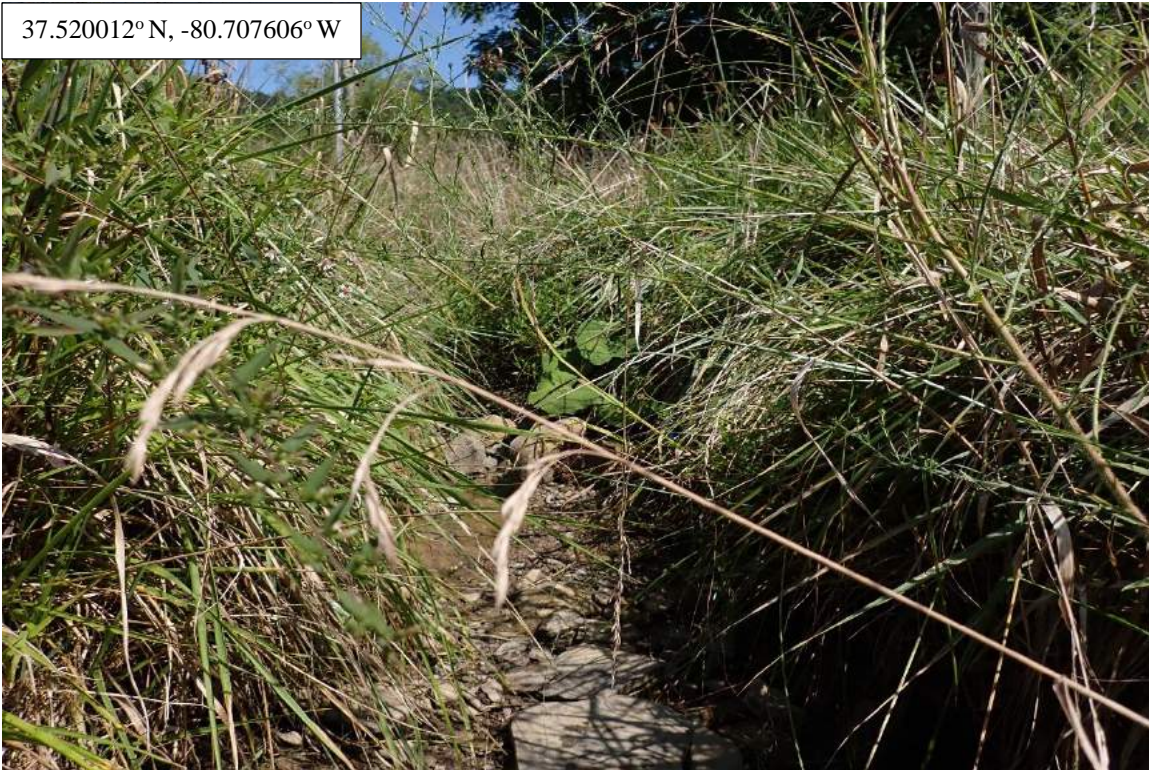
Photo Type: CP, US View

Location, Orientation, Photographer Initials: Center Right of Way, Upstream View, AK/TA/SM

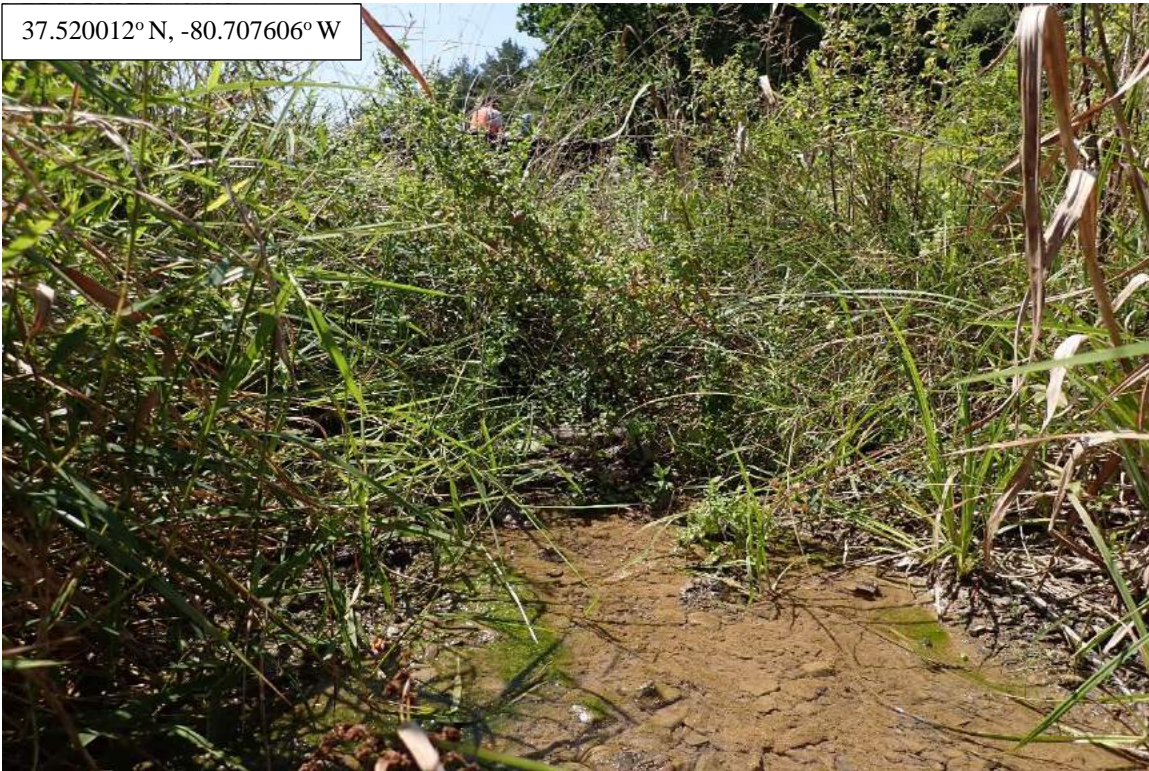
Photo Type: CP, DS View

Location, Orientation, Photographer Initials: Center Right of Way, Downstream View, AK/TA/SM

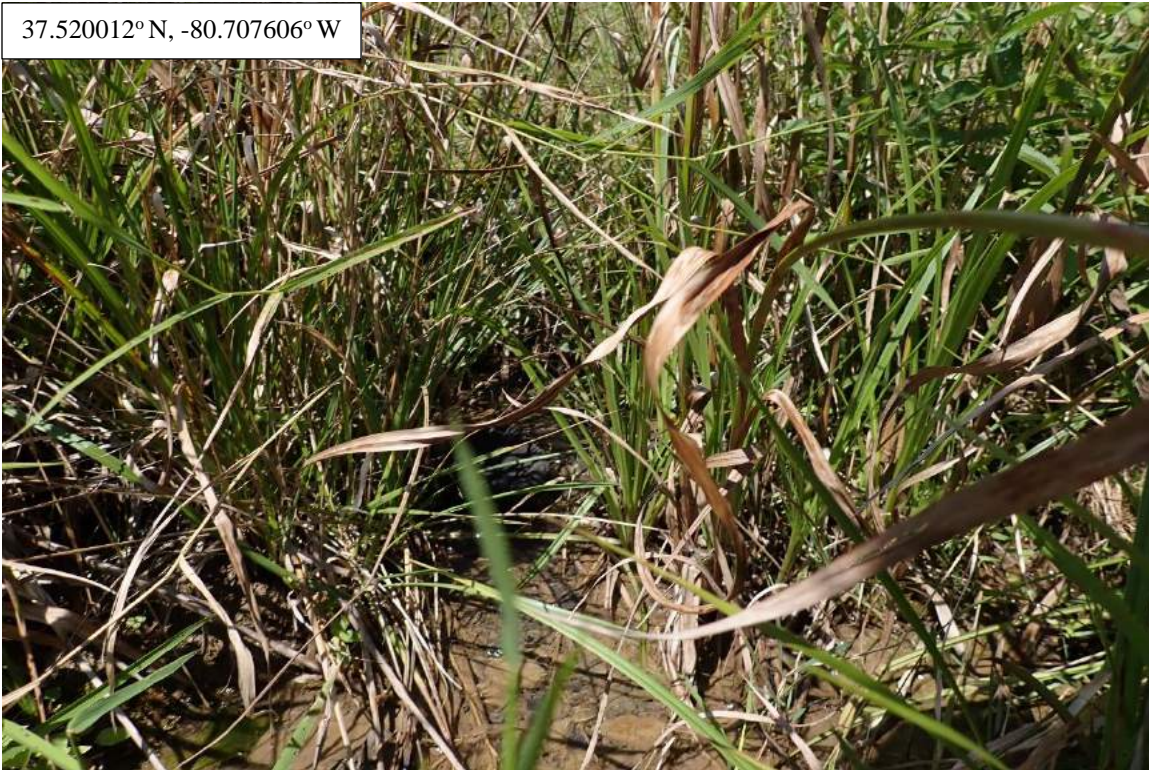
Photo Type: Start of Water

Location, Orientation, Photographer Initials: Start of Water, AK/TA/SM

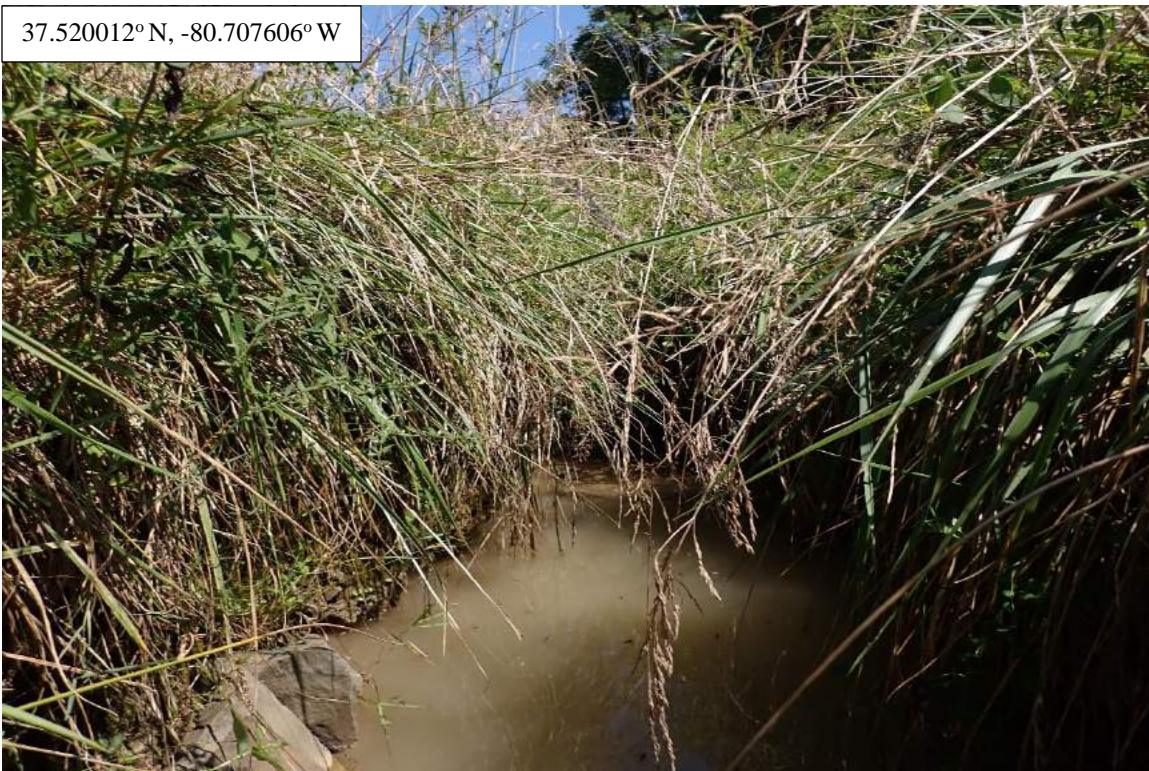
Photo Type: DS Edge of ROW, US View

Location, Orientation, Photographer Initials: Downstream Edge of Right of Way, Upstream View, AK/TA/SM

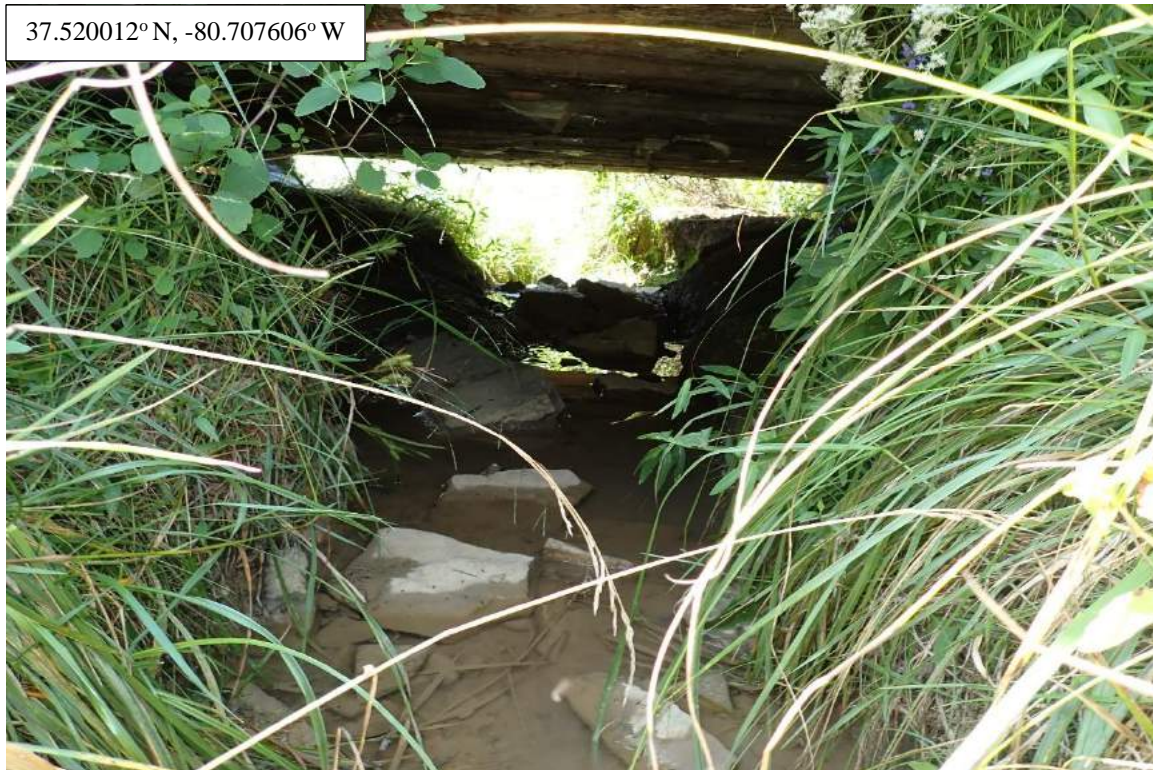
Photo Type: DS Edge of ROW, DS View

Location, Orientation, Photographer Initials: Downstream Edge of Right of Way, Downstream View, AK/TA/SM
