### Reach S-A105 (Timber Mat Crossing) Ephemeral Spread B Harrison County, West Virginia

### Spread B Stream S-A105 (Timber Mat Crossing) Harrison County

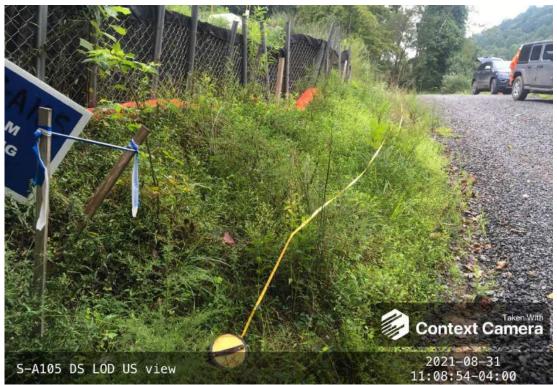
Photo Type: DS, US View

Location, Orientation, Photographer Initials: Downstream Edge of ROW, Upstream View, DP, HK, VM Lat: 39.168266 Long: -80.577815

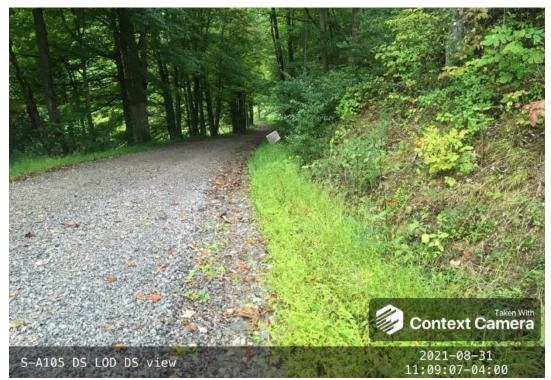
Photo Type: DS, DS View Location, Orientation, Photographer Initials: Downstream Edge of ROW, Downstream View, DP, HK, VM Lat: 39.168266 Long: -80.577815

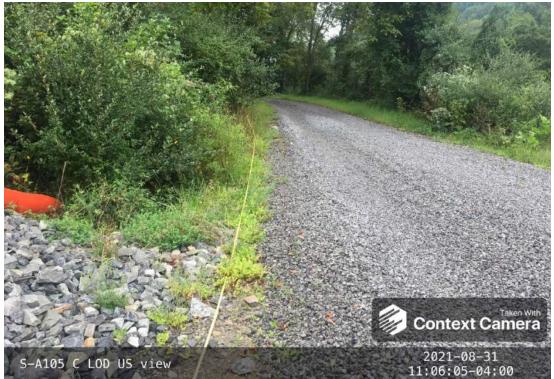
Photo Type: US View at Center Location, Orientation, Photographer Initials: Center ROW, Upstream View, DP, HK, VM Lat: 39.168266 Long: -80.577815

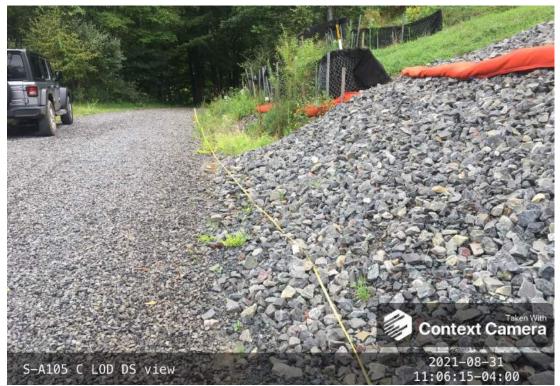
Photo Type: DS View at Center Location, Orientation, Photographer Initials: Center ROW, Downtstream View, DP, HK, VM Lat: 39.168266 Long: -80.577815

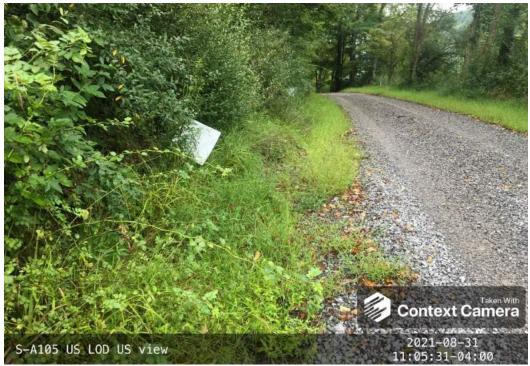
Photo Type: US, US View

Location, Orientation, Photographer Initials: Upstream Edge of ROW, Upstream View, DP, HK, VM Lat: 39.168266 Long: -80.577815

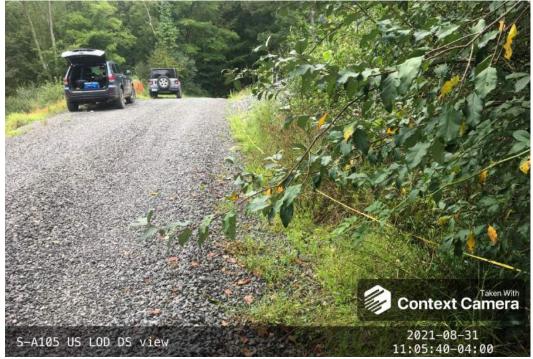
Photo Type: US, DS View Location, Orientation, Photographer Initials: Upstream Edge of ROW, Downstream View, DP, HK, VM Lat: 39.168266 Long: -80.577815

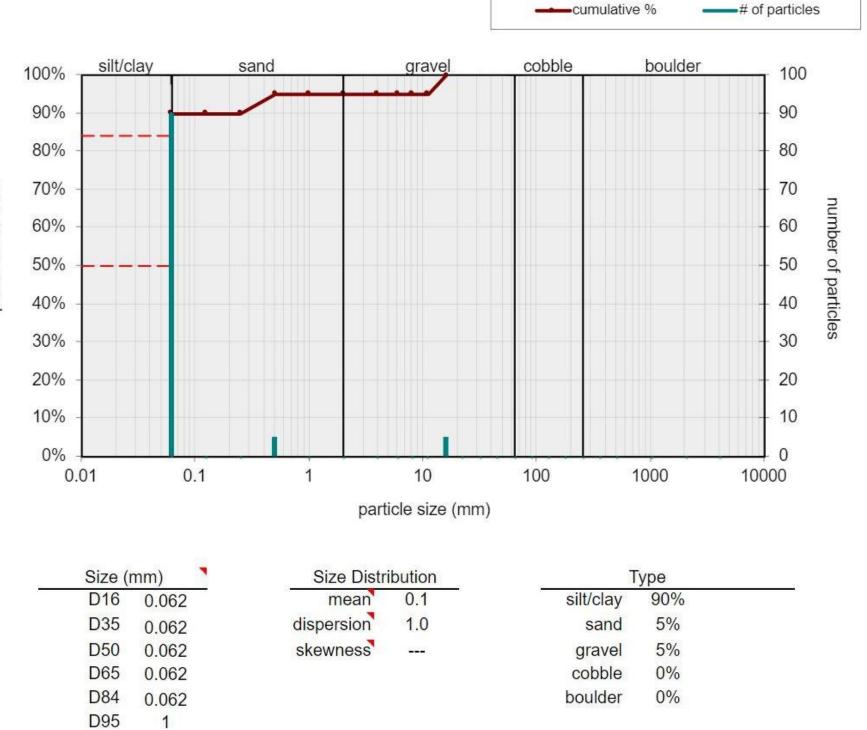
Bankfull Channel Pebble Count, S-A105, UNT to Kincheloe Creek

LE COUNT				
Inches	PARTICLE	Millimeters		Particle Count	Total #	Item %	% Cum
	Silt/Clay	< .062	S/C	• •	90	90.00	90.00
	Very Fine	.062125		▲ ▼	0	0.00	90.00
	Fine	.12525		▲ ▼	0	0.00	90.00
	Medium	.255	S A N D	▲ ▼	5	5.00	95.00
	Coarse	.50-1.0		▲ ▼	0	0.00	95.00
.0408	Very Coarse	1.0-2		* *	0	0.00	95.00
.0816	Very Fine	2 -4		* *	0	0.00	95.00
.1622	Fine	4 -5.7		▲ ▼	0	0.00	95.00
.2231	Fine	5.7 - 8		▲ ▼	0	0.00	95.00
.3144	Medium	8 -11.3		▲ ▼	0	0.00	95.00
.4463	Medium	11.3 - 16	GRAVEL	* *	5	5.00	100.00
.6389	Coarse	16 -22.6		▲ ▼	0	0.00	100.00
.89 - 1.26	Coarse	22.6 - 32		▲ ▼	0	0.00	100.00

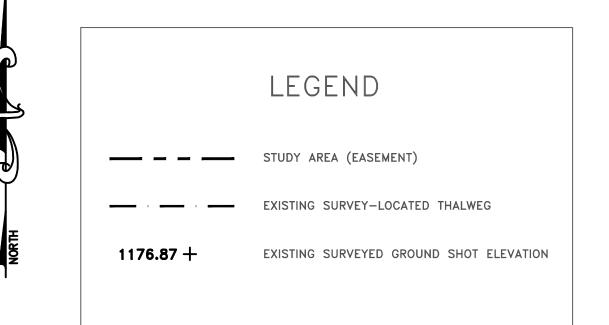
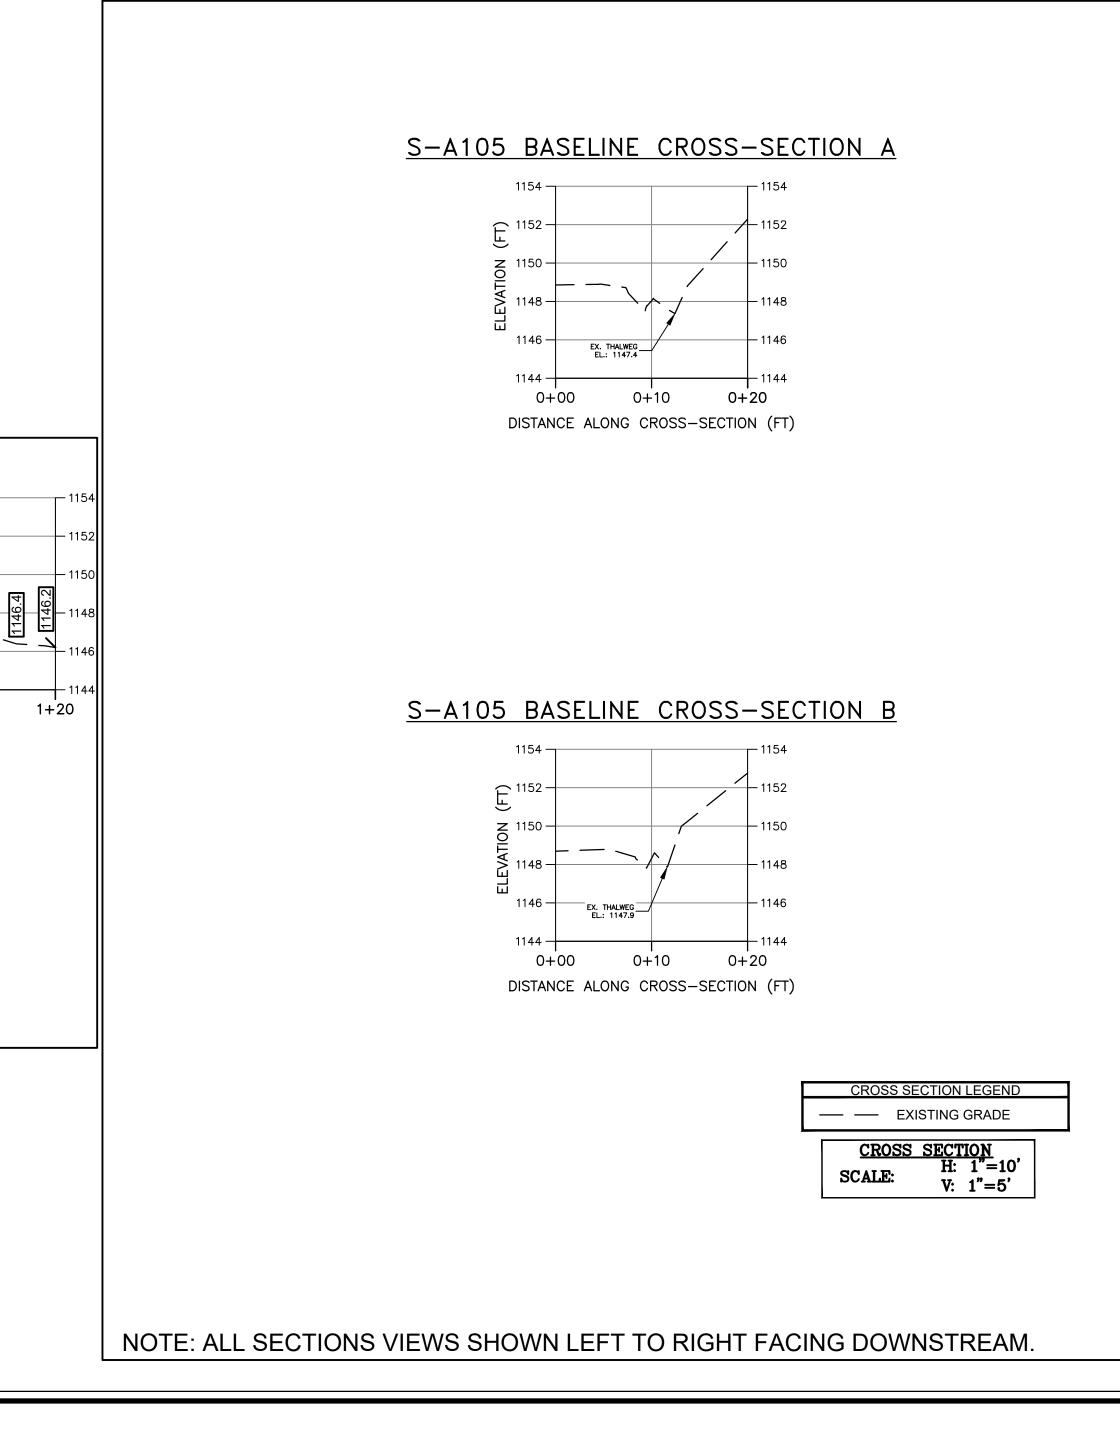
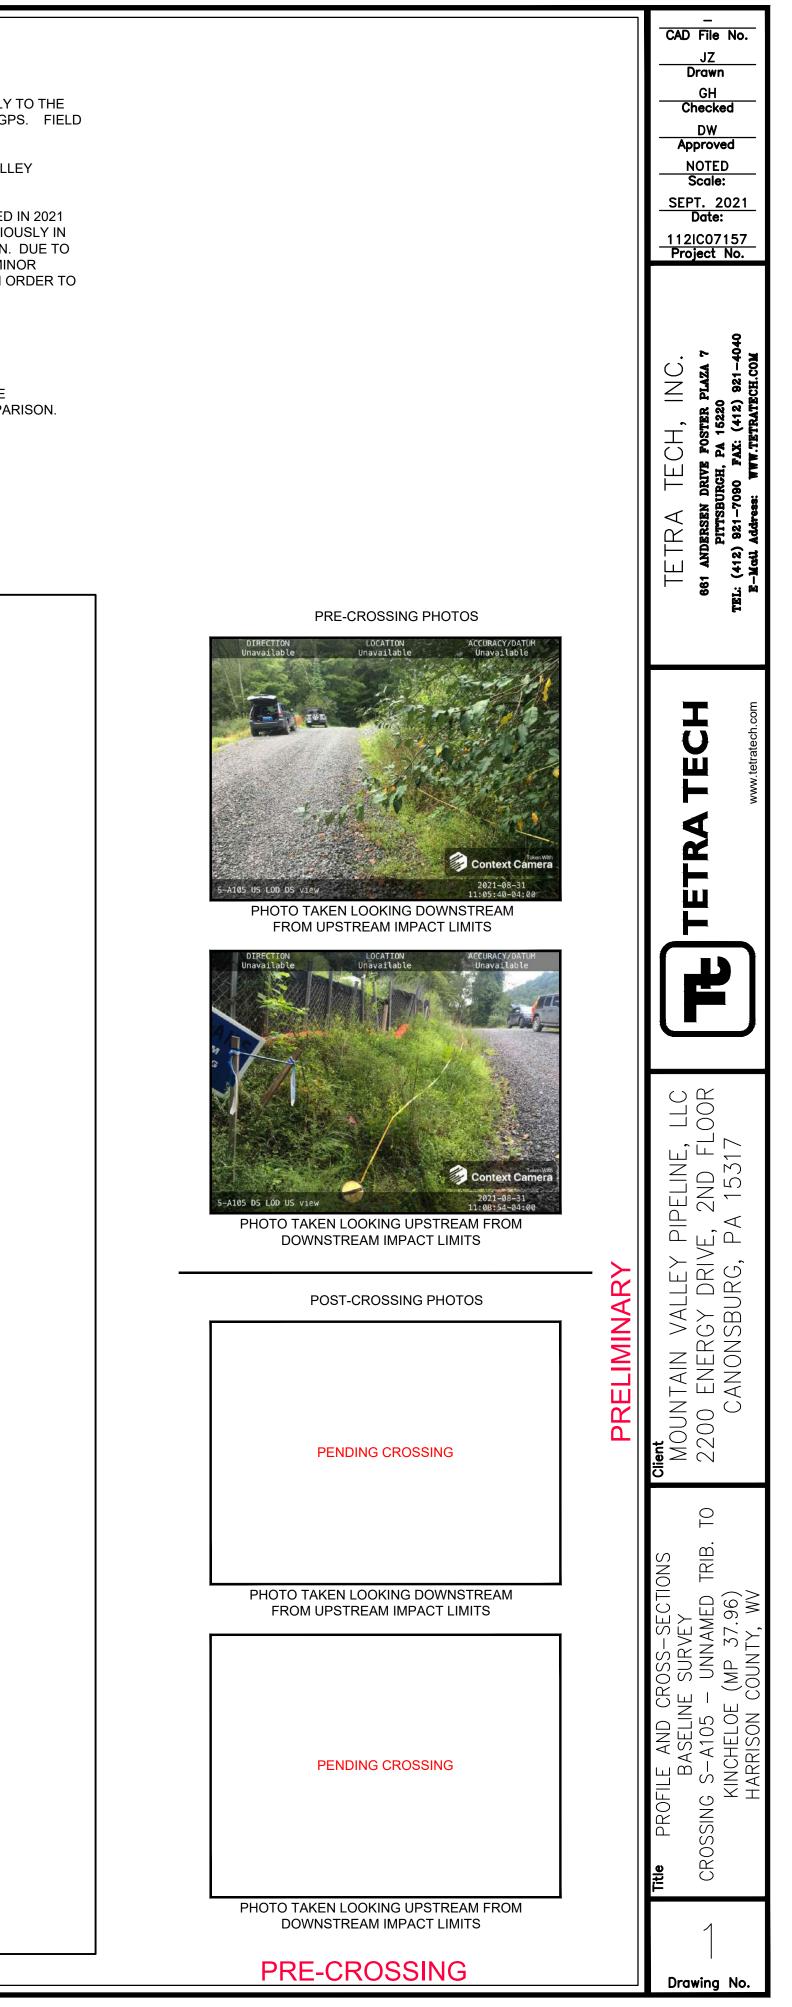
3. SURVEY POINTS FOR CROSS SECTIONS AND THALWEG PROFILES COLLECTED IN 2021 HAVE BEEN USED IN COMBINATION WITH SURVEY POINTS COLLECTED PREVIOUSLY IN 2020 IN ORDER TO GENERATE THE PRE-CROSSING SURFACE SHOWN IN PLAN. DUE TO NATURAL EROSIONAL STREAM PROCESSES THAT CAN OCCUR OVER TIME, MINOR ADJUSTMENTS TO THE PROFILE ALIGNMENTS MAY HAVE BEEN REQUIRED IN ORDER TO GENERATE A CLEAN PRE-CROSSING SURFACE.

- 4. ALL SECTION VIEWS SHOWN LEFT TO RIGHT FACING DOWNSTREAM.
- 5. POST-CROSSING SURVEY INFORMATION SHOWN IN RED. DATA PENDING.
- 6. POST-CROSSING SURVEY POINTS FOR CROSS SECTIONS AND THALWEG ARE PROJECTED ONTO PRE-CROSSING SECTION AND PROFILE VIEWS FOR COMPARISON.
