Baseline Assessment – Stream Attributes

Reach S-A10a (Timber Mat Crossing) Perennial Spread A Harrison County, West Virginia

CROSSING S-A10A - LITTLE ROCK
RUN (MP 17.76)
HARRISON COUNTY, WV

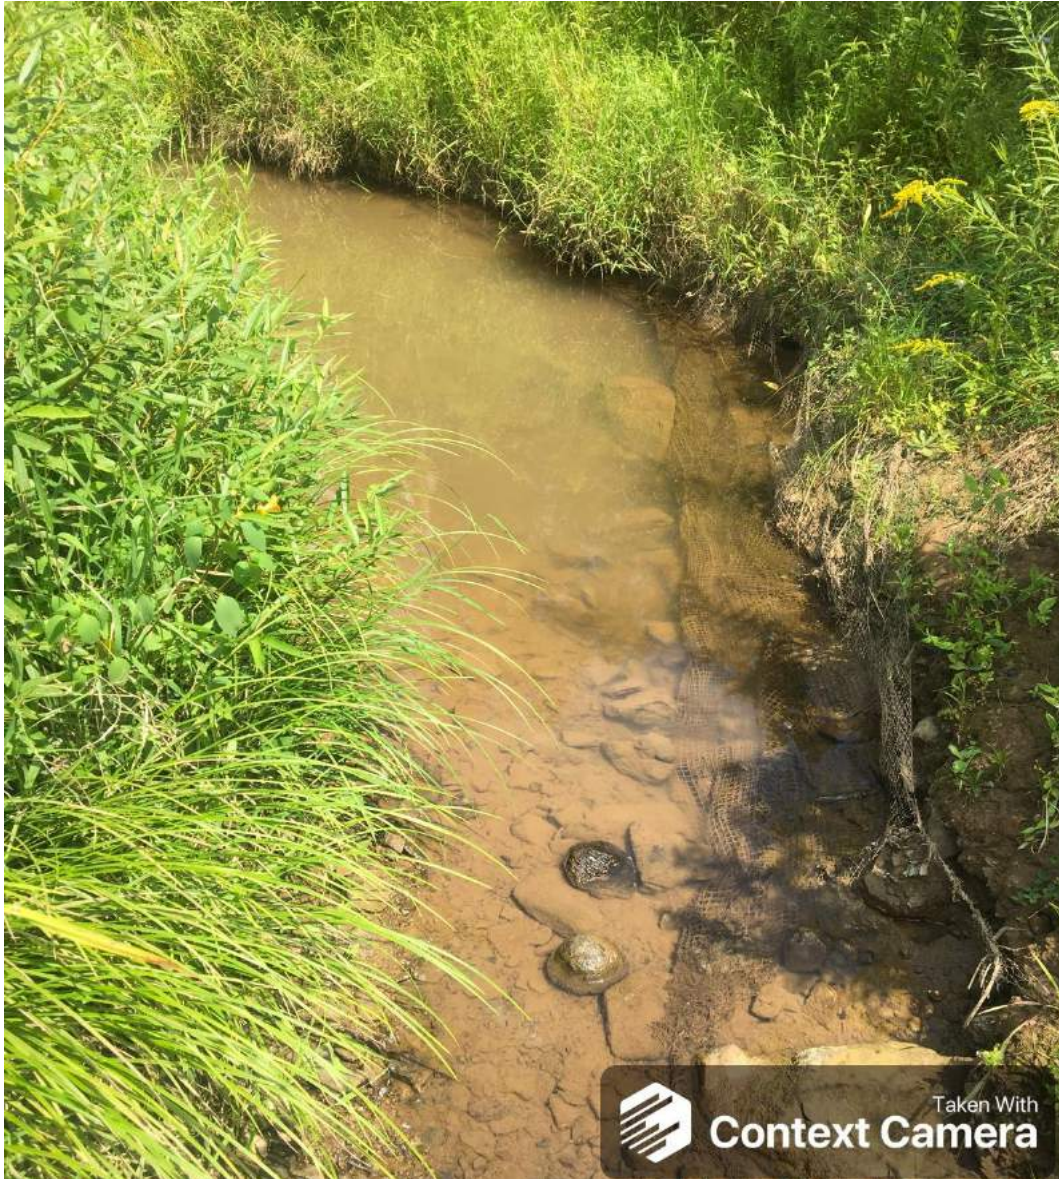
Photo Type: Downstream, US View

Location, Orientation, Photographer Initials: Downstream Edge of ROW, Upstream View, DP/PL

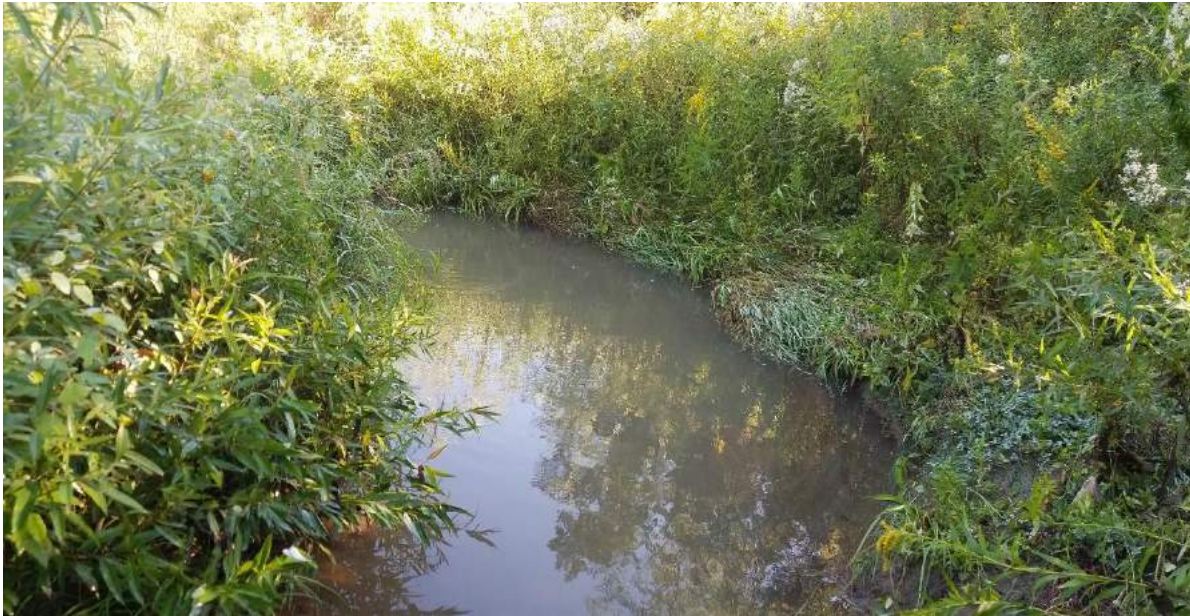
Photo Type: US View at Center
Location, Orientation, Photographer Initials: Center Edge of ROW, Upstream View, DP/PL
Lat: 39.370005 Long: -80.484974

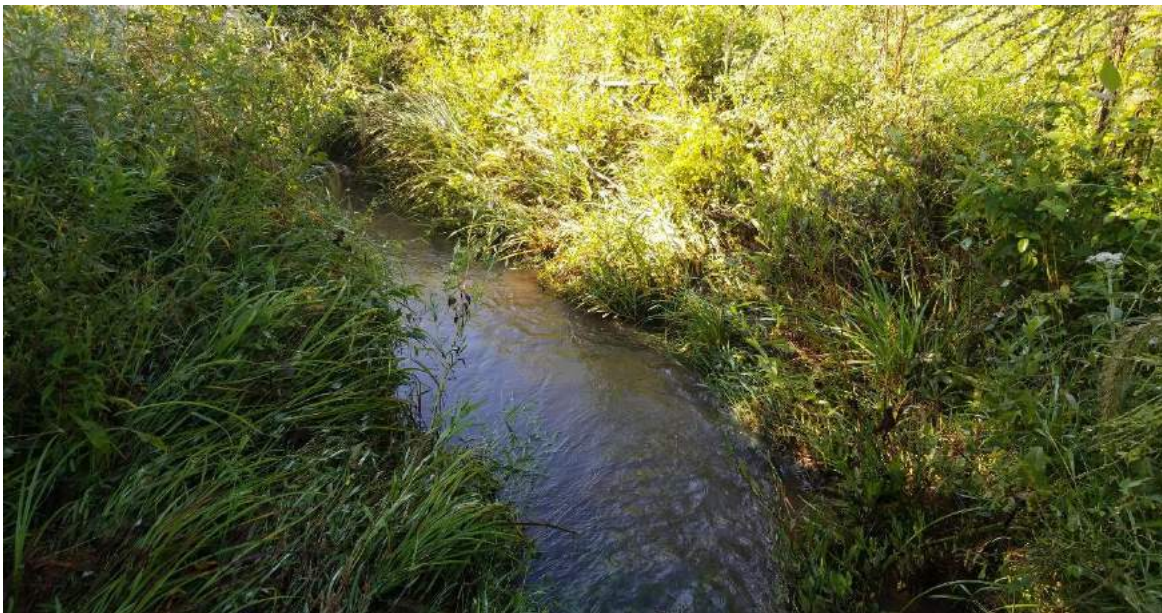
Photo Type: DS View at Center
Location, Orientation, Photographer Initials: Center Edge of ROW, Downstream View, DP/PL
Lat: 39.370005 Long: -80.484974

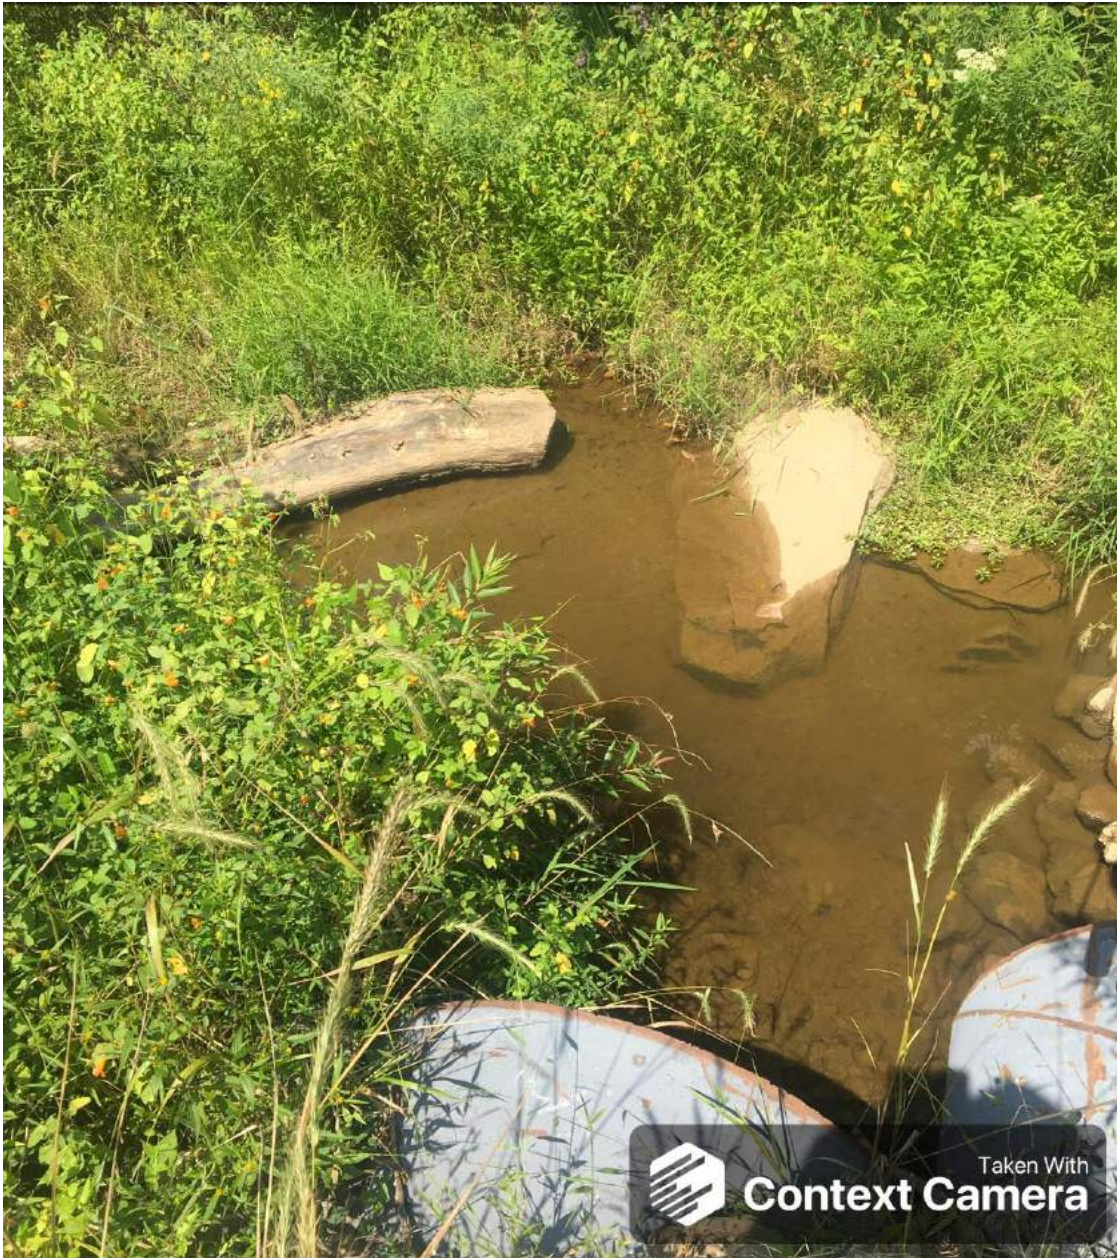
Photo Type: Upstream, US View
Location, Orientation, Photographer Initials: Upstream Edge of ROW, Upstream View, DP/PL
Lat: 39.370005 Long: -80.484974

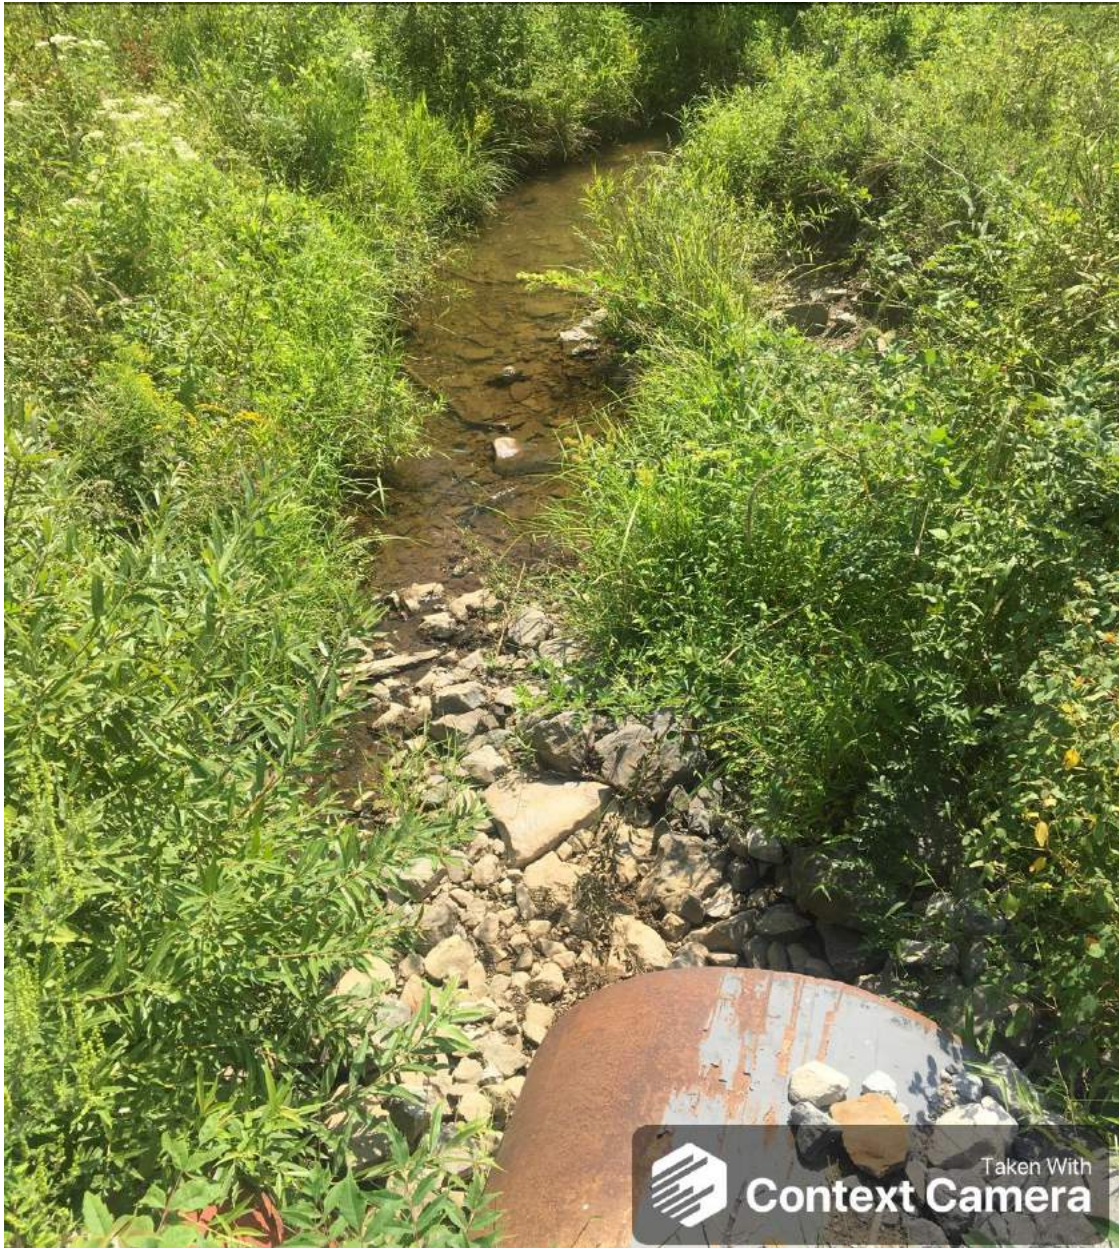
Photo Type: Upstream, DS View
Location, Orientation, Photographer Initials: Upstream Edge of ROW, Downstream View, DP/PL
Lat: 39.370005 Long: -80.484974

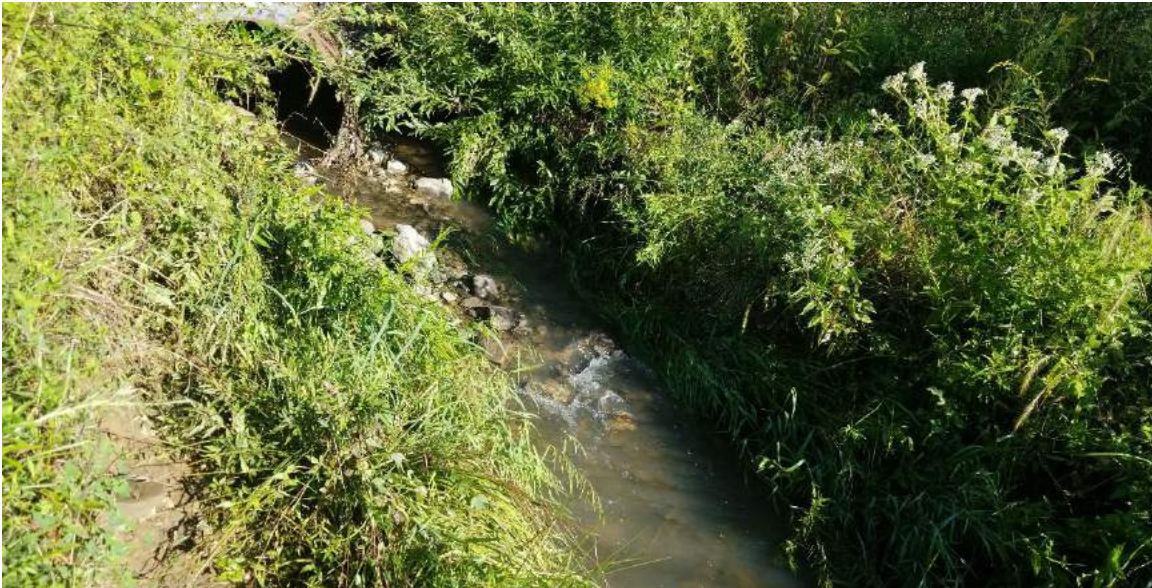
Photo Type: Riffle, US View

Location, Orientation, Photographer Initials: Center Stream Riffle, Upstream View, DP/PL

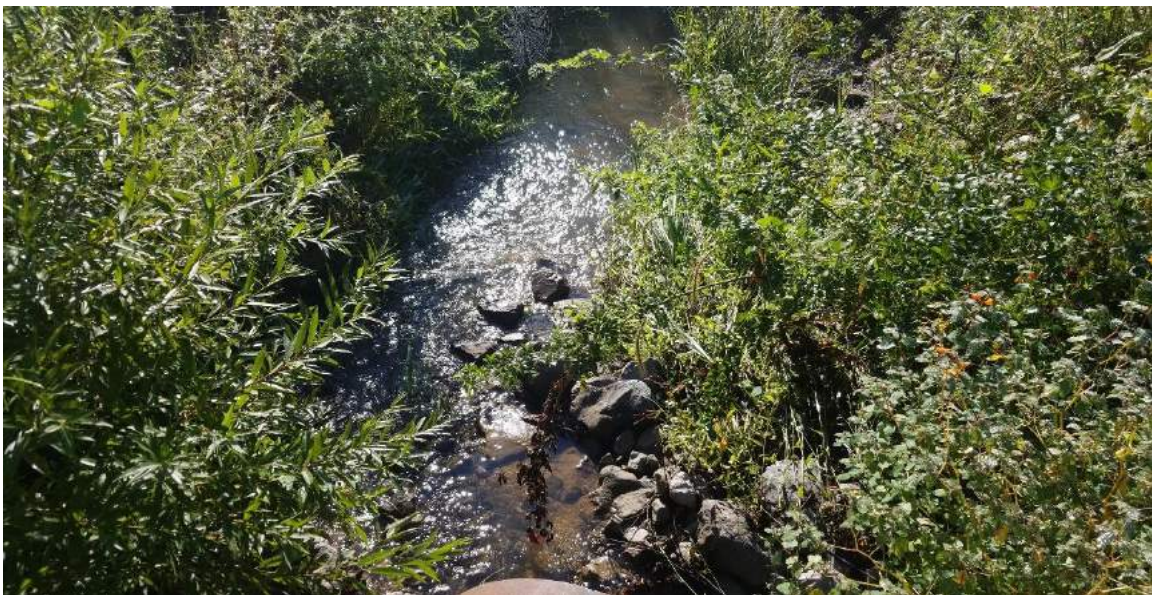
Photo Type: Riffle, Downstream View

Location, Orientation, Photographer Initials: Center Stream Riffle, Downstream View, DP/PL

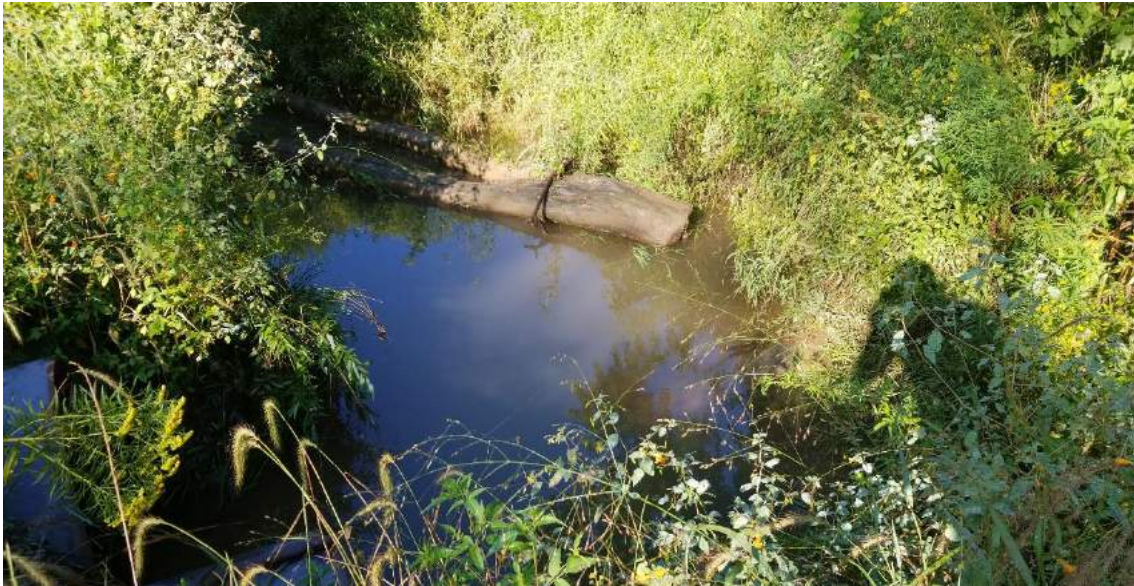
Photo Type: Pool, US View

Location, Orientation, Photographer Initials: Center Stream Pool, Upstream View, DP/PL

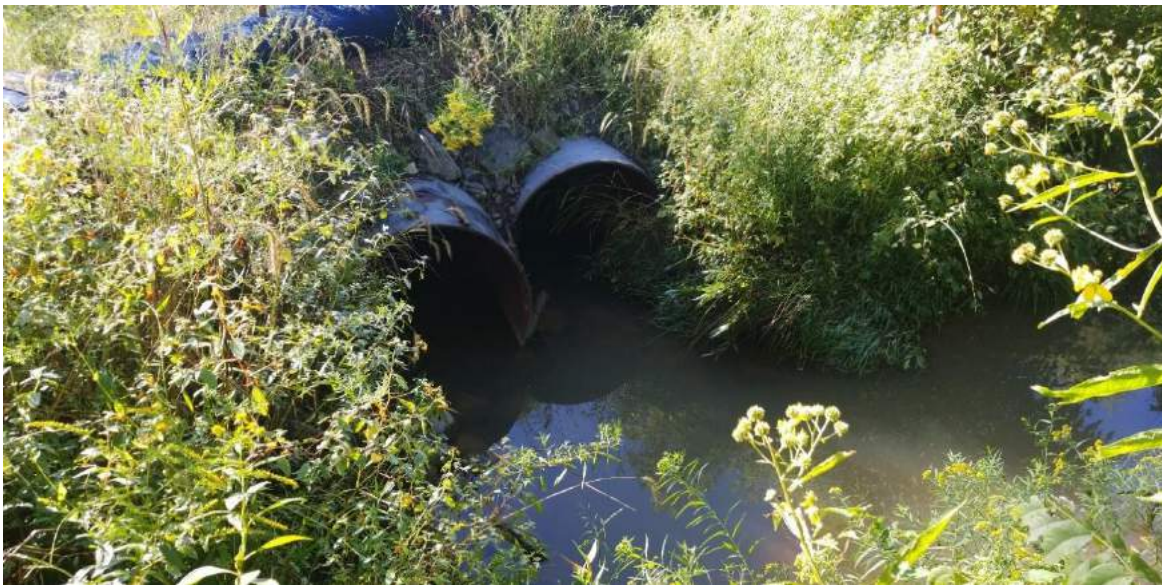
Photo Type: Pool, DS View

Location, Orientation, Photographer Initials: Center Stream Pool, Downstream View, DP/PL

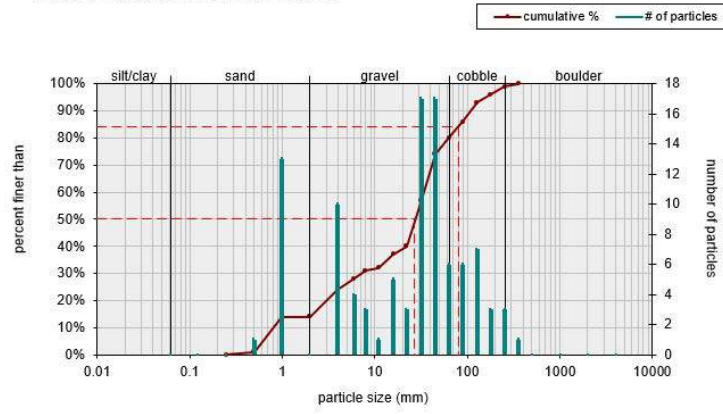
Bankfull Channel Pebble Count, S-A10a

Size (mm)			Size Distribution		Type	
D16	2.3	3.4	mean	13.6	silt/clay	0%
D35	14	12	dispersion	7.4	sand	14%
D50	27	17	skewness	-0.24	gravel	66%
D65	38	20			cobble	19%
D84	80	29			boulder	1%
D95	160	39

PEBBLE COUNT							
Inches	PARTICLE	Millimeters		Particle Count	Total #	Item %	% Cum
	Silt/Clay	< .062	S/C	▲ ▼	0	0.00	0.00
	Very Fine	.062-.125	S A N D	▲ ▼	0	0.00	0.00
	Fine	.125-.25		▲ ▼	0	0.00	0.00
	Medium	.25-.5		▲ ▼	1	1.00	1.00
	Coarse	.50-1.0		▲ ▼	13	13.00	14.00
.04-.08	Very Coarse	1.0-2		▲ ▼	0	0.00	14.00
.08 -.16	Very Fine	2 -4		G R A V E L	▲ ▼	10	10.00
.16 - .22	Fine	4 -5.7	▲ ▼		4	4.00	28.00
.22 - .31	Fine	5.7 - 8	▲ ▼		3	3.00	31.00
.31 - .44	Medium	8 -11.3	▲ ▼		1	1.00	32.00
.44 - .63	Medium	11.3 - 16	▲ ▼		5	5.00	37.00
.63 - .89	Coarse	16 -22.6	▲ ▼		3	3.00	40.00
.89 - 1.26	Coarse	22.6 - 32	▲ ▼		17	17.00	57.00

1.26 - 1.77	Vry Coarse	32 - 45	▲ ▼		17	17.00	74.00
1.77 -2.5	Vry Coarse	45 - 64	▲ ▼		6	6.00	80.00
2.5 - 3.5	Small	64 - 90	C O B B L E	▲ ▼	6	6.00	86.00
3.5 - 5.0	Small	90 - 128		▲ ▼	7	7.00	93.00

5.0 - 7.1	Large	128 - 180		▲ ▼	3	3.00	96.00
7.1 - 10.1	Large	180 - 256		▲ ▼	3	3.00	99.00
10.1 - 14.3	Small	256 - 362	B O U L D E R	▲ ▼	1	1.00	100.00
14.3 - 20	Small	362 - 512		▲ ▼	0	0.00	100.00
20 - 40	Medium	512 - 1024		▲ ▼	0	0.00	100.00
40 - 80	Large	1024 -2048		▲ ▼	0	0.00	100.00
80 - 160	Vry Large	2048 -4096		▲ ▼	0	0.00	100.00
	Bedrock		BDRK	▲ ▼	0	0.00	100.00
				Totals:	100		
	Total Tally:
