Baseline Assessment – Stream Attributes

Reach S-A111

Spread B

Doddridge County, West Virginia

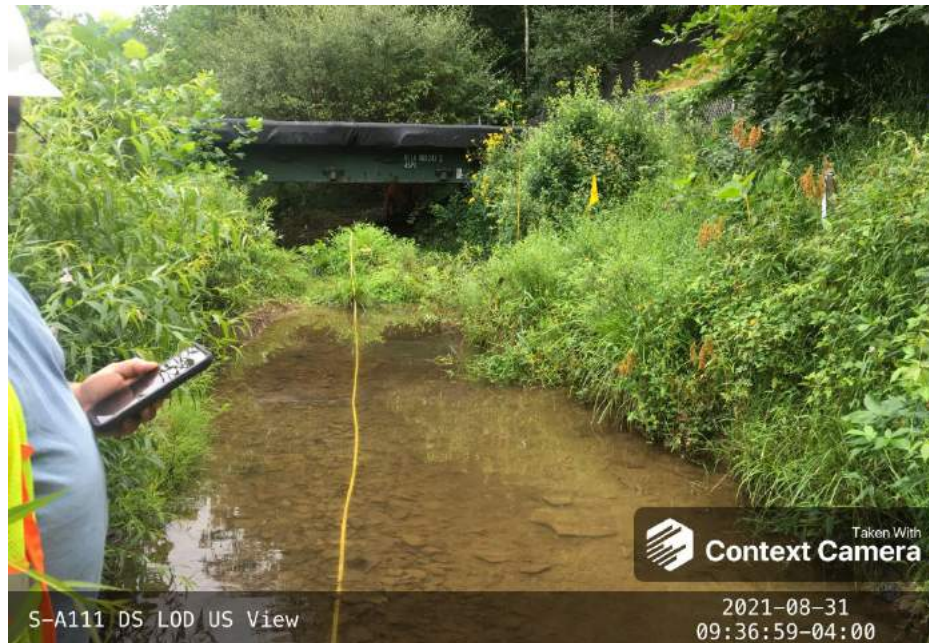
Photo Type: DS, US View

Location, Orientation, Photographer Initials: Downstream Edge of ROW, Upstream View, DP, HK, VM
Lat: 39.200749 Long: -80.55319

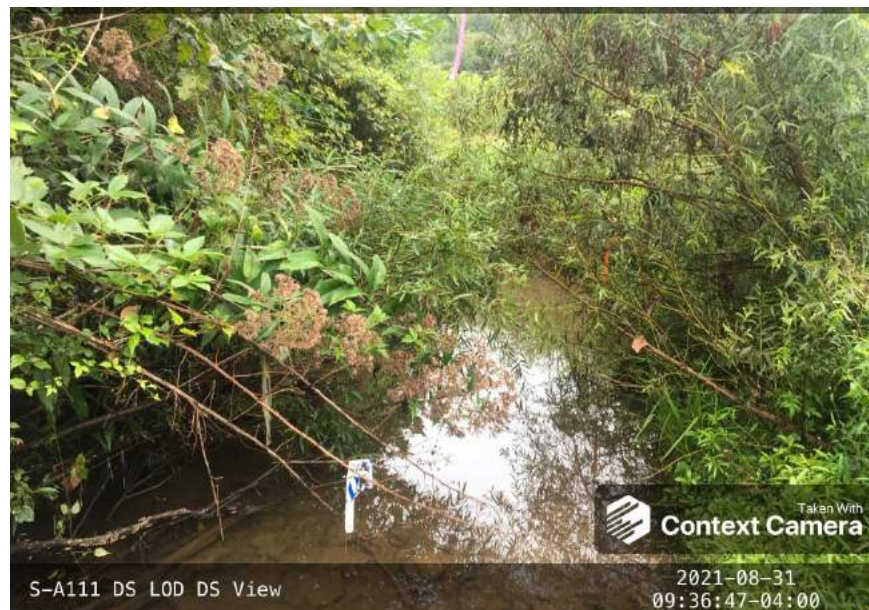
Photo Type: DS, DS View

Location, Orientation, Photographer Initials: Downstream Edge of ROW, Downstream View, DP, HK, VM
Lat: 39.200749 Long: -80.55319

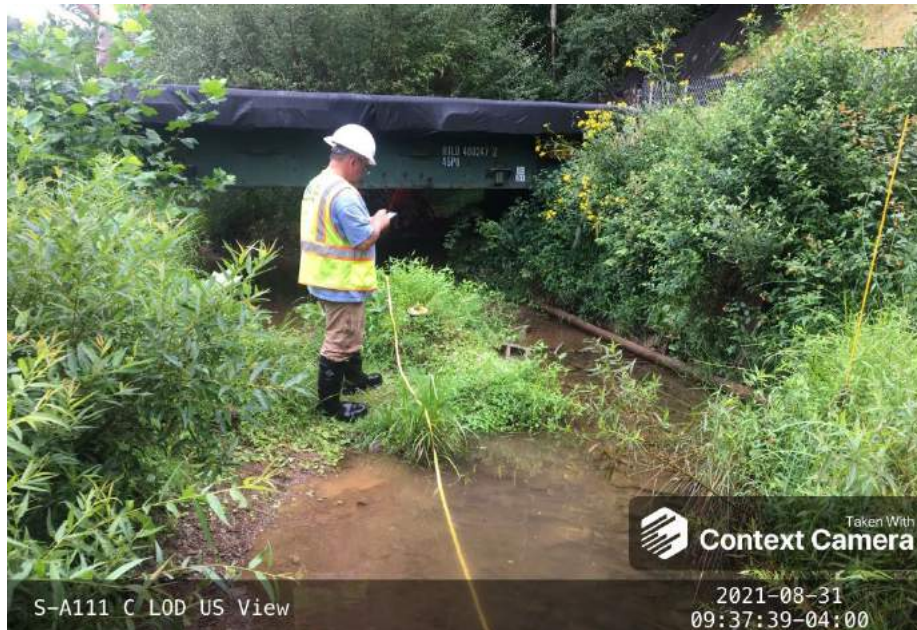
Photo Type: US View at Center
Location, Orientation, Photographer Initials: Center ROW, Upstream View, DP, HK, VM
Lat: 39.200749 Long: -80.55319

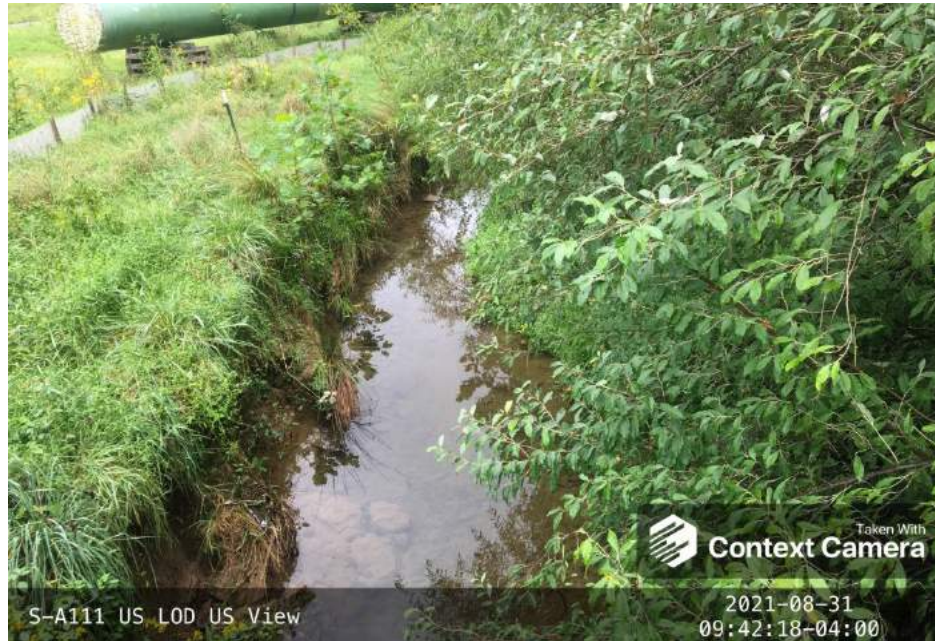
Photo Type: US, US View
Location, Orientation, Photographer Initials: Upstream Edge of ROW, Upstream View, DP, HK, VM
Lat: 39.200749 Long: -80.55319

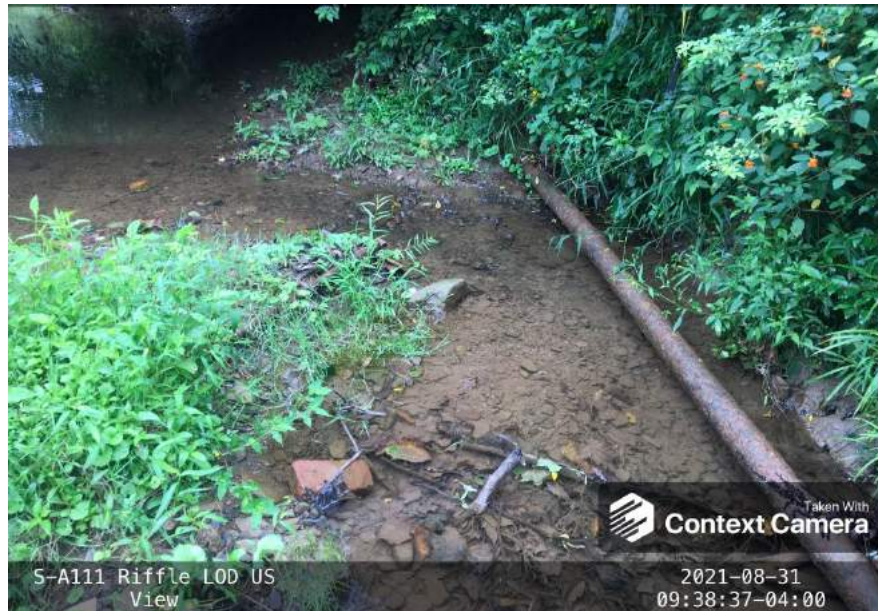
Photo Type: Riffle, US View

Location, Orientation, Photographer Initials: Downstream of Riffle, Upstream View, DP, HK, VM
Lat: 39.200749 Long: -80.55319

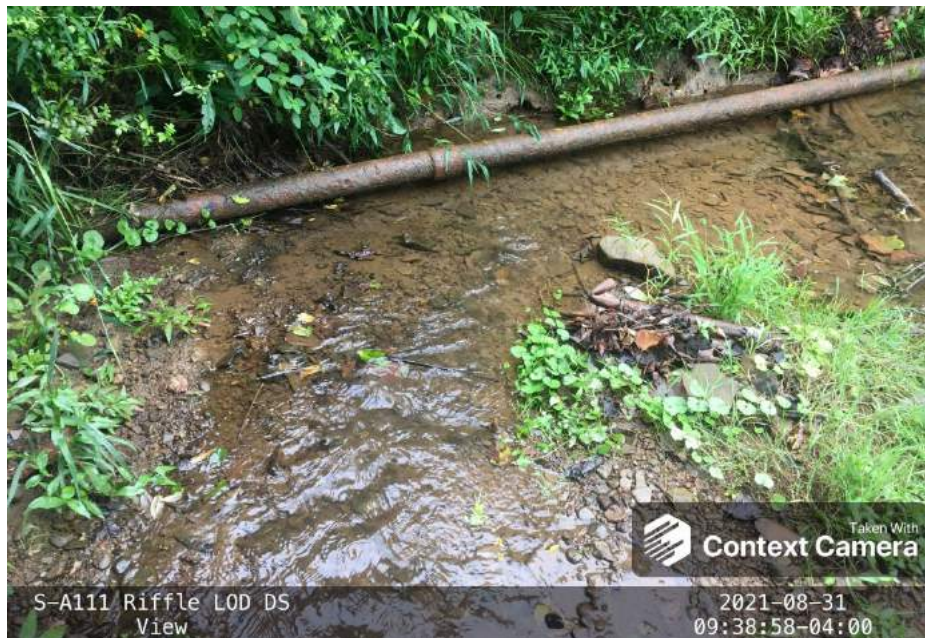
Photo Type: Riffle, DS View

Location, Orientation, Photographer Initials: Upstream of Riffle, Downstream View, DP, HK, VM
Lat: 39.200749 Long: -80.55319
