Baseline Assessment – Stream Attributes

Reach S-A118 (Pipeline ROW) Intermittent Spread A Wetzel County, West Virginia

Title	Profile and Cross-Sections	Client
BASELINE SURVEY CROSSING S-A118 - UNNAMED TRIB. TO PRICE RUN (MP 5.53) WETZEL COUNTY, WY		MC 222

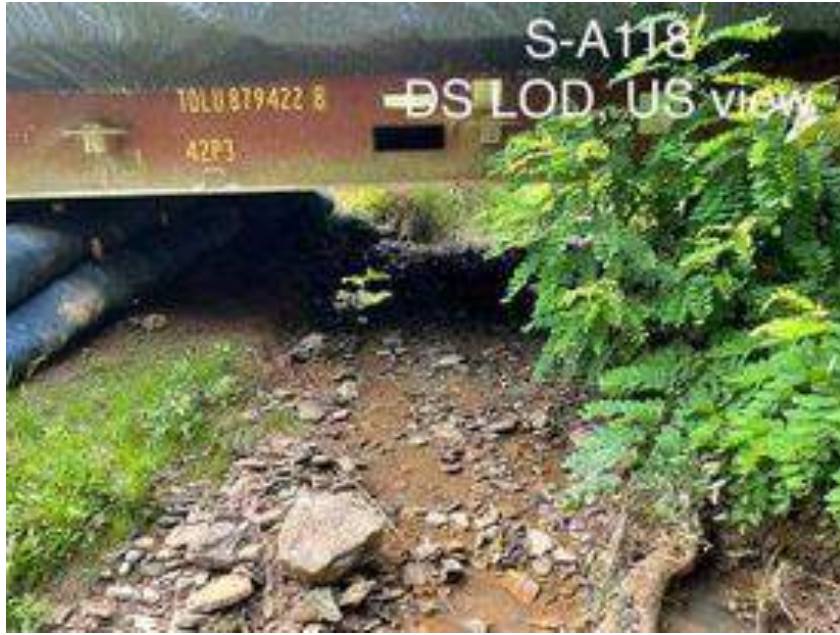
Photo Type: DS, US View

Location, Orientation, Photographer Initials: Downstream Edge of ROW, Upstream View, DPF/HK
Lat: 39.502399 Long: -80.52352

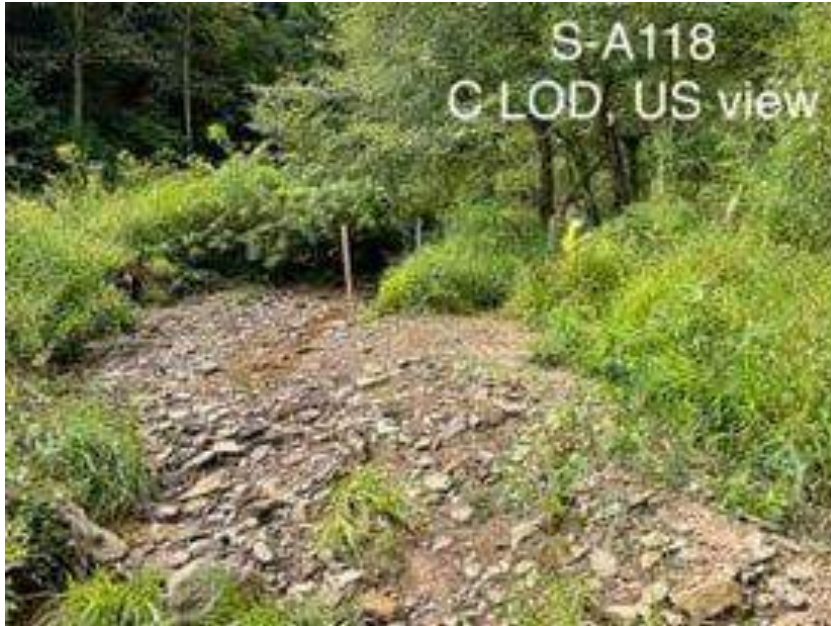
Photo Type: US View at Center
Location, Orientation, Photographer Initials: Center ROW, Upstream View, DPF/HK
Lat: 39.502399 Long: -80.52352

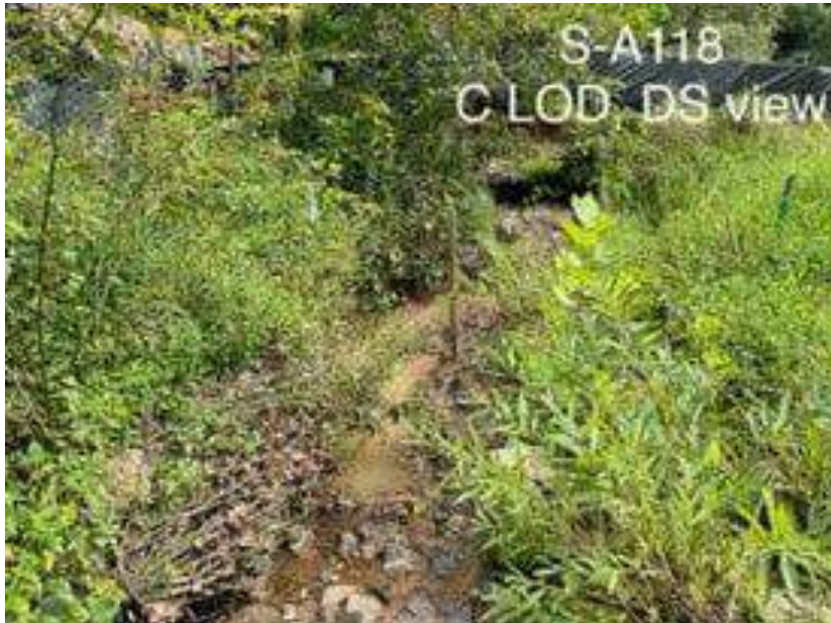
Photo Type: DS View at Center
Location, Orientation, Photographer Initials: ROW Center, Downstream View, DPF/HK
Lat: 39.502399 Long: -80.52352

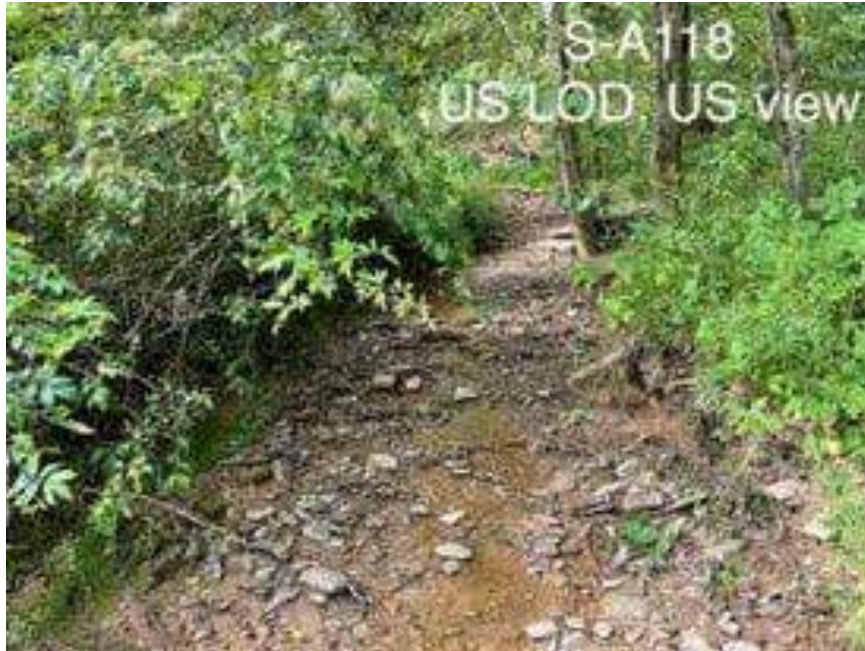
Photo Type: US, US View

Location, Orientation, Photographer Initials: Upstream Edge of ROW, Upstream View, DPF/HK
Lat: 39.502399 Long: -80.52352

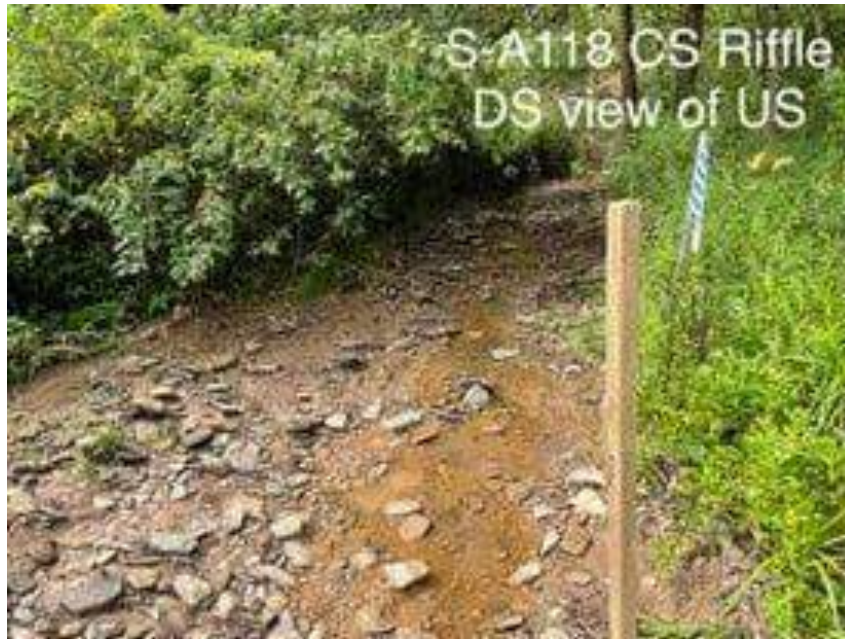
Photo Type: Riffle, DS View
Location, Orientation, Photographer Initials: Upstream of Riffle, Downstream View, DPF/HK
Lat: 39.502399 Long: -80.52352

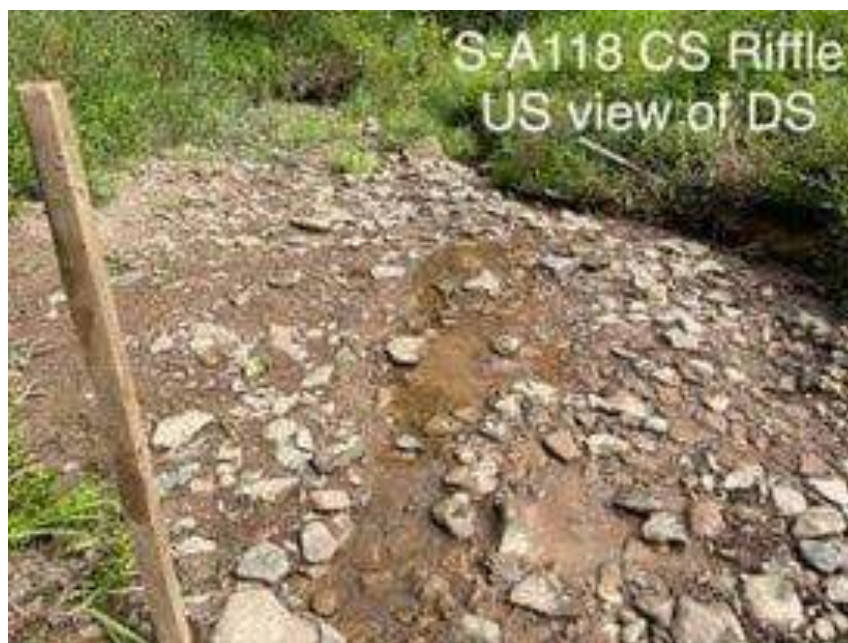
Photo Type: Riffle, US View
Location, Orientation, Photographer Initials: Downstream of Riffle, Upstream View, DPF/HK
Lat: 39.502399 Long: -80.52352

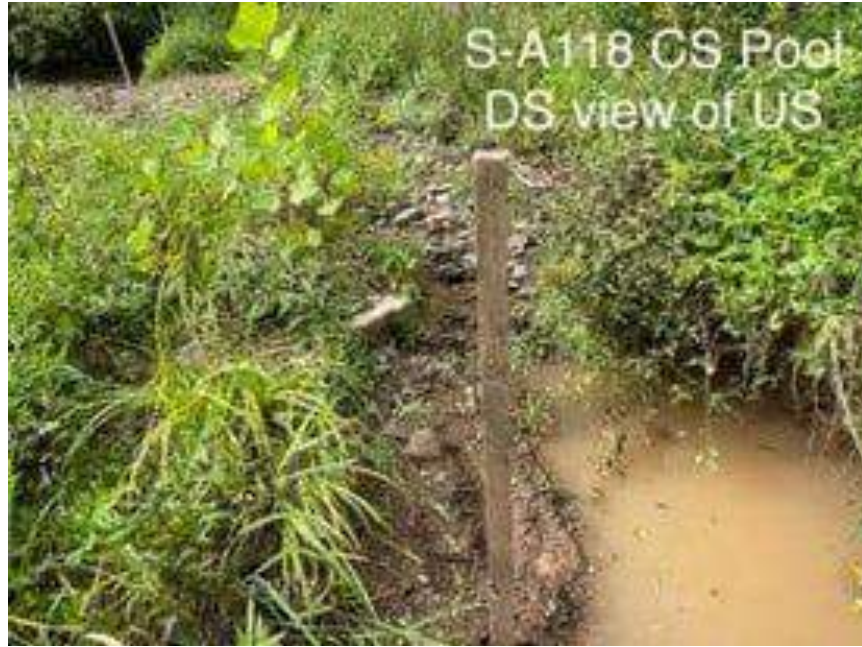
Photo Type: Pool, DS View
Location, Orientation, Photographer Initials: Upstream of Pool, Downstream View, DPF/HK
Lat: 39.502399 Long: -80.52352

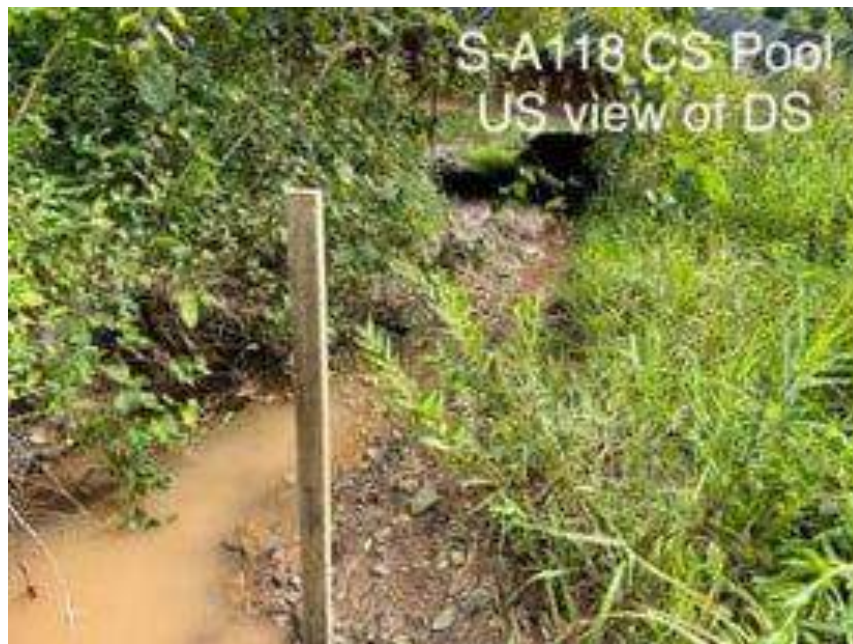
Photo Type: Pool, US View
Location, Orientation, Photographer Initials: Downstream of Pool, Upstream View, DPF/HK
Lat: 39.502399 Long: -80.52352

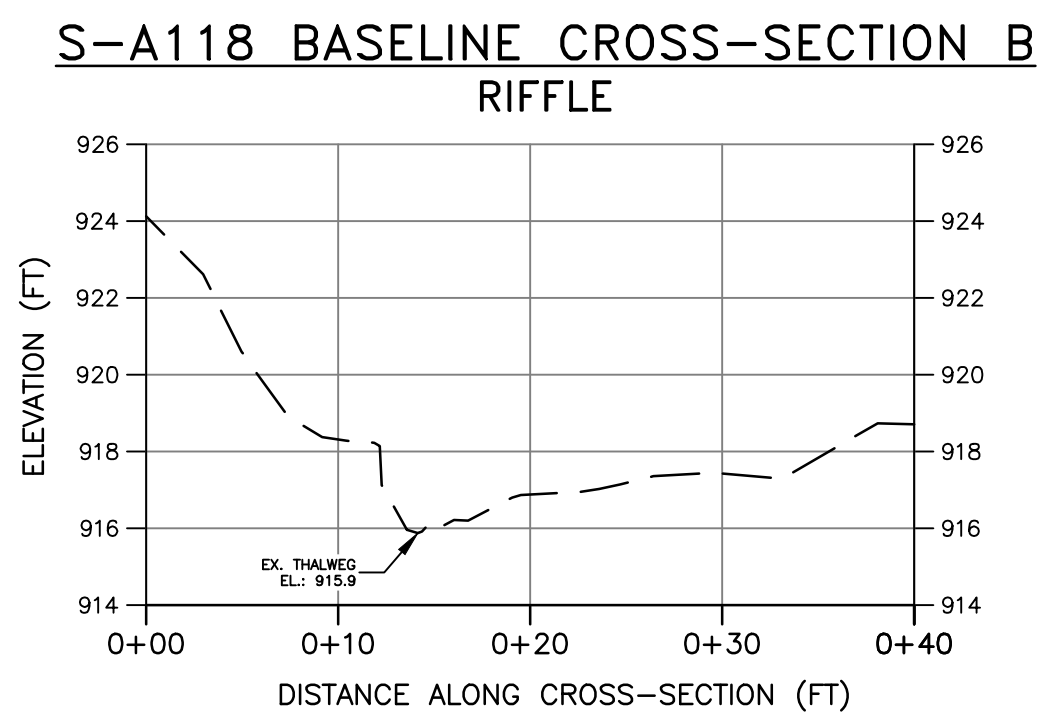
PROFILE
SCALE: H: 1"=10'
V: 1"=5'

4. ALL SECTION VIEWS SHOWN LEFT TO RIGHT FACING DOWNSTREAM.
5. POST-CROSSING SURVEY INFORMATION SHOWN IN RED. DATA PENDING.
6. POST-CROSSING SURVEY POINTS FOR CROSS SECTIONS AND THALWEG ARE PROJECTED ONTO PRE-CROSSING SECTION AND PROFILE VIEWS FOR COMPARISON.

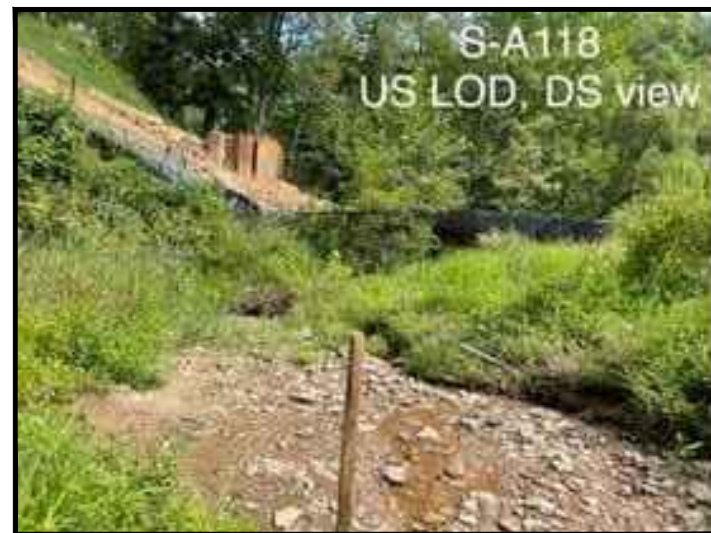
PHOTO TAKEN LOOKING DOWNSTREAM
FROM UPSTREAM IMPACT LIMITS
