Baseline Assessment – Stream Attributes

Reach S-A11a (Pipeline ROW) Perennial Spread A Harrison County, West Virginia

Spread A Stream S-A11a (Pipeline ROW) Harrison County

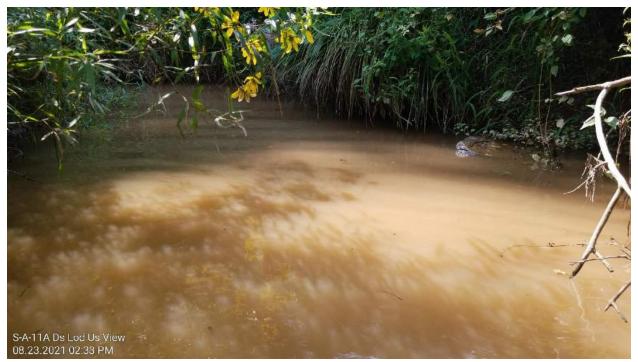
Photo Type: DS, US View Location, Orientation, Photographer Initials: Downstream Edge of ROW, Upstream View, MB Latitude, Longitude: 39.335511, -80.522421

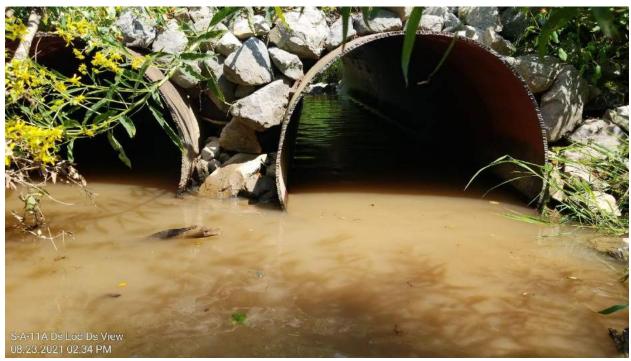
Photo Type: DS, DS View Location, Orientation, Photographer Initials: Downstream Edge of ROW, Downstream View, MB Latitude, Longitude: 39.335511, -80.522421

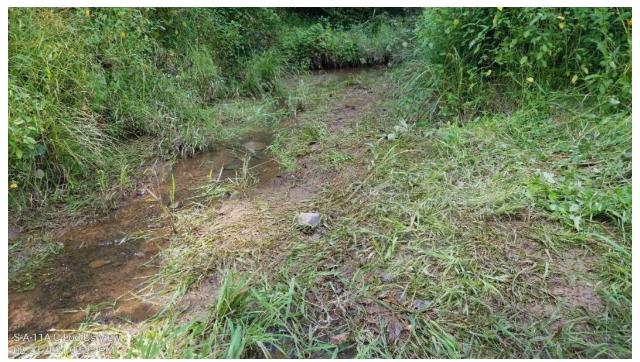
Photo Type: US View at Center Location, Orientation, Photographer Initials: Center ROW, Upstream View, MB Latitude, Longitude: 39.335511, -80.522421

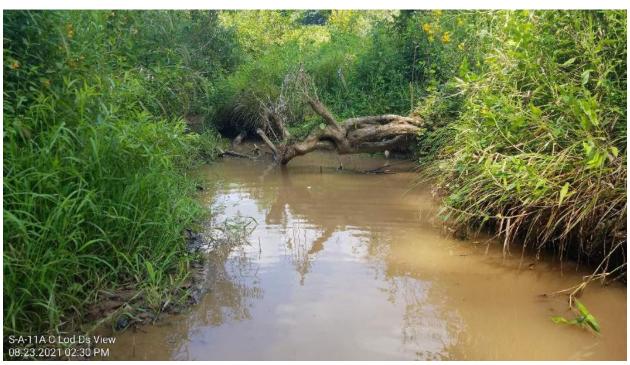
Photo Type: DS View at Center Location, Orientation, Photographer Initials: ROW Center, Downstream View, MB Latitude, Longitude: 39.335511, -80.522421

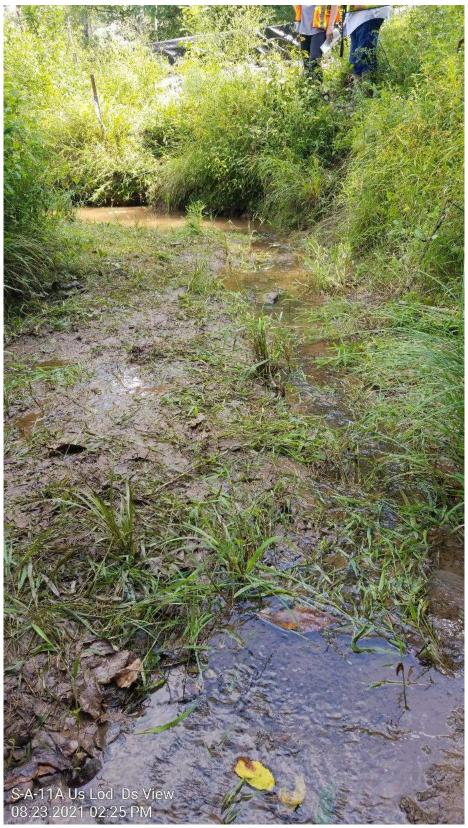
Photo Type: US, DS View
Location, Orientation, Photographer Initials: Upstream Edge of ROW, Downstream View, MB
Latitude, Longitude: 39.335511, -80.522421

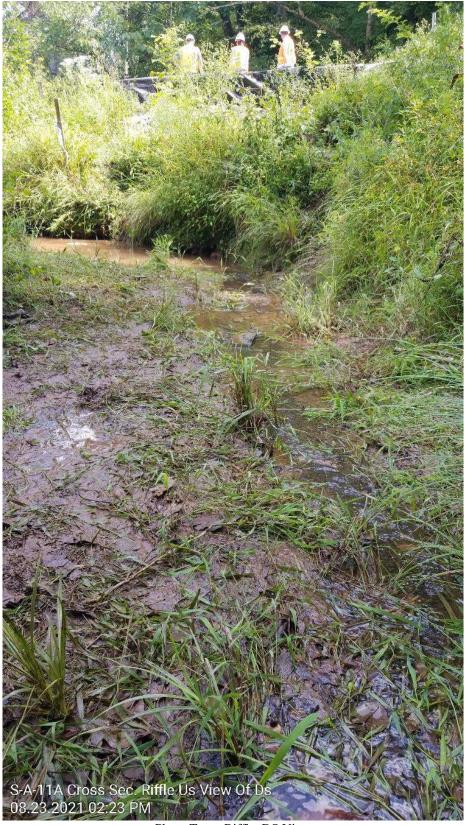
Photo Type: Riffle, DS View Location, Orientation, Photographer Initials: Upstream of Riffle, Downstream View, MB Latitude, Longitude: 39.335511, -80.522421

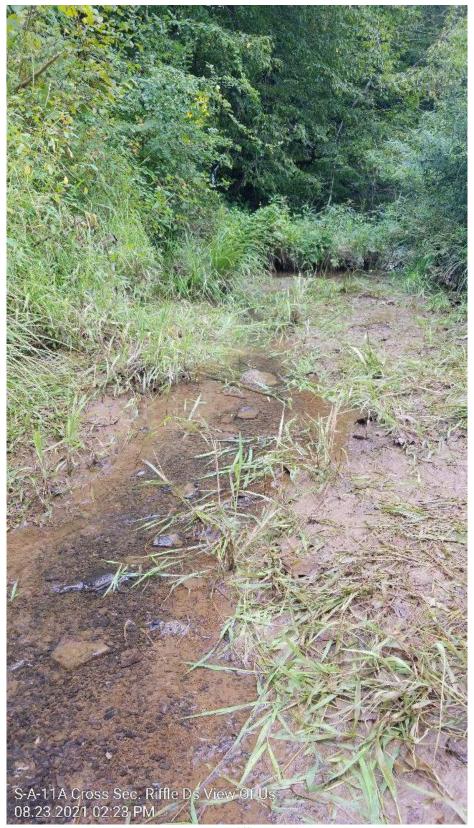
Photo Type: Riffle, US View Location, Orientation, Photographer Initials: Downstream of Riffle, Upstream View, MB Latitude, Longitude: 39.335511, -80.522421

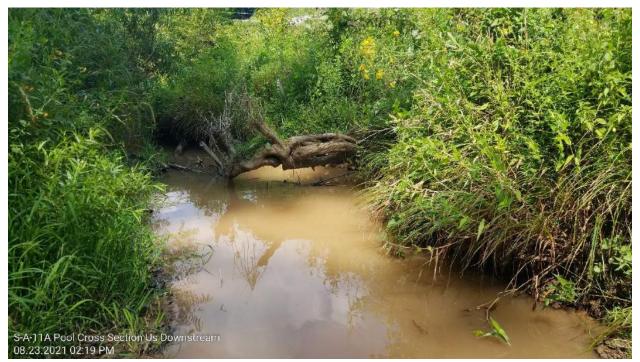
Photo Type: Pool, DS View Location, Orientation, Photographer Initials: Upstream of Pool, Downstream View, MB Latitude, Longitude: 39.335511, -80.522421

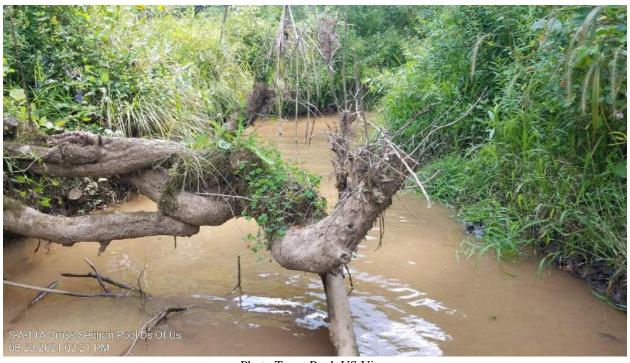
Photo Type: Pool, US View Location, Orientation, Photographer Initials: Downstream of Pool, Upstream View, MB Latitude, Longitude: 39.335511, -80.522421

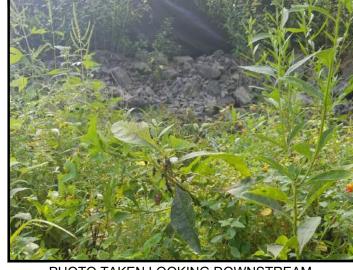
PHOTO TAKEN LOOKING DOWNSTREAM FROM UPSTREAM IMPACT LIMITS

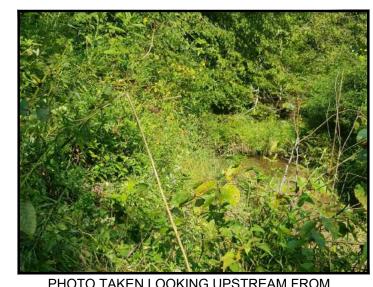
PHOTO TAKEN LOOKING UPSTREAM FROM

DOWNSTREAM IMPACT LIMITS
