Baseline Assessment – Stream Attributes

Reach S-A11a Braid 1 (Pipeline ROW) Intermittent Spread A Harrison County, West Virginia

Spread A Stream S-A11a-Braid-1 (Pipeline ROW) Harrison County

Title PROFILE AND CROSS-SECTIONS
BASELINE SURVEY
CROSSING S-A11A BRAID 1 - GRASS
(MP 21.60)
HARRISON COUNTY, WV

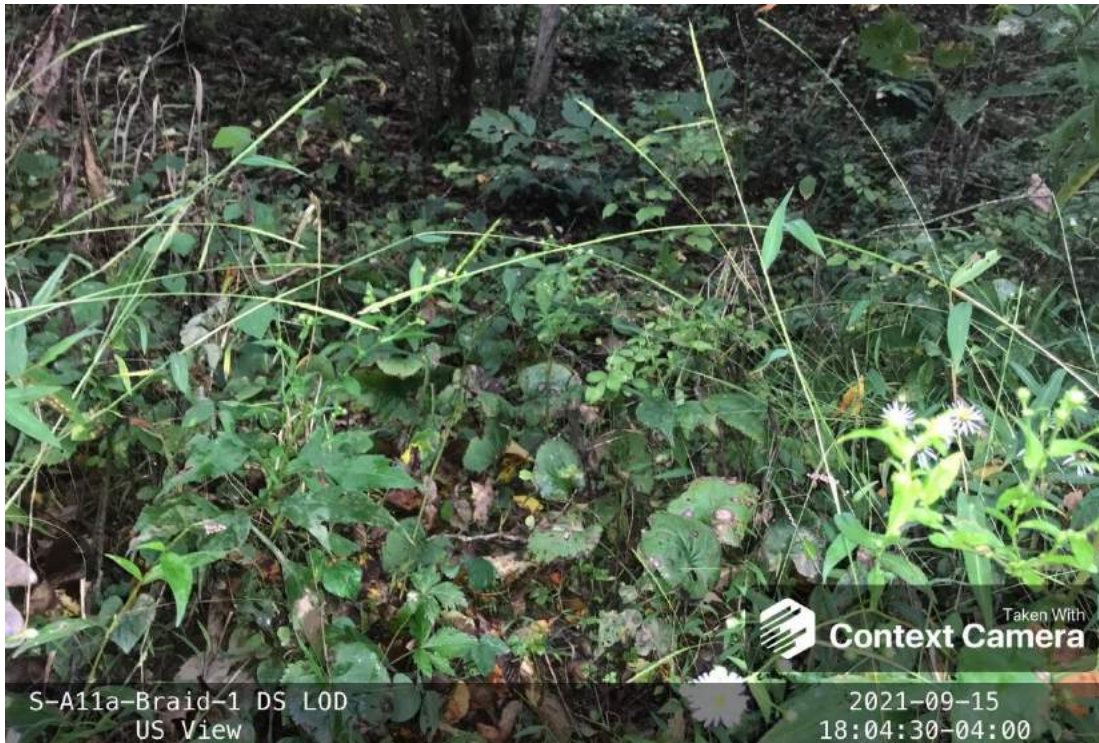
Photo Type: DS, US View
Location, Orientation, Photographer Initials: Downstream Edge of ROW, Upstream View, AJE
Lat: 39.3355 Long: -80.522502

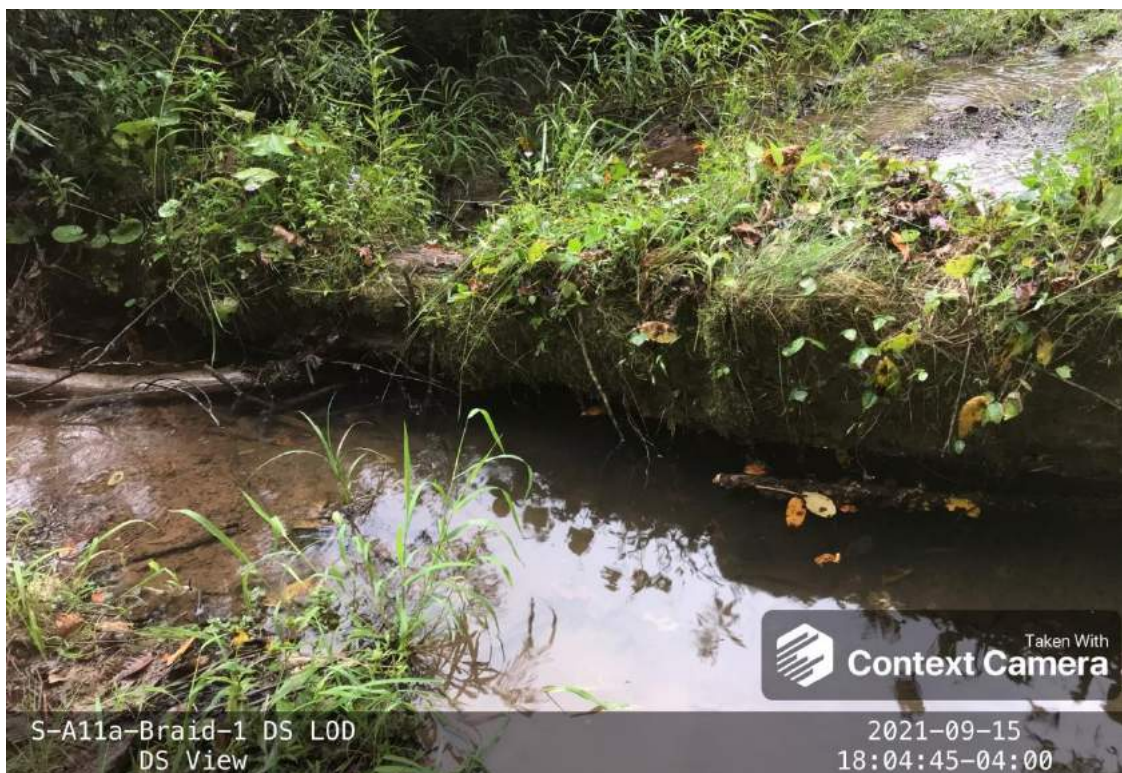
Photo Type: DS, DS View
Location, Orientation, Photographer Initials: Downstream Edge of ROW, Downstream View, AJE
Lat: 39.3355 Long: -80.522502

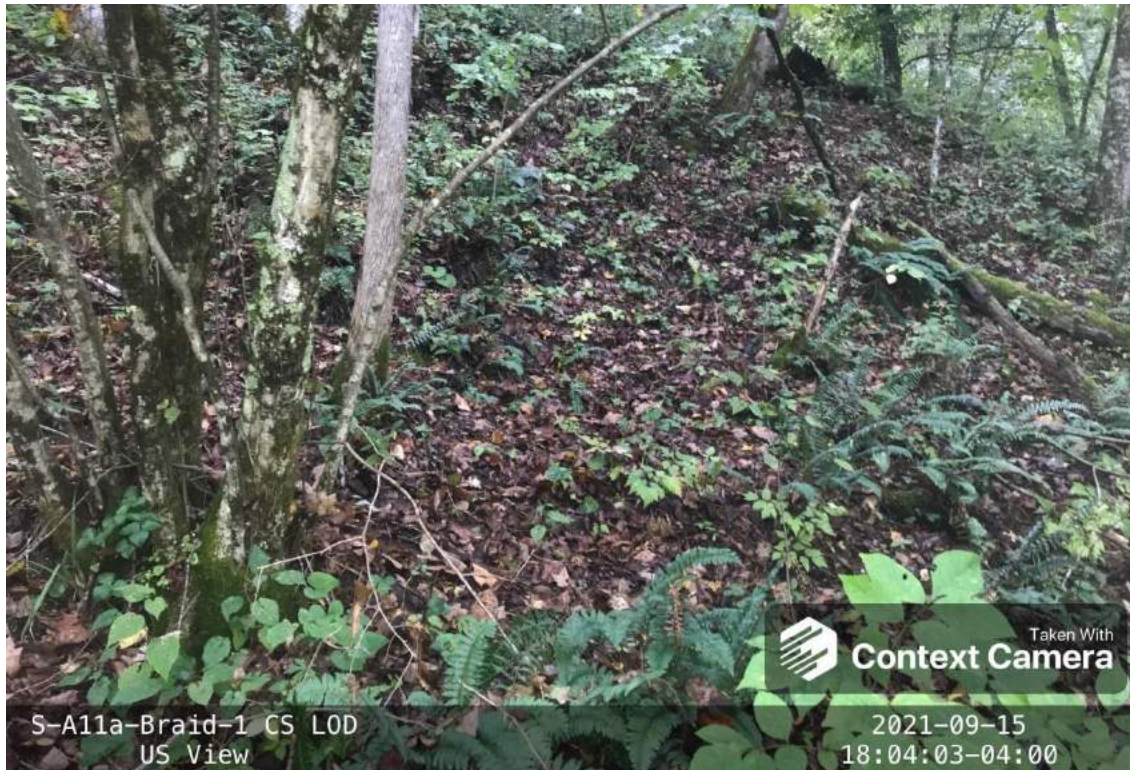
Photo Type: US View at Center
Location, Orientation, Photographer Initials: Center ROW, Upstream View, AJE
Lat: 39.3355 Long: -80.522502

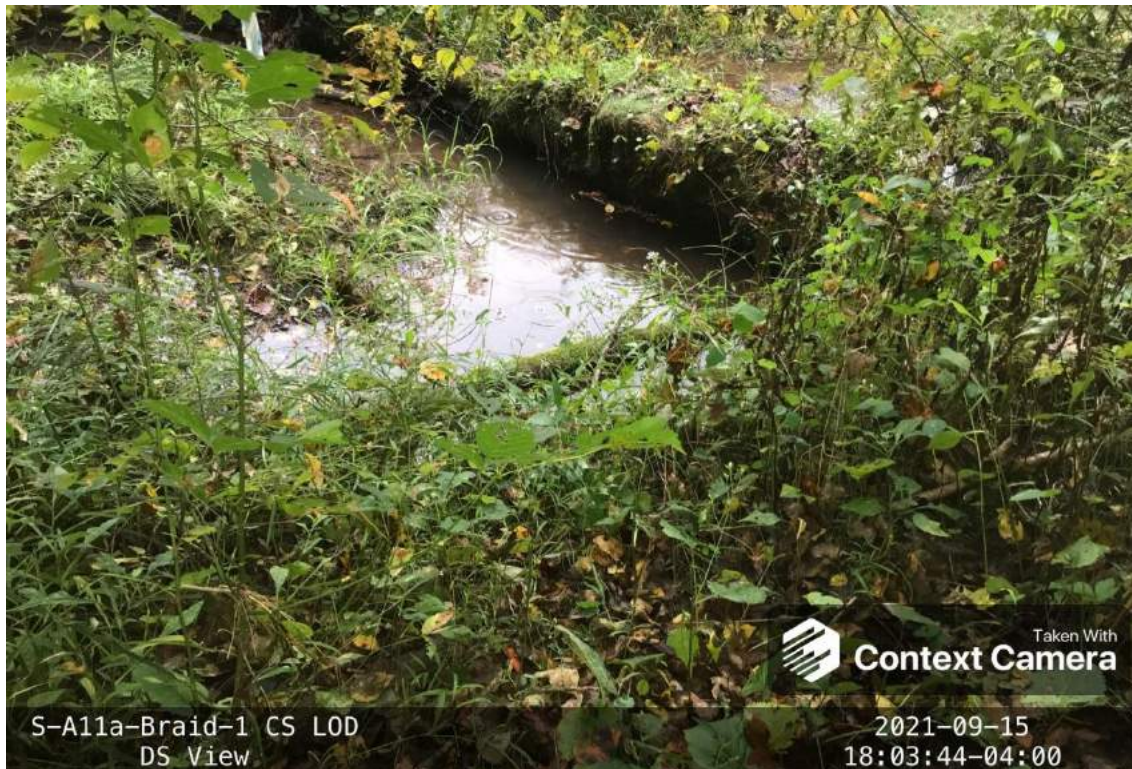
Photo Type: DS View at Center
Location, Orientation, Photographer Initials: ROW Center, Downstream View, AJE
Lat: 39.3355 Long: -80.522502

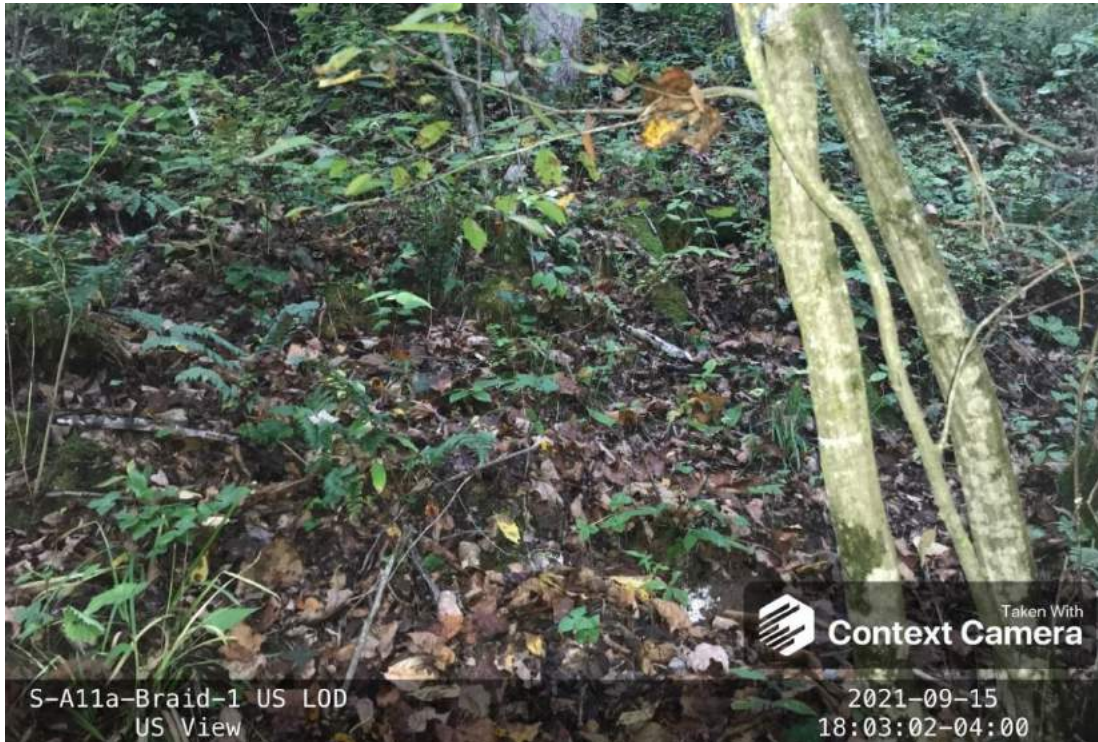
Photo Type: US, US View
Location, Orientation, Photographer Initials: Upstream Edge of ROW, Upstream View, AJE
Lat: 39.3355 Long: -80.522502

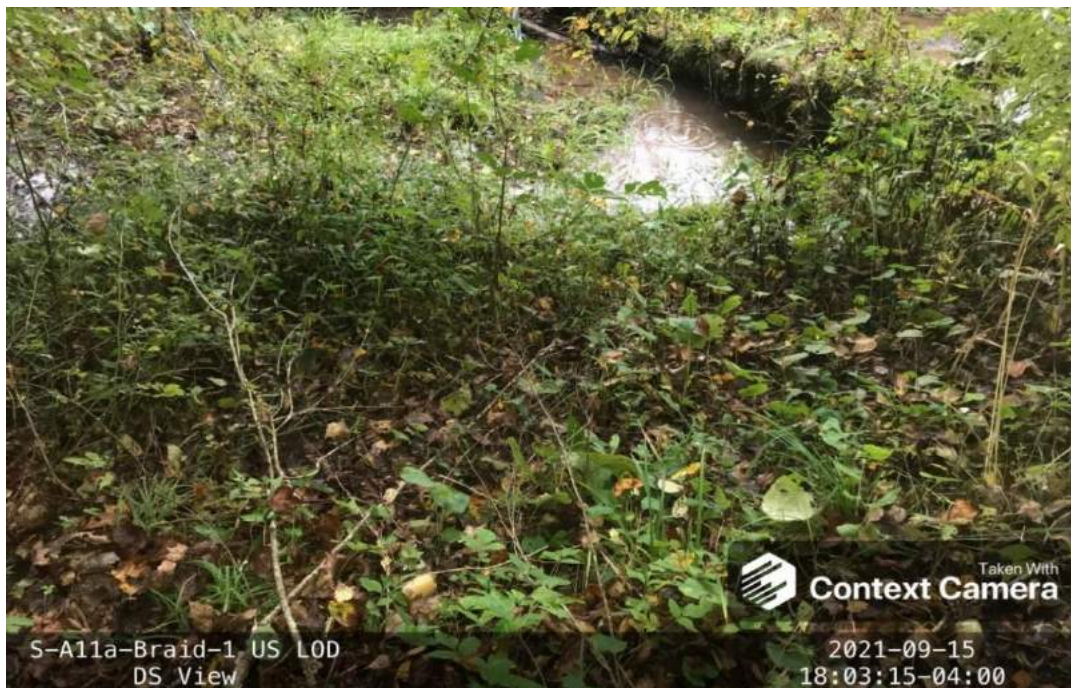
Photo Type: US, DS View
Location, Orientation, Photographer Initials: Upstream Edge of ROW, Downstream View, AJE
Lat: 39.3355 Long: -80.522502

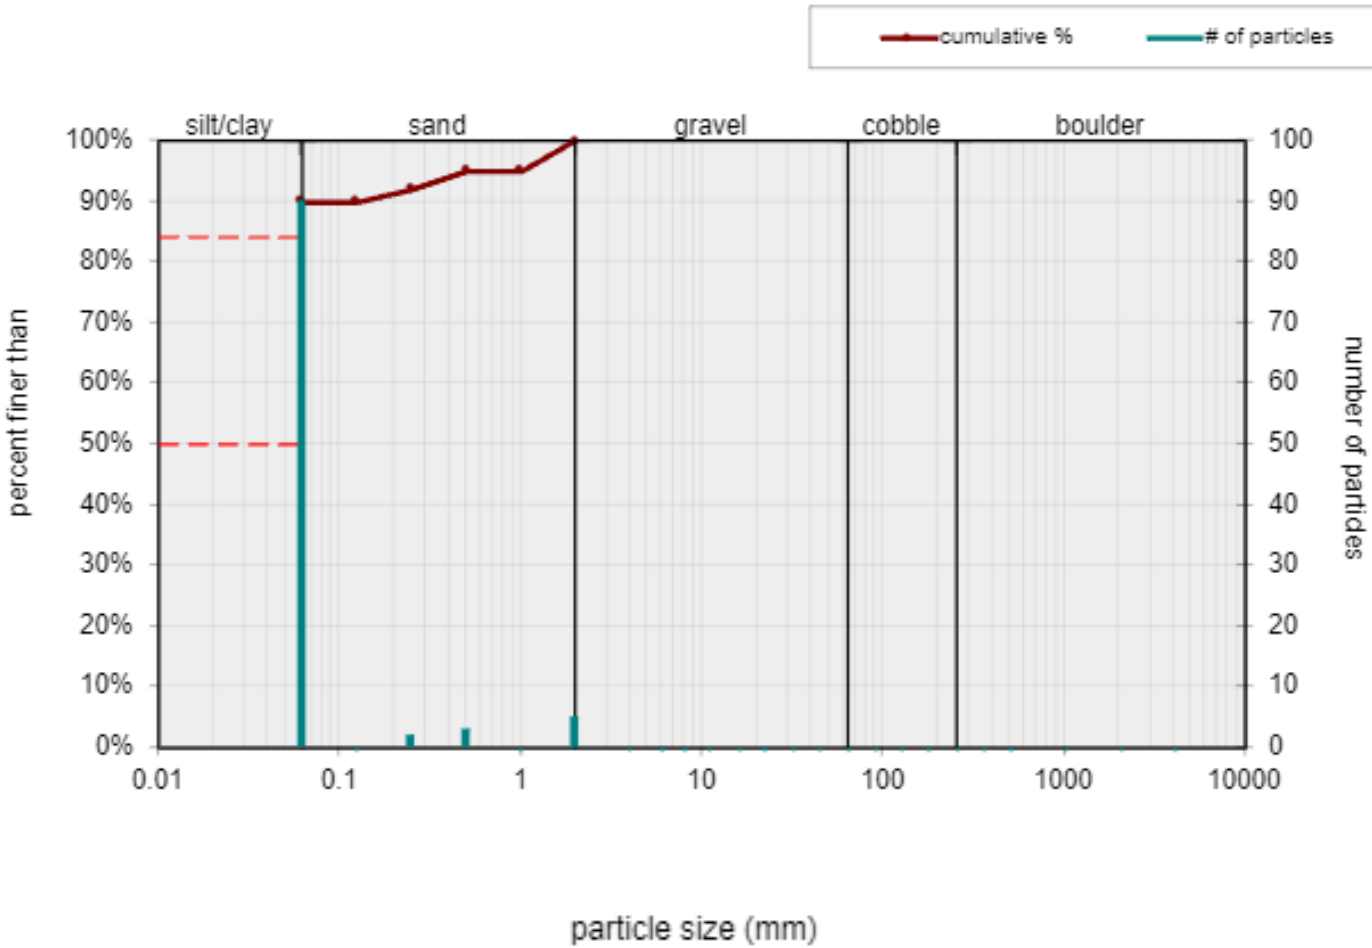
Bankfull Channel Pebble Count, S-A11a Brald 1, Grass Run

Size (mm)		Size Distribution		Type	
D16	0.062	mean	0.1	silt/clay	90%
D35	0.062	dispersion	1.0	sand	10%
D50	0.062	skewness	---	gravel	0%
D65	0.062			cobble	0%
D84	0.062			boulder	0%
D95	1
