Baseline Assessment – Stream Attributes

Reach S-A67 (Pipeline ROW) Perennial Spread D Nicholas County, West Virginia

Profile
CROSSING S-A67 - UNNAMED TRIBUTARY
BIG BEAVER CREEK (MP 115.44)
NICHOLAS COUNTY, WV

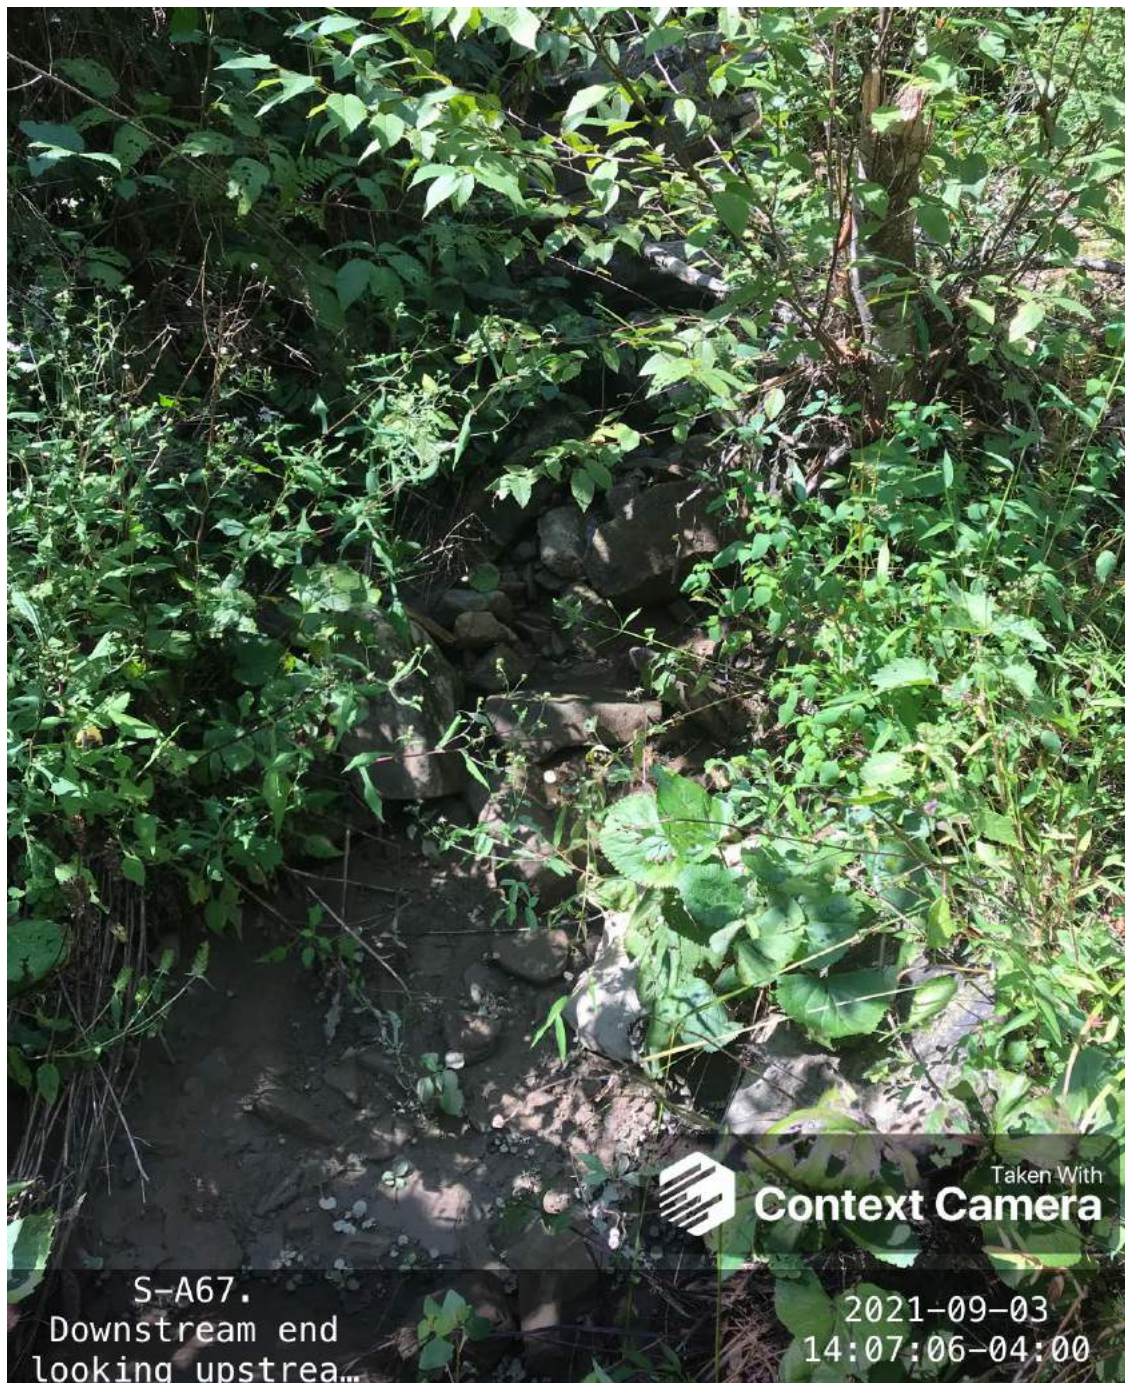
Photo Type: DS, US View
Location, Orientation, Photographer Initials: Downstream Edge of ROW, Upstream View, SM KP
Lat: 38.317575 Long: -80.671553

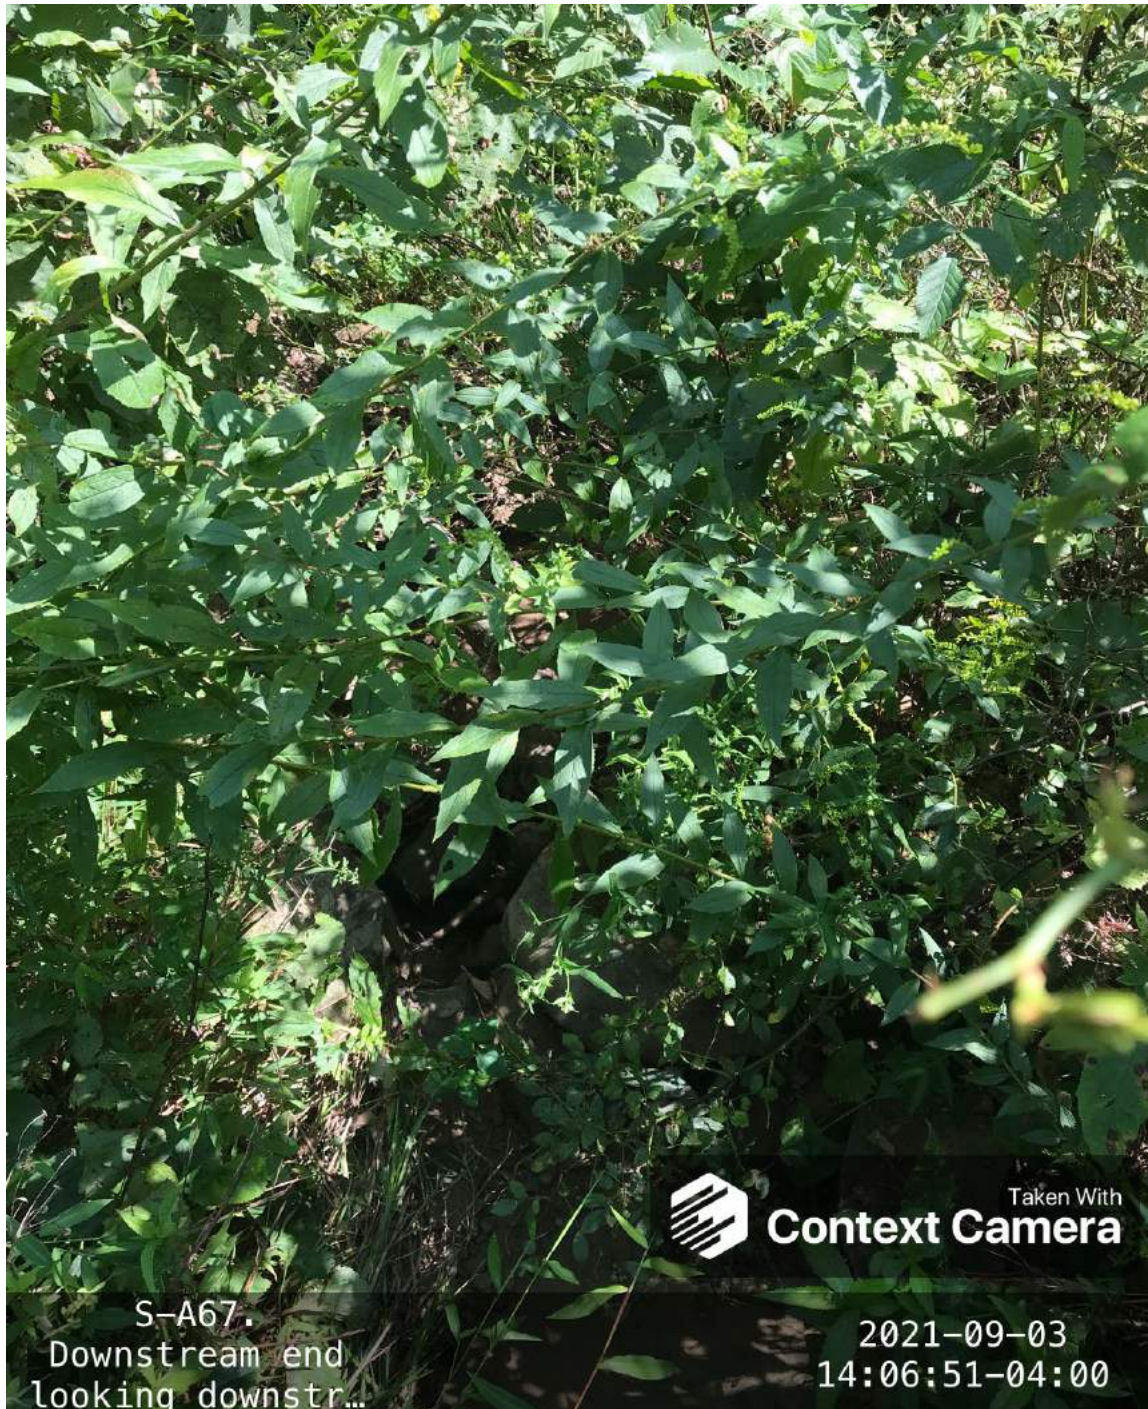
Photo Type: DS, DS View
Location, Orientation, Photographer Initials: Downstream Edge of ROW, Downstream View, SM KP
Lat: 38.317575 Long: -80.671553

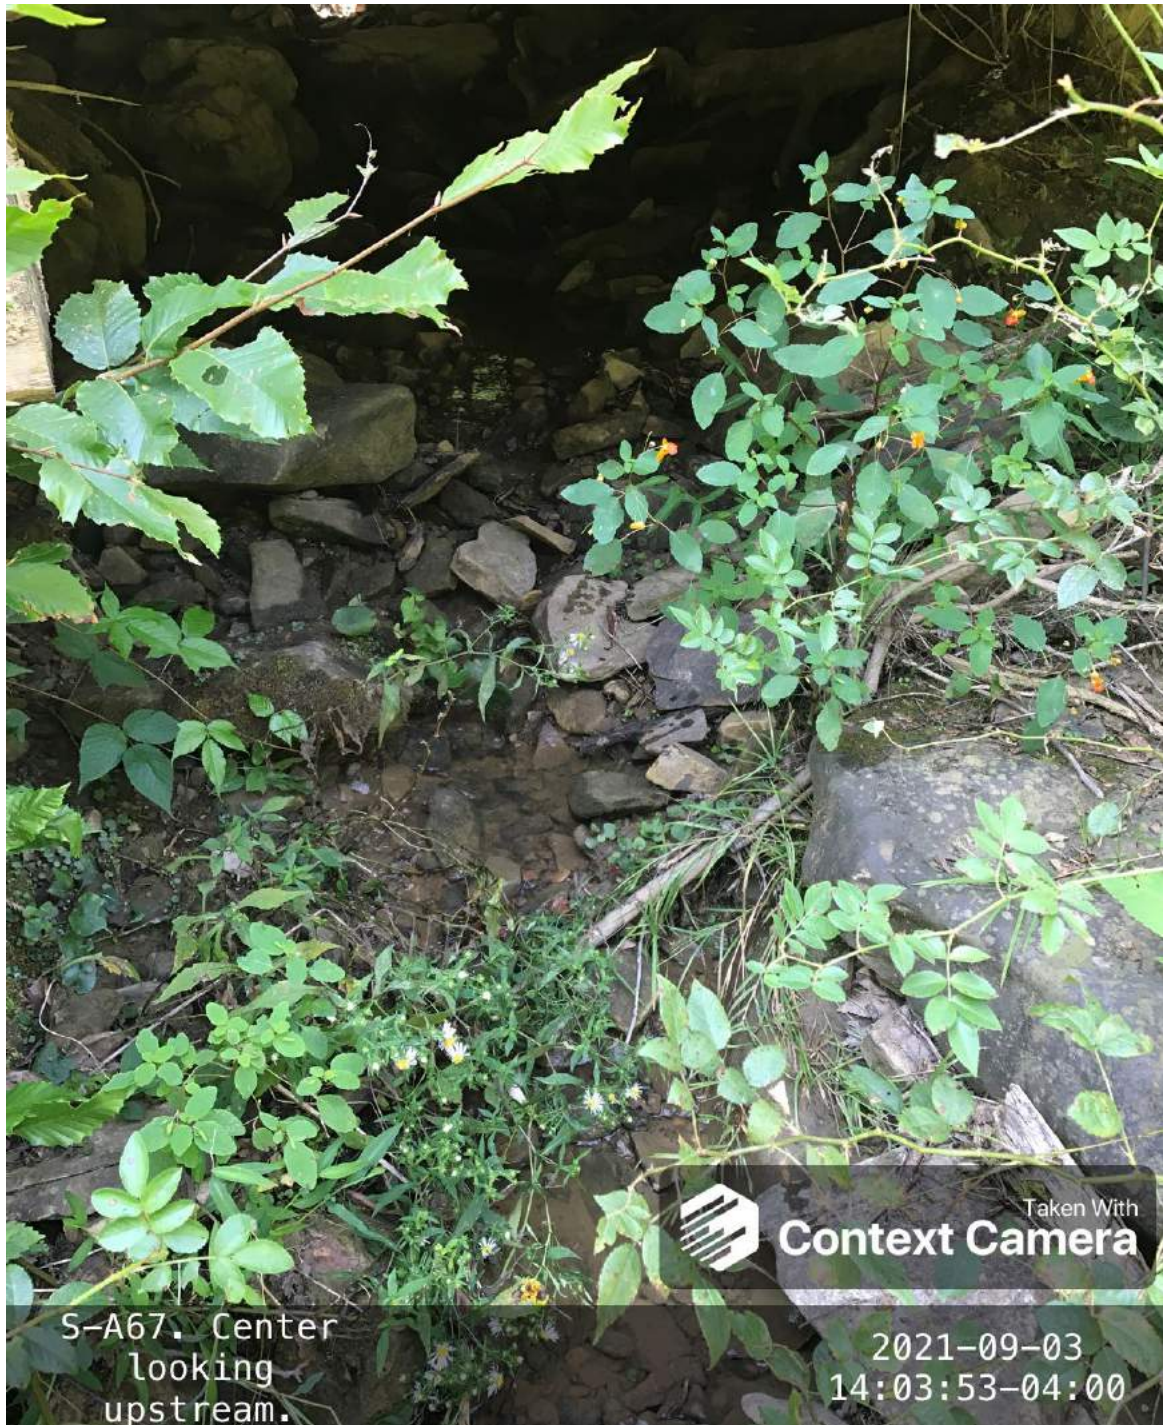
Photo Type: US View at Center
Location, Orientation, Photographer Initials: Center ROW, Upstream View, SM KP
Lat: 38.317575 Long: -80.671553

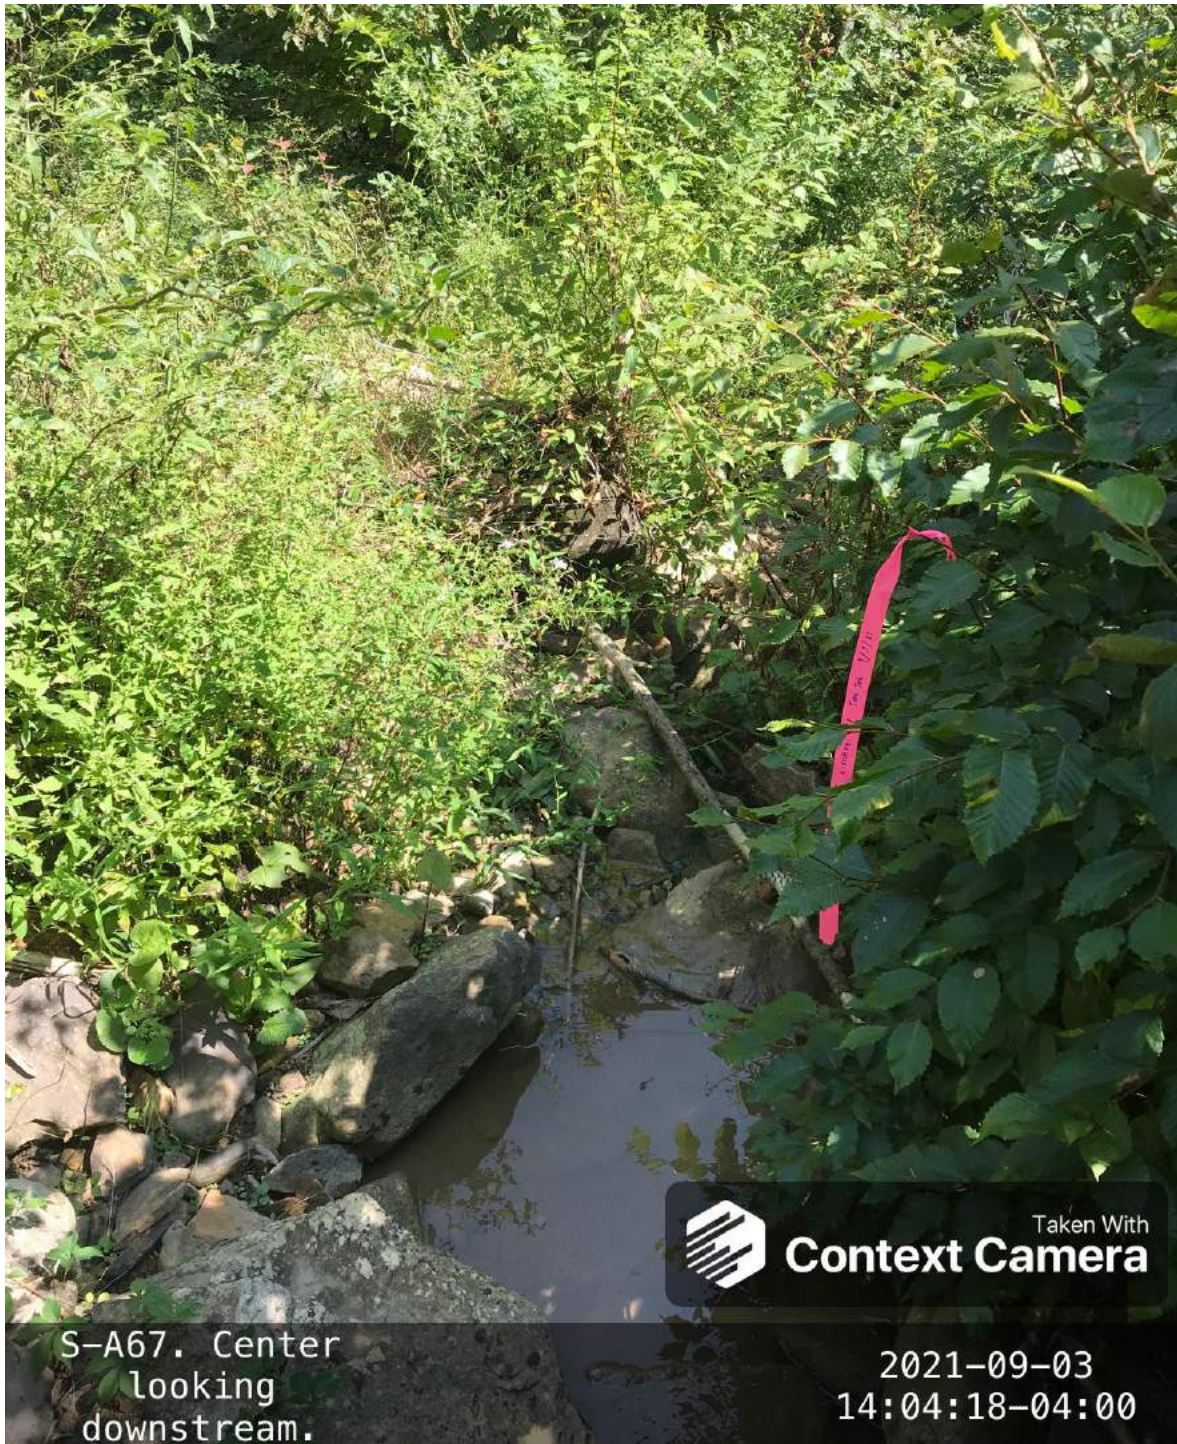
Photo Type: DS View at Center
Location, Orientation, Photographer Initials: ROW Center, Downstream View, SM KP
Lat: 38.317575 Long: -80.671553

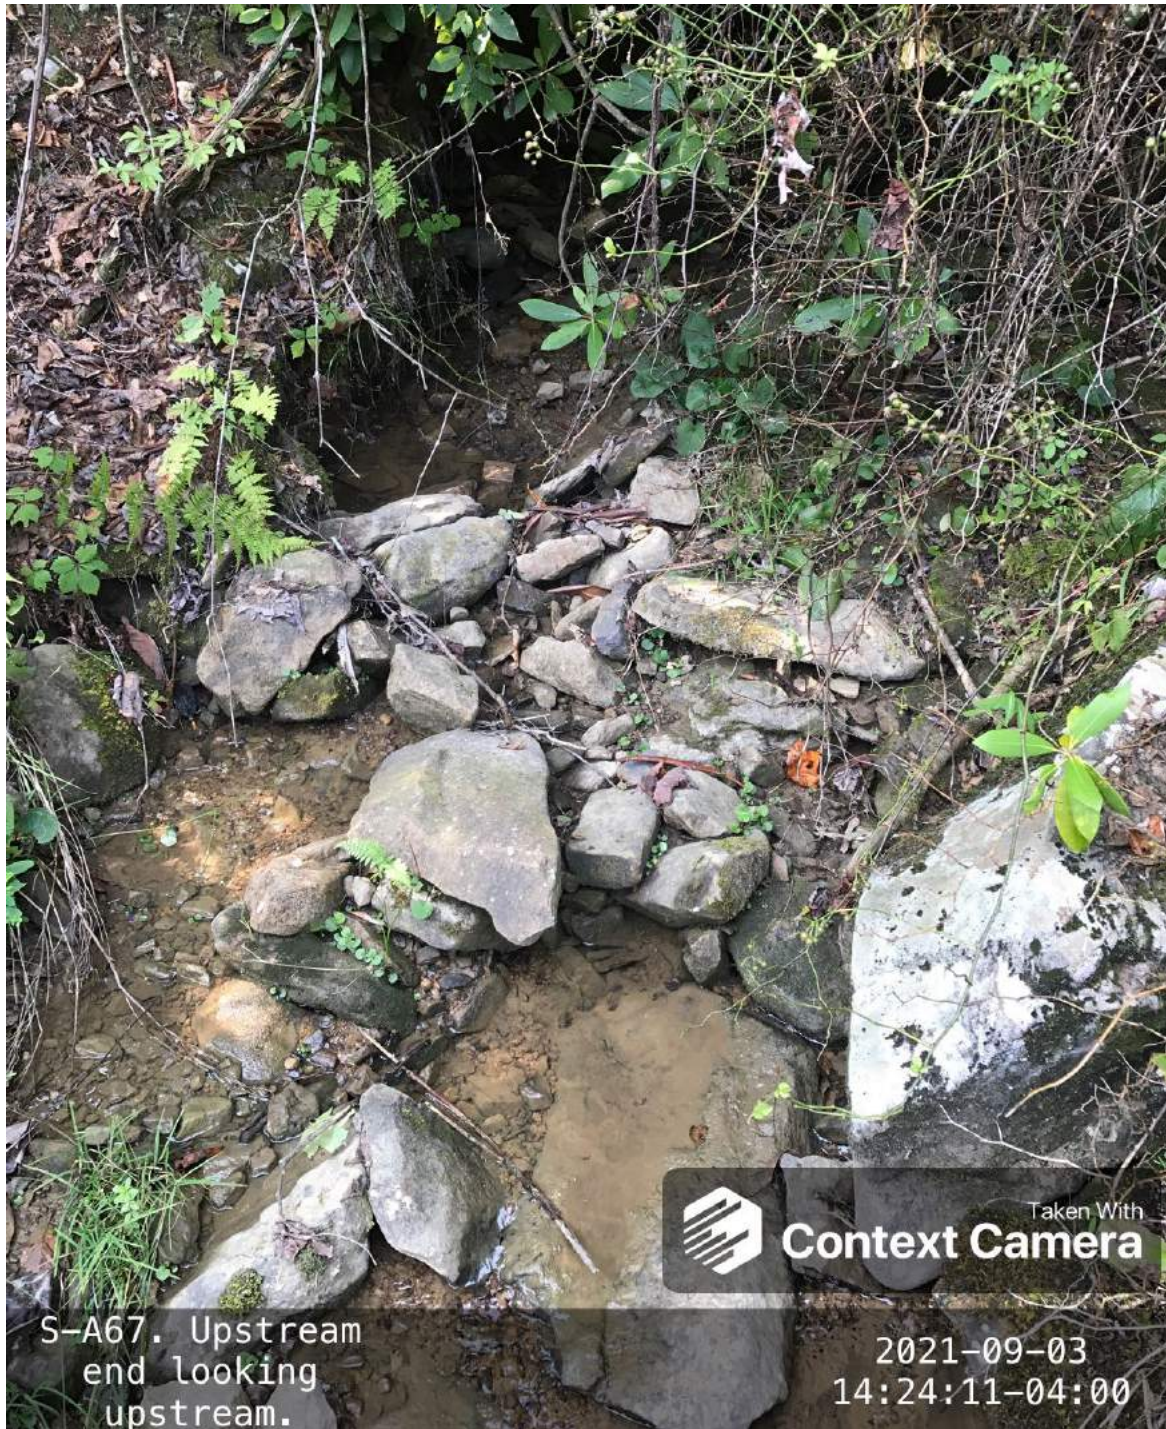
Photo Type: US, US View
Location, Orientation, Photographer Initials: Upstream Edge of ROW, Upstream View, SM KP
Lat: 38.317575 Long: -80.671553

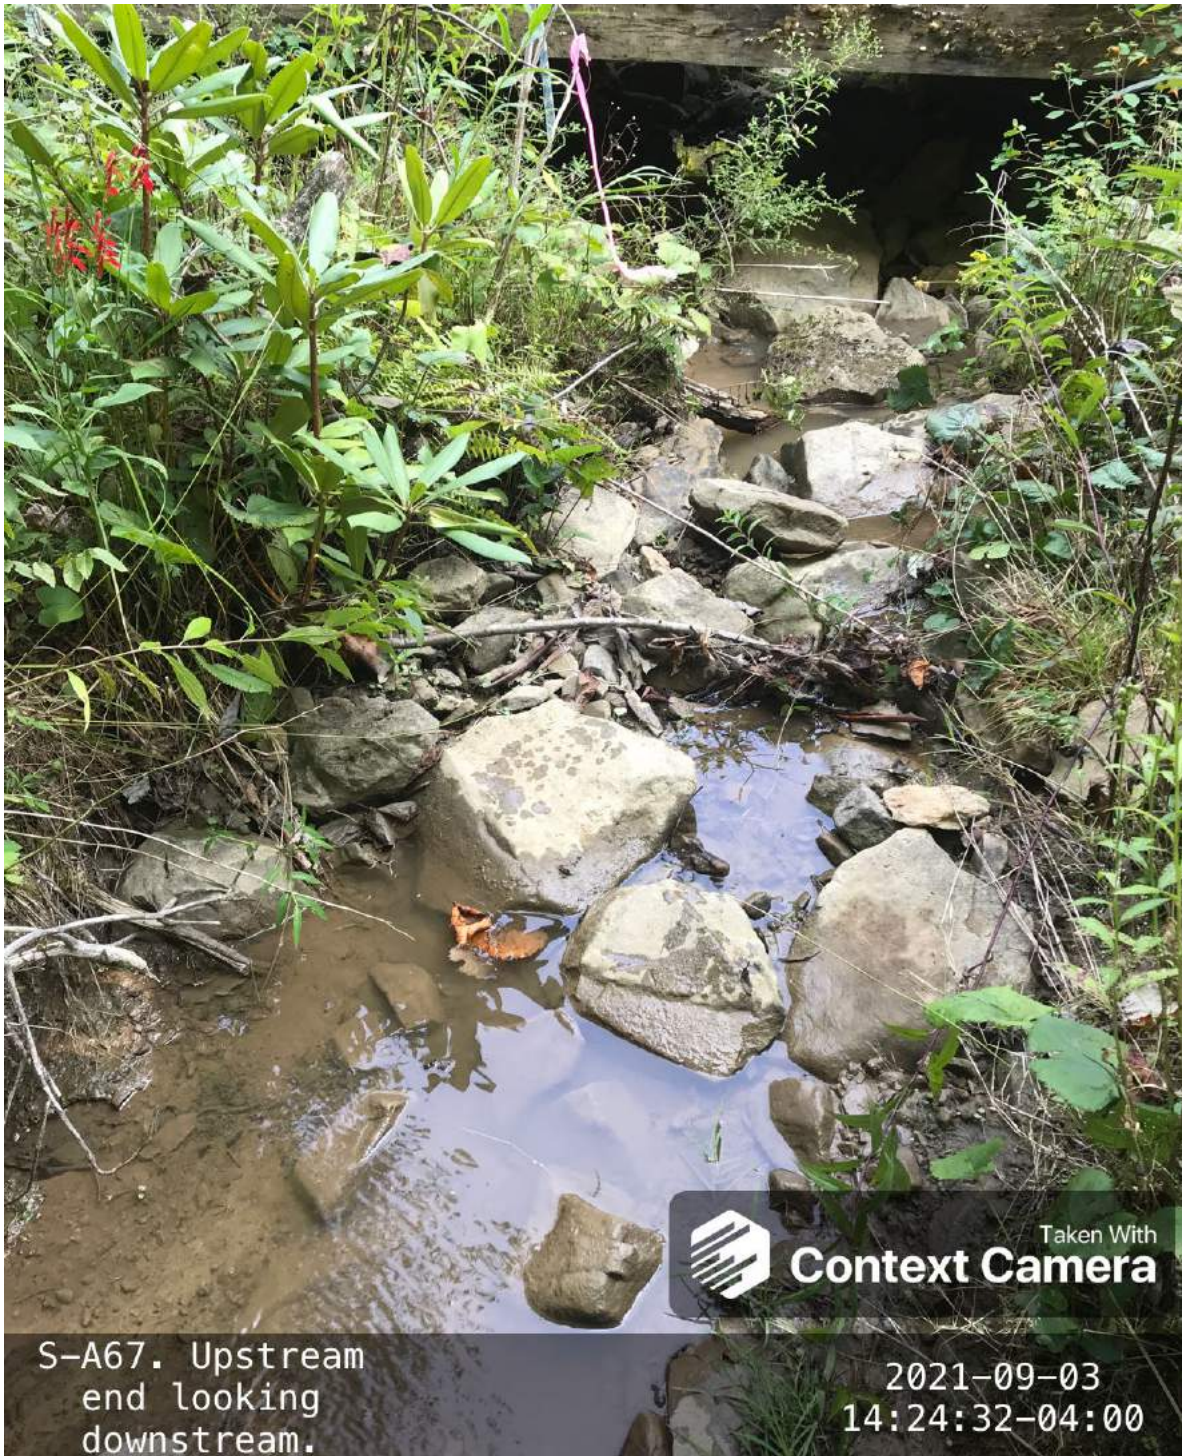
Photo Type: US, DS View
Location, Orientation, Photographer Initials: Upstream Edge of ROW, Downstream View, SM KP
Lat: 38.317575 Long: -80.671553

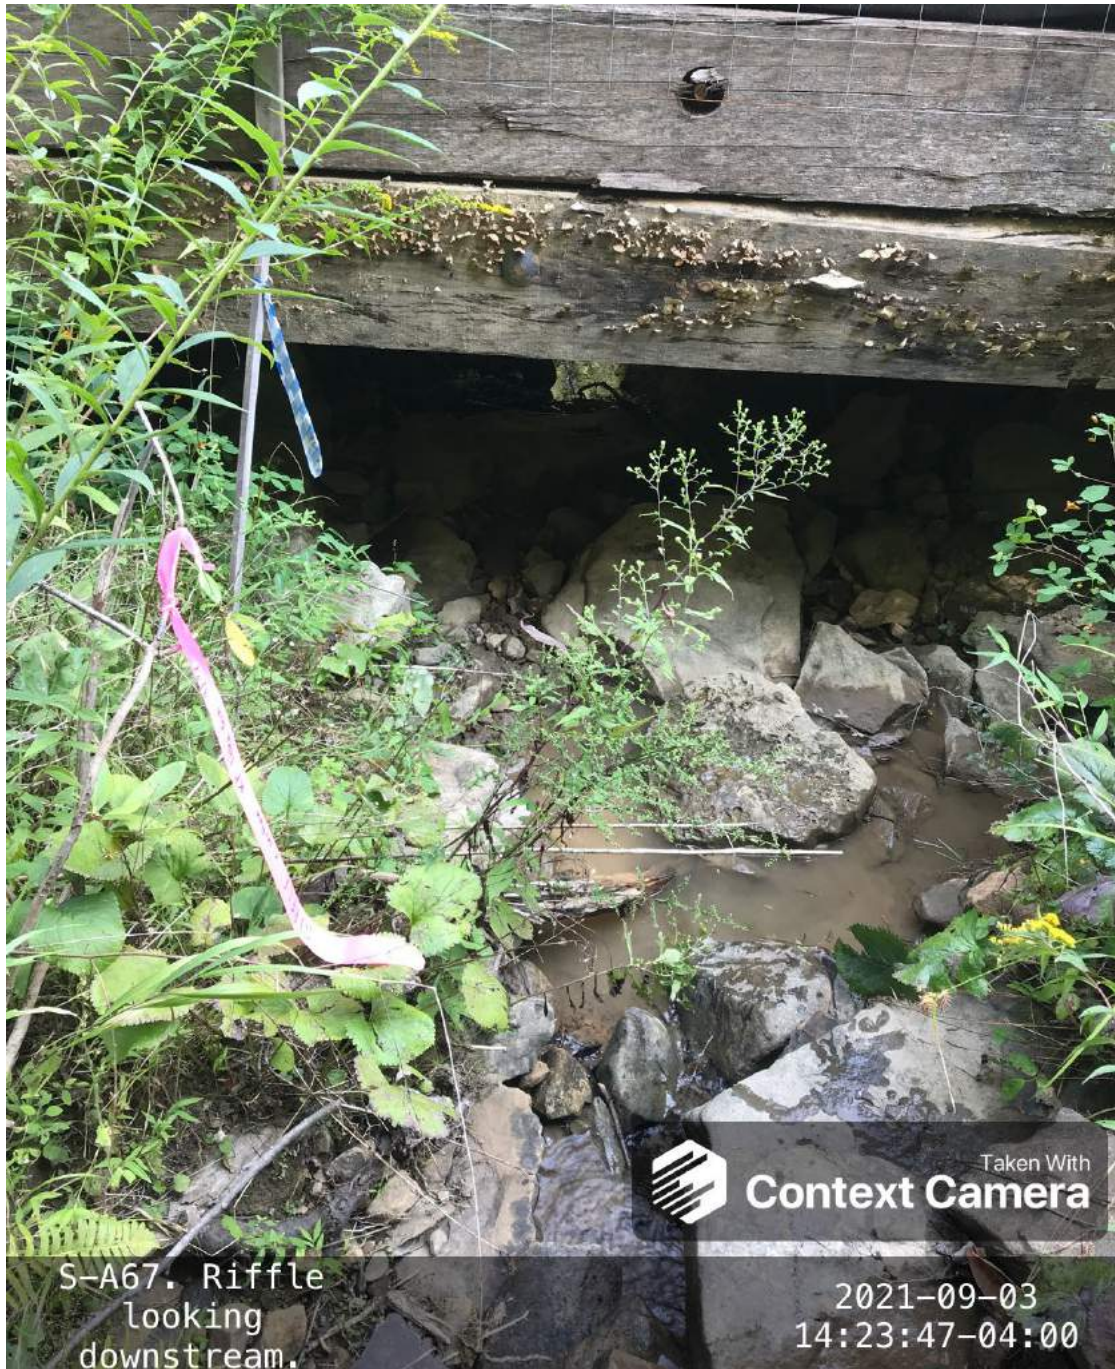
Photo Type: Riffle, DS View
Location, Orientation, Photographer Initials: Upstream of Riffle, Downstream View, SM KP
Lat: 38.317575 Long: -80.671553

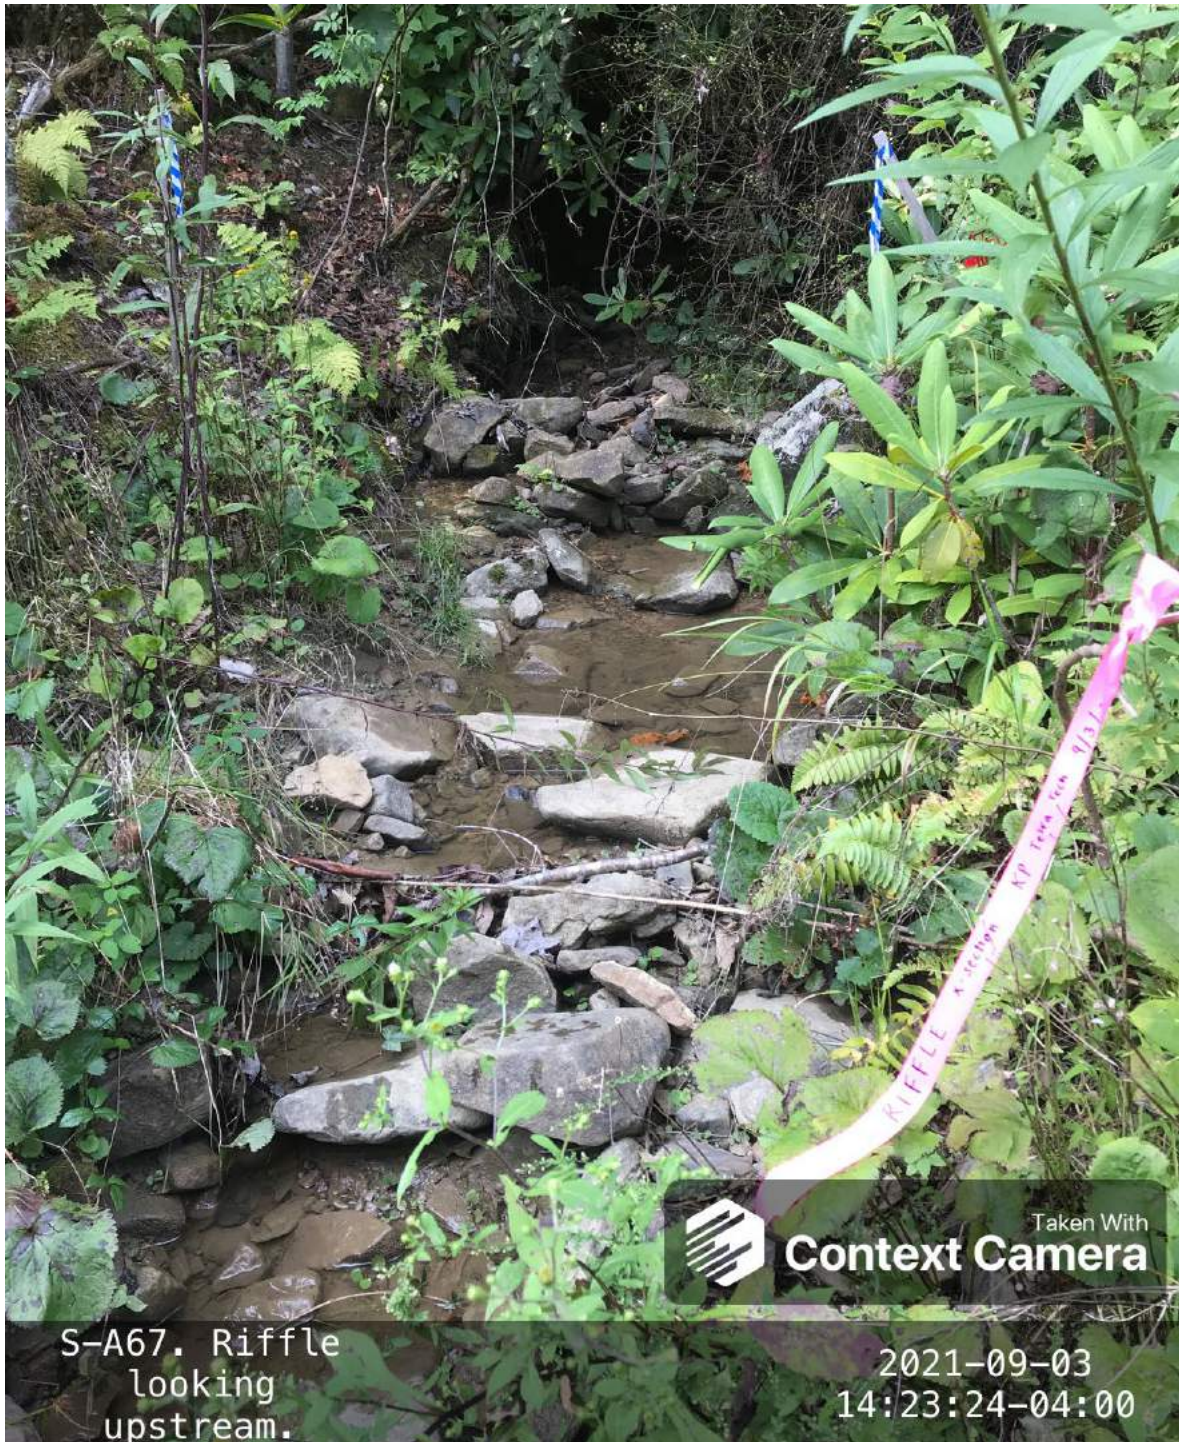
S-A67. Riffle
looking
upstream.

Photo Type: Riffle, US View
Location, Orientation, Photographer Initials: Downstream of Riffle, Upstream View, SM KP
Lat: 38.317575 Long: -80.671553

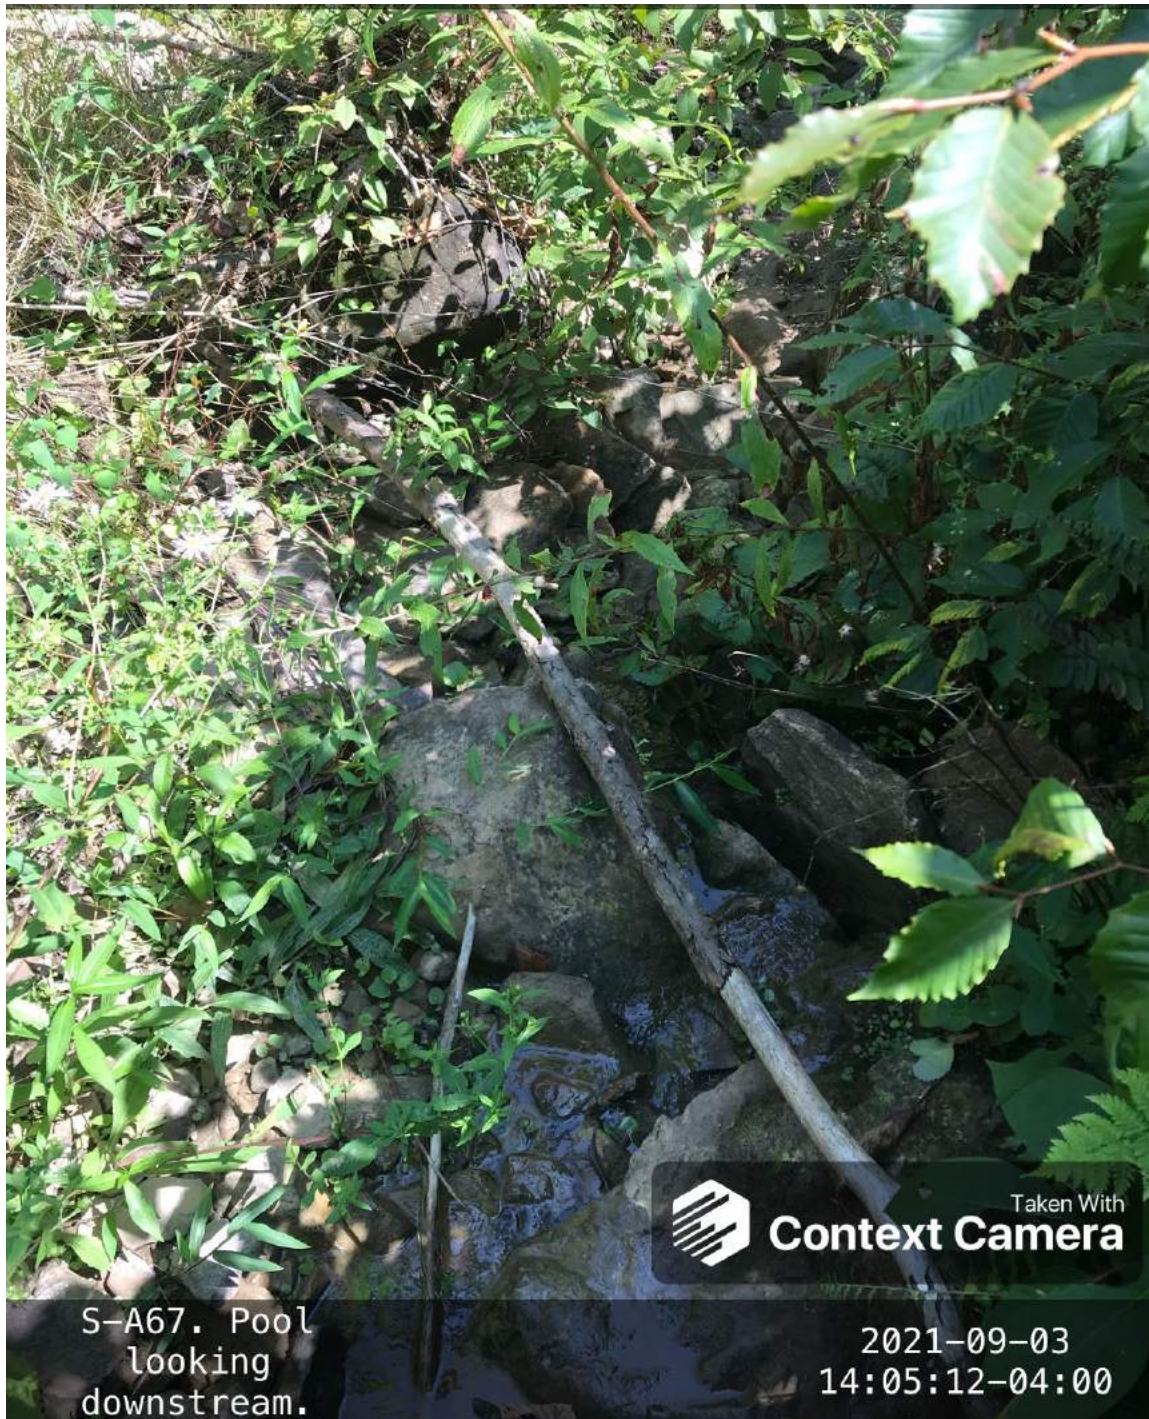
Photo Type: Pool, DS View
Location, Orientation, Photographer Initials: Upstream of Pool, Downstream View, SM KP
Lat: 38.317575 Long: -80.671553

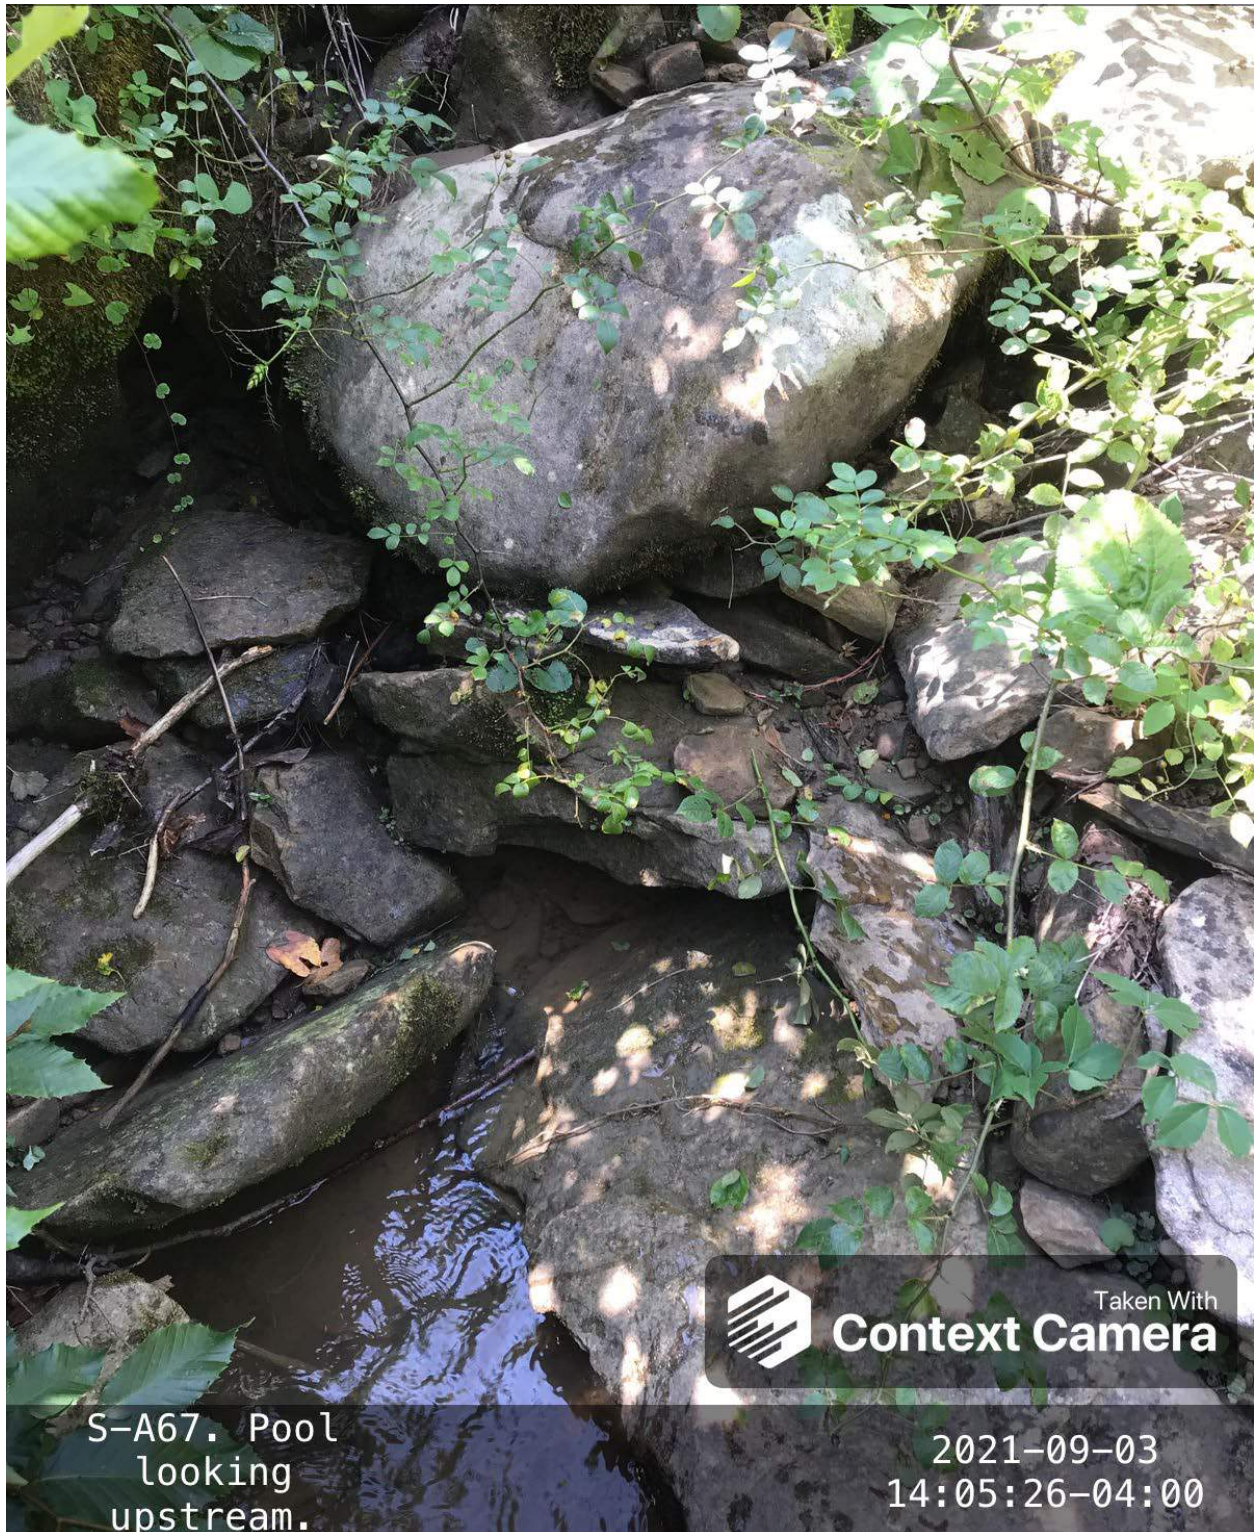
S-A67. Pool
looking
upstream.

Photo Type: Pool, US View
Location, Orientation, Photographer Initials: Downstream of Pool, Upstream View, SM KP
Lat: 38.317575 Long: -80.671553

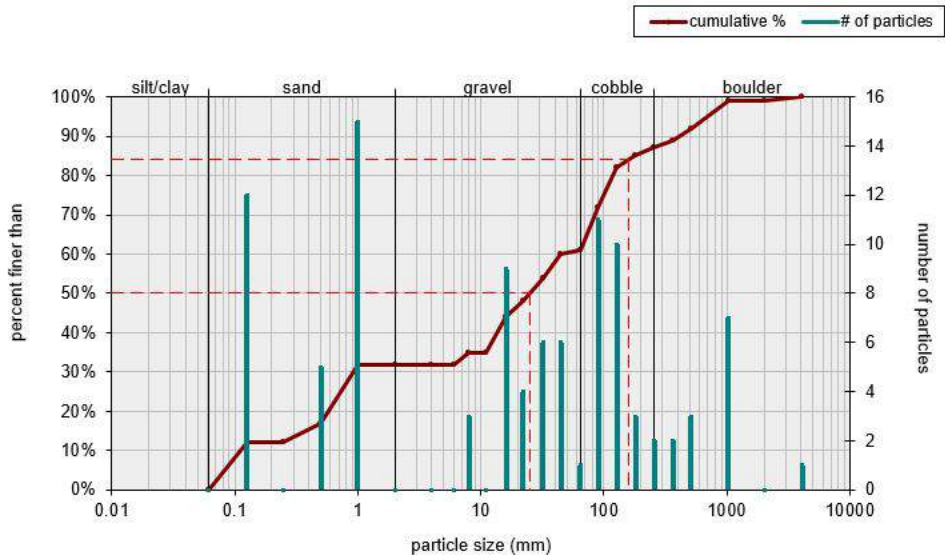
Bankfull Channel Pebble Count, S-A67

Size (mm)		Size Distribution		Type	
D16	0.44	mean	8.4	silt/clay	0%
D35	11	dispersion	31.6	sand	32%
D50	25	skewness	-0.30	gravel	29%
D65	72			cobble	26%
D84	160			boulder	13%
D95	690

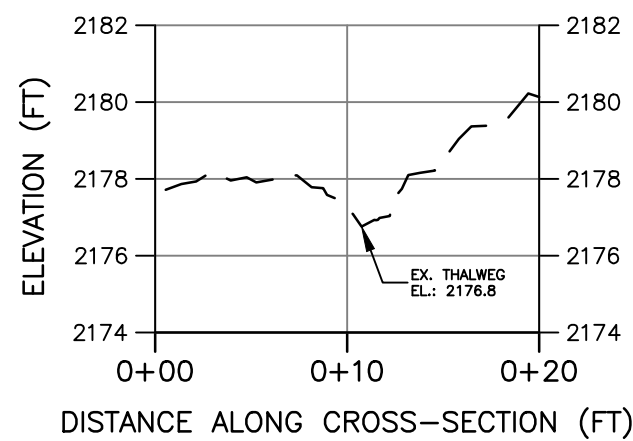
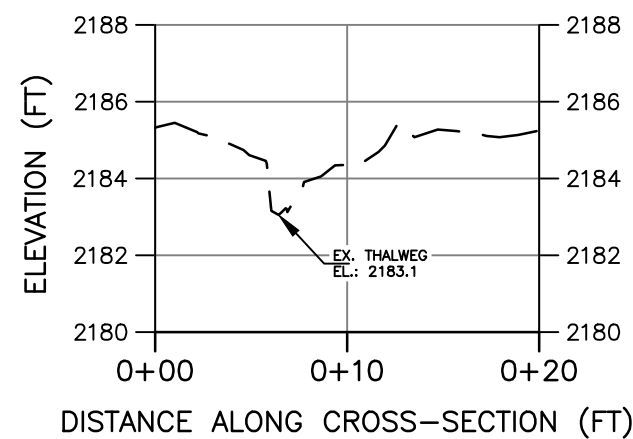
Title PROFILE AND CROSS-SECTIONS

4. ALL SECTION VIEWS SHOWN LEFT TO RIGHT FACING DOWNSTREAM.
5. POST-CROSSING SURVEY INFORMATION SHOWN IN RED, DATA PENDING.
6. POST-CROSSING SURVEY POINTS FOR CROSS SECTIONS AND THALWEG ARE PROJECTED ONTO PRE-CROSSING SECTION AND PROFILE VIEWS FOR COMPARISON.

SCALE: H: 1"=10'
V: 1"=5'

PRE-CROSSING
