**Reach S-A71 (Timber Mat Crossing)**  
**Perennial**  
**Spread D**  
**Nicholas County, West Virginia**

Title	Profile and Cross-Sections
CROSSING S-A71 - UNNAMED TRIB. BASELINE SURVEY	
BEAVER CREEK (MP 115.1)	
NICHOLAS COUNTY, WV

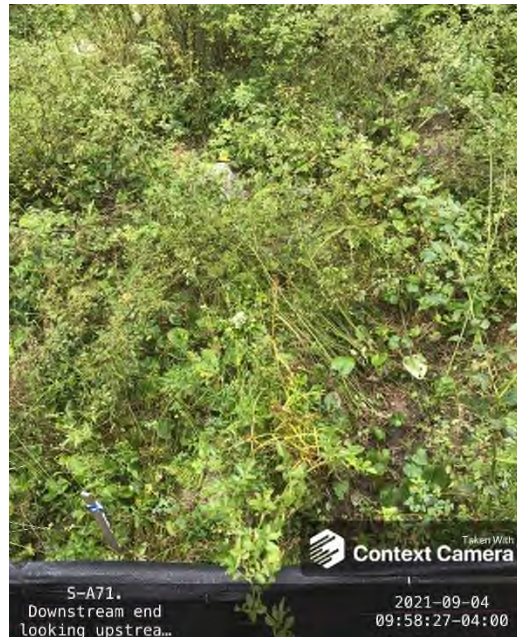
Photo Type: DS, US View

Location, Orientation, Photographer Initials: Downstream Edge of ROW, Upstream View, KP/SM  
Lat: 38.321572 Long: -80.670958

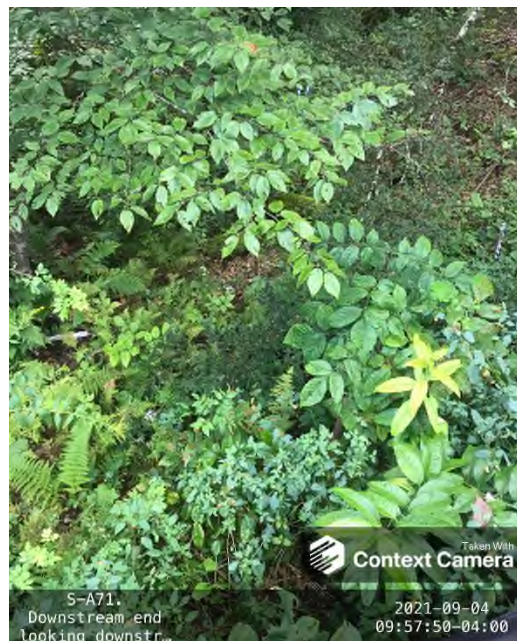
Photo Type: DS, DS View

Location, Orientation, Photographer Initials: Downstream Edge of ROW, Downstream View, KP/SM  
Lat: 38.321572 Long: -80.670958

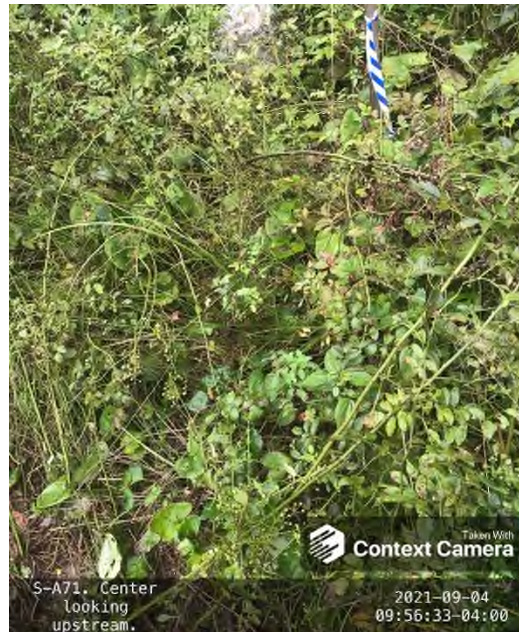
Photo Type: US View at Center  
Location, Orientation, Photographer Initials: Center ROW, Upstream View, KP/SM  
Lat: 38.321572 Long: -80.670958

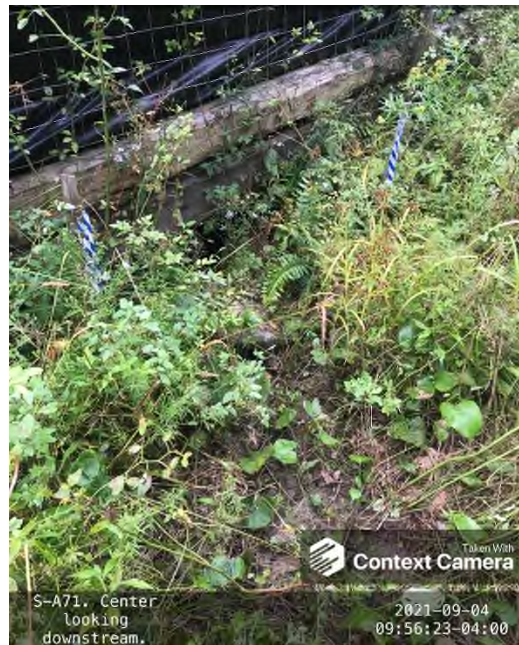
Photo Type: DS View at Center  
Location, Orientation, Photographer Initials: ROW Center, Downstream View, KP/SM  
Lat: 38.321572 Long: -80.670958

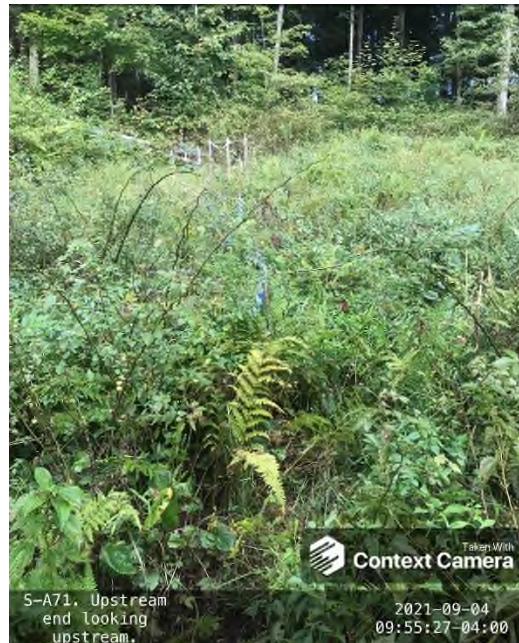
Photo Type: US, US View

Location, Orientation, Photographer Initials: Upstream Edge of ROW, Upstream View, KP/SM

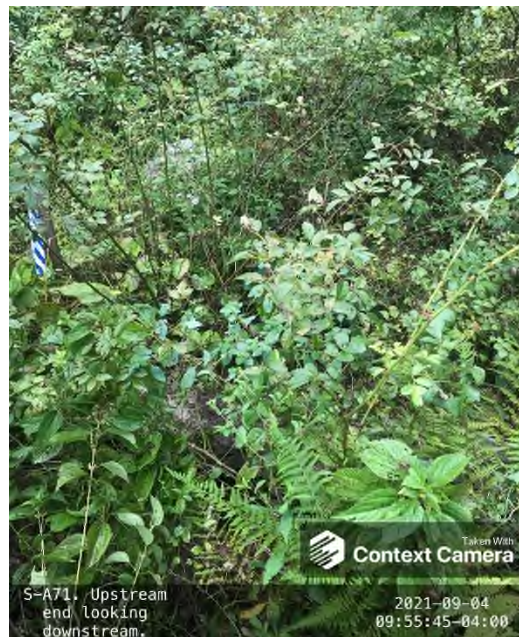
Photo Type: US, DS View

Location, Orientation, Photographer Initials: Upstream Edge of ROW, Downstream View, KP/SM

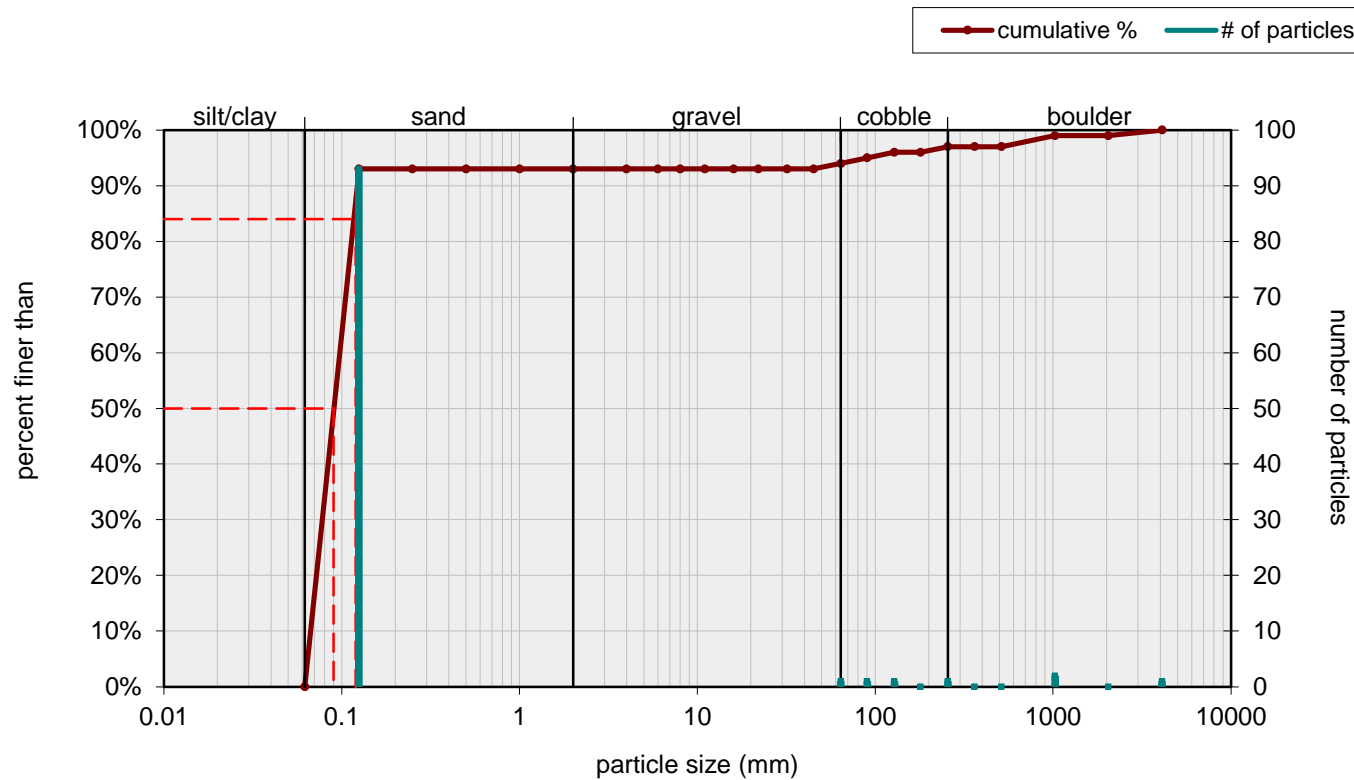
# Bankfull Channel Pebble Count, S-A71; UNT to Big Beaver Creek

Size (mm)		Size Distribution		Type	
D16	0.07	mean	0.1	silt/clay	0%
D35	0.081	dispersion	1.3	sand	93%
D50	0.09	skewness	0.02	gravel	1%
D65	0.1			cobble	3%
D84	0.12			boulder	3%
D95	90

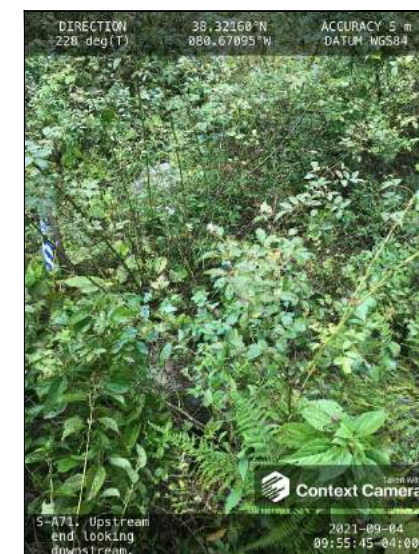
PHOTO TAKEN LOOKING DOWNSTREAM  
FROM UPSTREAM IMPACT LIMITS

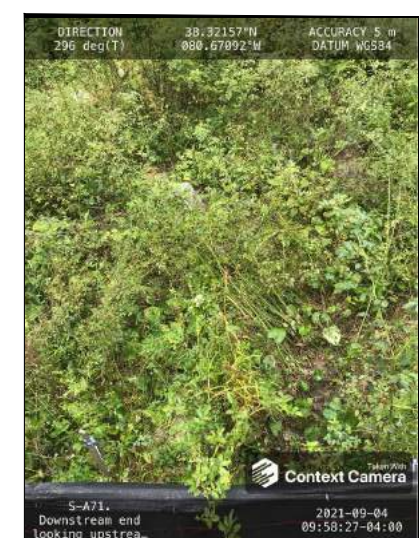
PHOTO TAKEN LOOKING UPSTREAM FROM  
DOWNSTREAM IMPACT LIMITS
