**Reach S-A75 (Pipeline ROW)**  
**Perennial**  
**Spread D**  
**Nicholas County, West Virginia**

**Spread D      Stream S-A75 (Pipeline ROW)      Nicholas County**

FILE AND CROSS-SECTIONS  
BASELINE SURVEY  
CROSSING S-A75 - UNT TO BIG  
LEAVER CREEK (MP 114.79)  
NICHOLAS COUNTY, WV

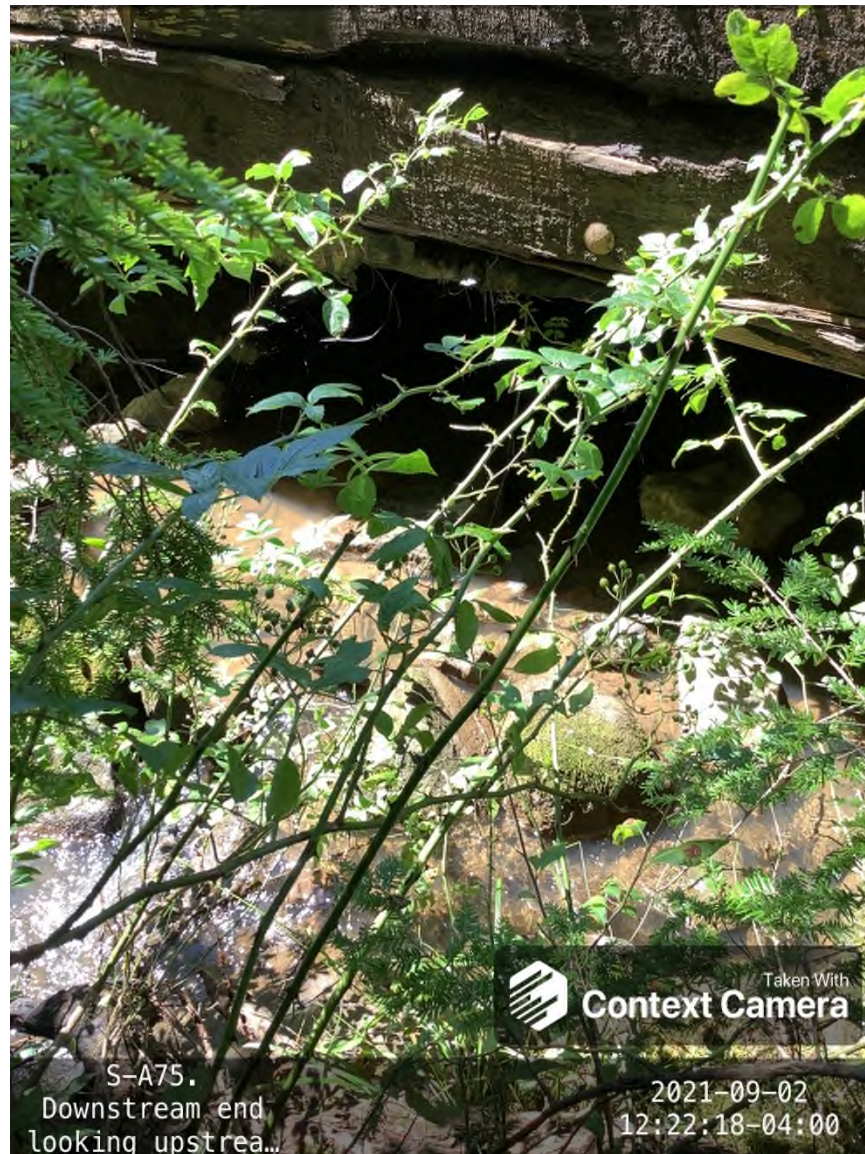
Photo Type: DS, US View  
Location, Orientation, Photographer Initials: Downstream Edge of ROW, Upstream View, AJE/PEL  
Lat: 38.326001 Long: -80.670358

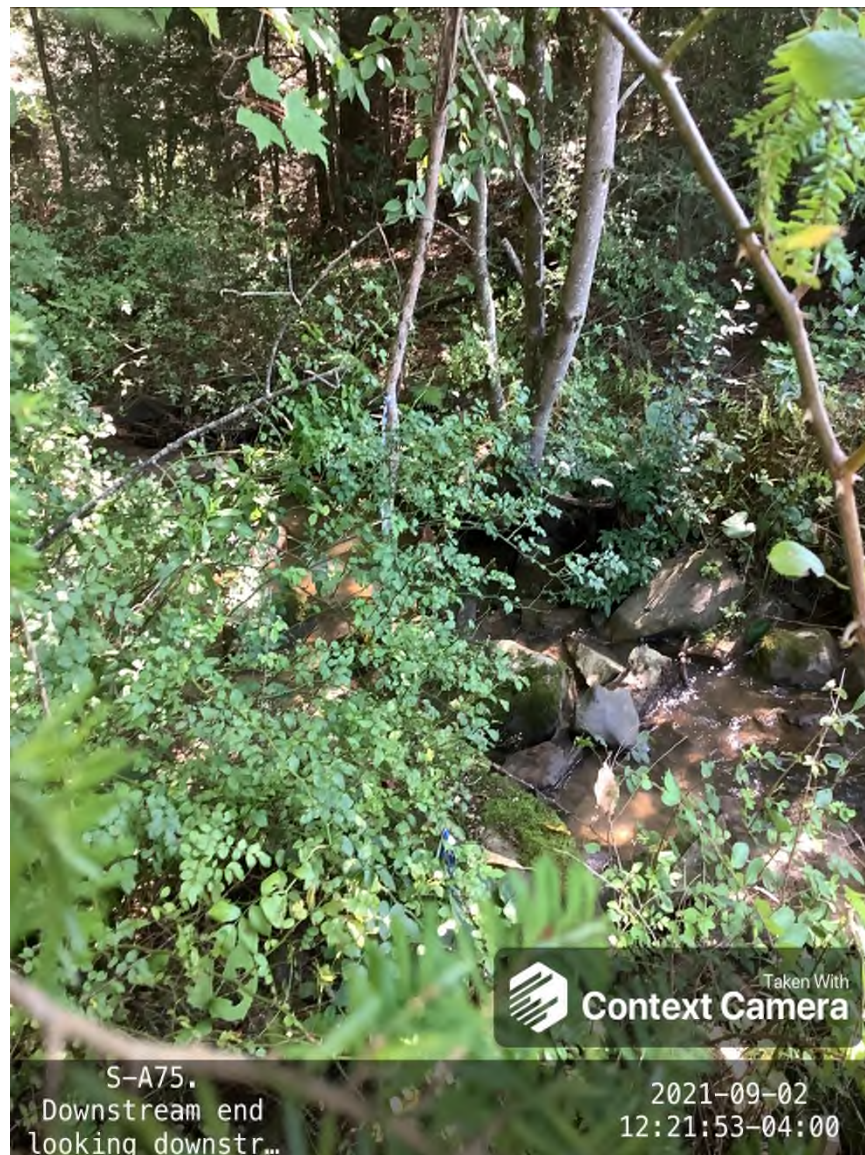
Photo Type: DS, DS View  
Location, Orientation, Photographer Initials: Downstream Edge of ROW, Downstream View, AJE/PEL  
Lat: 38.326001 Long: -80.670358

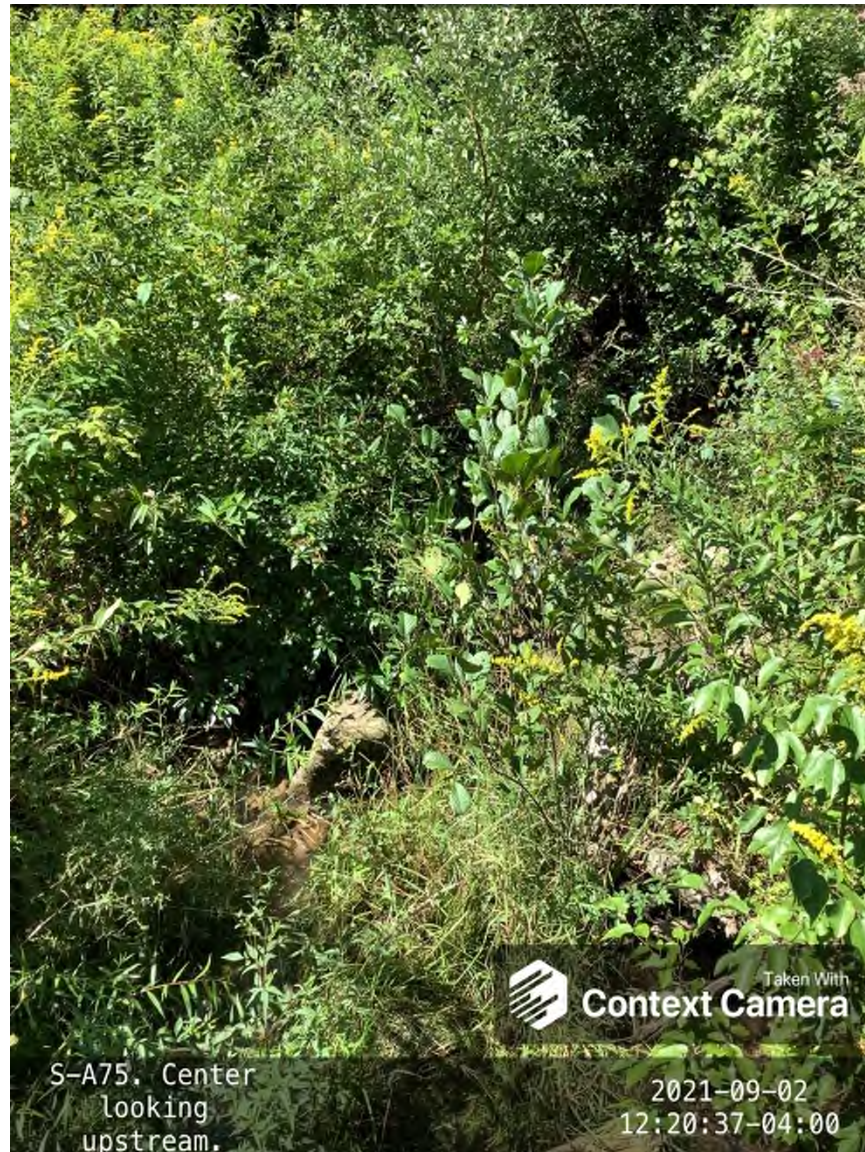
Photo Type: US View at Center  
Location, Orientation, Photographer Initials: Center ROW, Upstream View, AJE/PEL  
Lat: 38.326001 Long: -80.670358

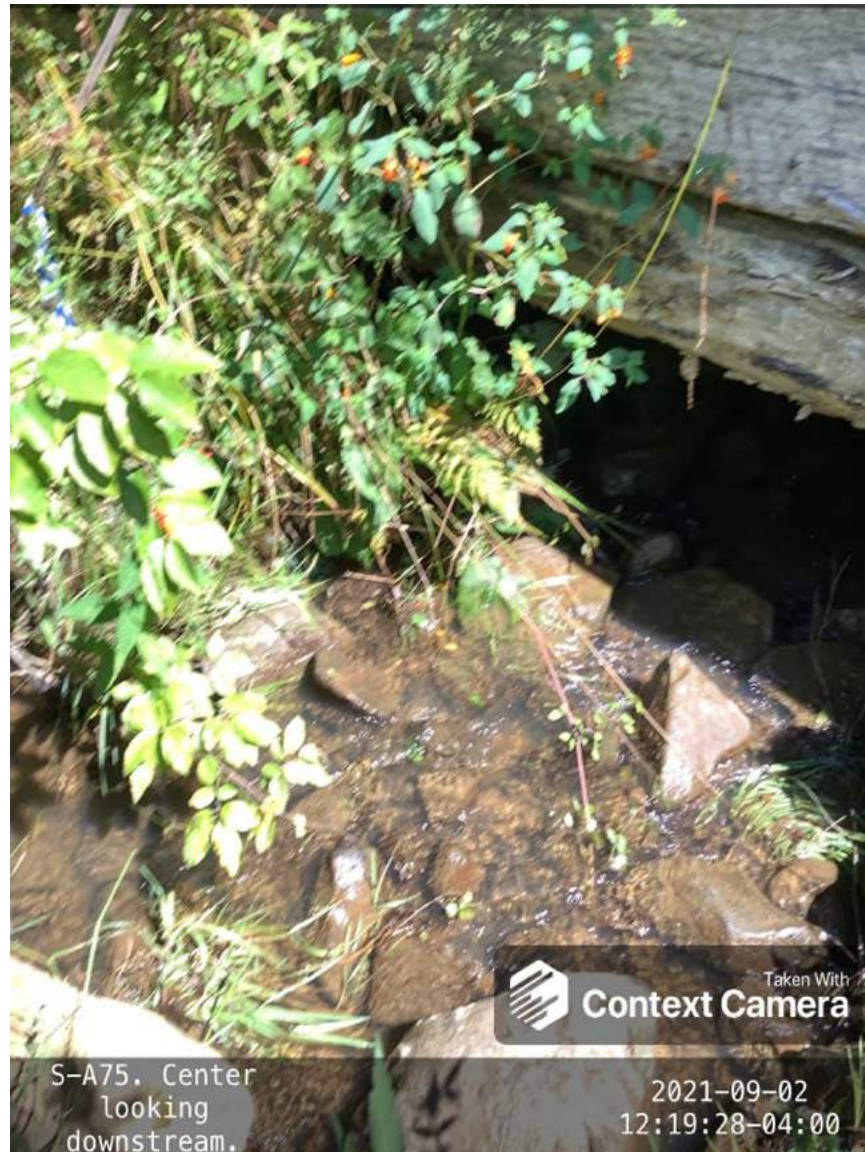
Photo Type: DS View at Center  
Location, Orientation, Photographer Initials: ROW Center, Downstream View, AJE/PEL  
Lat: 38.326001 Long: -80.670358

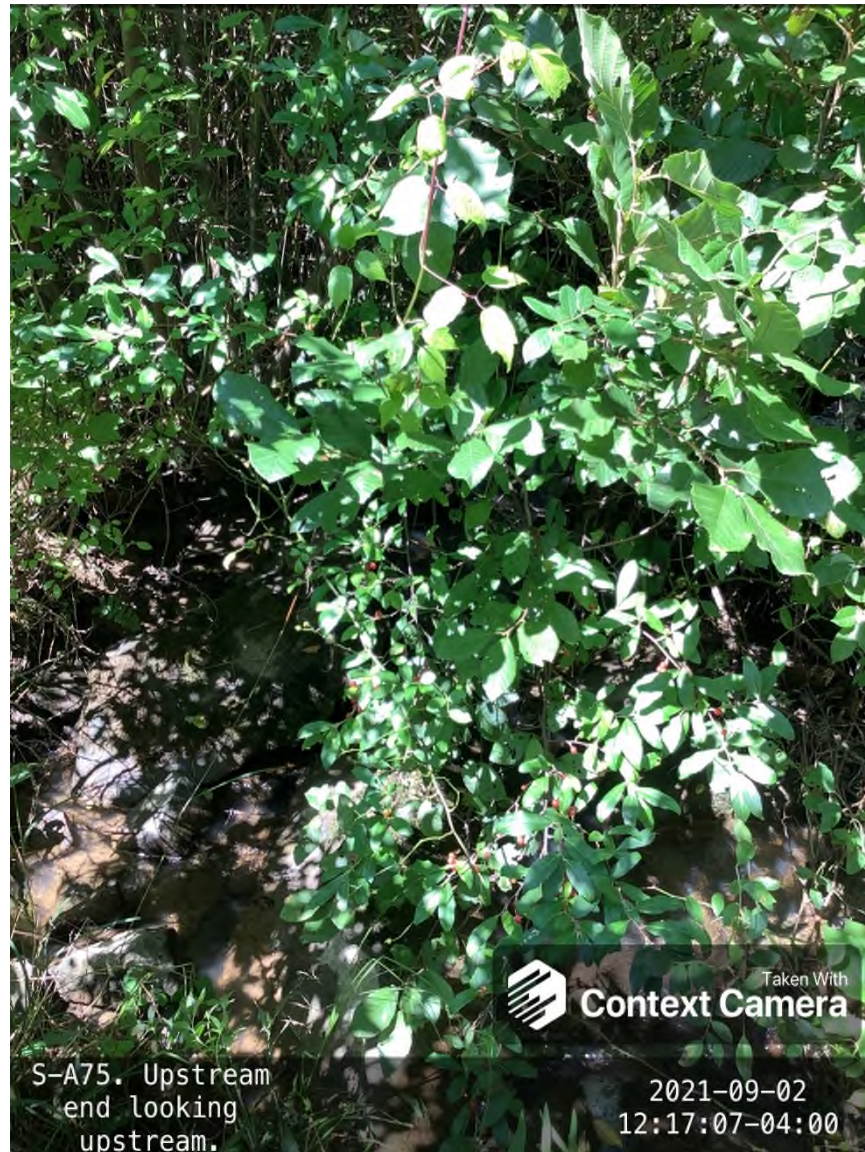
Photo Type: US, US View  
Location, Orientation, Photographer Initials: Upstream Edge of ROW, Upstream View, AJE/PEL  
Lat: 38.326001 Long: -80.670358

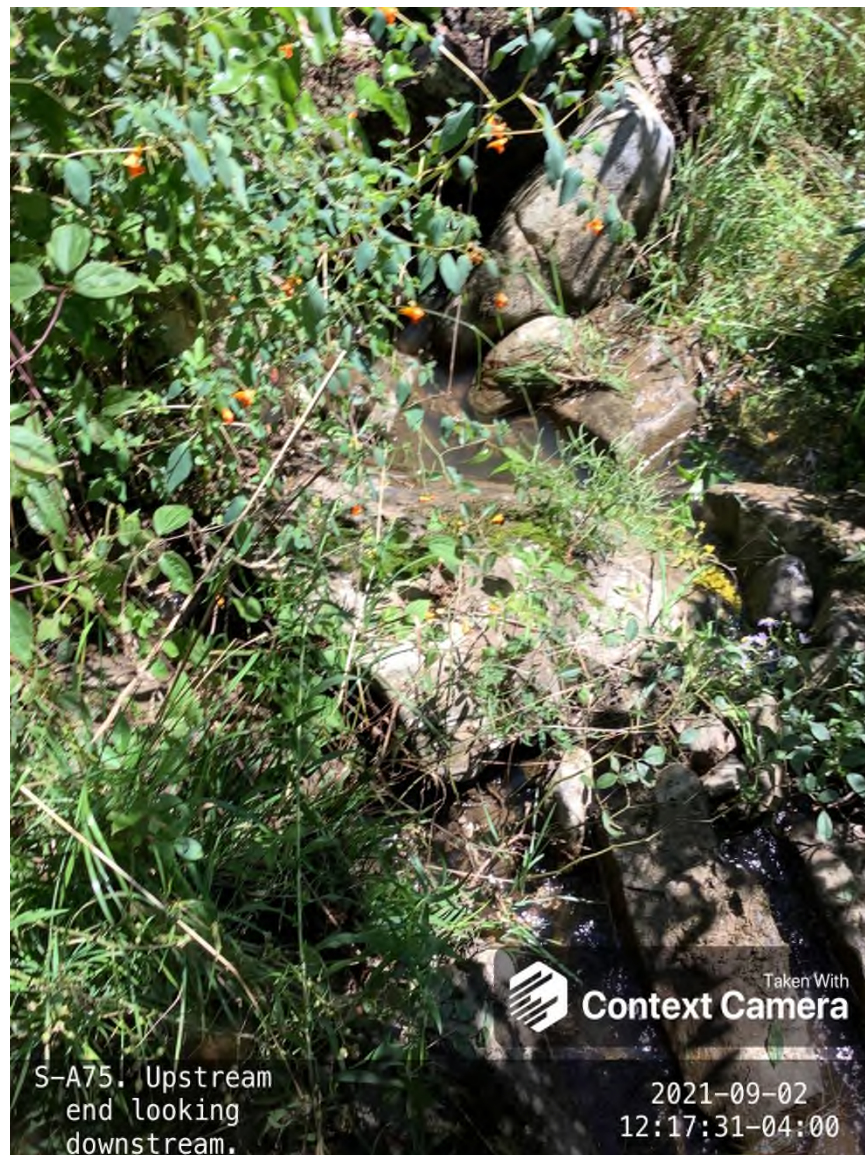
Photo Type: US, DS View

Location, Orientation, Photographer Initials: Upstream Edge of ROW, Downstream View, AJE/PEL  
Lat: 38.326001 Long: -80.670358

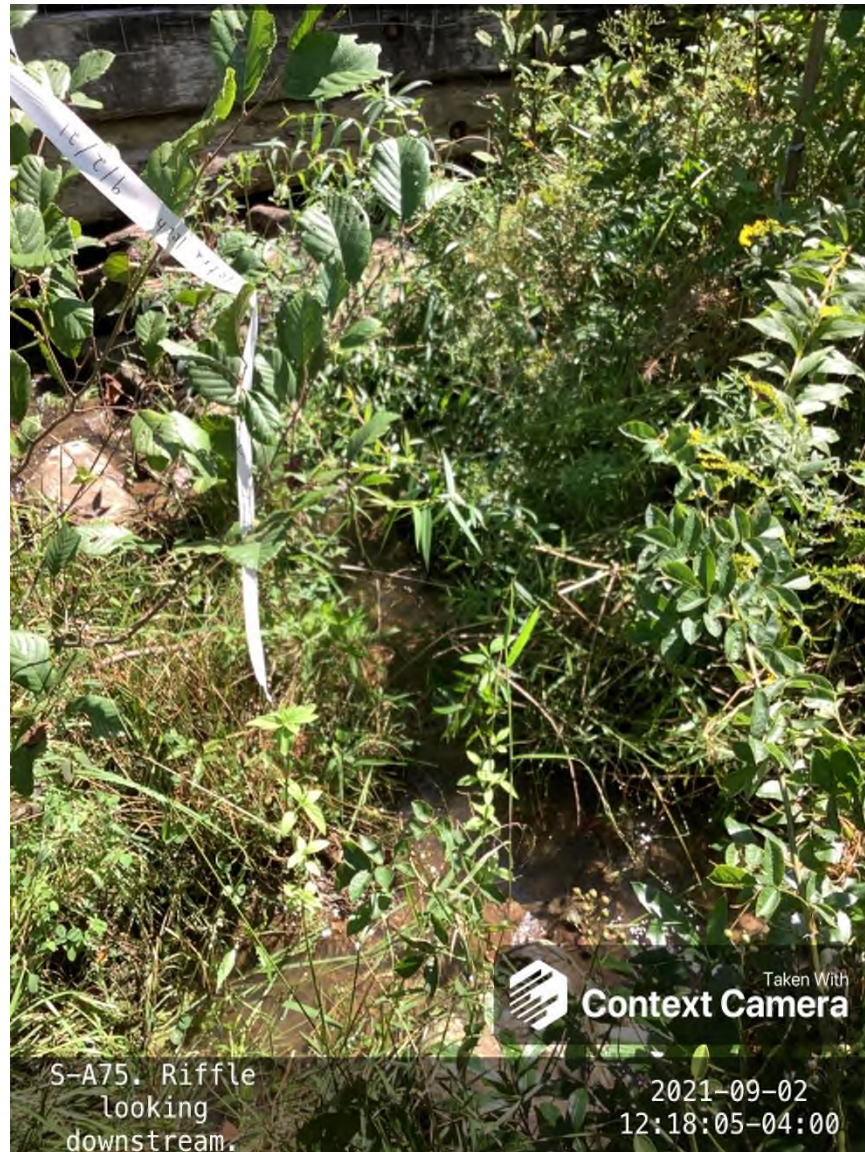
Photo Type: Riffle, DS View  
Location, Orientation, Photographer Initials: Upstream of Riffle, Downstream View, AJE/PEL  
Lat: 38.326001 Long: -80.670358

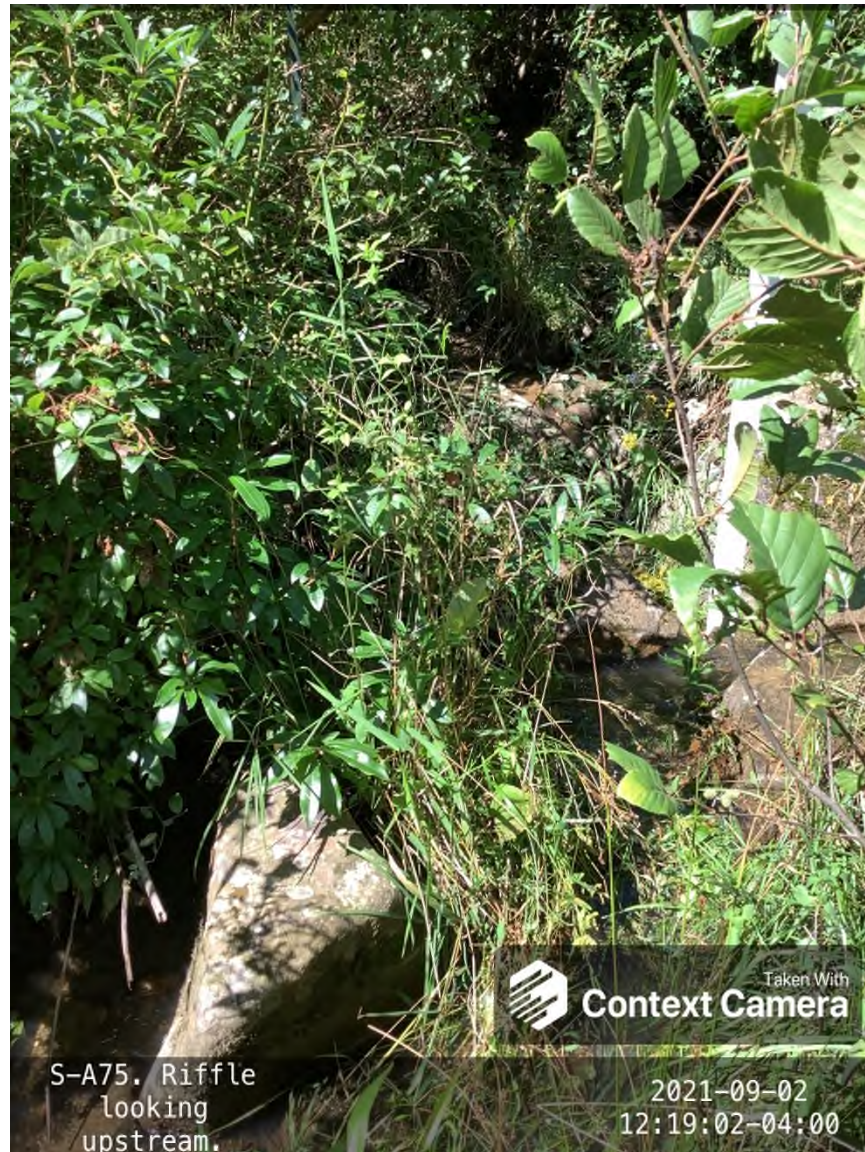
Photo Type: Riffle, US View  
Location, Orientation, Photographer Initials: Downstream of Riffle, Upstream View, AJE/PEL  
Lat: 38.326001 Long: -80.670358
