Baseline Assessment – Stream Attributes

Reach S-A76 (Pipeline ROW)
Perennial
Spread D
Nicholas County, West Virginia

Spread D Stream S-A76 (Pipeline ROW) Nicholas County

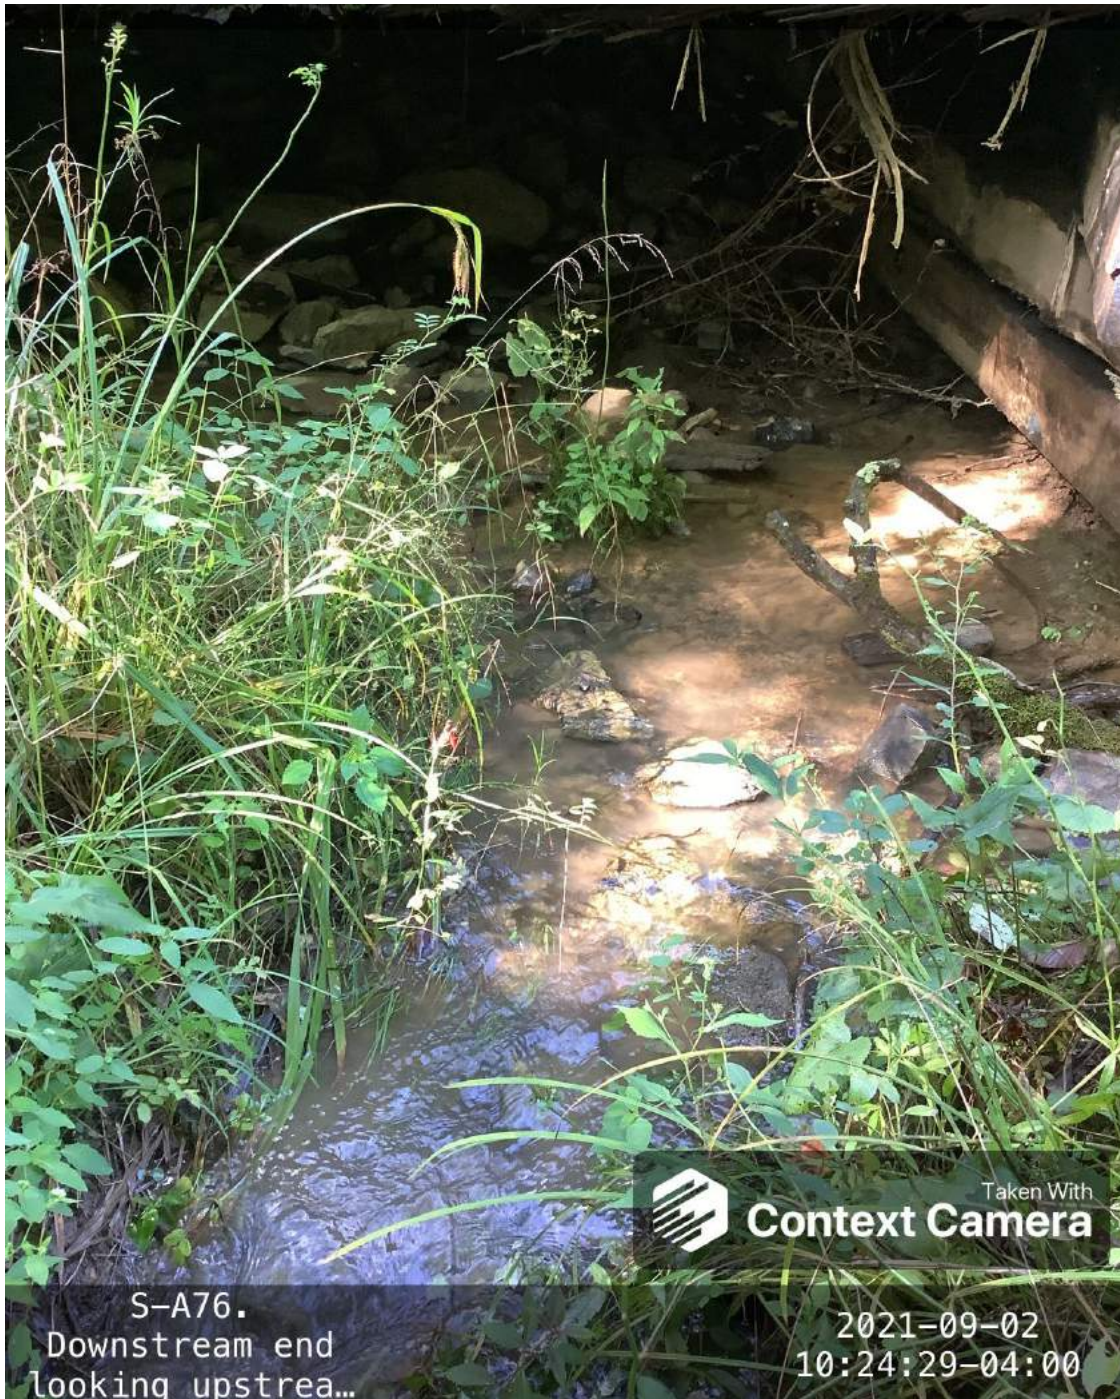
S-A76.
Downstream end
looking upstrea...

Photo Type: DS, US View
Location, Orientation, Photographer Initials: Downstream Edge of ROW, Upstream View, KP JR
Lat: 38.329126 Long: -80.671211

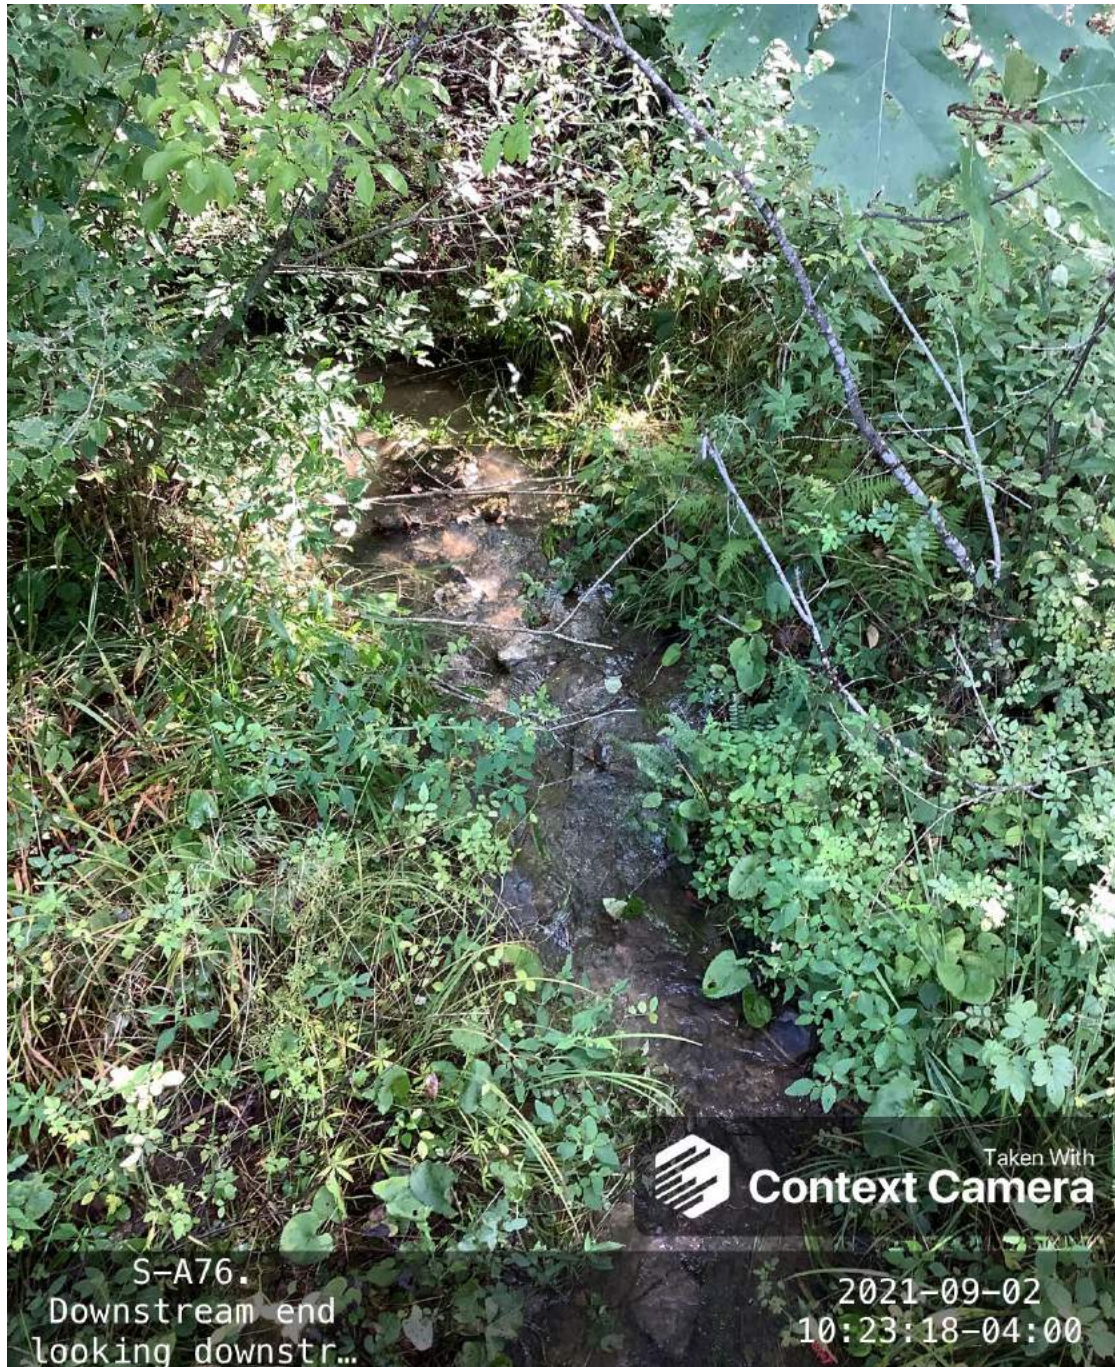
Photo Type: DS, DS View
Location, Orientation, Photographer Initials: Downstream Edge of ROW, Downstream View, KP JR
Lat: 38.329126 Long: -80.671211

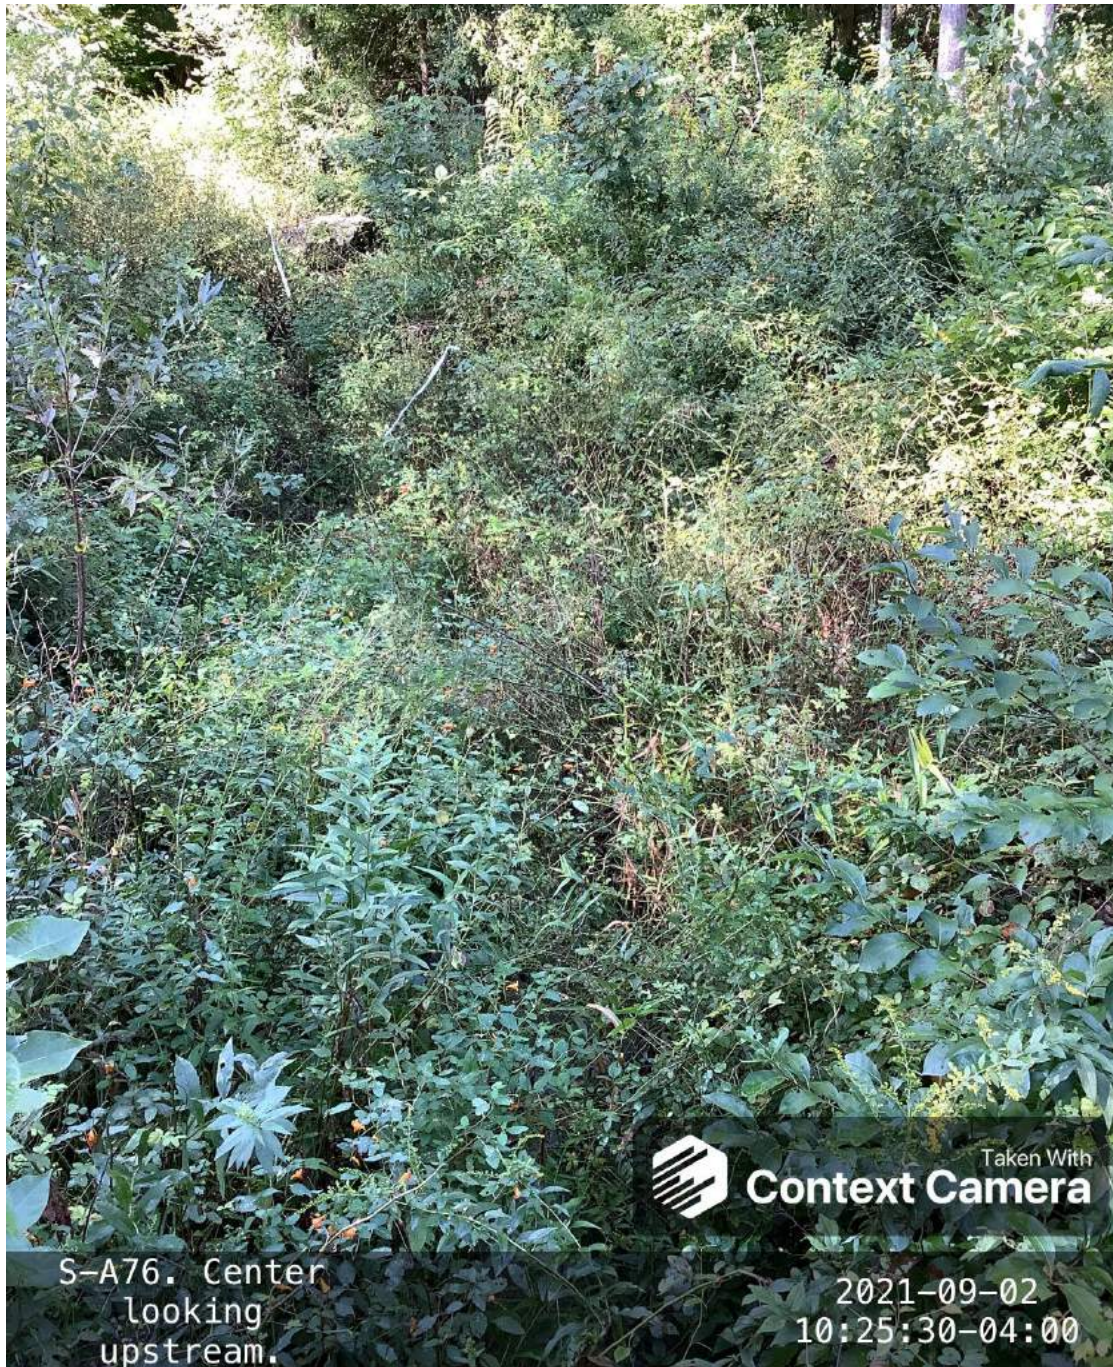
Photo Type: US View at Center
Location, Orientation, Photographer Initials: Center ROW, Upstream View, KP JR
Lat: 38.329126 Long: -80.671211

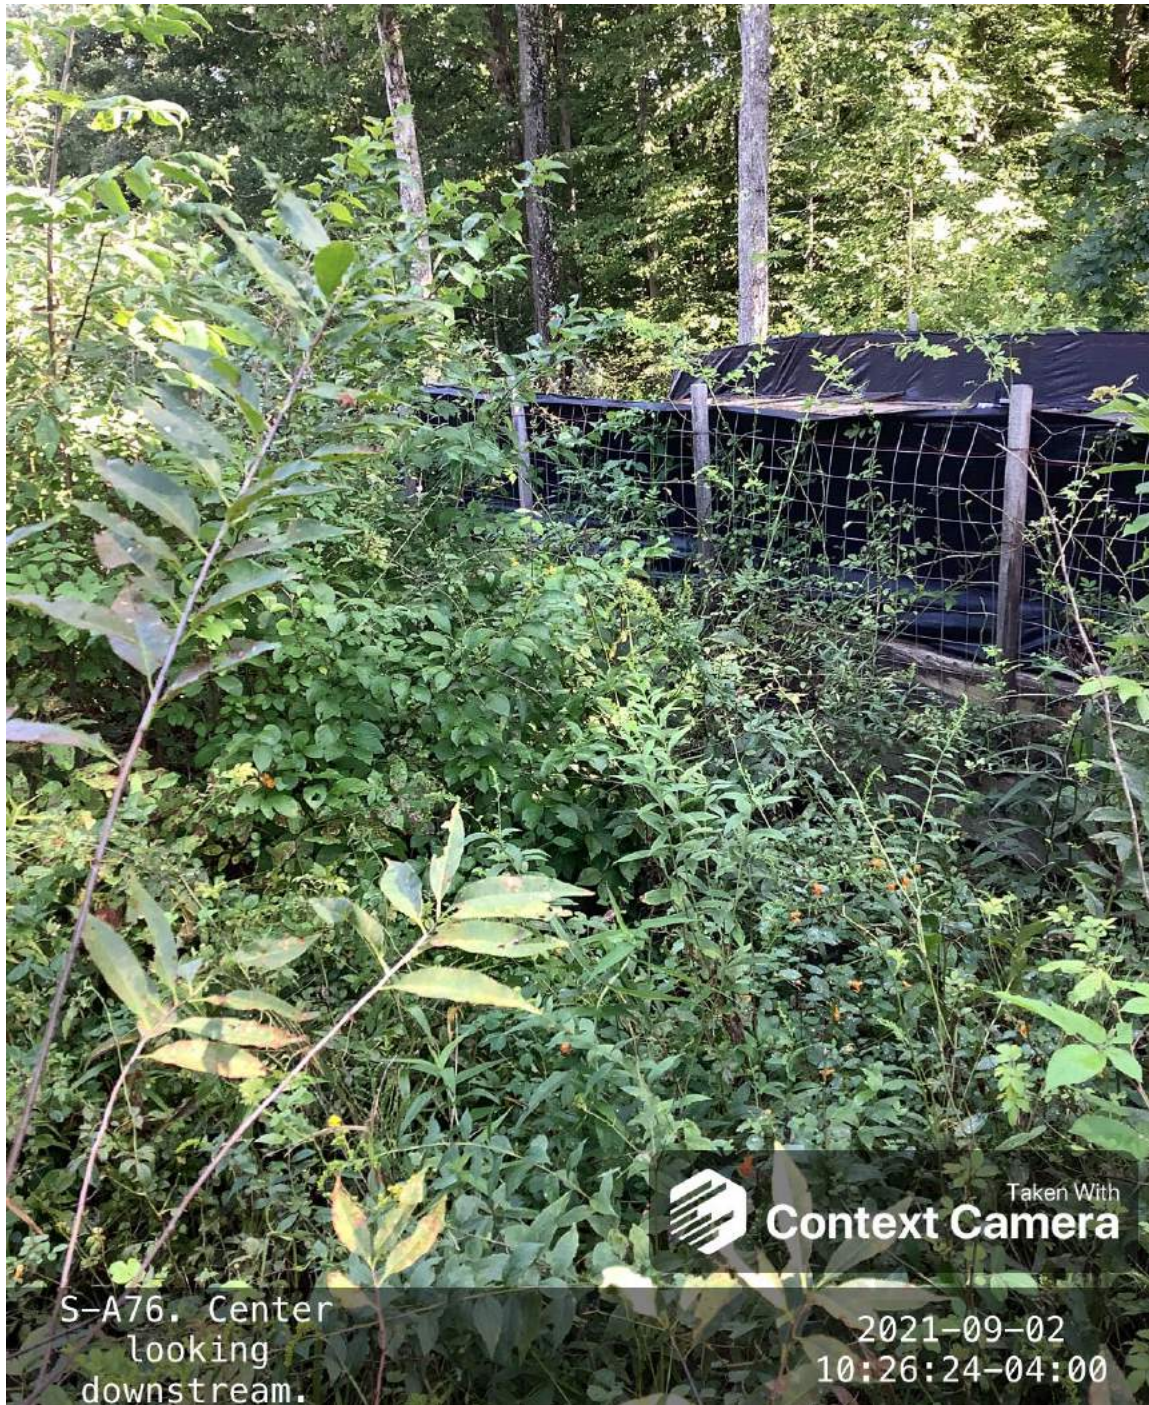
Photo Type: DS View at Center
Location, Orientation, Photographer Initials: ROW Center, Downstream View, KP JR
Lat: 38.329126 Long: -80.671211

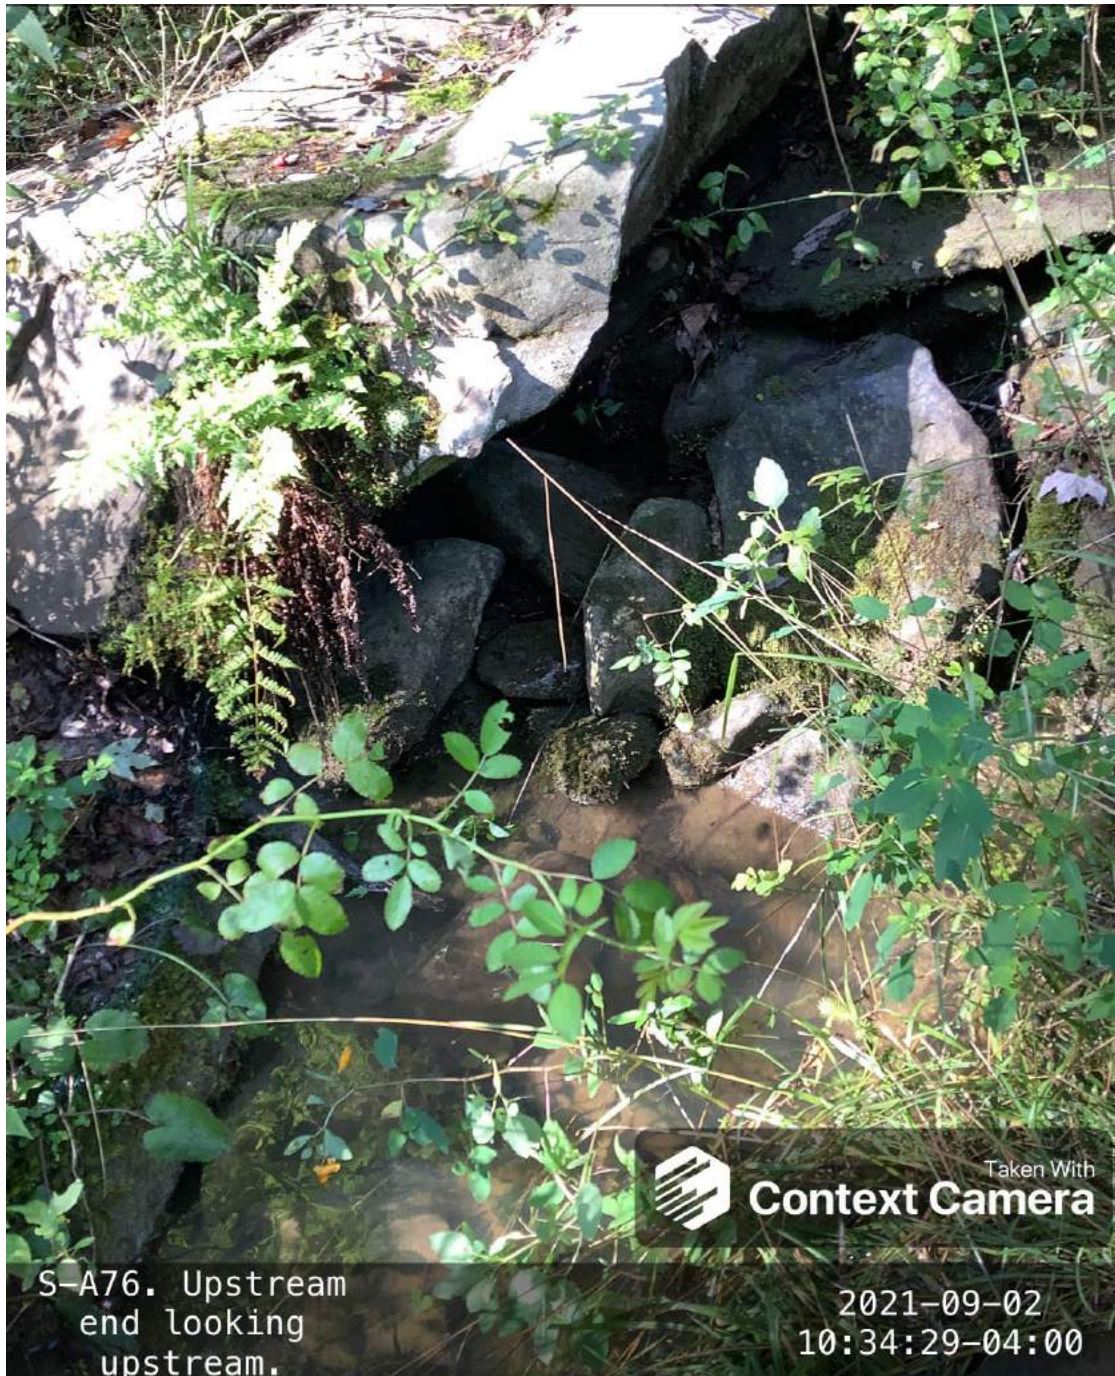
S-A76. Upstream
end looking
upstream.

Photo Type: US, US View

Location, Orientation, Photographer Initials: Upstream Edge of ROW, Upstream View, KP JR
Lat: 38.329126 Long: -80.671211

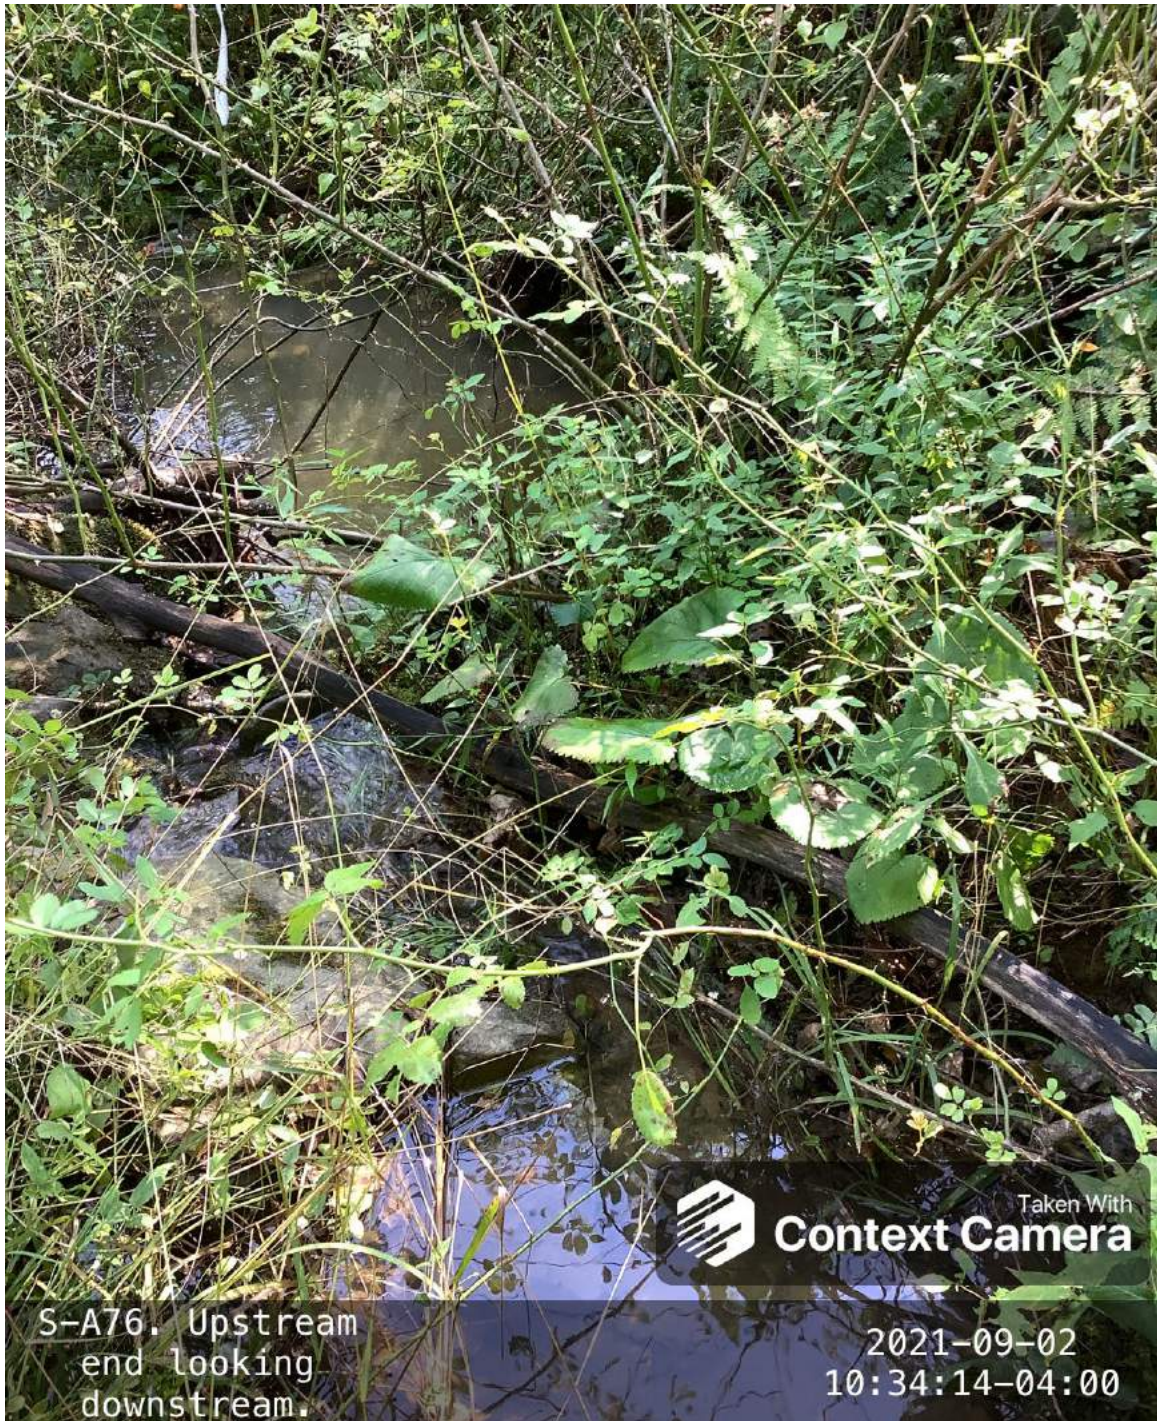
Photo Type: US, DS View
Location, Orientation, Photographer Initials: Upstream Edge of ROW, Downstream View, KP JR
Lat: 38.329126 Long: -80.671211

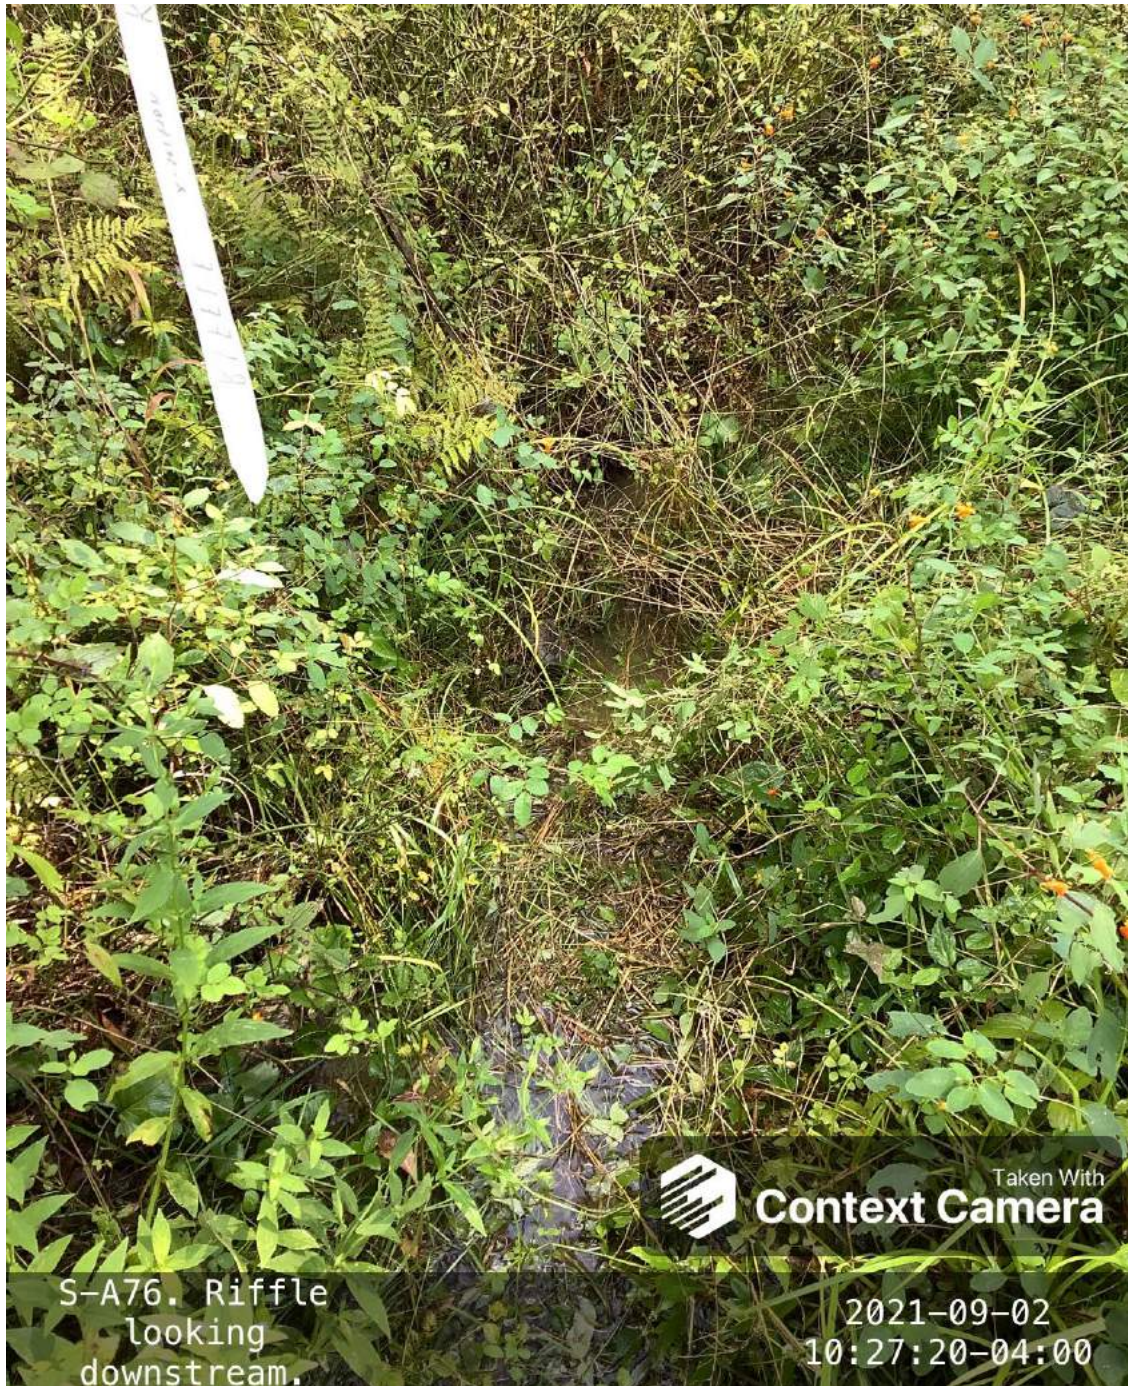
S-A76. Riffle
looking
downstream.

Photo Type: Riffle, DS View

Location, Orientation, Photographer Initials: Upstream of Riffle, Downstream View, KP JR

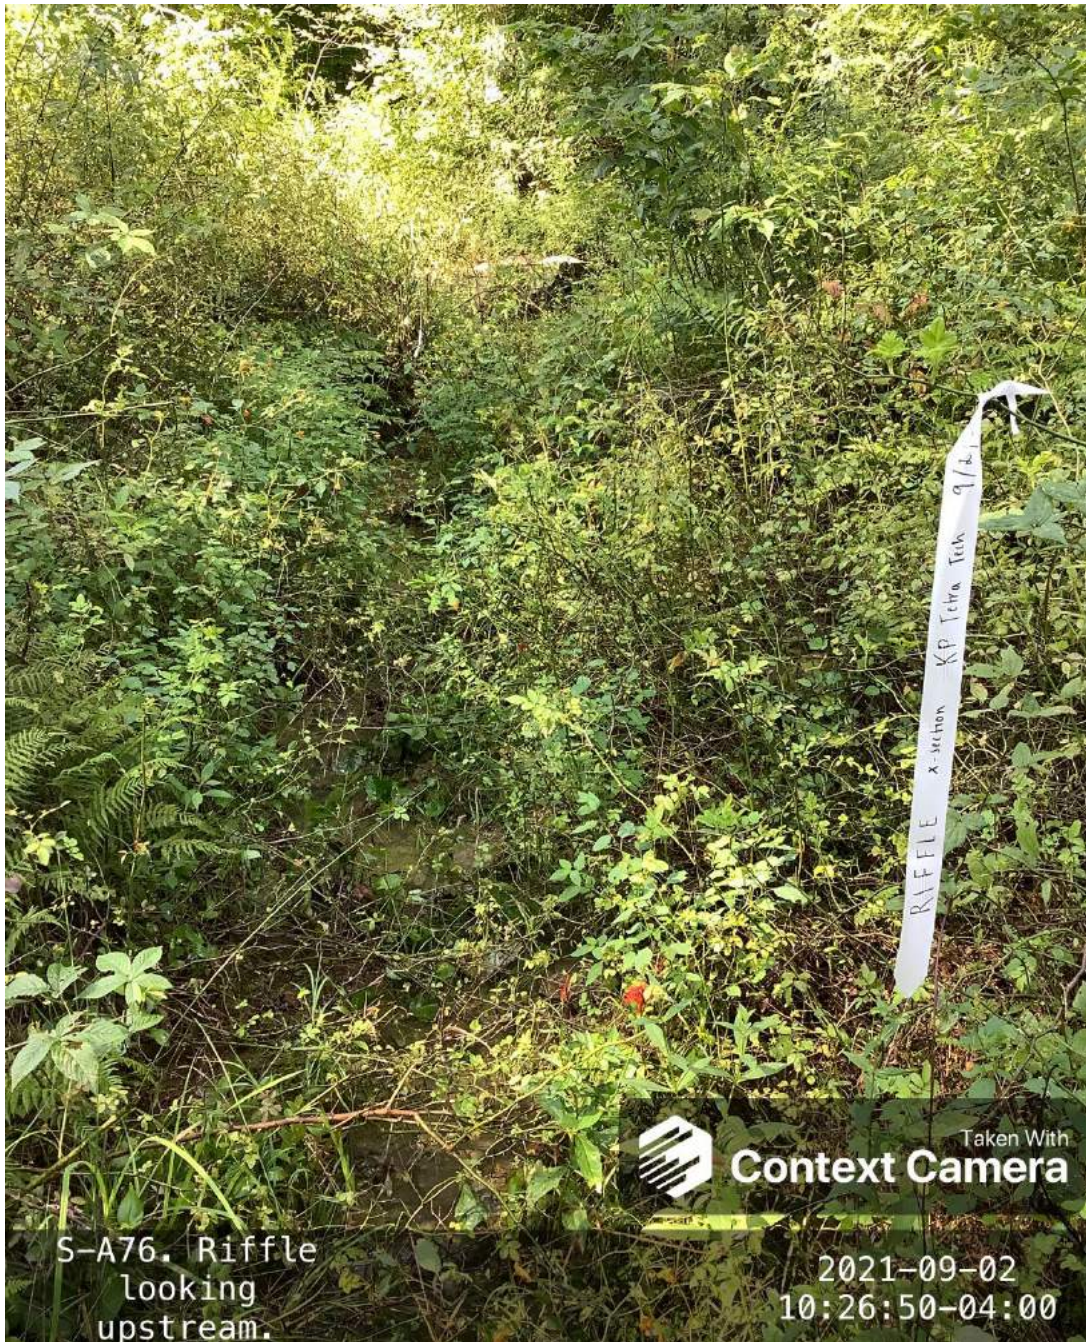
Photo Type: Riffle, US View
Location, Orientation, Photographer Initials: Downstream of Riffle, Upstream View, KP JR
Lat: 38.329126 Long: -80.671211

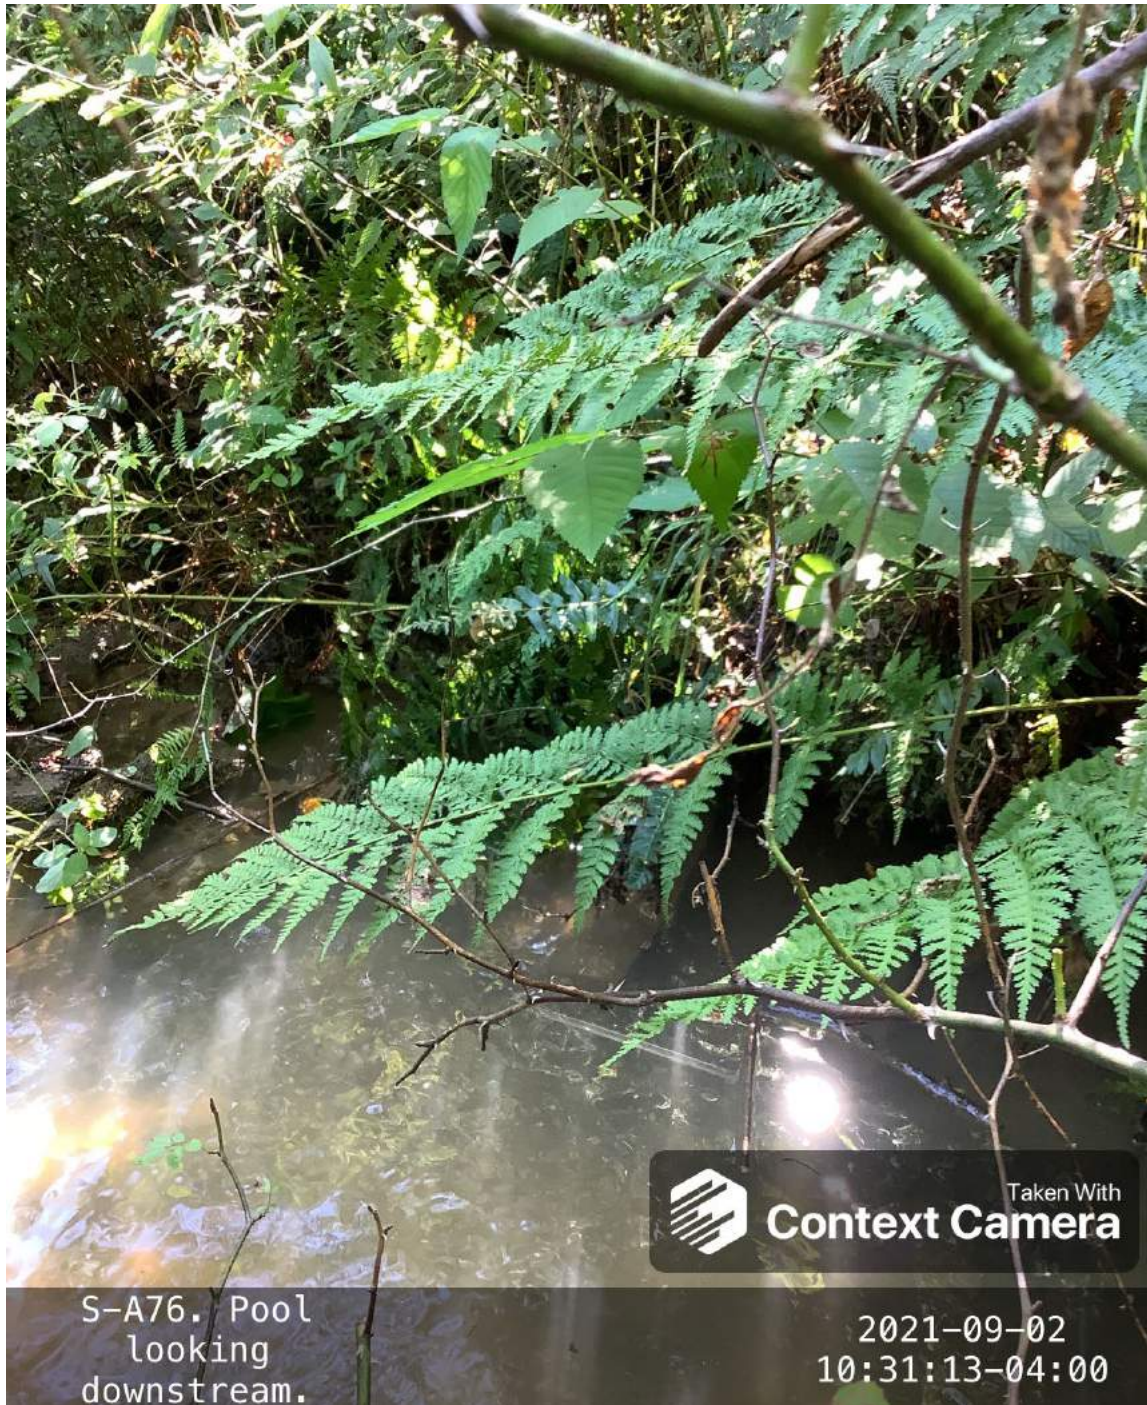
Photo Type: Pool, DS View
Location, Orientation, Photographer Initials: Upstream of Pool, Downstream View, KP JR
Lat: 38.329126 Long: -80.671211

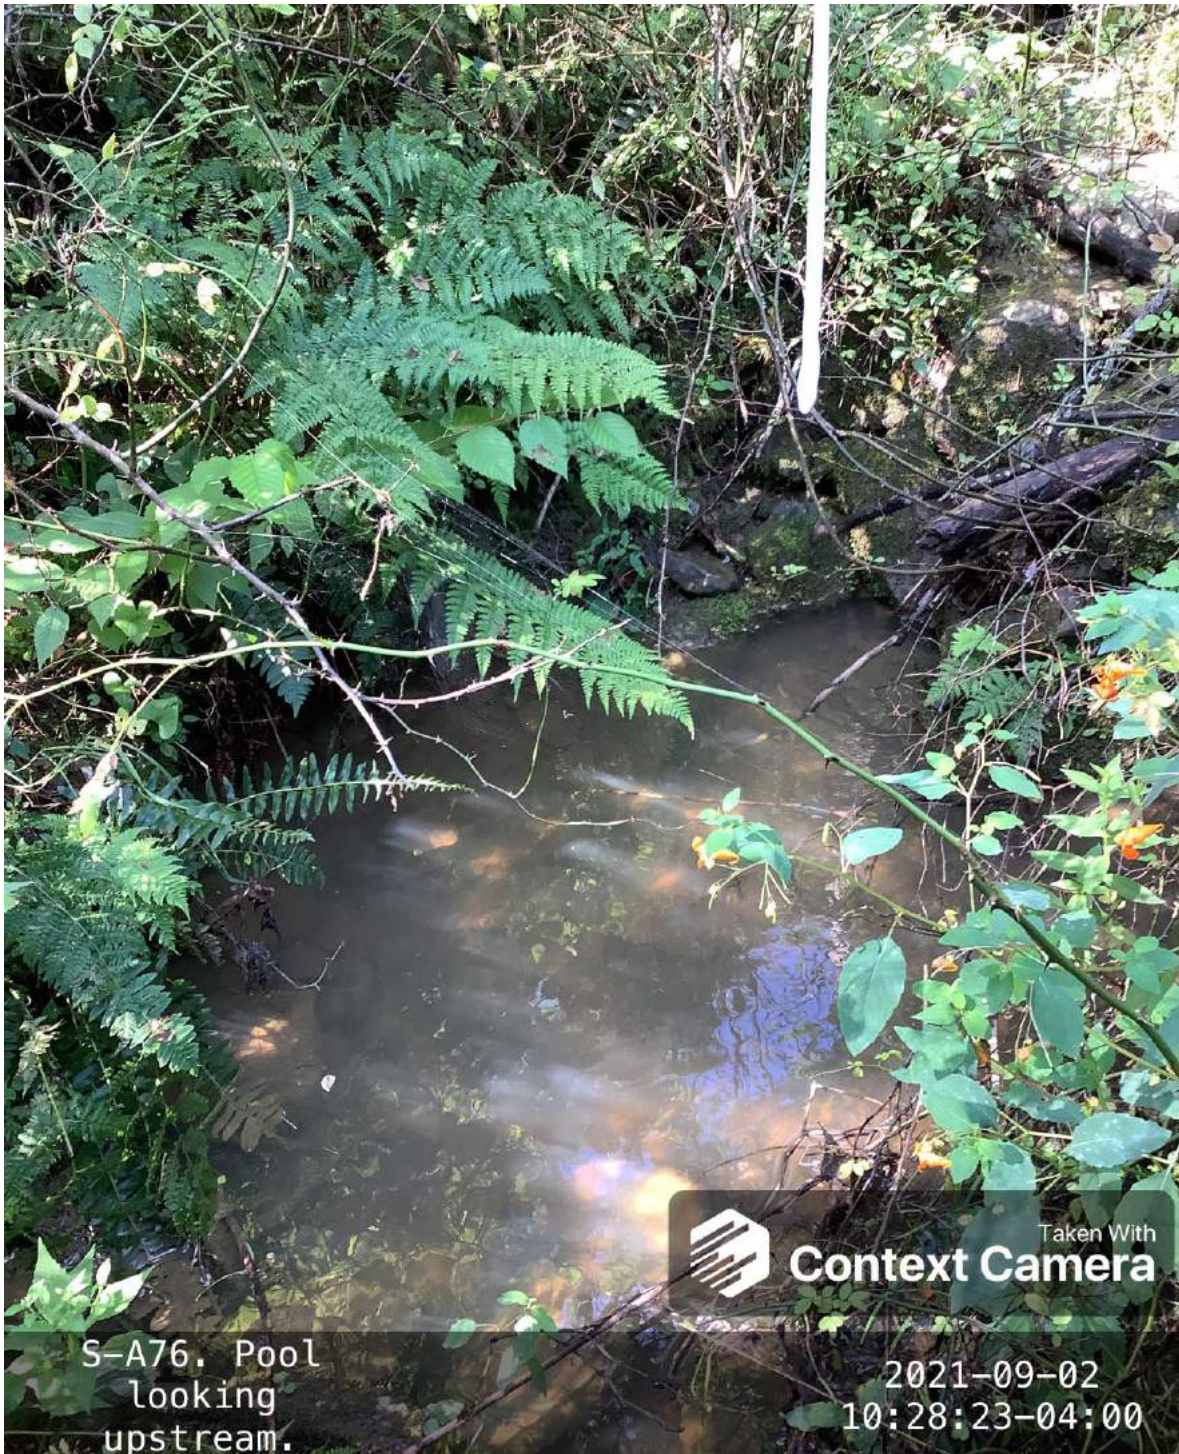
S-A76, Pool
looking
upstream.

Photo Type: Pool, US View
Location, Orientation, Photographer Initials: Downstream of Pool, Upstream View, KP JR
Lat: 38.329126 Long: -80.671211

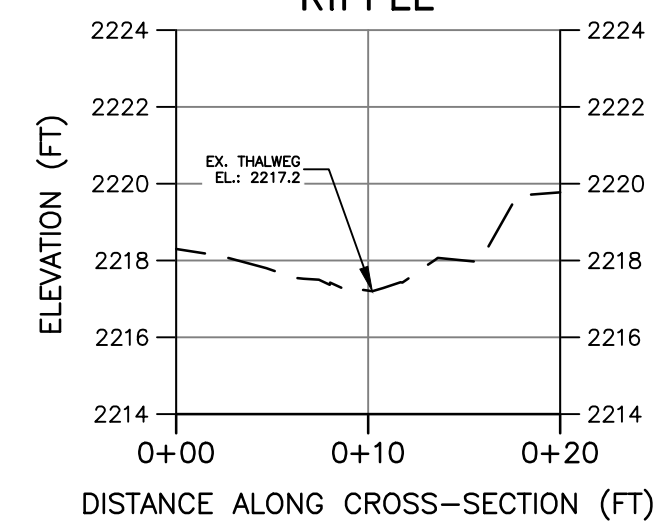
Title	PROFILE AND CROSS-SECTIONS BASELINE SURVEY CROSSING S-A76 - UNNAMED TRIB. TO BIG BEAVER CREEK (MP 114.57) NICHOLAS COUNTY, WV	Client	MC 222
--------------	---	---------------	-----------

4. ALL SECTION VIEWS SHOWN LEFT TO RIGHT FACING DOWNSTREAM.
5. POST-CROSSING SURVEY INFORMATION SHOWN IN RED. DATA PENDING.
6. POST-CROSSING SURVEY POINTS FOR CROSS SECTIONS AND THALWEG ARE PROJECTED ONTO PRE-CROSSING SECTION AND PROFILE VIEWS FOR COMPARISON.

AS-BUILT TABLE: S-A76 CROSS SECTION A					
PT. LOC.	PRE-CROSSING			AS-BUILT	
	NORTHING	EASTING	ELEV	VERT. DIFF.	HORZ. DIFF.
TS-L	13918532.9300	1734680.1250	2219.754'		
BS-L	13918528.5100	1734681.3970	2218.012'		
THW	13918526.1700	1734682.5940	2217.324'		
BS-R	13918524.2400	1734683.4950	2217.895'		
TS-R	13918523.8100	1734683.5380	2218.581'
