Baseline Assessment – Stream Attributes

Reach S-B26 (Temporary Access Road) Intermittent Spread D Nicholas County, West Virginia

Title PROFILE AND CROSS-SECTIONS
BASELINE SURVEY
CROSSING S-B26 - UNNAMED TRIBUTARY
TO CHERRY RUN (MP 113.6)
NICHOLAS COUNTY WV

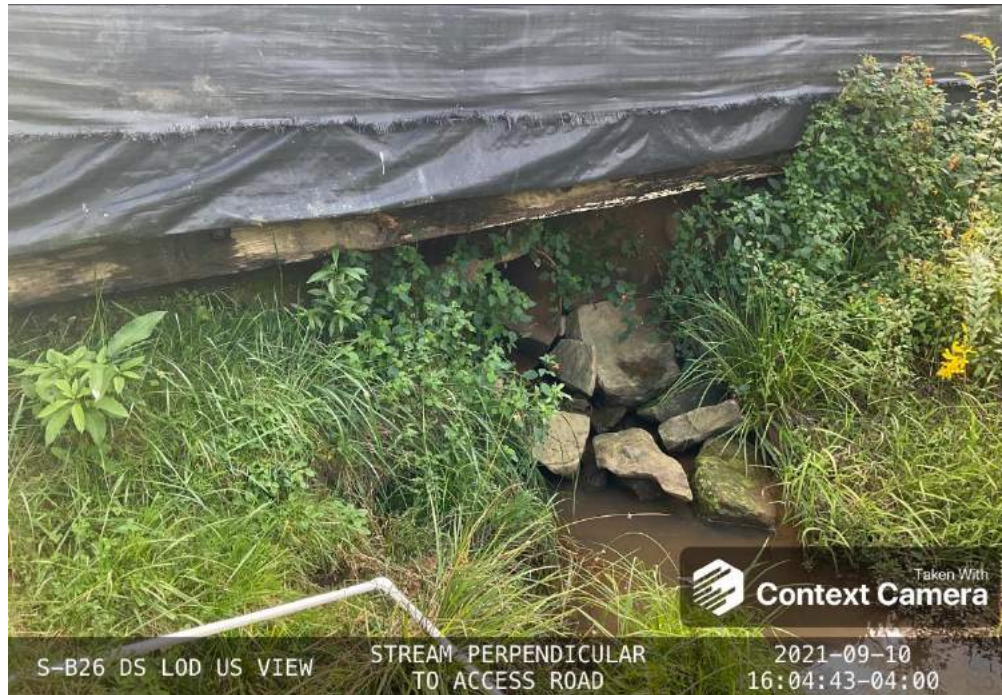
S-B26 DS LOD US VIEW

STREAM PERPENDICULAR
TO ACCESS ROAD

Photo Type: DS, US View

Location, Orientation, Photographer Initials: Downstream Edge of ROW, Upstream View, CNJ
Lat: 38.339012 Long: -80.659609

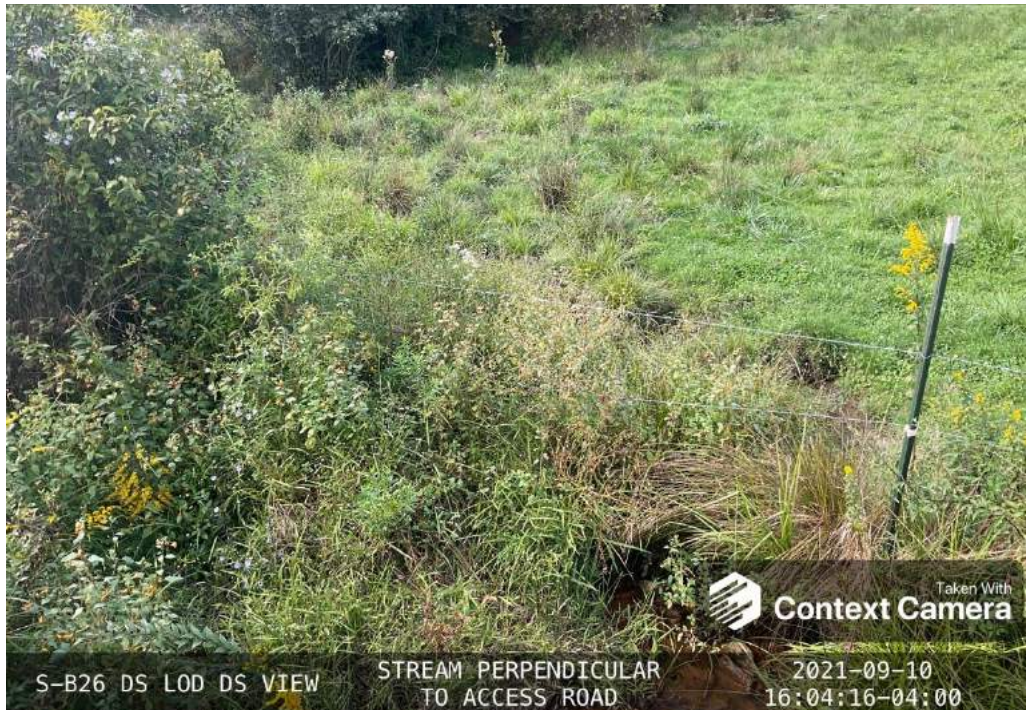
S-B26 DS LOD DS VIEW

STREAM PERPENDICULAR
TO ACCESS ROAD

Photo Type: DS, DS View

Location, Orientation, Photographer Initials: Downstream Edge of ROW, Downstream View, CNJ
Lat: 38.339012 Long: -80.659609

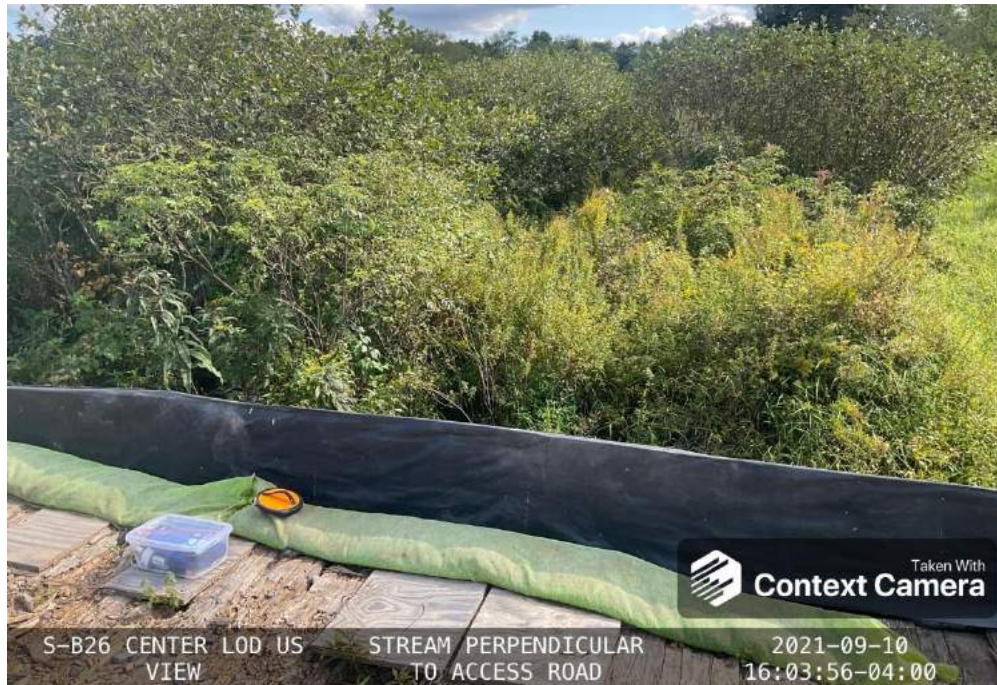
Photo Type: US View at Center
Location, Orientation, Photographer Initials: Center ROW, Upstream View, CNJ
Lat: 38.339012 Long: -80.659609

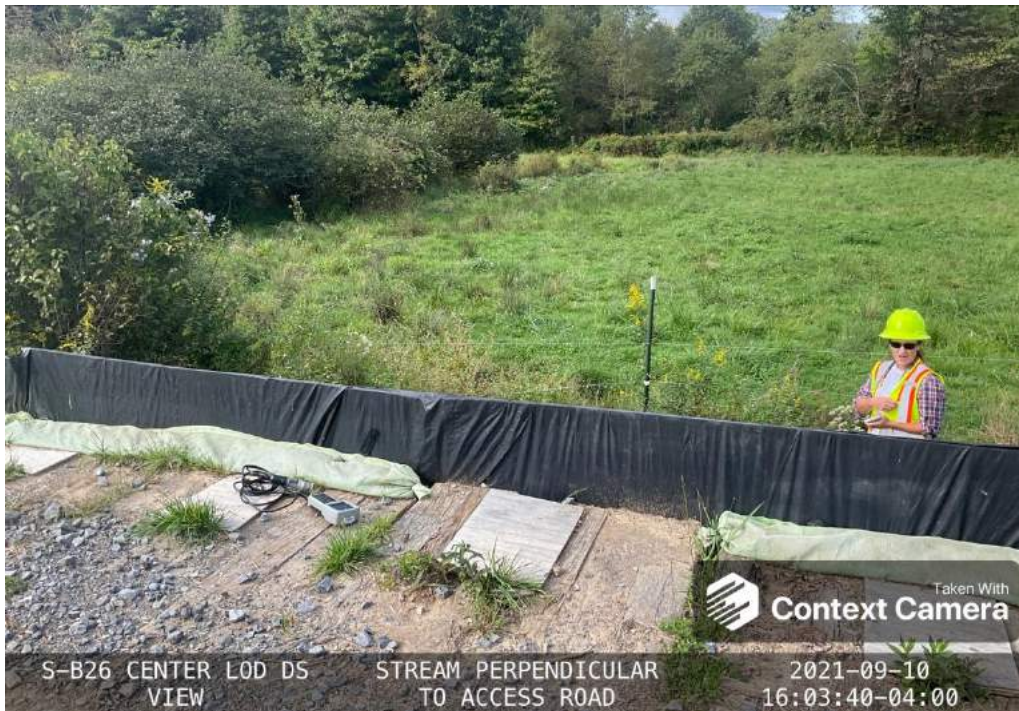
Photo Type: DS View at Center
Location, Orientation, Photographer Initials: ROW Center, Downstream View, CNJ
Lat: 38.339012 Long: -80.659609

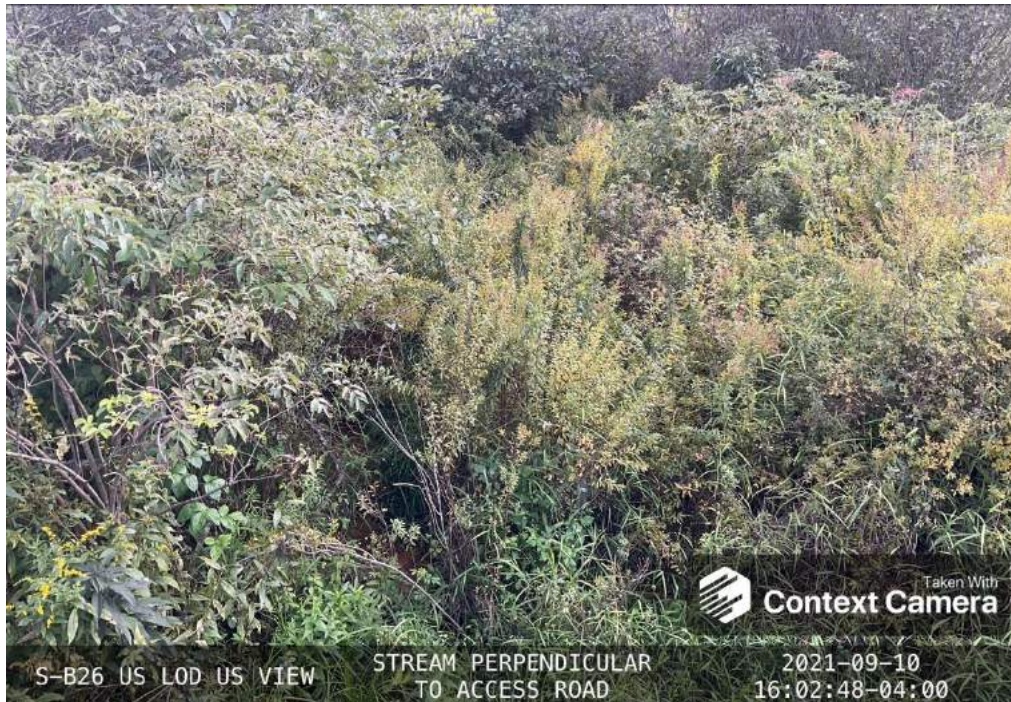
Photo Type: US, US View

Location, Orientation, Photographer Initials: Upstream Edge of ROW, Upstream View, CNJ

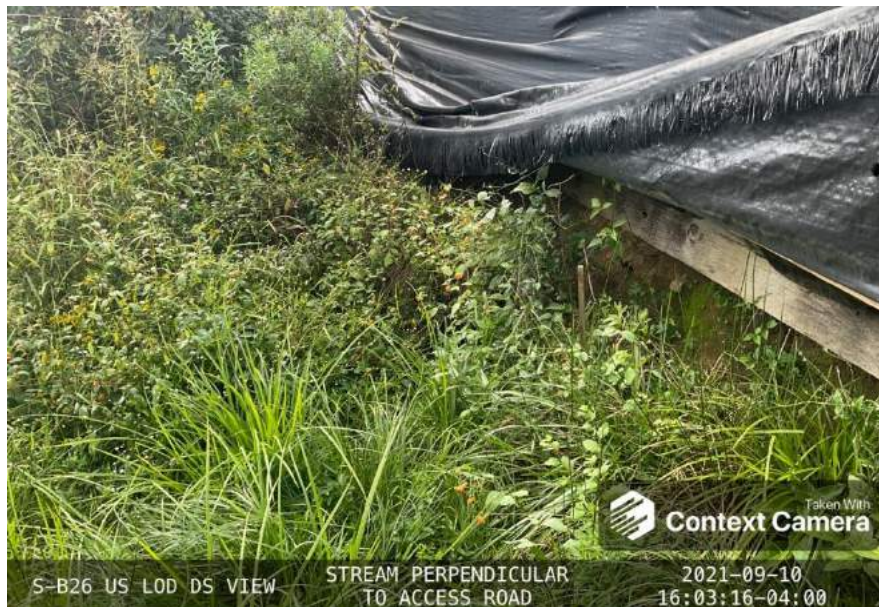
Photo Type: US, DS View

Location, Orientation, Photographer Initials: Upstream Edge of ROW, Downstream View, CNJ

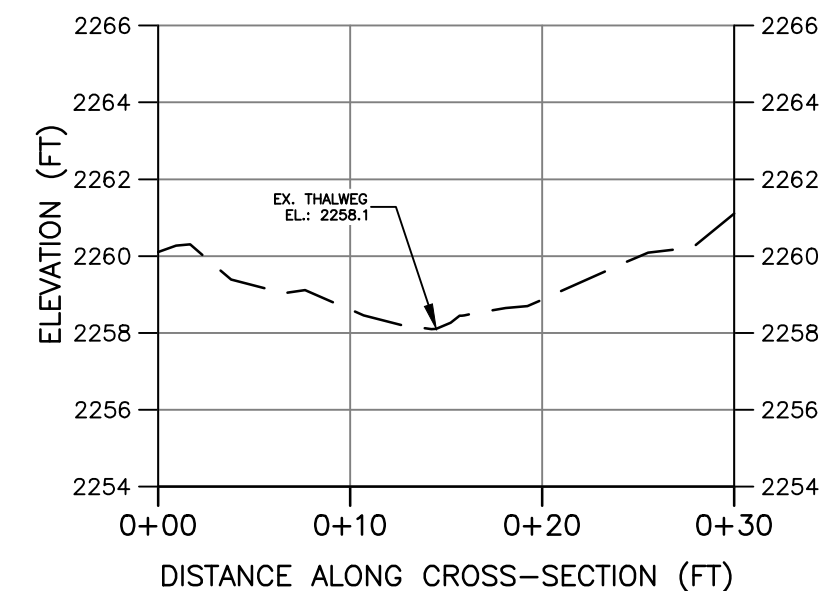
EXISTING STREAM PROFILE
INVERT ALONG THALWEG

TYPICAL 5-POINT CROSS-SECTION
(FACING DOWNSTREAM)

TS: TOP OF SLOPE
BS: BOTTOM OF SLOPE
THW: THALWEG (INVERT)

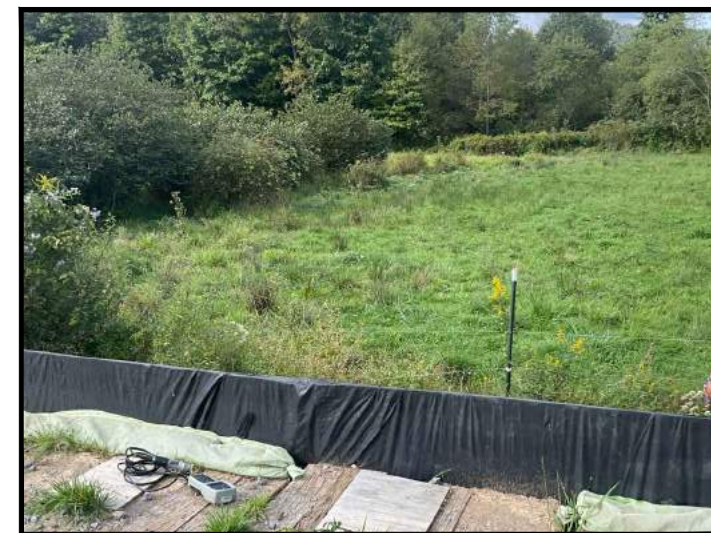
PHOTO TAKEN LOOKING DOWNSTREAM
FROM UPSTREAM IMPACT LIMITS

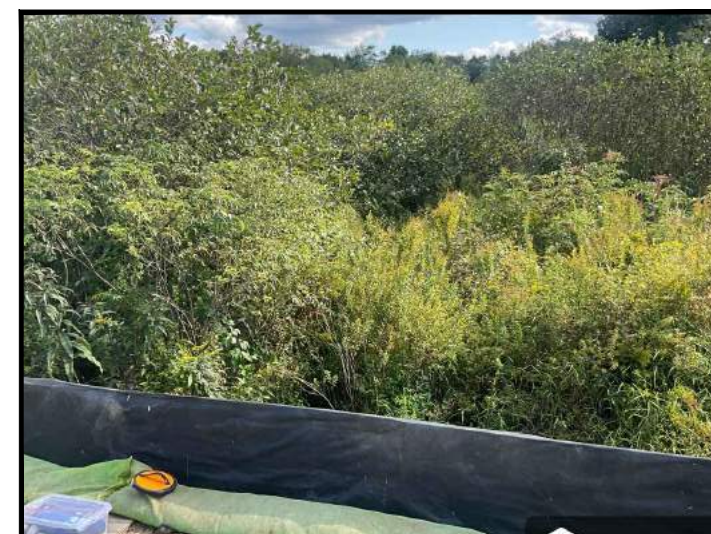
PHOTO TAKEN LOOKING UPSTREAM FROM
DOWNSTREAM IMPACT LIMITS
