Baseline Assessment – Stream Attributes

Reach S-B28 (Timber Mat Crossing)

Spread D

Nicholas County, West Virginia

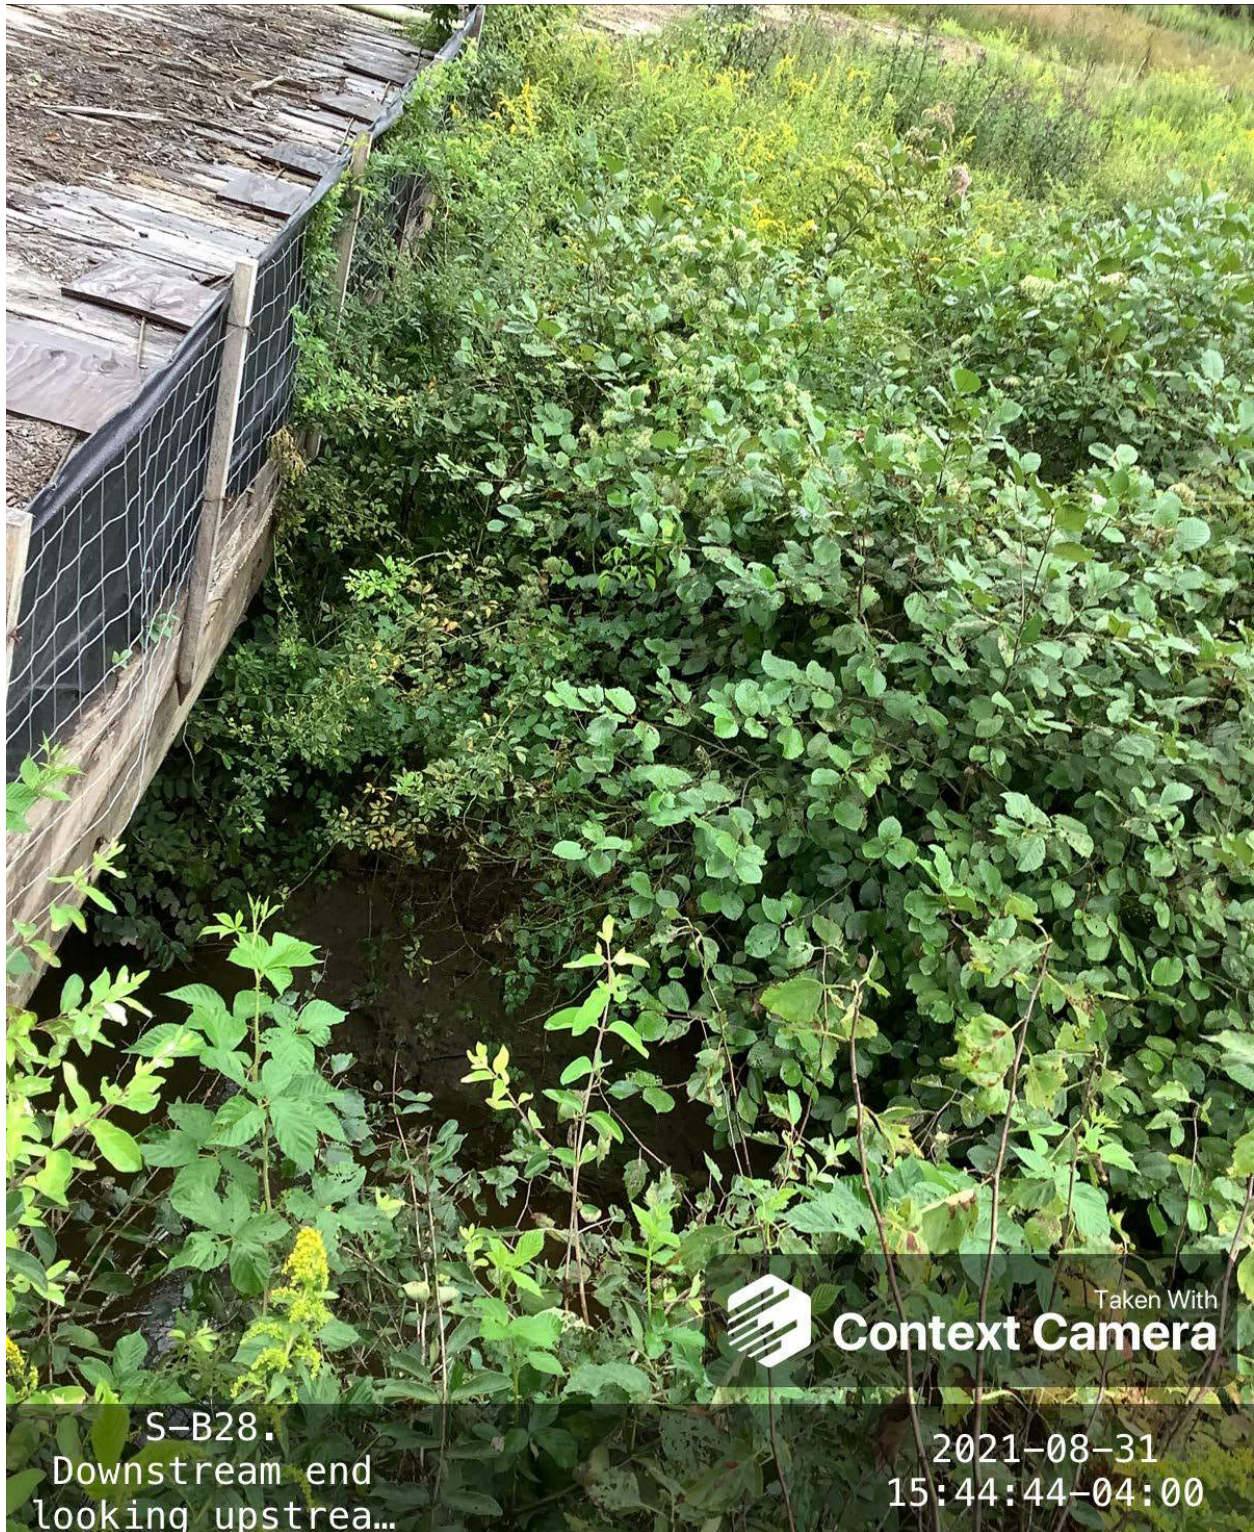
S-B28.
Downstream end
looking upstream...

Photo Type: DS, US View
Location, Orientation, Photographer Initials: Downstream Edge of ROW, Upstream View, JR/KP
Lat: 38.340083 Long: -80.655413

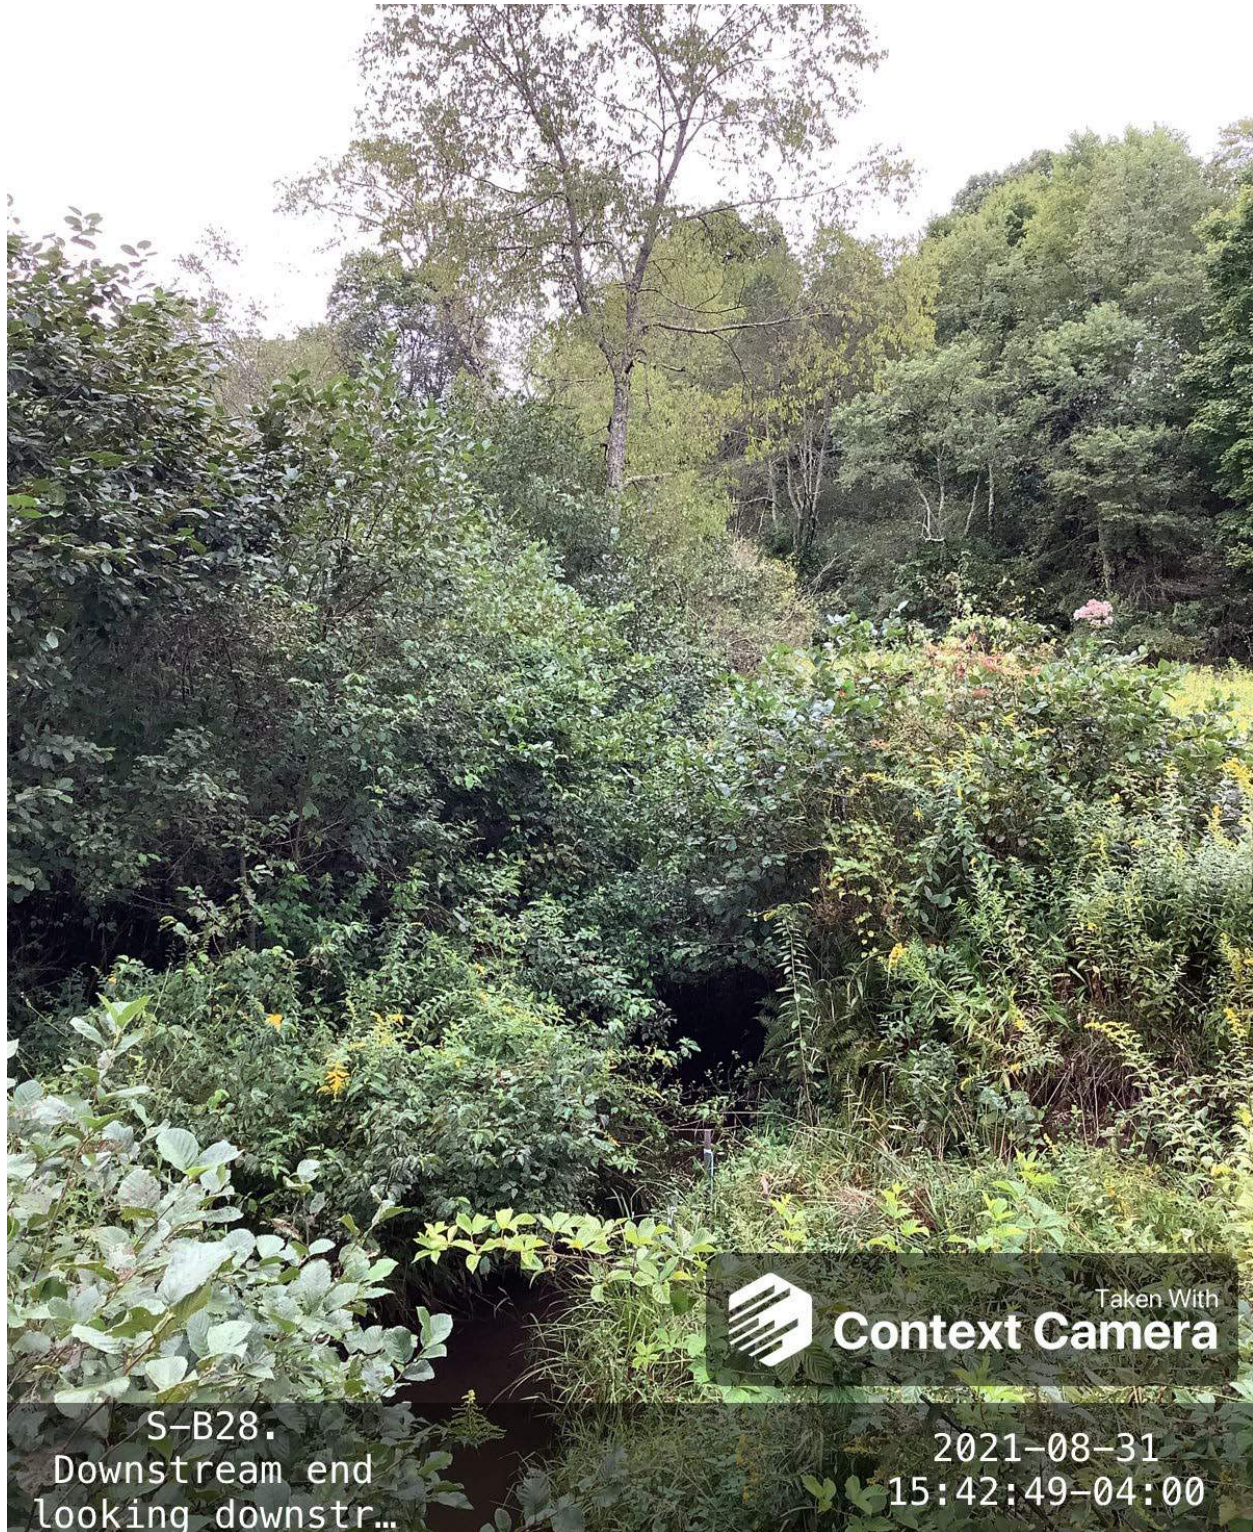
S-B28.
Downstream end
looking downstr...

Photo Type: DS, DS View

Location, Orientation, Photographer Initials: Downstream Edge of ROW, Downstream View, JR/KP

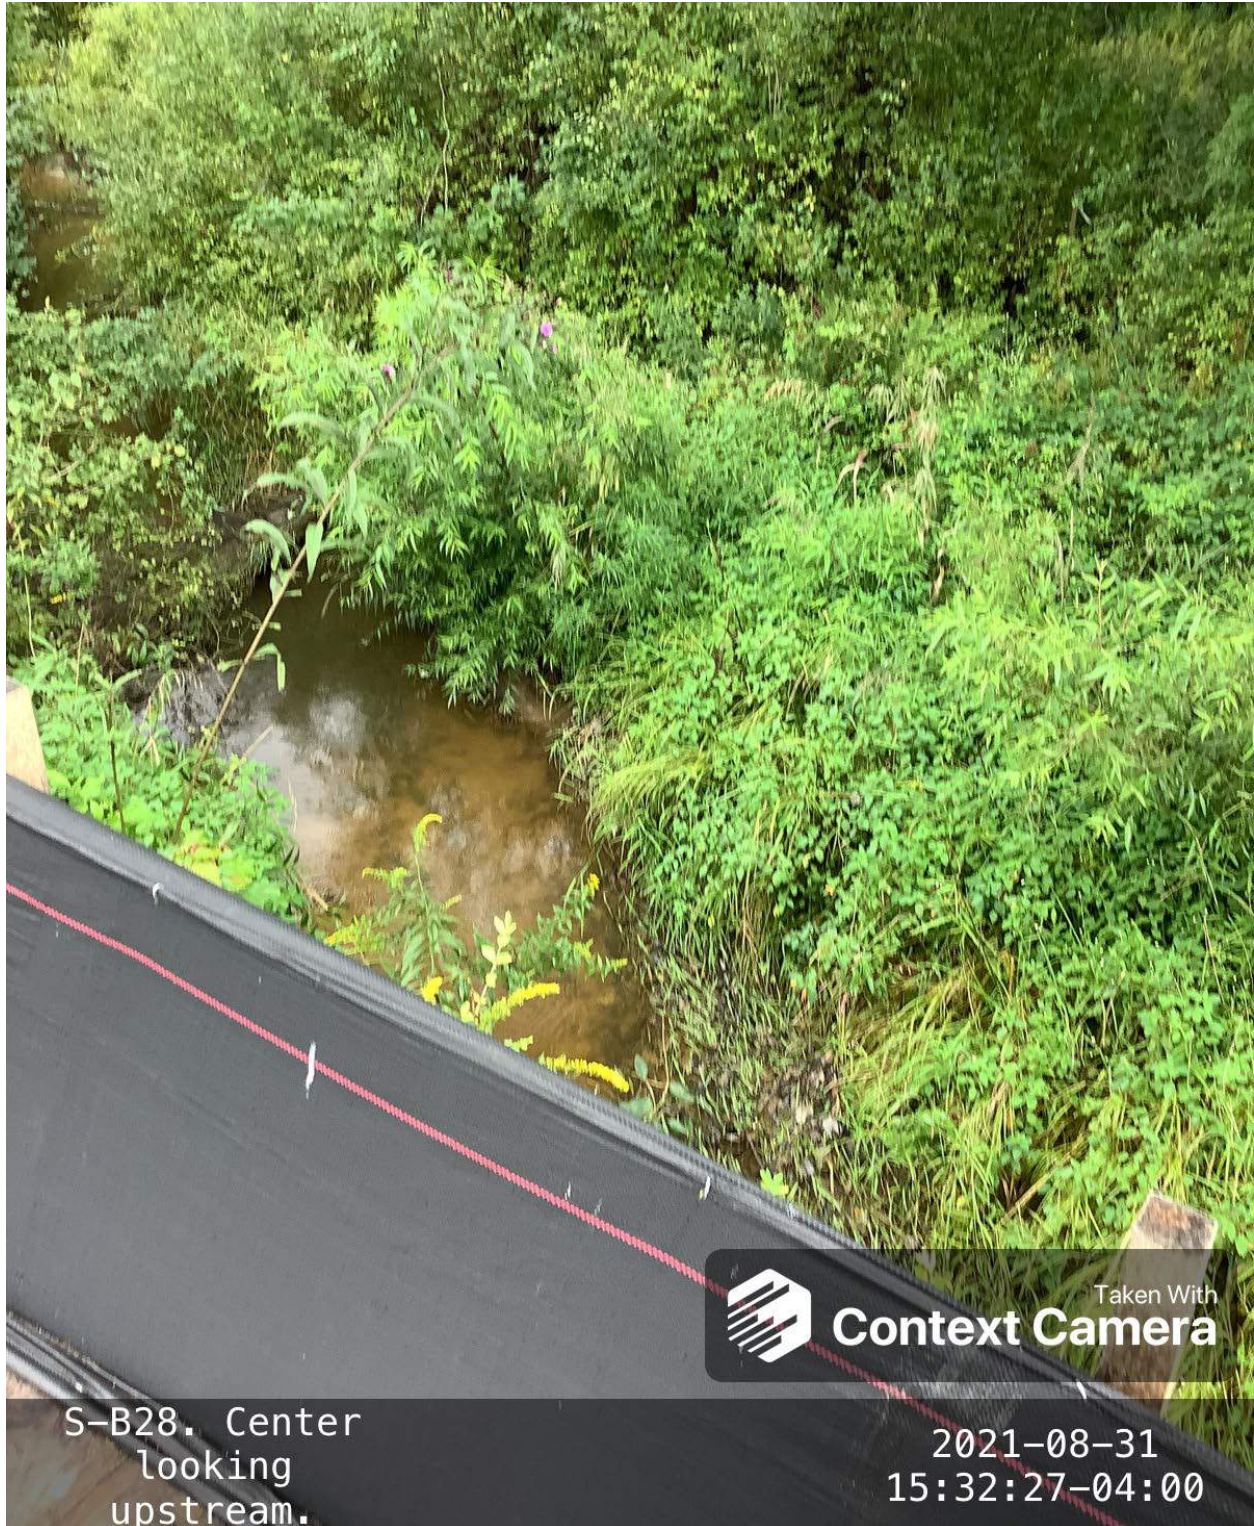
S-B28. Center
looking
upstream.

Photo Type: US View at Center
Location, Orientation, Photographer Initials: Center ROW, Upstream View, JR/KP
Lat: 38.340083 Long: -80.655413

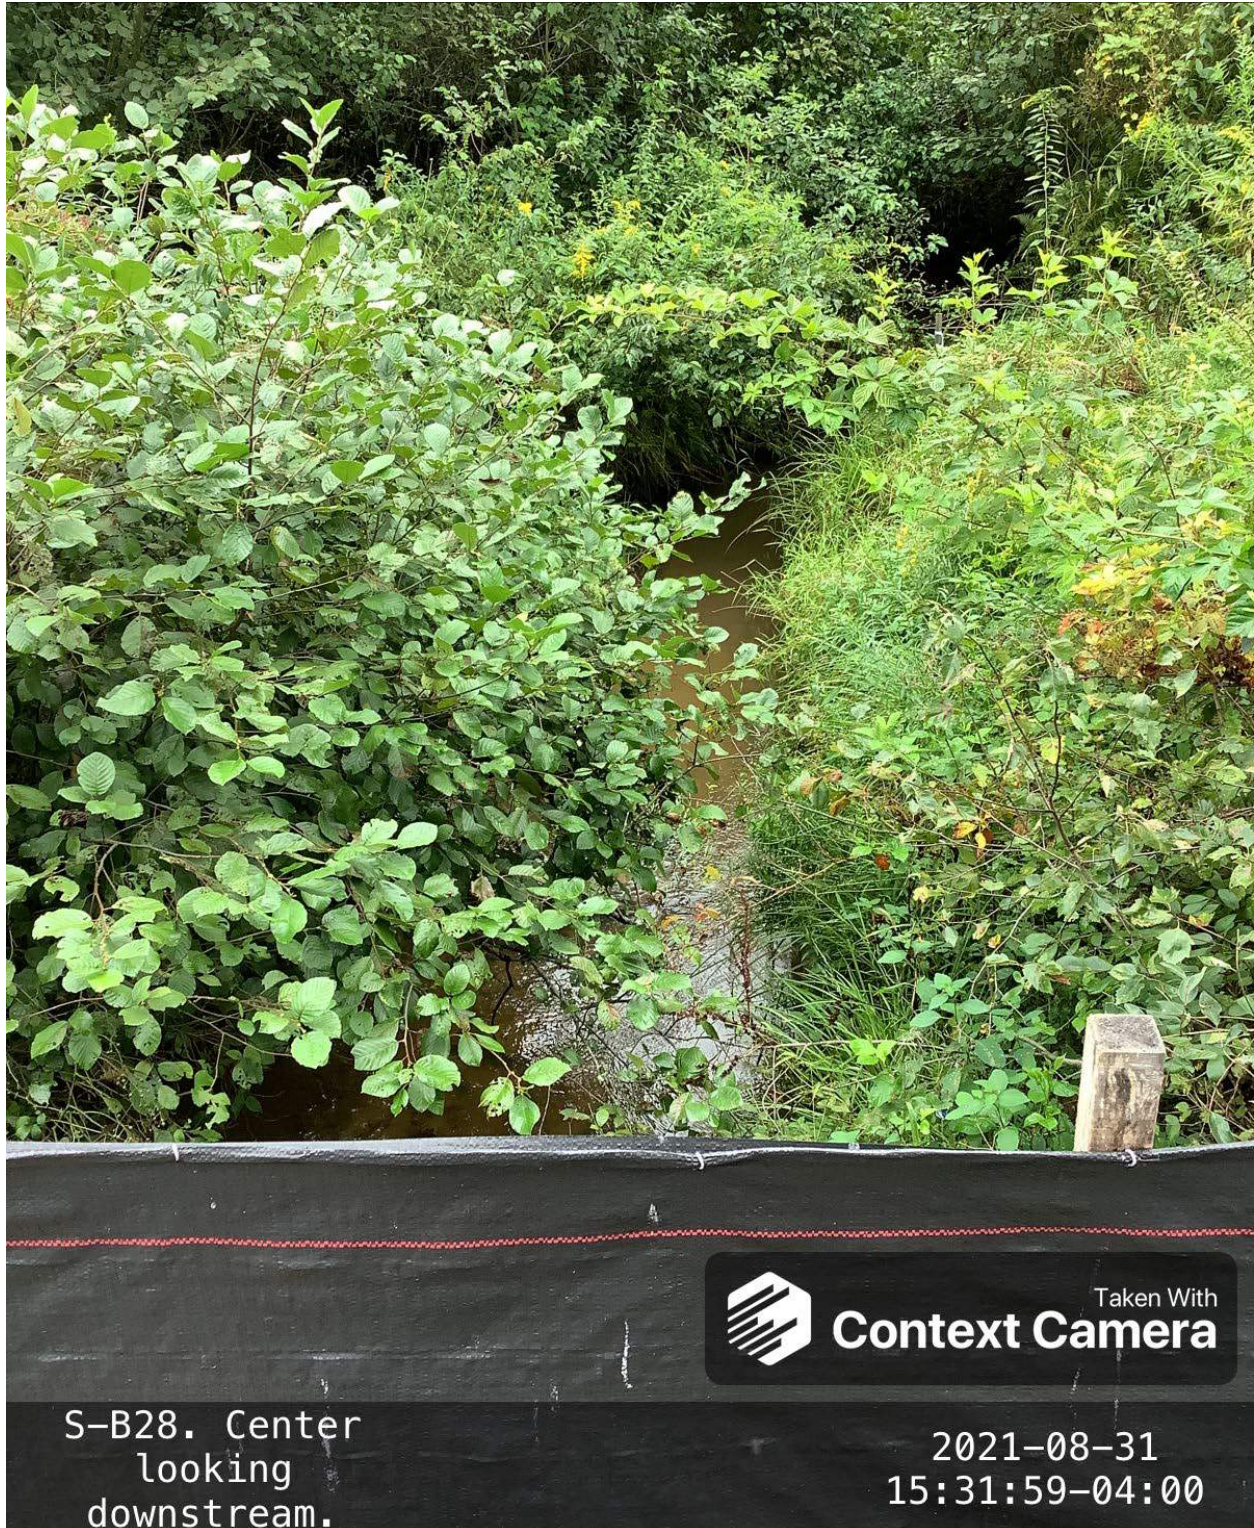
S-B28. Center
looking
downstream.

Photo Type: DS View at Center
Location, Orientation, Photographer Initials: Center ROW, Downstream View, JR/KP
Lat: 38.340083 Long: -80.655413

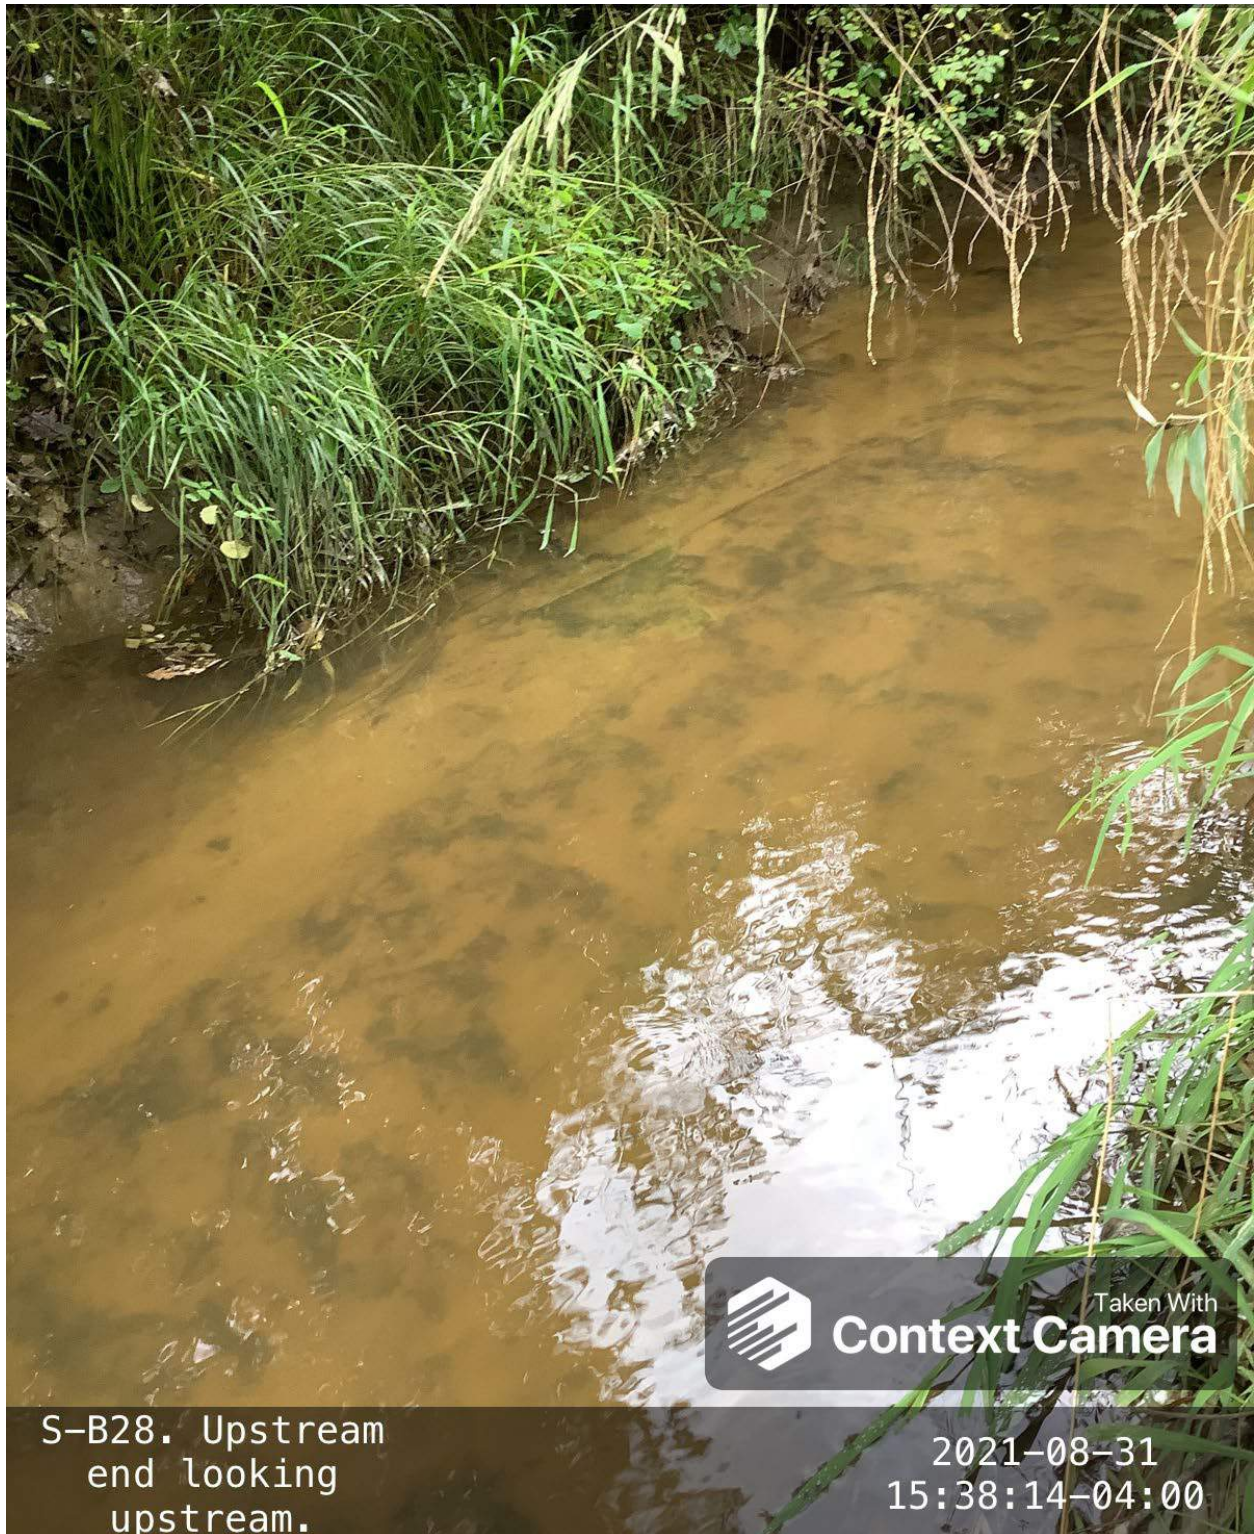
Photo Type: US, US View
Location, Orientation, Photographer Initials: Upstream Edge of ROW, Upstream View, JR/KP
Lat: 38.340083 Long: -80.655413

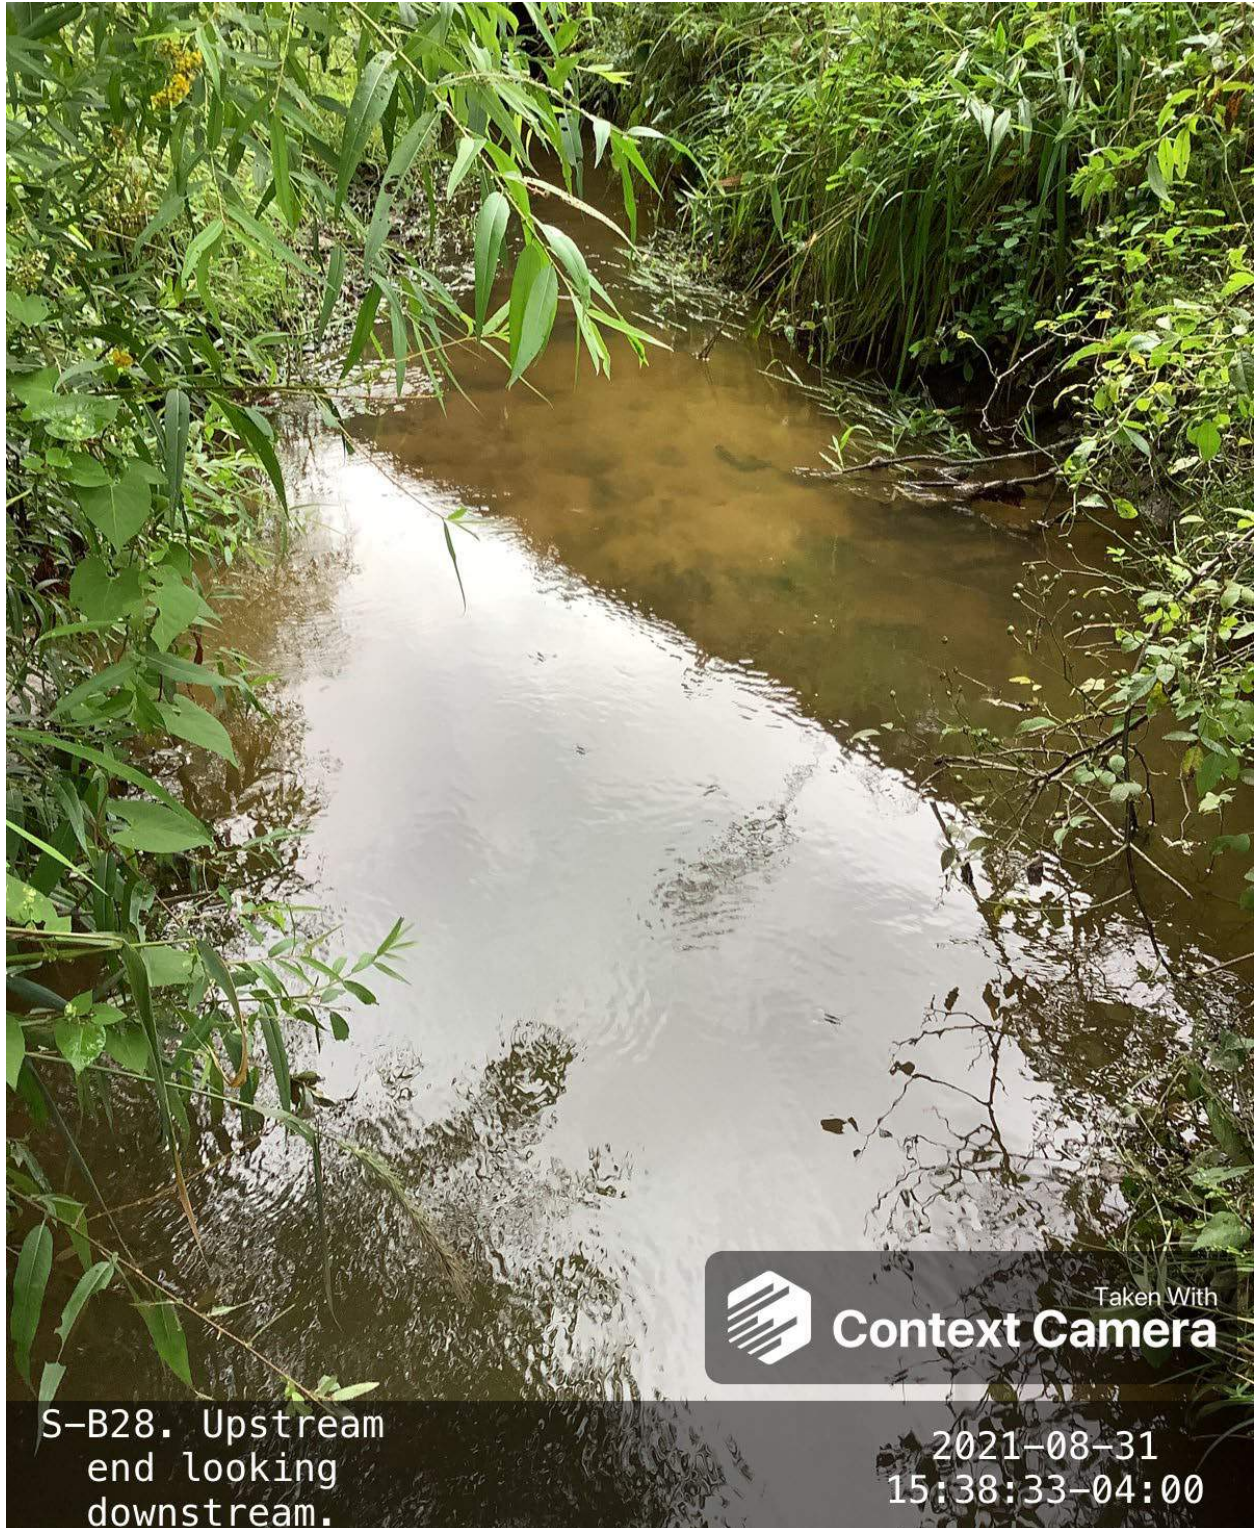
S-B28. Upstream
end looking
downstream.

Photo Type: US, DS View

Location, Orientation, Photographer Initials: Upstream Edge of ROW, Downstream View, JR/KP

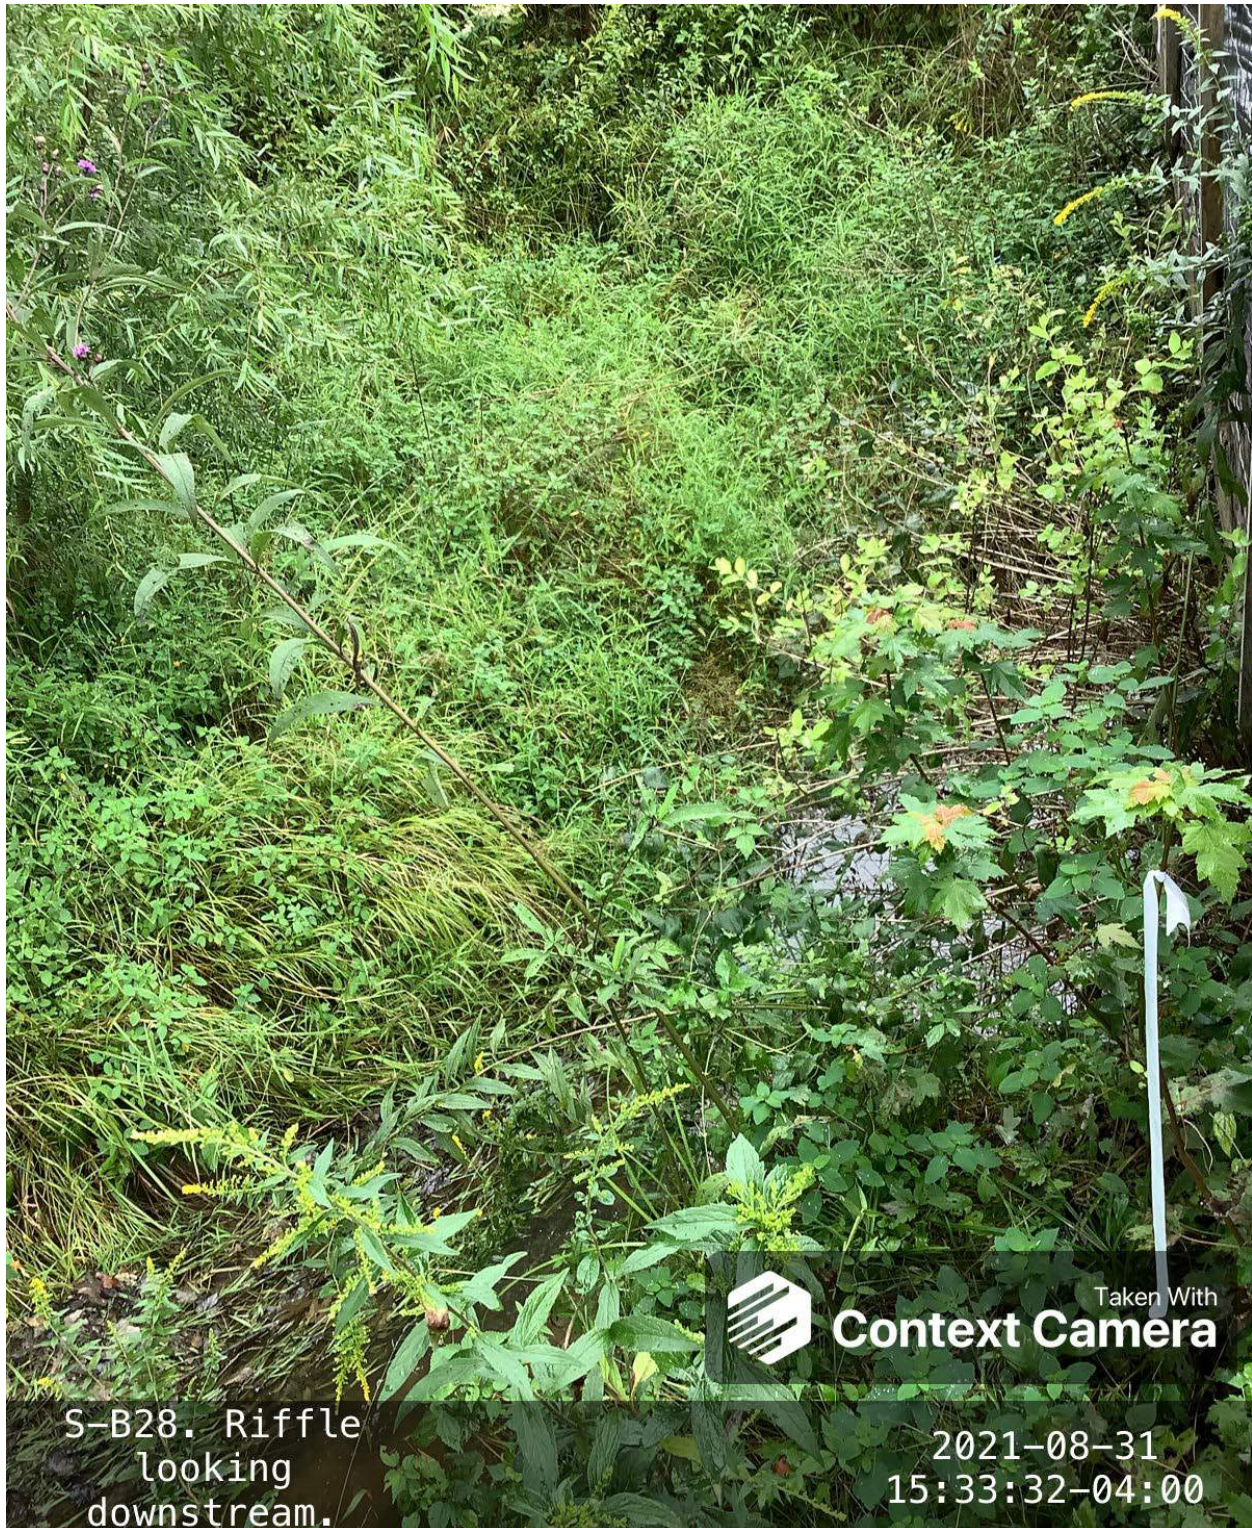
S-B28. Riffle
looking
downstream.

Photo Type: Riffle, DS View
Location, Orientation, Photographer Initials: Upstream of Riffle, Downstream View, JR/KP
Lat: 38.340083 Long: -80.655413

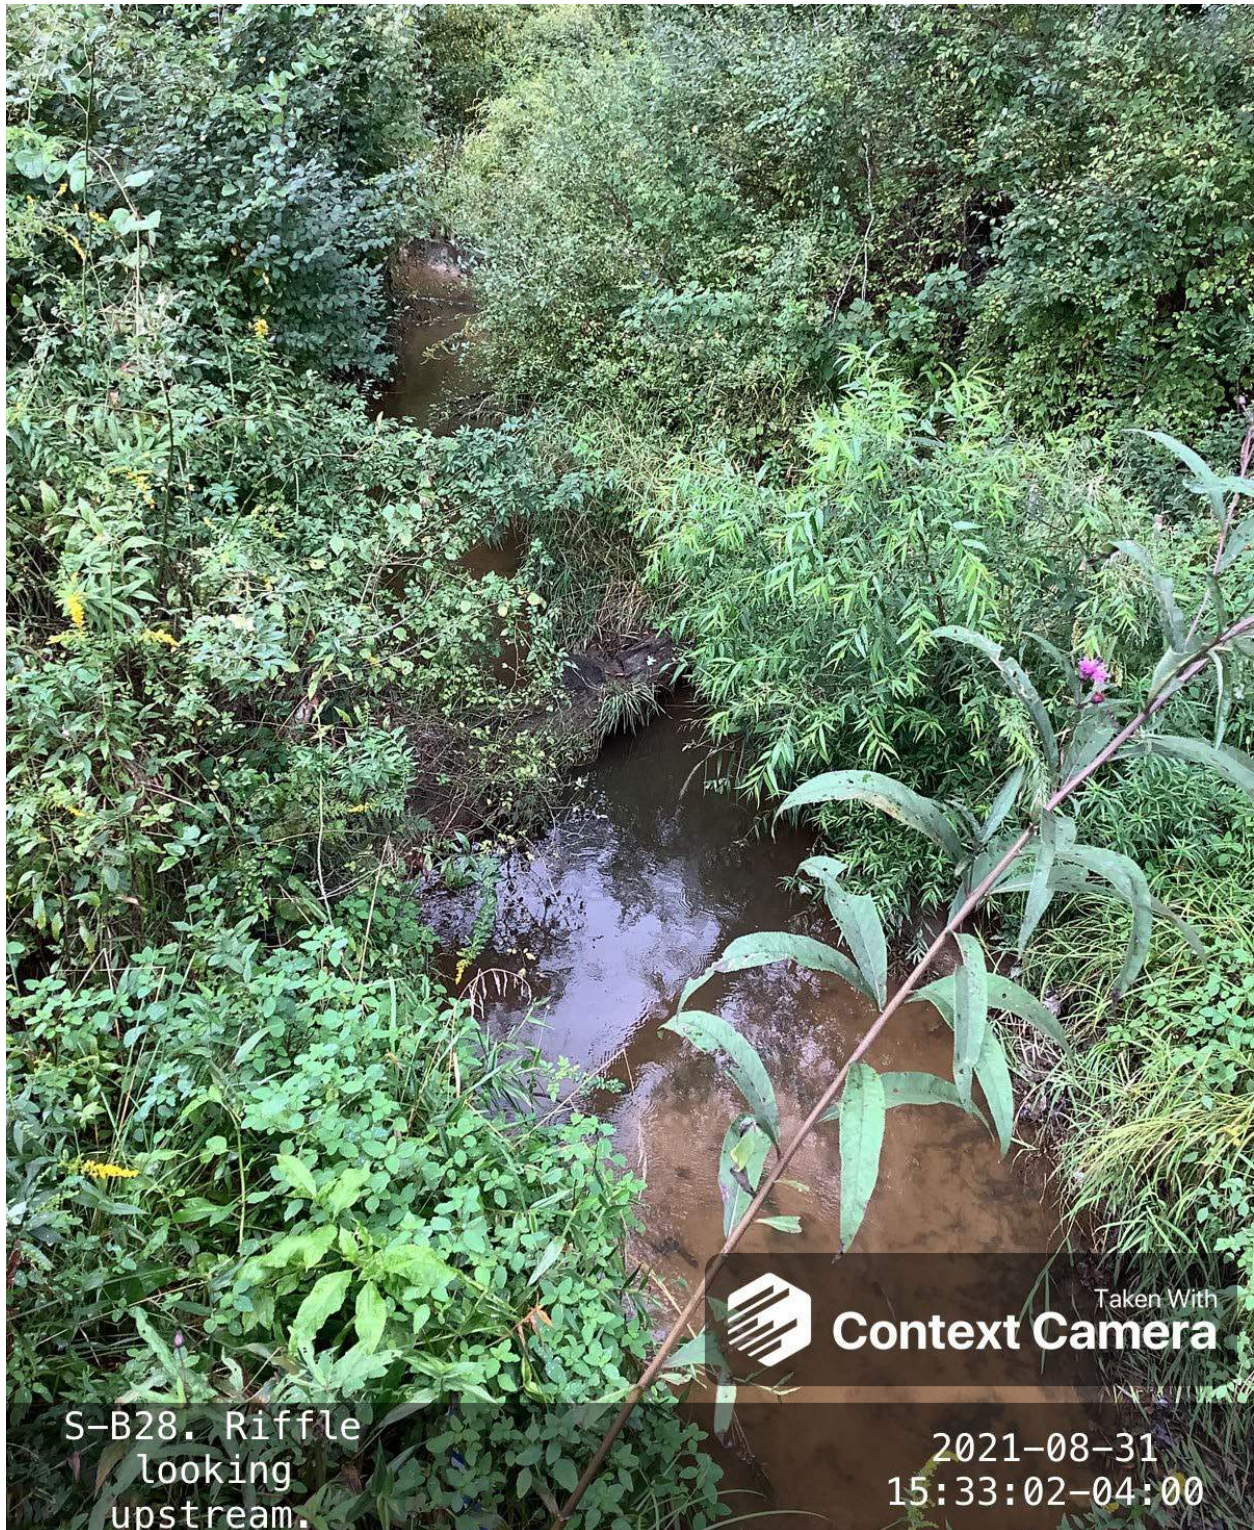
S-B28. Riffle
looking
upstream.

Photo Type: Riffle, US View
Location, Orientation, Photographer Initials: Downstream of Riffle, Upstream View, JR/KP
Lat: 38.340083 Long: -80.655413

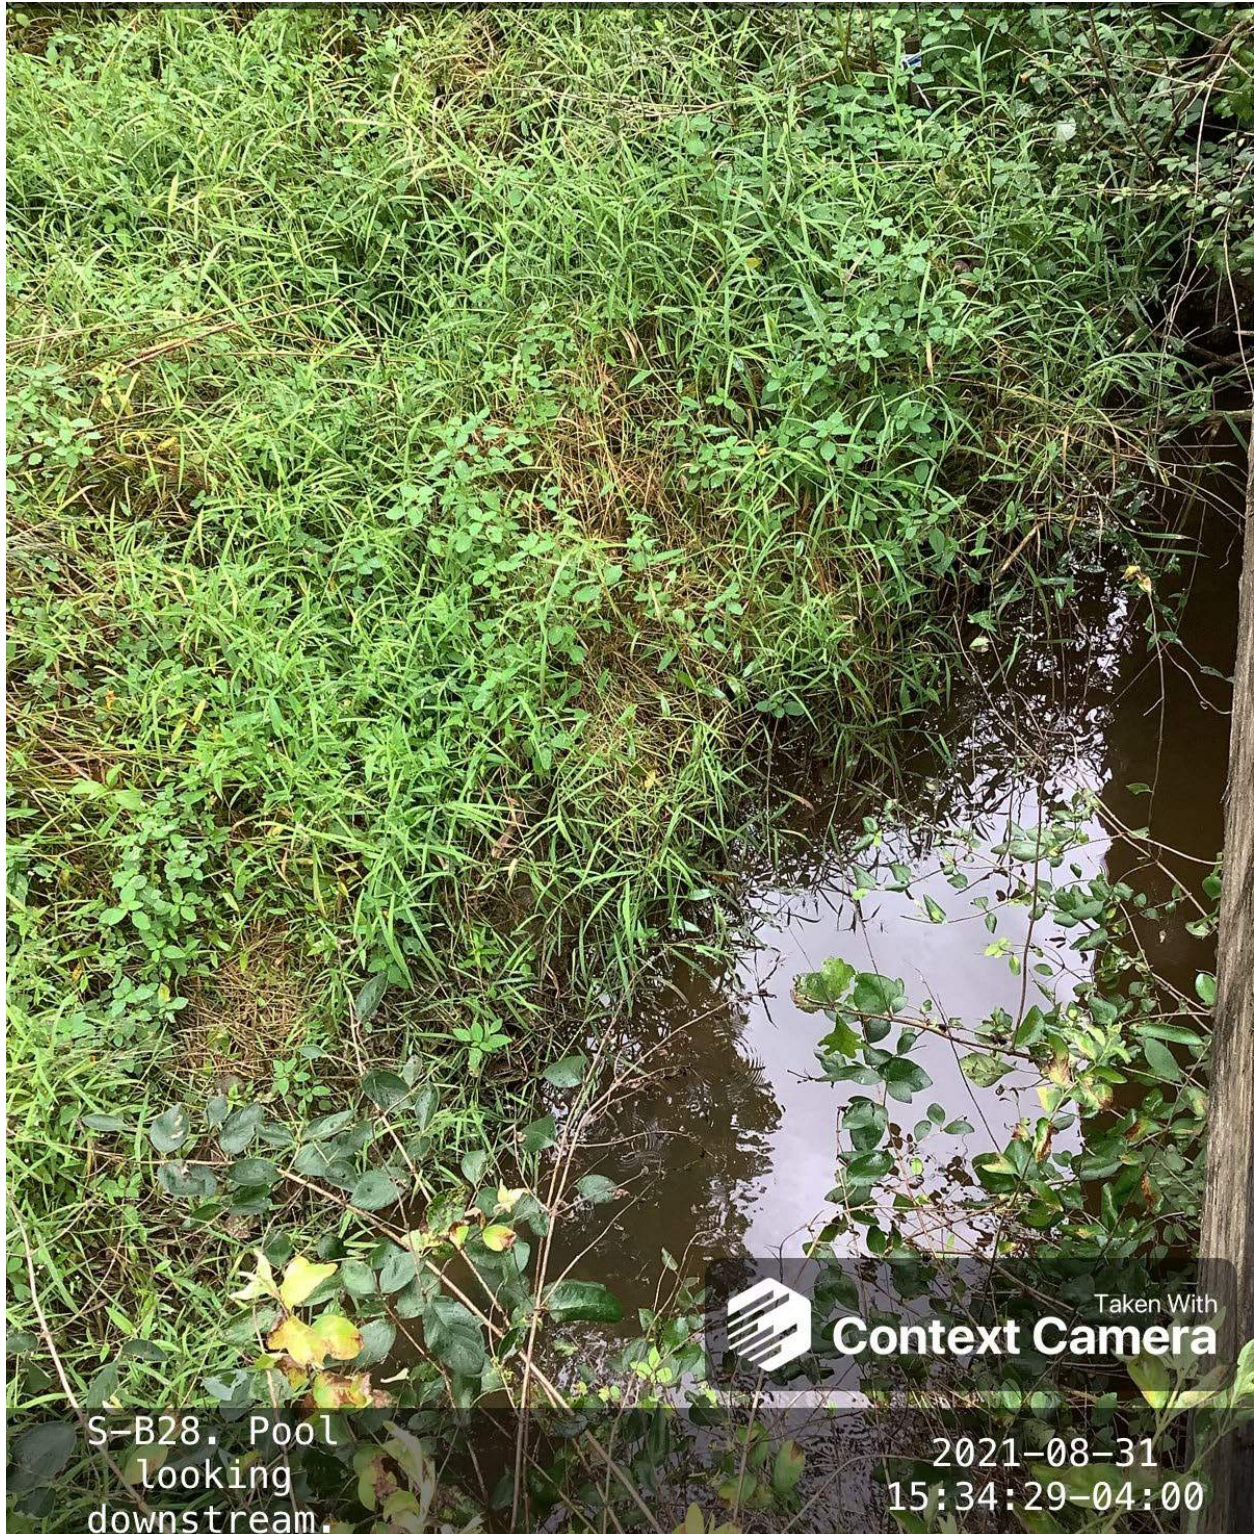
Photo Type: Pool, DS View
Location, Orientation, Photographer Initials: Upstream of Pool, Downstream View, JR/KP
Lat: 38.340083 Long: -80.655413

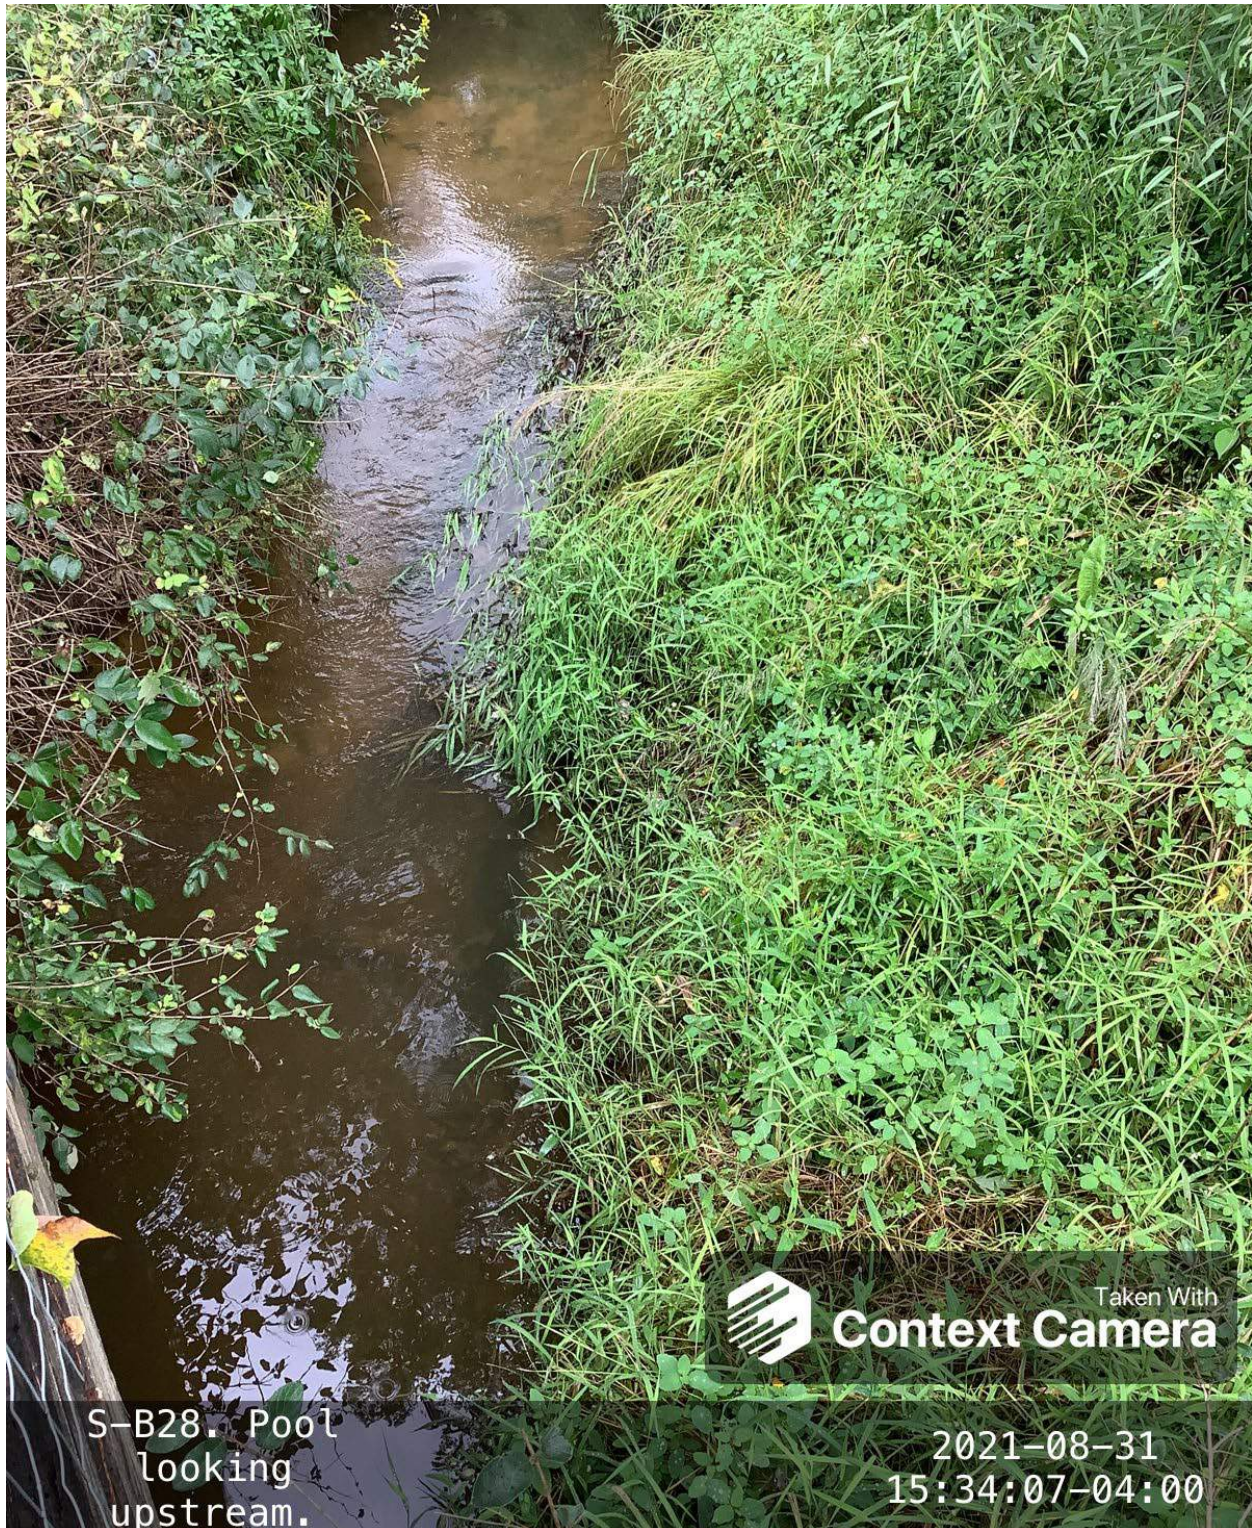
Photo Type: Pool, US View
Location, Orientation, Photographer Initials: Downstream of Pool, Upstream View, JR/KP
Lat: 38.340083 Long: -80.655413

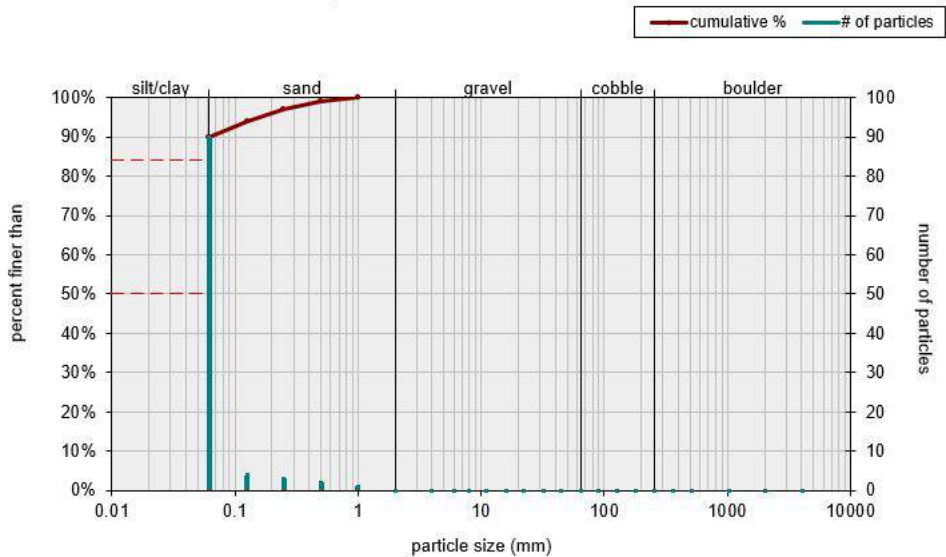
Bankfull Channel Pebble Count, S-B28

Size (mm)		Size Distribution		Type	
D16	0.062	mean	0.1	silt/clay	90%
D35	0.062	dispersion	1.0	sand	10%
D50	0.062	skewness	---	gravel	0%
D65	0.062			cobble	0%
D84	0.062			boulder	0%
D95	0.16
