Baseline Assessment – Stream Attributes

Reach S-B32 (Timber Mat Crossing)

Webster County, West Virginia

Profile and Cross-Sections
Baseline Survey
Crossing S-B32 - Unnamed Trib
Meadow Fork (MP 106.35)
Webster County, WV

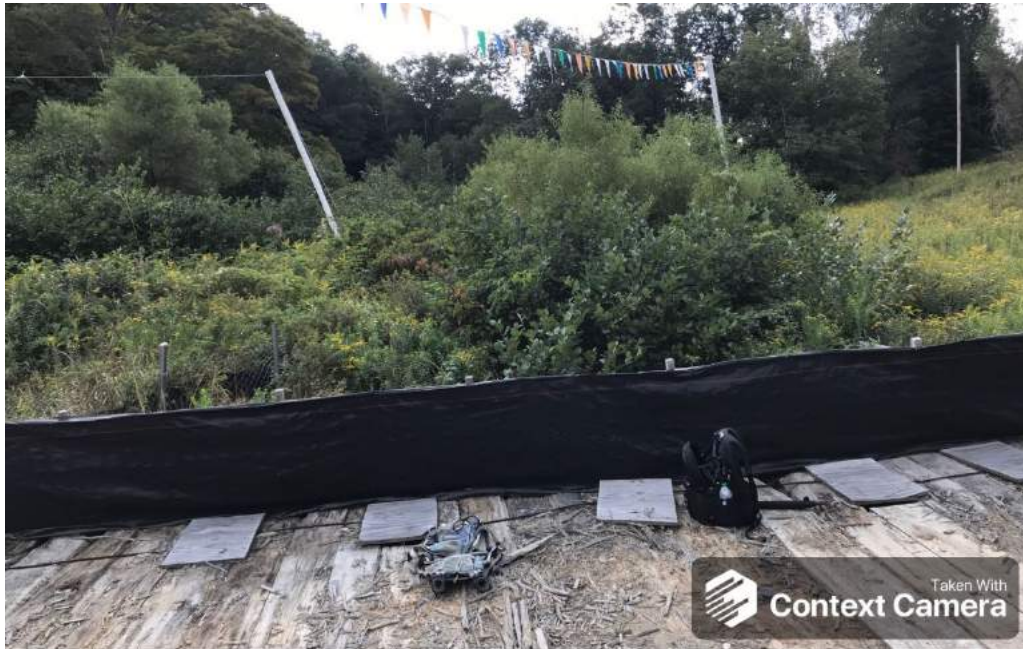
Photo Type: DS, US View

Location, Orientation, Photographer Initials: Downstream Edge of ROW, Upstream View, RH/AR

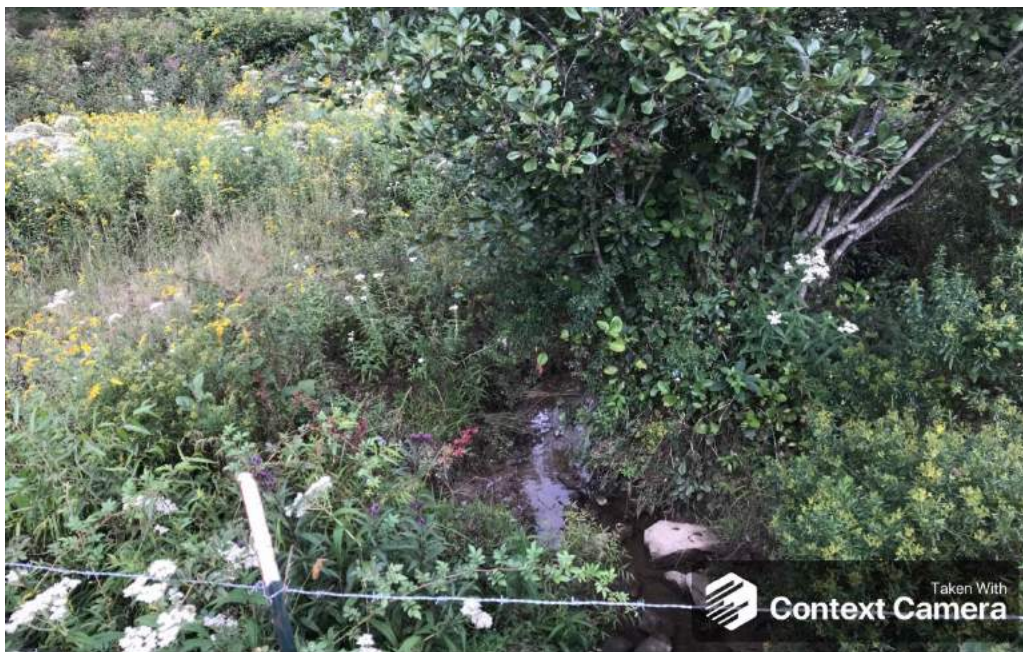
Photo Type: DS, DS View

Location, Orientation, Photographer Initials: Downstream Edge of ROW, Downstream View, RH/AR

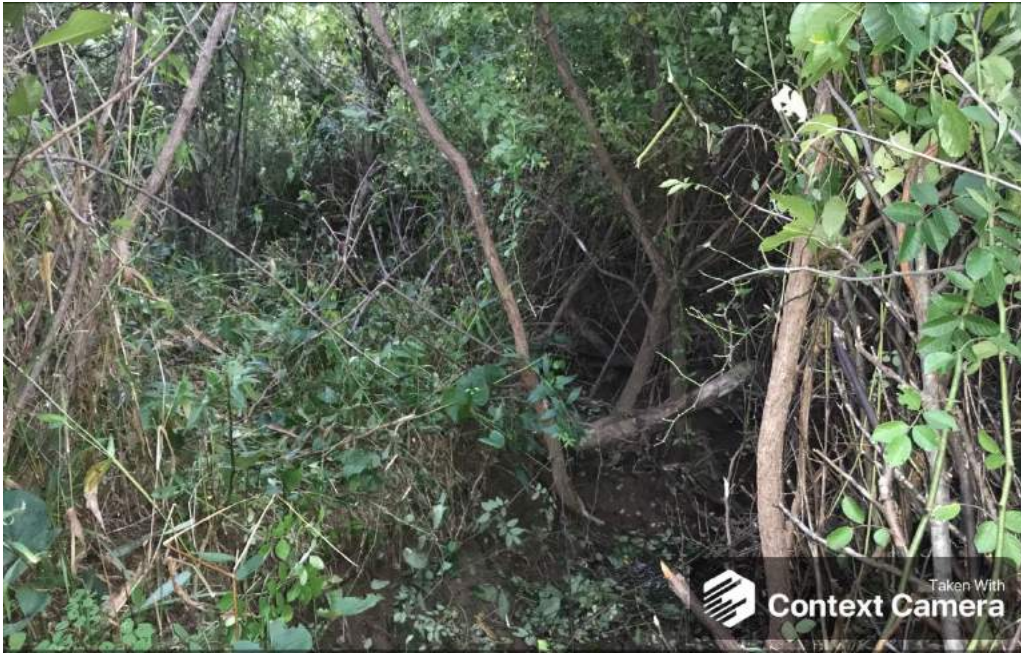
Photo Type: US View at Center
Location, Orientation, Photographer Initials: Center ROW, Upstream View, RH/AR
Lat: 38.405683 Long: -80.591116
Date: 9/8/2021

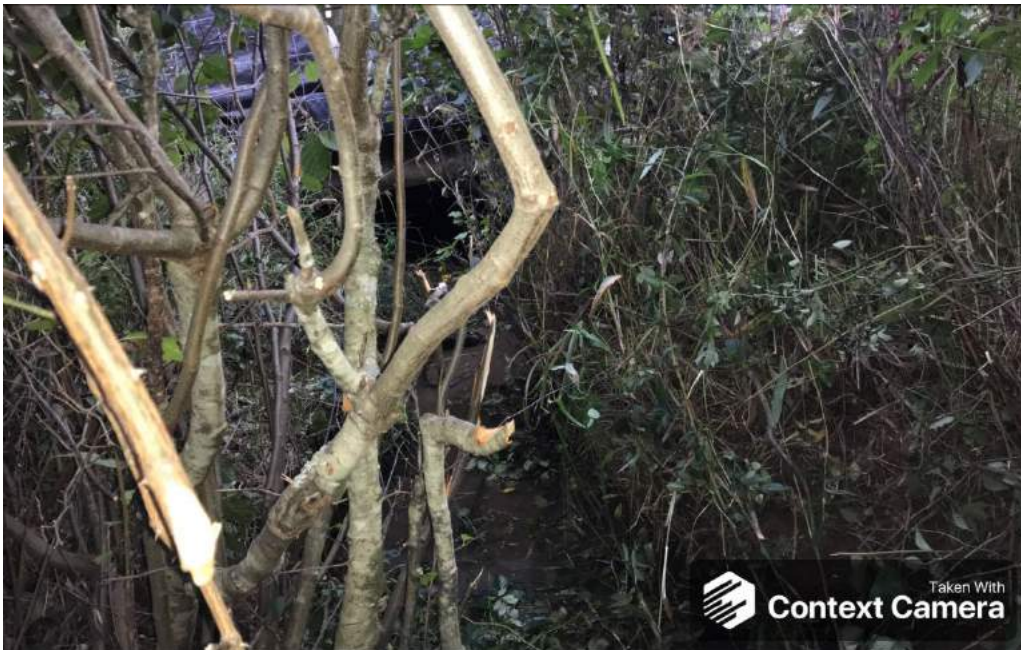
Photo Type: DS View at Center
Location, Orientation, Photographer Initials: ROW Center, Downstream View, RH/AR
Lat: 38.405683 Long: -80.591116
Date: 9/8/2021

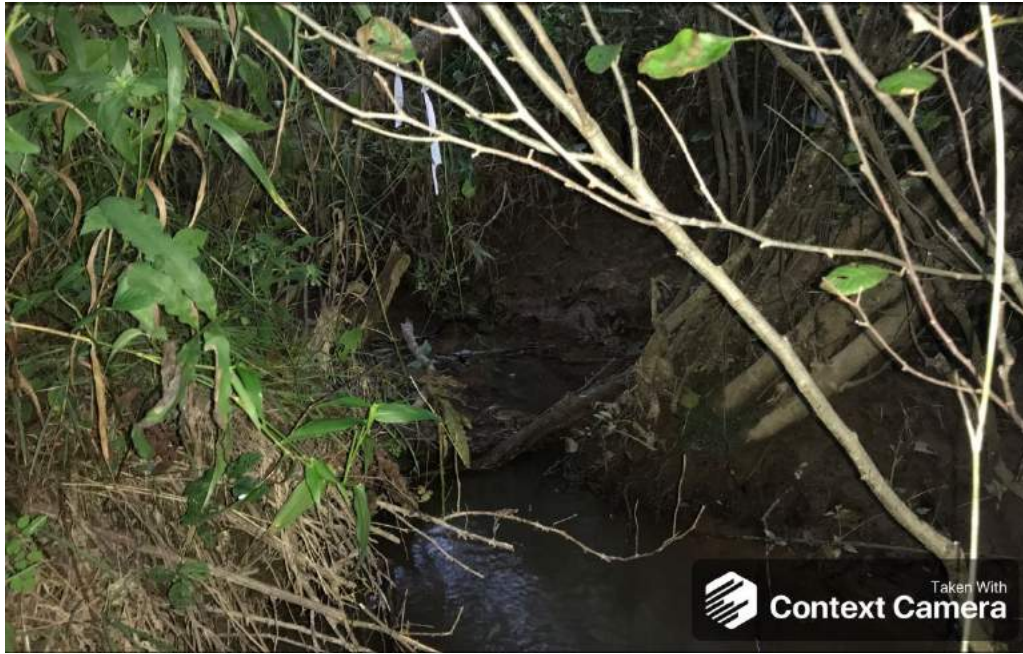
Photo Type: US, US View

Location, Orientation, Photographer Initials: Upstream Edge of ROW, Upstream View, RH/AR

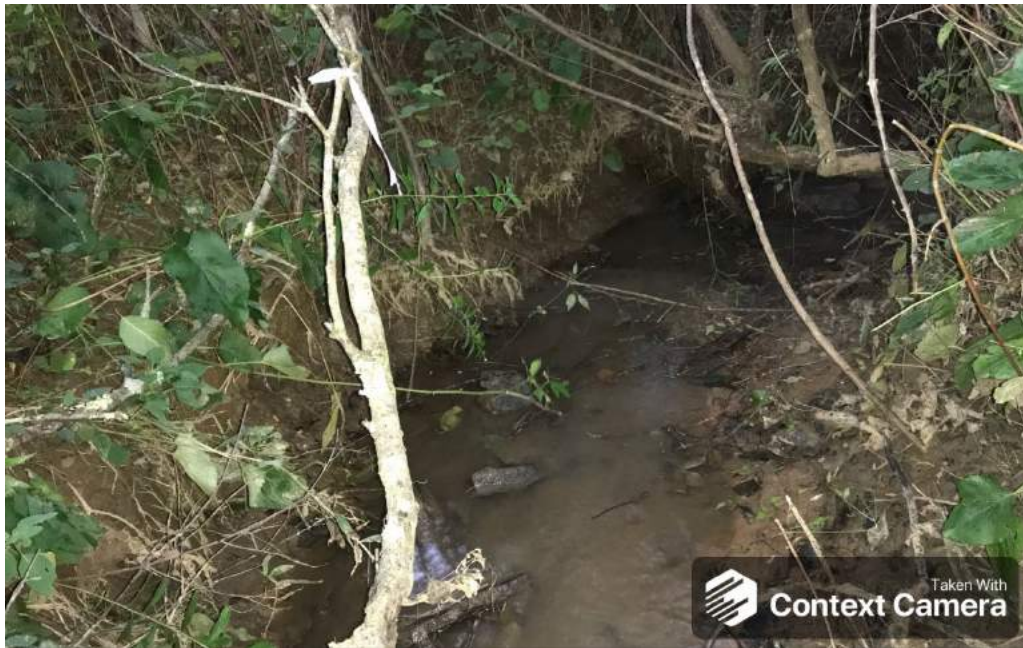
Photo Type: US, DS View

Location, Orientation, Photographer Initials: Upstream Edge of ROW, Downstream View, RH/AR

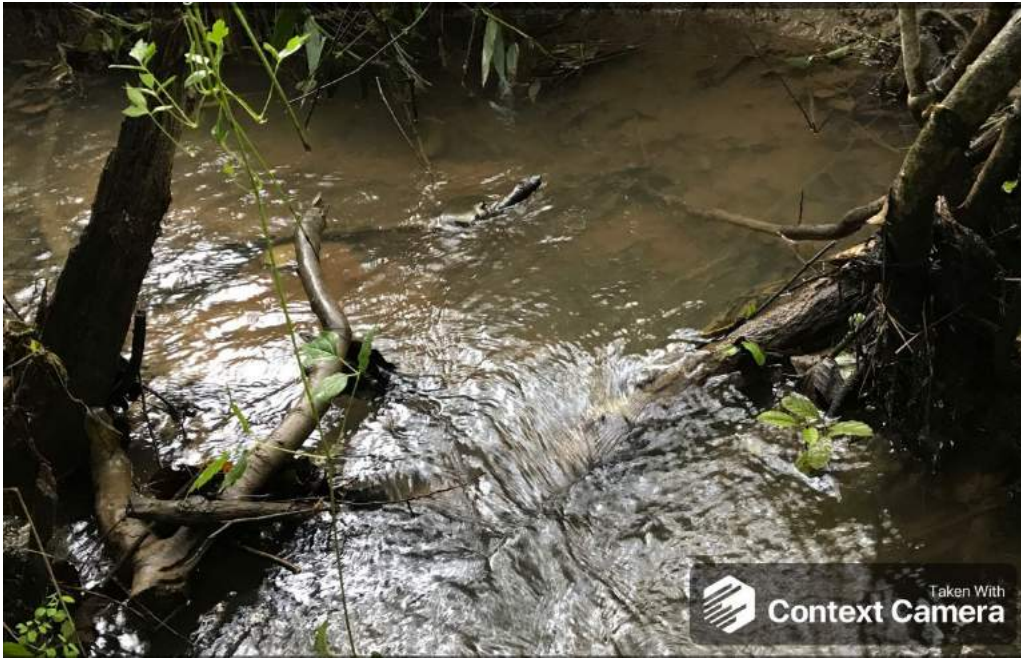
Photo Type: Riffle, DS View
Location, Orientation, Photographer Initials: Upstream of Riffle, Downstream View, RH/AR
Lat: 38.405683 Long: -80.591116
Date: 9/8/2021

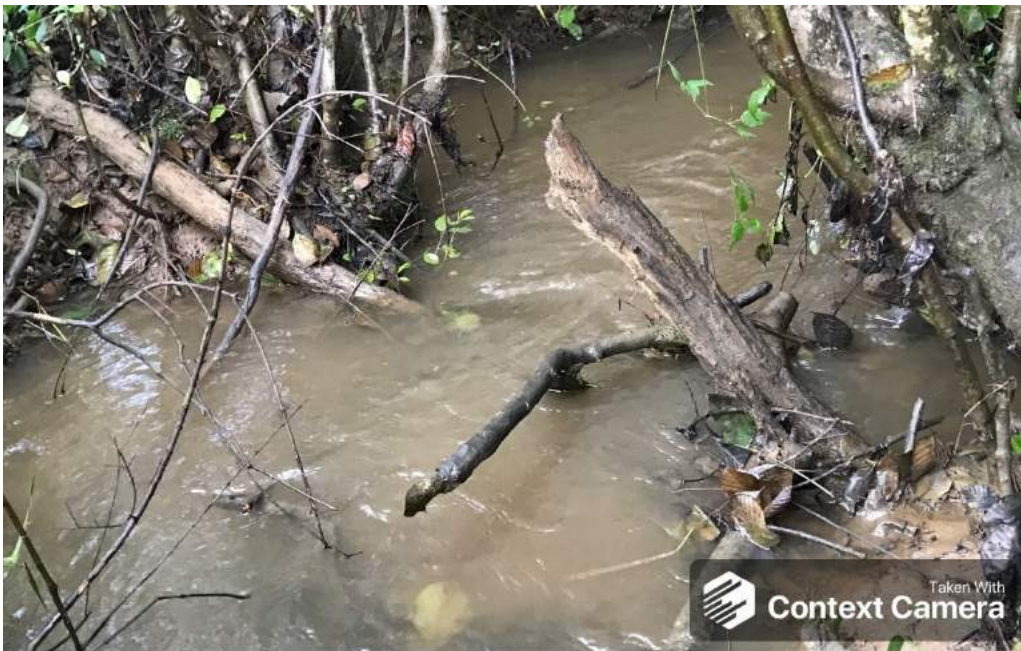
Photo Type: Riffle, US View
Location, Orientation, Photographer Initials: Downstream of Riffle, Upstream View, RH/AR
Lat: 38.405683 Long: -80.591116
Date: 9/8/2021

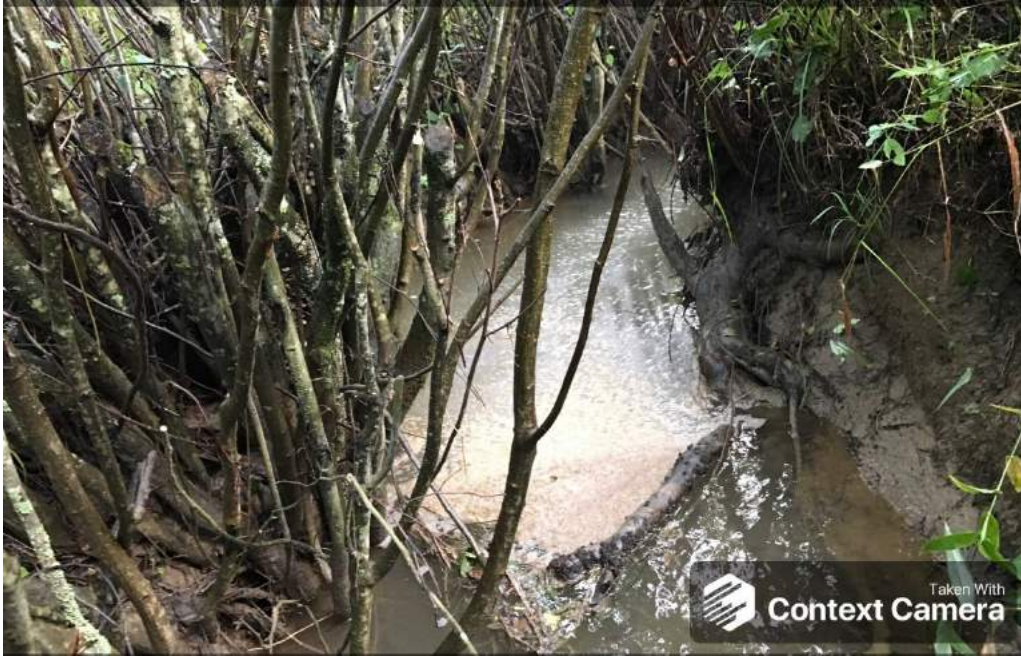
Photo Type: Pool, DS View
Location, Orientation, Photographer Initials: Upstream of Pool, Downstream View, RH/AR
Lat: 38.405683 Long: -80.591116
Date: 9/8/2021

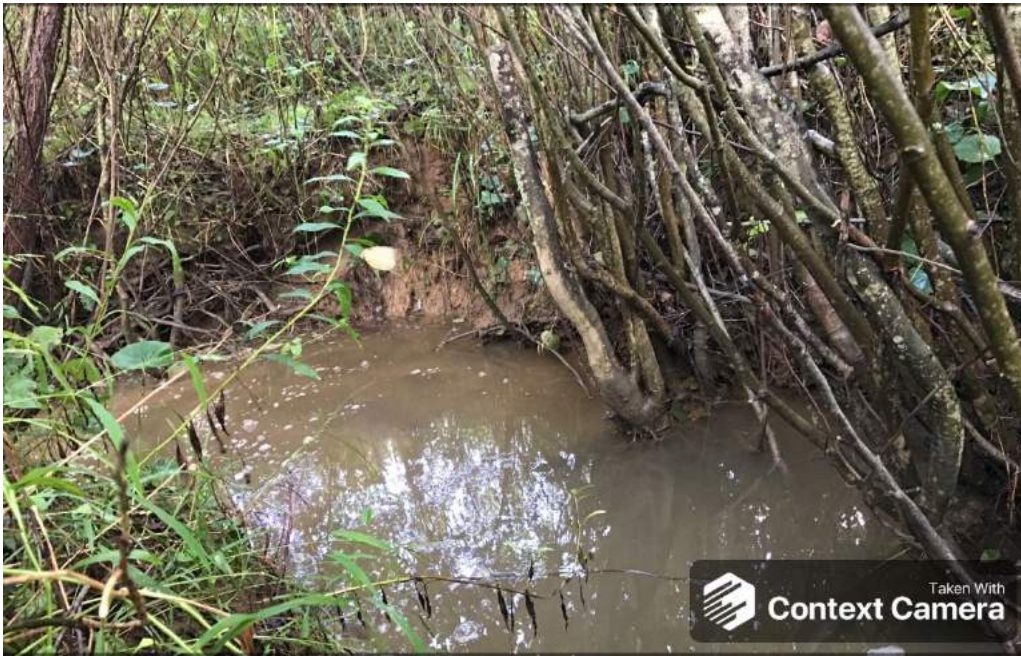
Photo Type: Pool, US View
Location, Orientation, Photographer Initials: Downstream of Pool, Upstream View, RH/AR
Lat: 38.405683 Long: -80.591116
Date: 9/8/2021

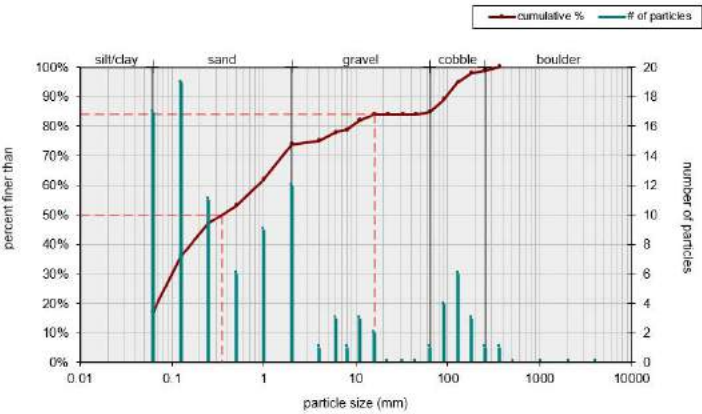
Bankfull Channel Pebble Count, S-B32

Size (mm)		Size Distribution		Type	
D18	0.062	mean	1.0	silt/clay	17%
D35	0.12	dispersion	25.7	sand	57%
D60	0.35	skewness	0.29	gravel	11%
D65	1.2			cobble	14%
D84	18			boulder	1%
D95	130
